ROOKS NEST FARM, HIGH STREET, WALKERN, HERTFORDSHIRE

ARCHAEOLOGICAL MONITORING AND RECORDING

ARCHAEOLOGICAL SOLUTIONS LTD

Author: P. Harris MA		
C. Hallybone BSc, MSc		
NGR: TL 2873 2582	Report No: 2180	
District: East Hertfordshire	Site Code: AS 1008	
Approved: Claire Halpin	Project No: P2143	
Signed:	Date: May 2007

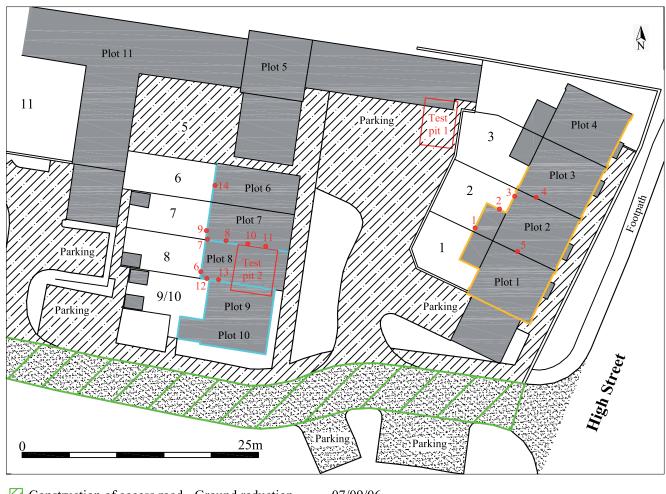
✓ Construction of access road - Ground reduction
 ✓ Excavation of test pits 1 and 2
 ✓ Excavation of foundation trenches - plots 1-4
 ✓ Excavation of foundation trenches - plots 6-10
 ✓ Excavation of foundation trenches - plots 6-10

●¹ Sample sections
