**7 COWBRIDGE,
HERTFORD,
HERTFORDSHIRE**

HISTORIC BUILDING APPRAISAL

7 COWBRIDGE, HERTFORD, HERTFORDSHIRE HISTORIC BUILDING APPRAISAL

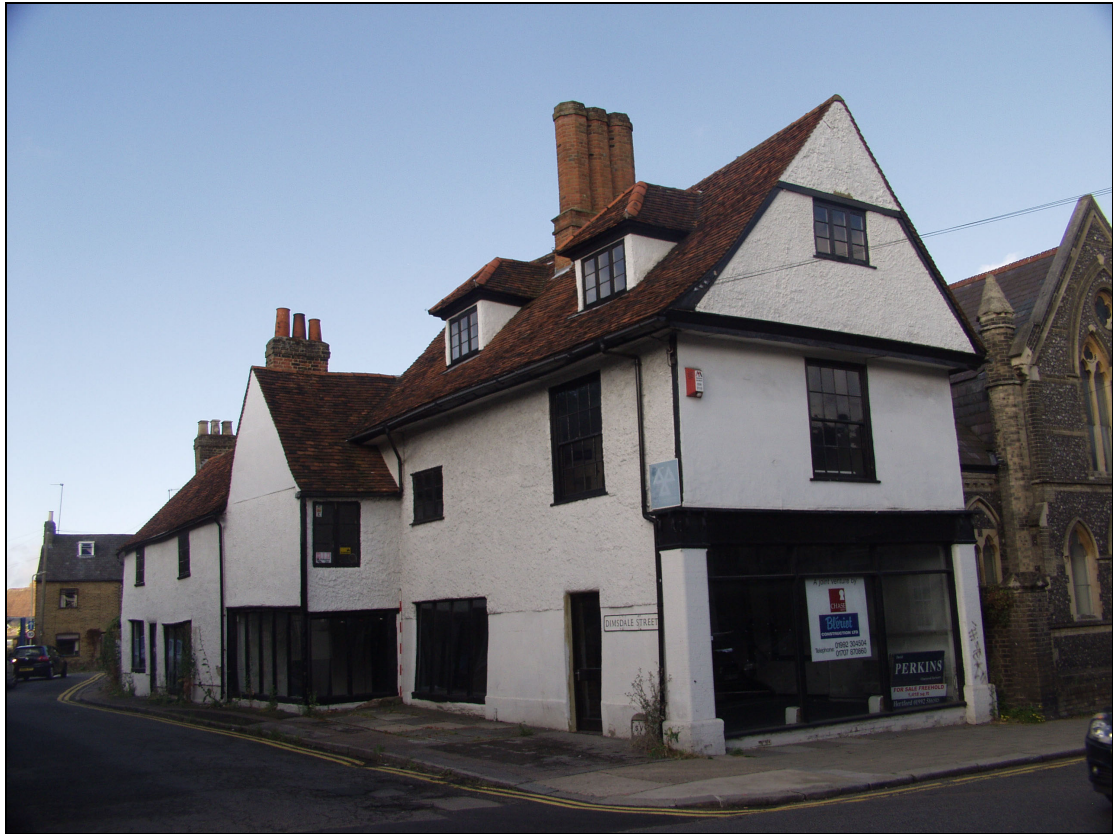
Plate 1 View of assessment building, taken from the north-east (6)

4.2.2 The exterior is mostly rendered with rough-cast, much probably of 20th century date, now coated with masonry paint (Plate 1). In the upper gable ends and other discrete areas, however, more traditional plaster-work with ashlar-lining and pargeting survive. This was probably the universal medium before the 20th century fashion for the rougher, textured finish which we now see over much of the building.

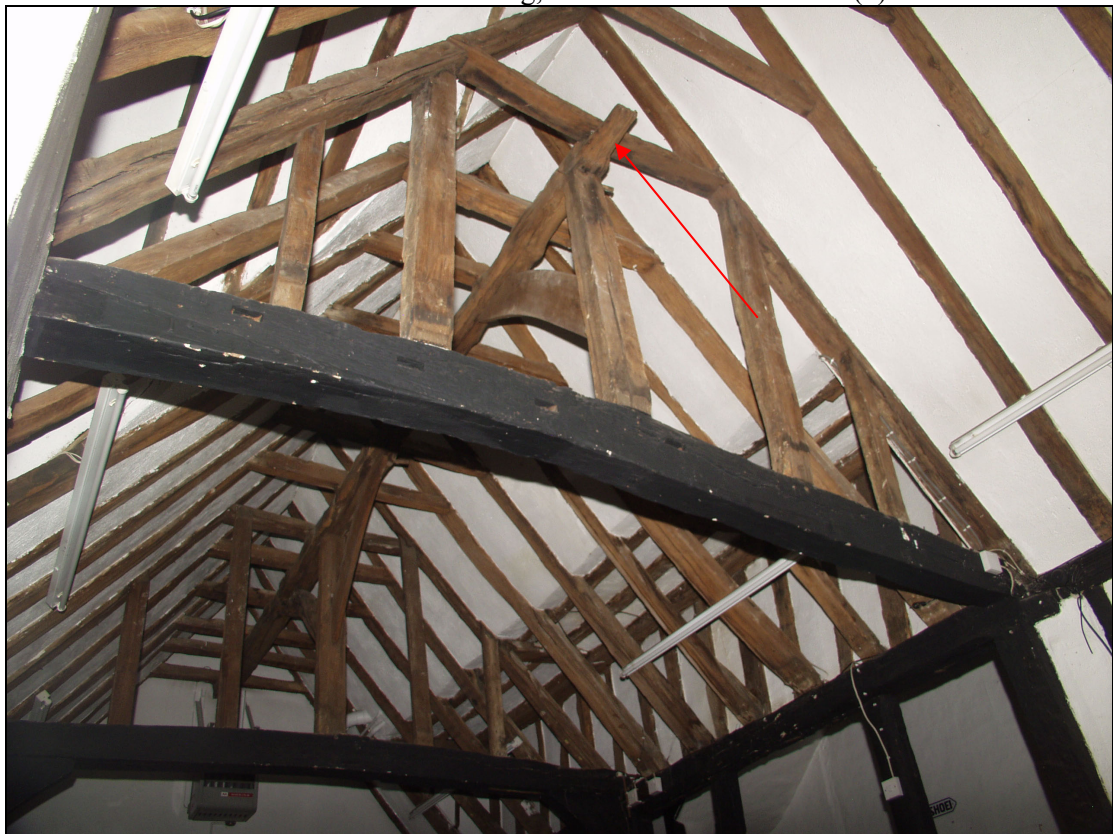
Plate 2 Roof structure of the central range showing crown-purlin stump (indicated) to the original gable end, taken from the south-east (40)

4.3.2 Two bays of the original, central 15th century range survive. This may have been truncated on the west, where the building has been walled up in yellow brick, but further analysis would be needed to establish this. Most importantly the building preserves its original, open crown-post roof intact.

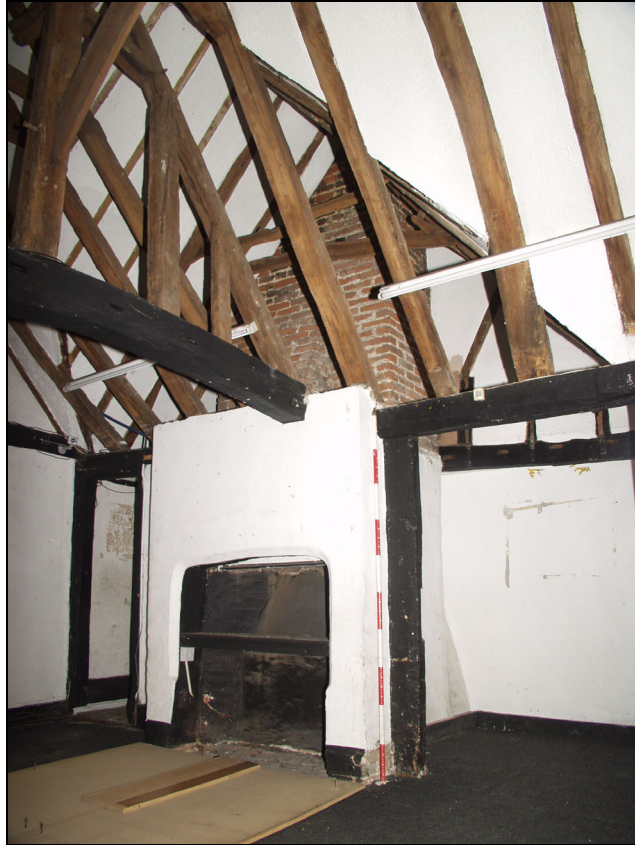
Plate 3 Detail of fireplace and chimney extension in Room 7, first floor of the central range, taken from the north-west (42)

4.3.5 In the early 17th century, the existing chimney stack was added to the south, attached to the exterior (rather than being installed in an internal position), with a small gable spanning the gap thereby introduced between the brickwork and the roof. The roof here is of rudimentary trapped side-purlin form (Plate 3), but clearer dating is given by the fabric of the

bricks and the treatment of the fireplace surround (with flattened, chamfered arch and high stops to the jambs), suggesting that it was built at the same time as the north range, which displays identical characteristics.

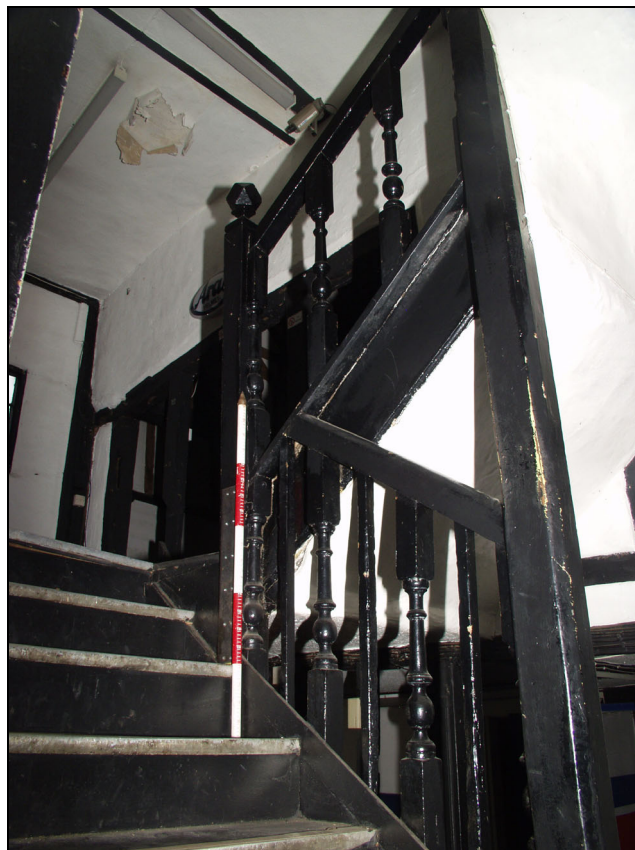
Plate 4 Detail of staircase, north range, taken from the north-west (26)

4.3.9 The staircase is of considerable interest (Plate 4). The manner in which it winds around a central, partly-chamfered newel running up through the building is traditional, but other elements, such as the balusters and decorations have probably been added. The handrail is of fairly simple profile, while the first floor newel preserves a moulded top with a rhomboid finial. This, together with the shape and wide spacing of the balusters suggest it was upgraded in the later 17th or early 18th century; a date around 1680 could be suggested.

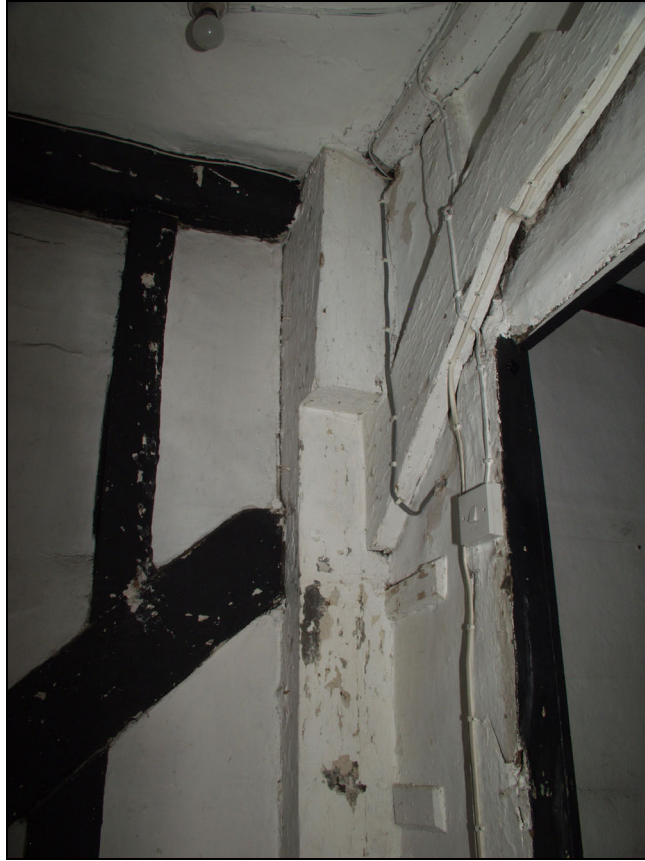
Plate 5 Detail within cupboard on south-west of Room 5, first floor of the north range, taken from the west (30)

4.3.10 At first floor level there is a disparity of floor levels, perhaps deliberately intended to give the lower, principal room a high ceiling. The upper chamber (Room 5) is now reached by a short flight of steps, through a 17th century doorway, which preserves heavy chamfers and lamb's-tongue chamfer stops to the jambs, which are of the same date as the other exposed decorative timbers. The flanking in-fill panels are probably also of contemporary date, though no original door survives, and the existing applied architrave is of 19th century date. The room itself also preserves good original fabric. On the north wall, for example we see heavily jowled corner posts, while the east window has a 17th century surround, though the mullions have been replaced. The fireplace is an exceptional survival. In form, it has the flattened arch with high stops on chamfered jambs as we see in the central range, but the aperture was probably blocked for many years, as it preserves its original ruddling or colour-washing to the internal cheeks and back, which is extremely rare, and most unusual given the level of modification we see elsewhere. In addition, a cupboard to the west of the chimneystack has a 17th century door architrave with 19th century door frame. The flanking walls comprise studwork, with heavy lath and plaster, along with a cranked brace rising from the bay division post on the west (Plate 5).

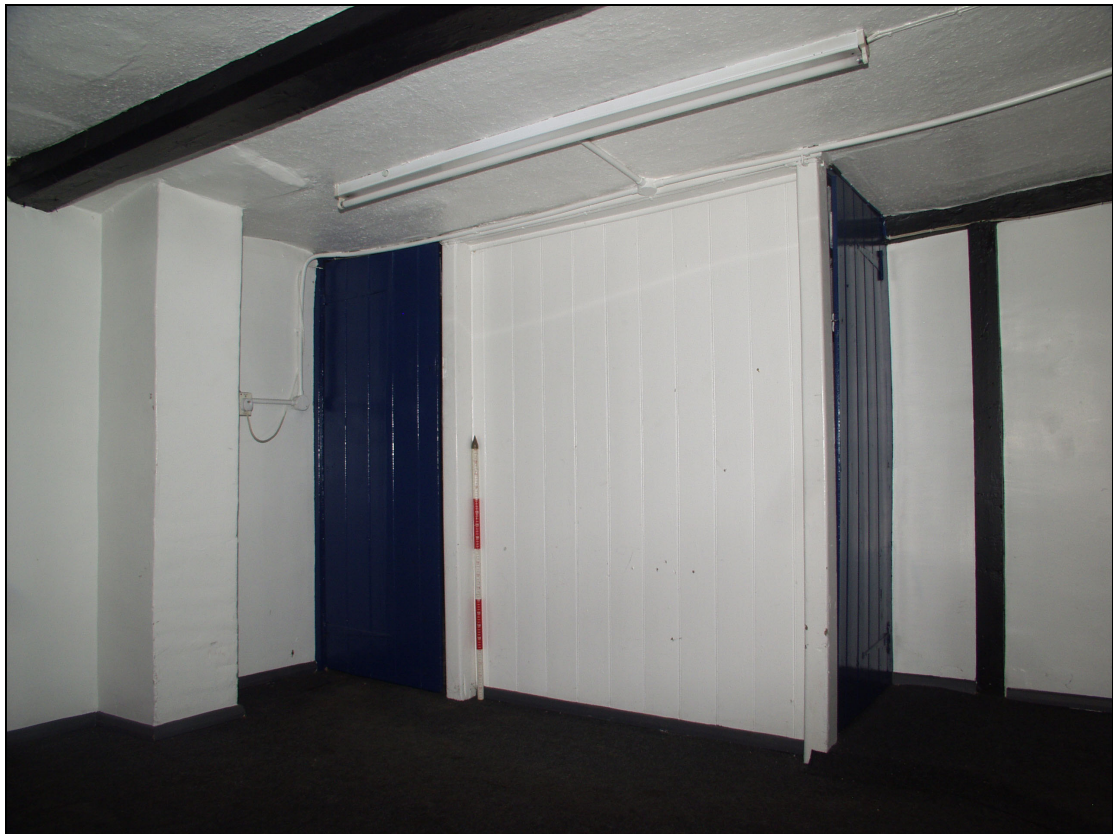
Plate 6 Room 4, ground floor of the south range, taken from the north-east (23)

4.3.12 The south range is the most recent and modest addition to the complex. Elements such as the window surround and lack of decoration suggest this was a service range, providing kitchens and other functions. Much less fabric is visible, making clear interpretation difficult, but overall several elements point to the late 17th / early 18th century for construction. At ground floor level little of interest is visible, aside from a re-worked fireplace on the north and the 19th century compartment on the west enclosing a modest back-stair (Plate 6).

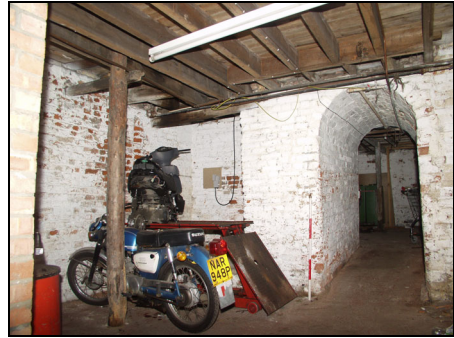
10.

North area of the south range cellar, with arch supporting the chimneystack above, taken from the south

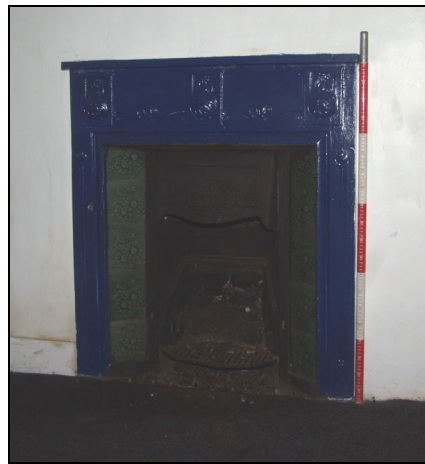
18.

Fireplace in Room 3, ground floor of the central range, taken from the north

7 – Alterations to the chimneystack on the east – possible impact on historic fabric if this includes the removal of fire surround and grate dating to turn of 20th century. This area is also likely to block a larger, earlier aperture.

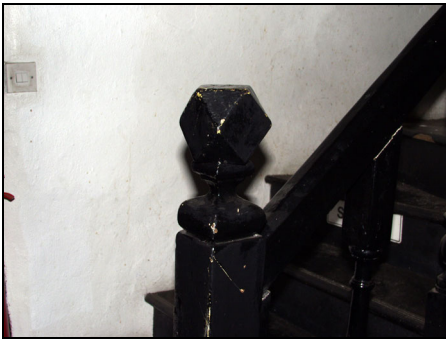
27.

Finial on newel of staircase in the north range, taken from the north-east

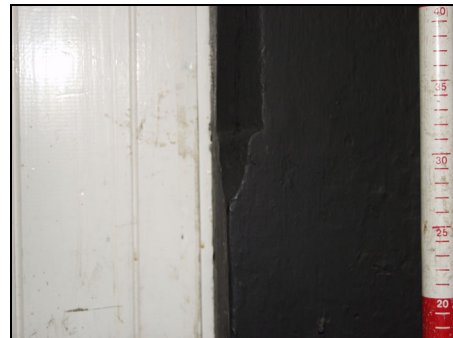
34.

Wave moulding to door architrave to Room 5, first floor of the north range, taken from the south-west

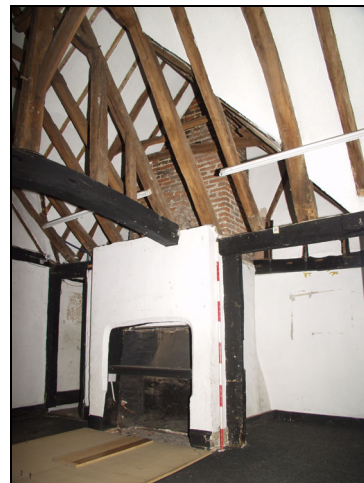
42.

Detail of fireplace and chimney extension in Room 7, first floor of the central range, taken from the north-west

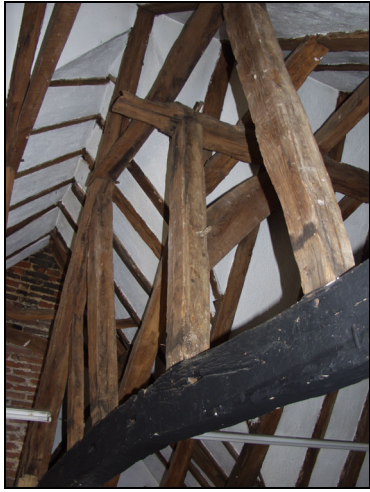
43.

Detail of weathered crown-purlin in roof of the central range, taken from the north-east

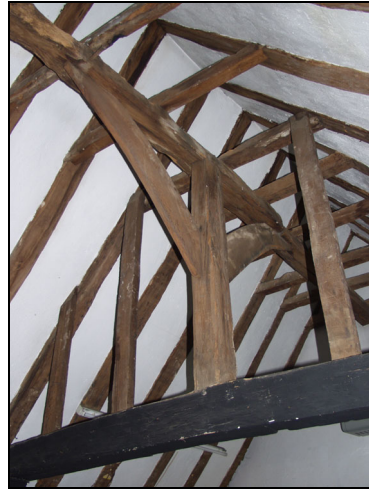
44.

Detail of crown-post in roof of the central range, taken from the north-east
