**LIME COTTAGE & THE WALLED GARDENS
BALLS PARK, HERTFORD**

HISTORIC BUILDING RECORDING

Author: Matthew Williams MA MSc	
NGR: TL 3350 1198	Report No. 3268
Parish: Hertford	Site Code: AS 1070
Approved: Claire Halpin MIFA	Project No. 2606
Signed:	Date: March 2009

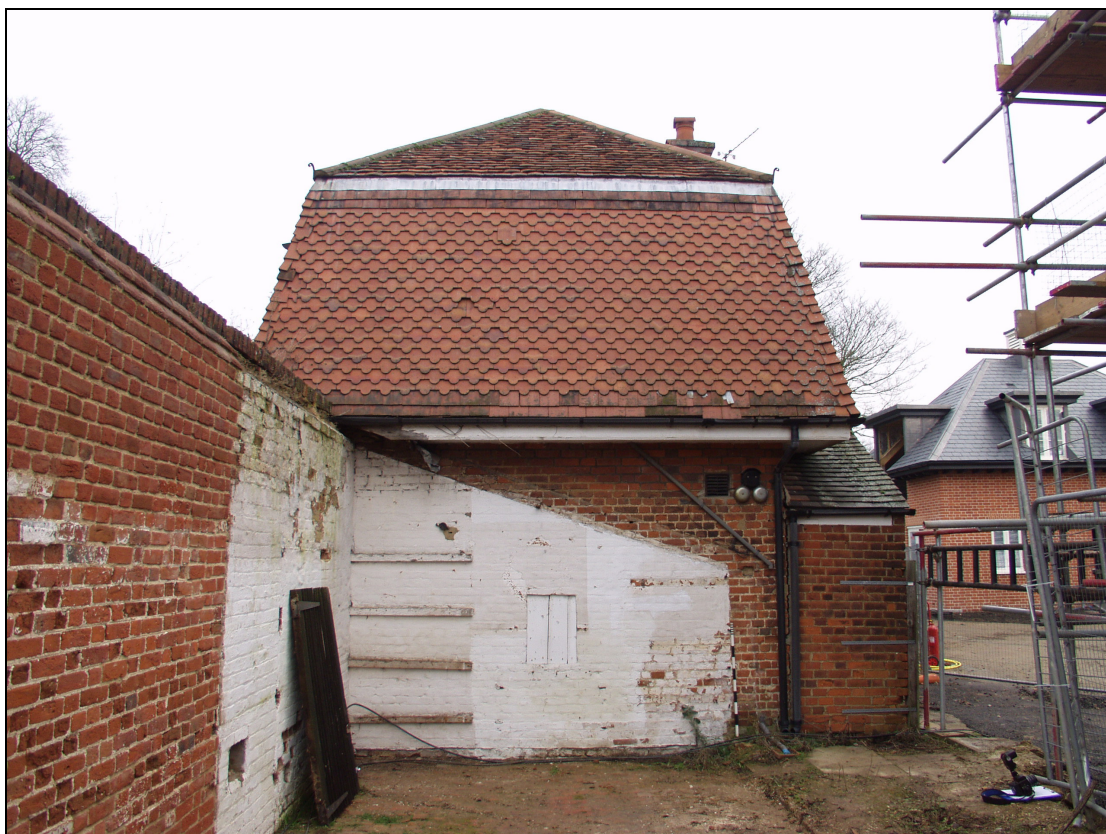
5.1.2 The south elevation of Lime Cottage reveals the former position of the outbuilding as it preserves the limewash with which the building's interior was painted (Plate 1). Wooden battens to support storage shelves in the outbuilding also remain, along with a small hatch which appears to give access to the interior of the cottage but is now blocked with rudimentary wooden planking. The limewash and shelving can also be traced on the adjacent garden wall against which the former outbuilding was constructed. The footprint of the outbuilding is also still visible and retains flooring apparently of late 19th century date composed of a type of pavement presenting a surface measuring 8¾" x 4¼" with an unknown depth.

1 South elevation of Lime Cottage, forming the side wall of the demolished outbuilding, taken from the south (2)

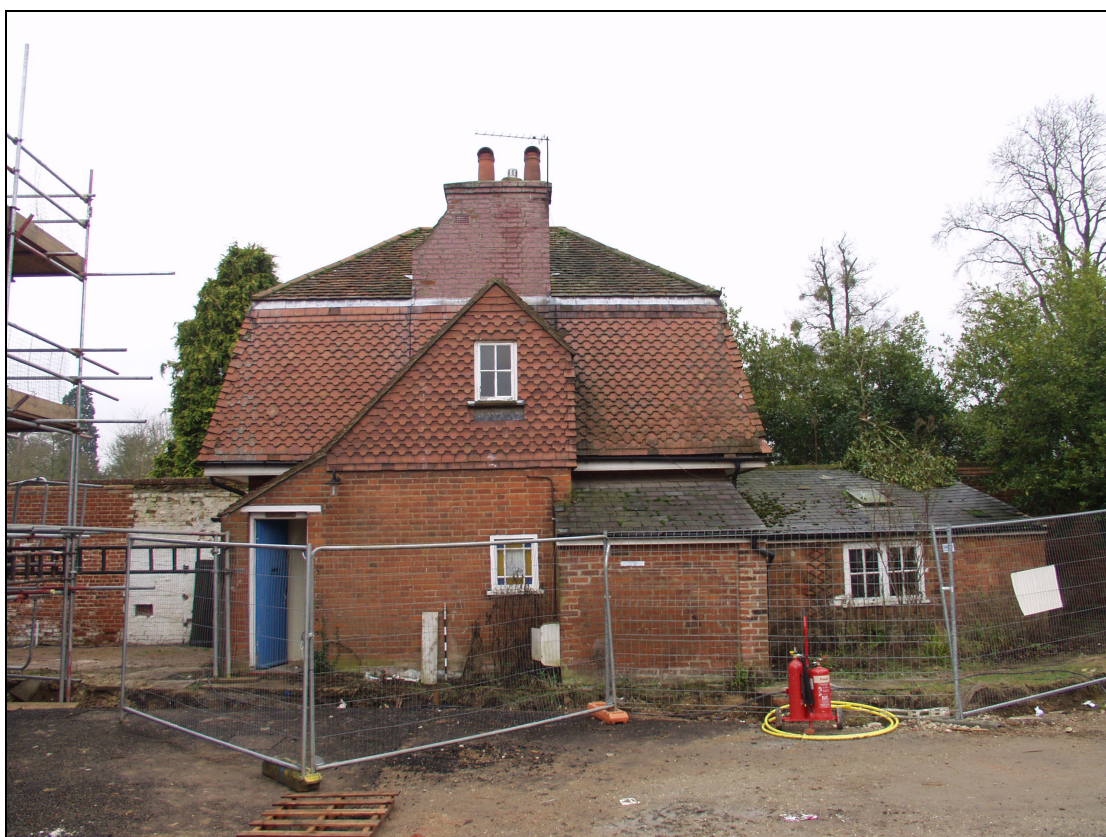
5.1.5 The east, principal elevation of Lime Cottage faces away from the walled garden and is all in the later red brick bonded with cement mortar seen in parts of the south elevation (Plate 2). The ground floor entrance door to the south of the façade is probably original and is of vertical five-boarded form with a small letter box. This leads into a stair tower which projects slightly from the main body of the building and has its own asymmetrical pitched roof with machine-made red tiles. To the right of the entrance at the base of the stair tower is a small rectangular window which lights the WC beneath the stairs and retains a simple floral decorative scheme in blue, yellow and clear glass, typical of the early 20th century. To the right is a small pent slate-roofed outshut containing the bathroom which presents a plain brick wall on this elevation. It has a small window dating from the 1950s – 60s to the north side with a fixed lower panel and a smaller top-opening casement, both in plain obscured glass. The brickwork of this outshut is not keyed into that of the rest of the building behind, suggesting that it may be an extension of slightly later date.

2 East elevation of Lime Cottage, taken from the east (3)

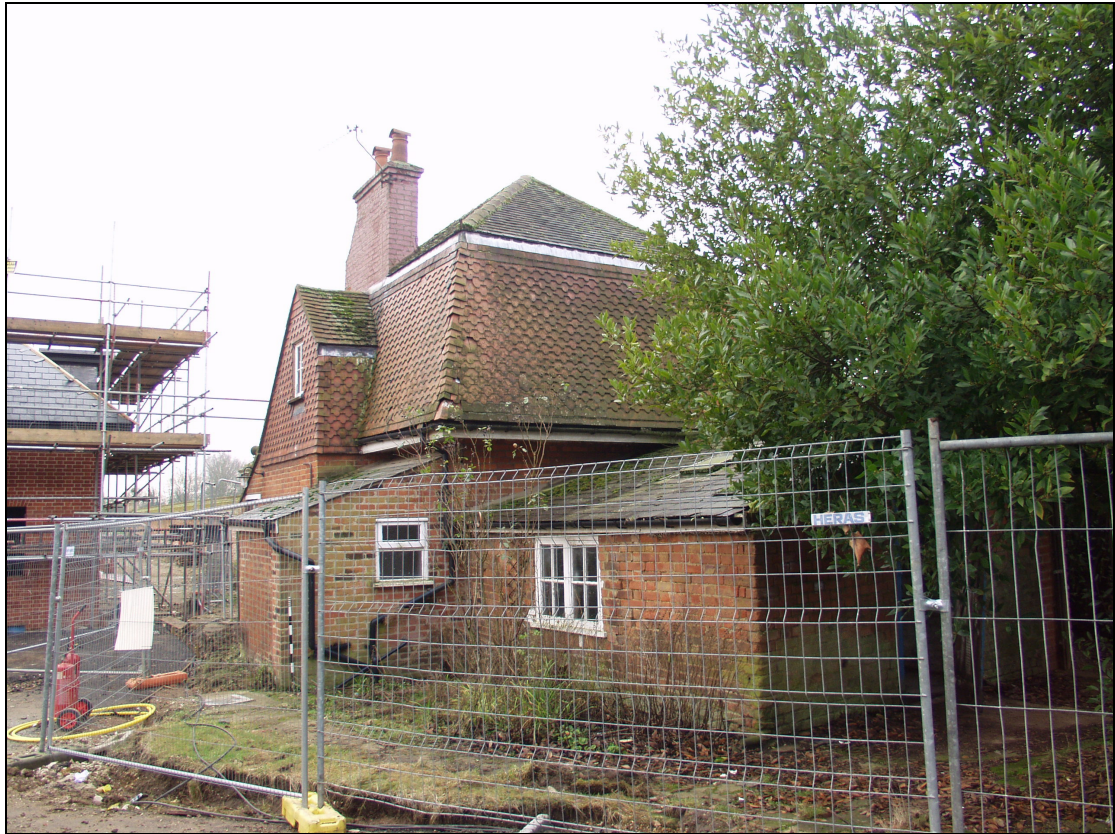
5.1.7 The north elevation is largely concealed by the outshut containing the bathroom, discussed above, and by the surviving outbuilding to the north (Plate 3). In the small area of brickwork which does remain visible on the ground floor of the main cottage, the same division can be seen as on the south elevation between a much older lower section with hand-made bricks in lime mortar and, from about 2 m upwards, a more modern section with later bricks in cement. Above this the Mansard roof is of the same form as before.

3 East elevation of Lime Cottage, taken from the north-east (5)

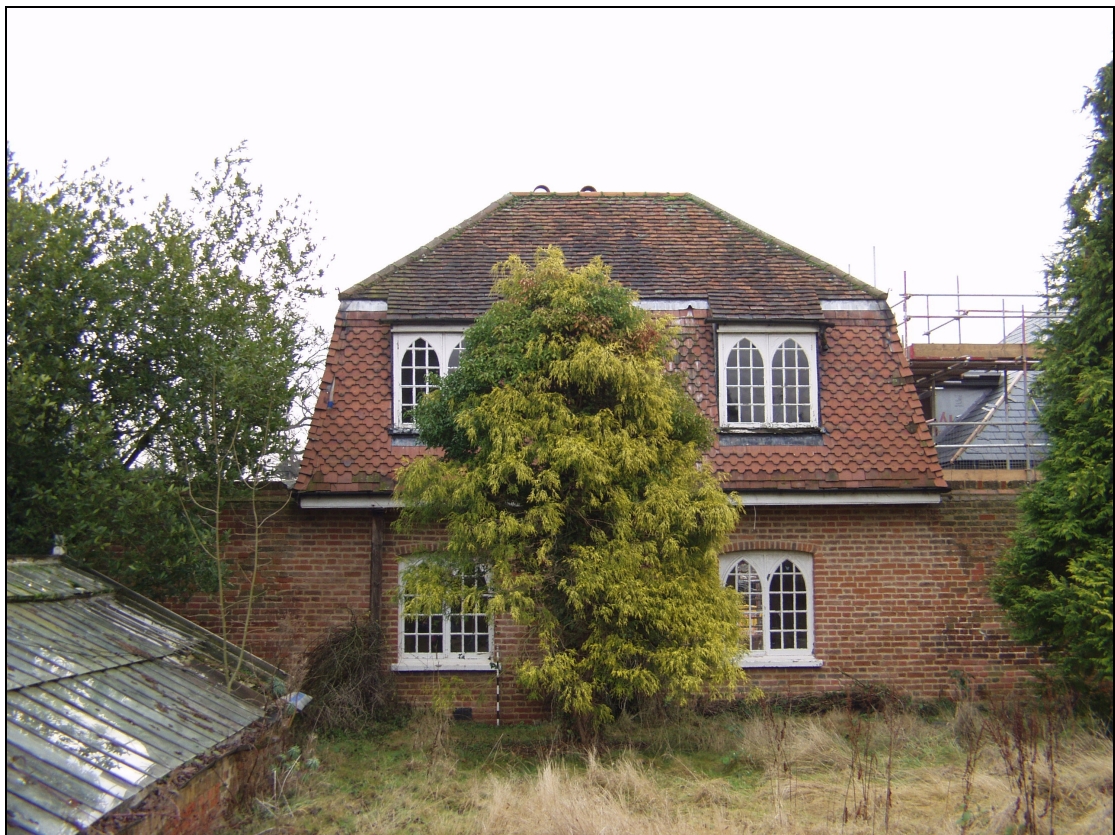
5.1.9 The west elevation of Lime cottage faces the estate's walled garden (Plate 4). The ground floor is indistinguishable from the garden wall and this 18th century structure appears not to have been interfered with except by the removal of any capping and the insertion of two pairs of windows. It is built of large bricks with lime mortar joints as before, and has recently been sympathetically re-pointed.

4 West elevation of Lime Cottage, taken from the west (6)

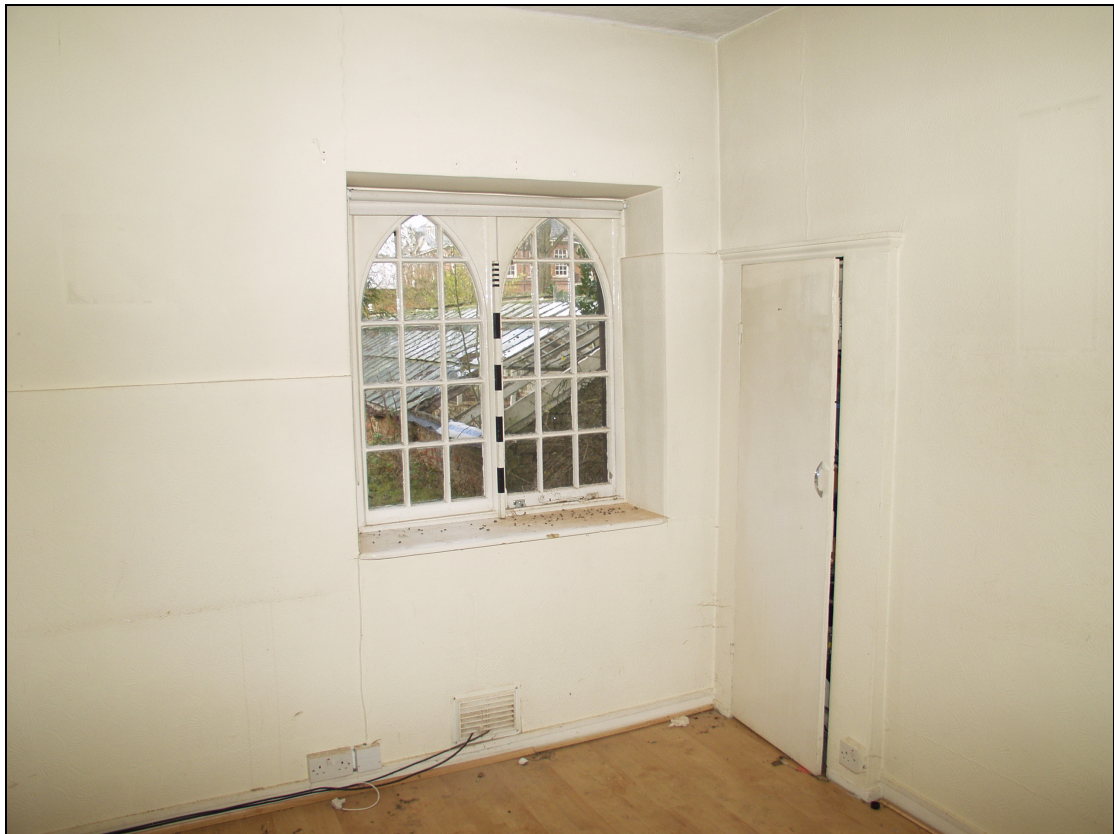
5.2.4 The only features of historic interest in the sitting room are the pair of Gothic windows and a well-concealed cupboard of late 19th century date in the north-west corner (Plate 5). The Gothic windows retain the same internal fixtures as the pair described above in the kitchen although here the L-shaped strengthening strap is missing. The cupboard is given access by a very small wooden door with four vertical boards and three ledges disguised on the front by a plain painted board and chrome handle of 1960s – 70s date. Although the cupboard now houses the electricity meter and fuse box for the building it retains vertical wooden boarding and the remains of a row of coat hooks which are both of typical late 19th century form.

5 Ground floor living room in Lime Cottage, taken from the south-east (12)

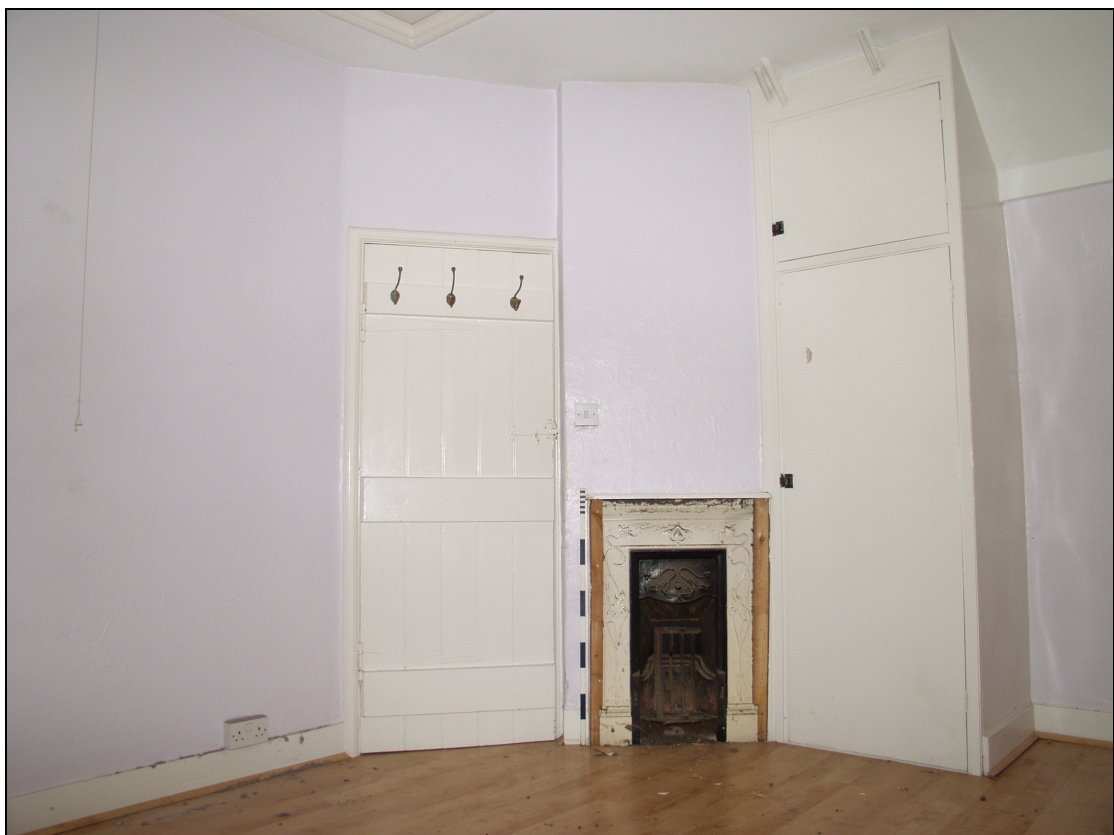
5.2.9 The skirting, laminated pine flooring and a built-in wardrobe to the north-east corner are all modern. However the pair of Gothic windows to the west wall survive, as described above, and retain all the internal fixtures noted on the ground floor. In addition between the door and the cupboard in the north-east corner an original cast iron fire grate survives which is of some interest as it is decorated with an unusual floral decorative scheme influenced by the contemporary Art Nouveau movement (Plate 6).

6 South bedroom on first floor of Lime Cottage, taken from the south-west (17)

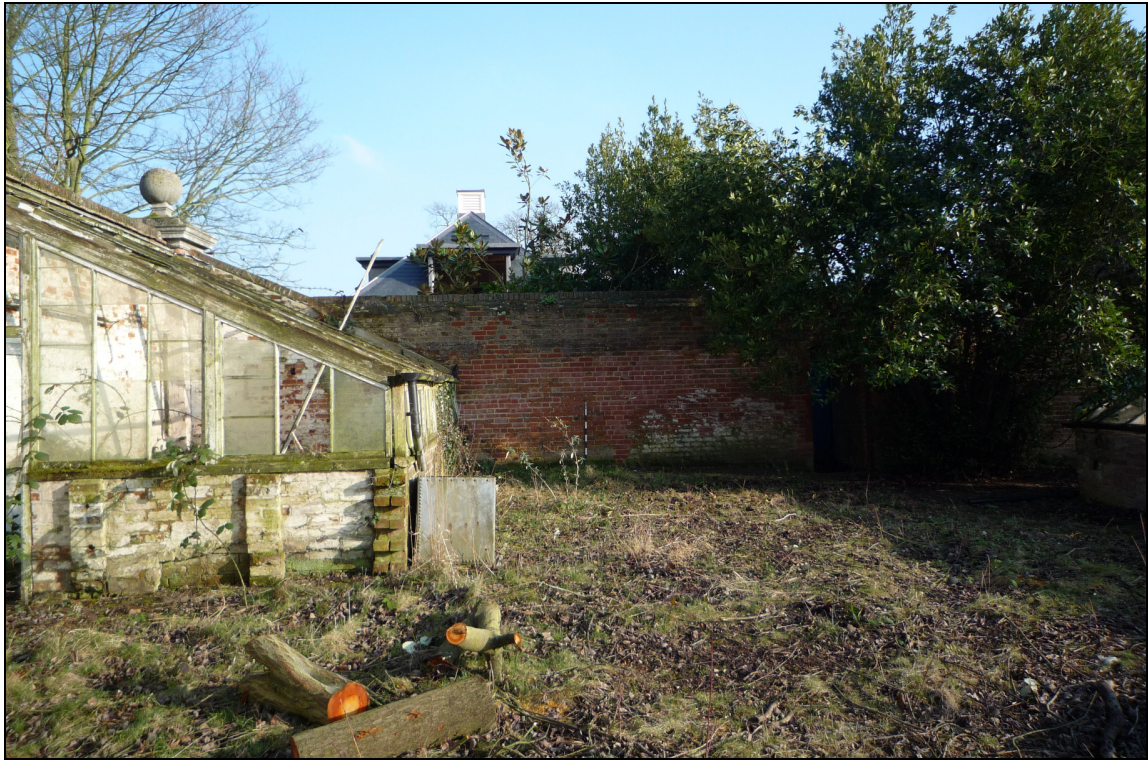
7 Vestigial greenhouse and north section of the east wall of the north walled garden, taken from the west (30)

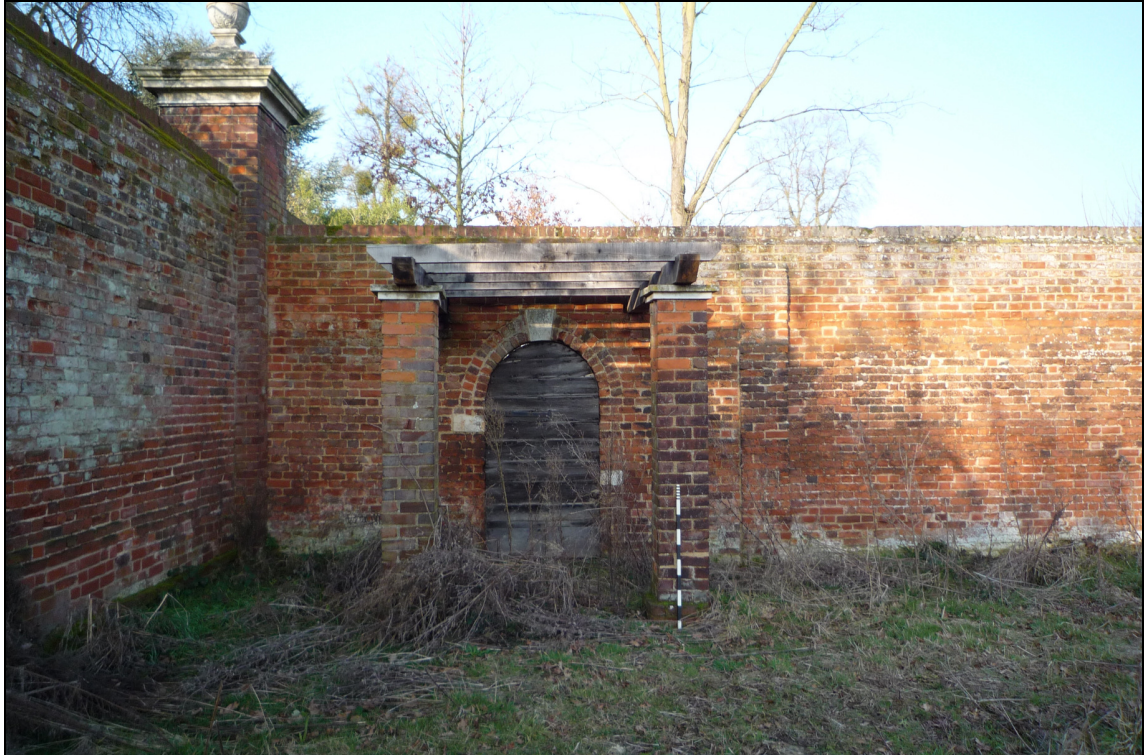
8 West section of the north wall of the south walled garden, and typical pagoda and gate, taken from the south (37)
