# SALPERTON, MERRY HILL ROAD, BUSHEY, HERTFORDSHIRE HISTORIC BUILDING RECORDING

Authors: Matthew Williams MA M Lee Prosser BA PhD	/ISc
NGR: TQ 1334 9444	Report No. 3202
Parish: Bushey	Site Code: AS 1178
Approved: Claire Halpin MIFA	Project No. 3234
Signed:	Date: December 2008

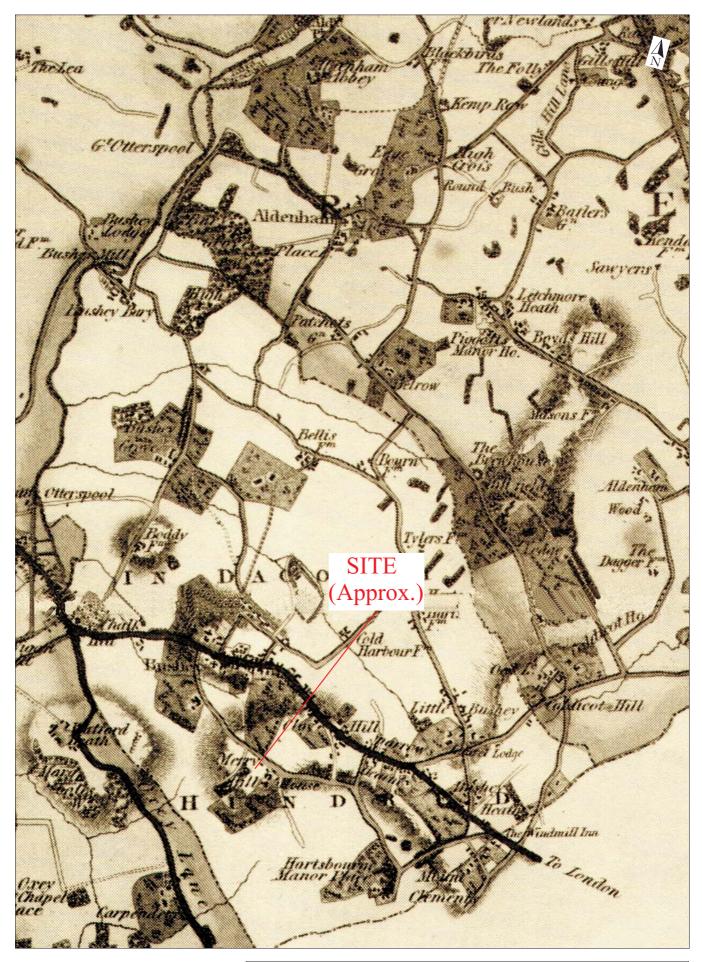
Archaeological Solutions Ltd Fig. 6 Bryant's map of Hertfordshire, 1822 Not to scale

Like Dury and Andrews' Map of 1766, this map gives rudimentary illustrations of the buildings and roads on the site, these having remained unchanged since 1800. Bryant's map, however, provides more information about the surrounding area. This appears to remain as largely open countryside although it is notable that both Bushey and Watford have grown considerably in the period since 1766, the outer parts of Watford having crossed the River Colne and advanced south-east.

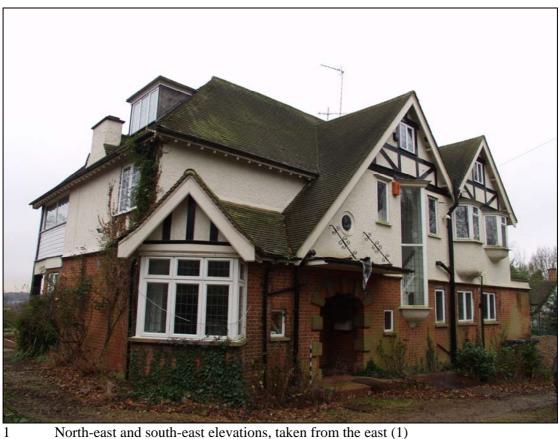
6.1.1 Salperton is a typical large, late Victorian or Edwardian house in eclectic style, using a combination of motifs such as brick and rough-cast render, projecting hoods and other rustic features, perhaps in emulation of the work of Voysey, but clearly more conservative and diluted in form. The house is set back from the road and screened with mature trees. It is faced in sandy red brick laid in Flemish bond on the ground floor with painted roughcast render above and machine-made tiles to the roof. The rear façade is arranged with an asymmetry typical of the time, pitching a corner bay, double gables, a long stair and oriels within gables together in a seemingly haphazard manner, but clearly with order and thought to internal layout and usage while projecting a picturesque ensemble (Plate 1). Other typical features include heavy bargeboards, faux timber-framing, some decorative ironwork which supports the porch hood, and shaped corbelled supports to oriel windows. What has most conspicuously been lost is the original timber window treatment, which has been replaced without exception with plastic double-glazing.

North-east and south-east elevations, taken from the east (1)

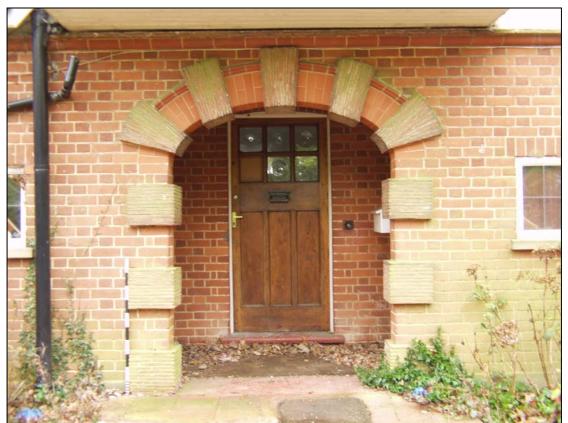
2

6.1.2 The principal doorway is off-set to the left and recessed within an open porch (Plate 2). This is protected by a flat projecting canopy of simple timber boarding suspended from two decorative, scrolled iron brackets. The doorway forms a wide elliptical arch with voussoirs alternating fine gauged brickwork and bold projecting quoins of composite flat tiles to give a rusticated effect. Much of the surrounding brickwork preserves the original pointing which is of fine, buff coloured lime mortar with small flint pieces. A moulded brick string-course marks the division between the lower brickwork and upper render.

Detail of the porch and main entrance, taken from the north-east (2)

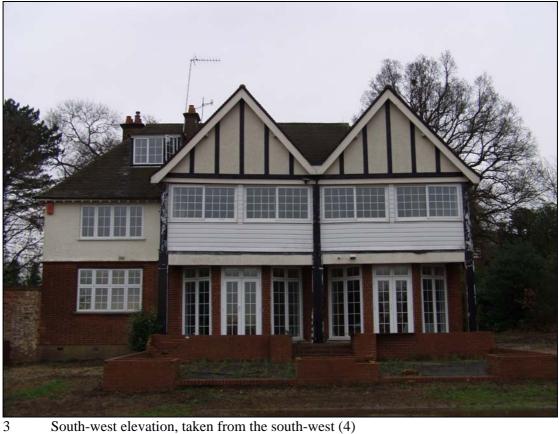
6.1.4 The south-west, garden elevation is less elaborate but displays more conventional symmetry (Plate 3). Two deeply-projecting gables enclose bay windows to the main reception rooms, and an extensive balcony above, designed to take in the views and to provide a verandah, now latterly enclosed with plastic boarding and windows. The adjoining ground floor windows are now both three-cant bays, but lie within semi-circular profiles which might indicate the original pattern. The balcony was originally framed with robust posts decorated with chamfers and inset medallions, but most is now obscured by later reinforcement and crude boxing-in with plywood. There is no trace of the original balustrade, but the balcony is floored with lead, indicating that it was originally open. The upper parts of the gables preserve the faux timbering seen elsewhere, though the bargeboards are simpler and probably replaced. To the left is a wide kitchen window to ground floor, with a bedroom window above. The attic preserves dormer windows with flat roofs. Immediately adjoining the house, the garden has been extensively remodelled with a stepped patio and brick planters, all in modern materials.

South-west elevation, taken from the south-west (4)

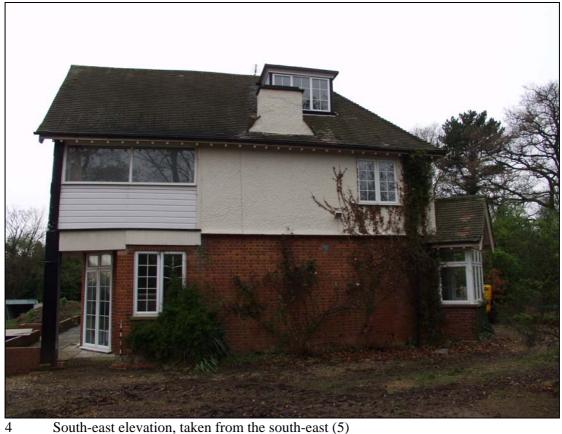
6.1.6 The south-east side elevation is fairly simple (Plate 4). There is a single side window accompanying the main bay window frontage along with a single upper window adjoining the side of the former balcony described above. Chamfered timbers can be seen framing the balcony here as on the south-west elevation. Protruding rafter ends may also be seen; the fact that they are not interrupted by the chimney confirms that these are primarily decorative. The chimney stack, though truncated still retains its shoulders.

South-east elevation, taken from the south-east (5)

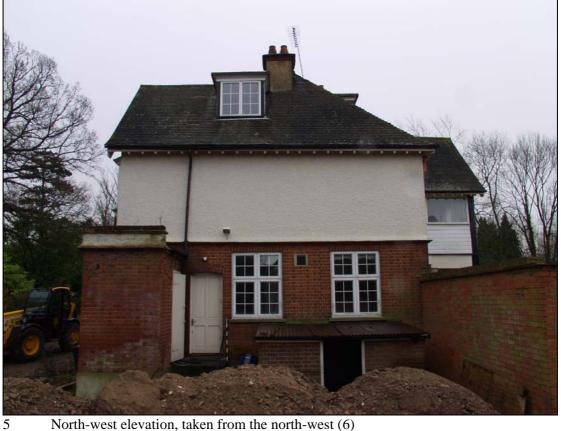
6.1.7 The north-west elevation incorporates the former kitchen yard (Plate 5). A flight of steps gives access to the original back door. Unlike all the other openings, which have flat heads or 'soldier' arches, this has a cambered voussoir. To the left a brick-built, flat-roofed lavatory survives, while adjoining the step is a pent-roofed lean-to with a corrugated sheet roof. The first floor is blank, while above this in the roof is a simple dormer window.

North-west elevation, taken from the north-west (6)

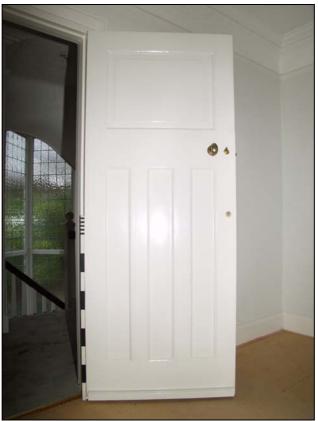
6 Detail of indicative door (bedroom two) (17)

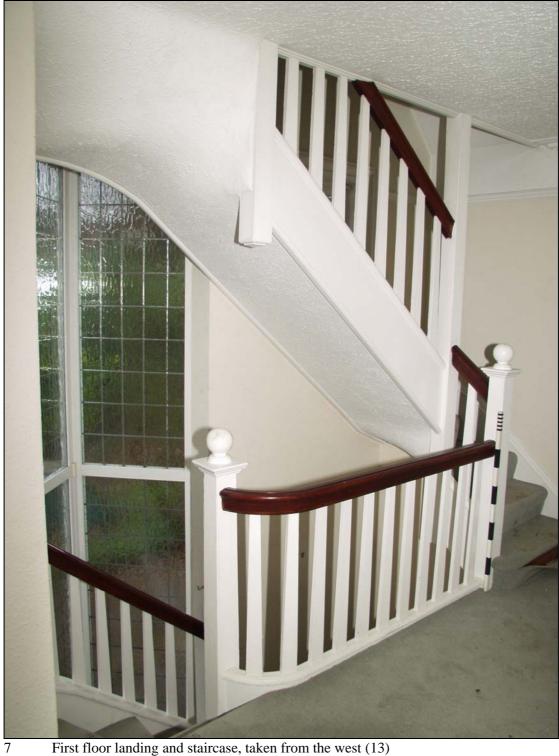
6.2.7 The narrow, winder staircase is typical of the Edwardian period. This has simple newels with a moulded cap and ball finial and flat balusters tapering slightly to a moulded handrail. The staircase is of closed string form with a curtail at the base. It rises through two storeys in the same style with a curved string on the first floor landing (Plate 7). It appears to be well-made with the hand rail pegged to the newels.

First floor landing and staircase, taken from the west (13)

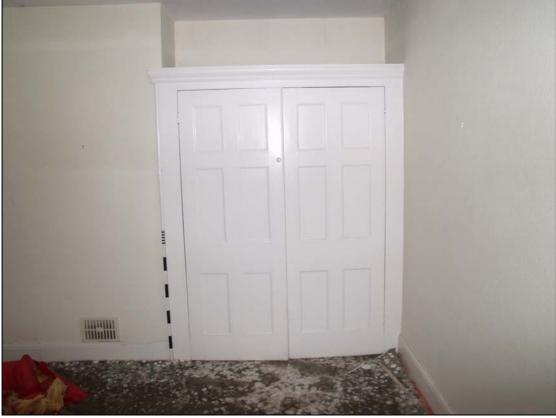
6.2.10 The second bedroom, lying over the dining room, is fairly modest. Original decorative features survive as in the master bedroom. There is a chimneybreast and a blocked fireplace to the north-west wall. The entrance door is of the same pattern as those on the ground floor (Plate 6). The bathroom adjoining the stair has a three-cant oriel bay window but otherwise retains no original features except the door and door case. A third bedroom lies directly above the kitchen and retains an original skirting and picture rail along with a typical door. There is a blocked fireplace to the northeast wall. Bedroom four has a typical door, three-cant oriel bay window and retains its original high skirting and a built-in wardrobe (Plate 8).

8 Detail of built-in cupboard to bedroom four, taken from the north-east (19)
