**HILLSIDE, LAMER LANE,  
LOWER GUSTARD WOOD, HERTFORDSHIRE**

**HISTORIC BUILDING RECORDING  
&  
ARCHAEOLOGICAL MONITORING AND RECORDING**

Authors: Amy Williamson BA Lee Prosser BA PhD Richard Greene MA AIFA Michal Rozwadowski Kathren Henry (Graphics)	
NGR: TL 1772 1562	Report No. 3164
Parish: Wheathampstead	Site Code: AS 1119
Approved: Claire Halpin MIFA	Project No. 3141
Signed:	Date: April 2008

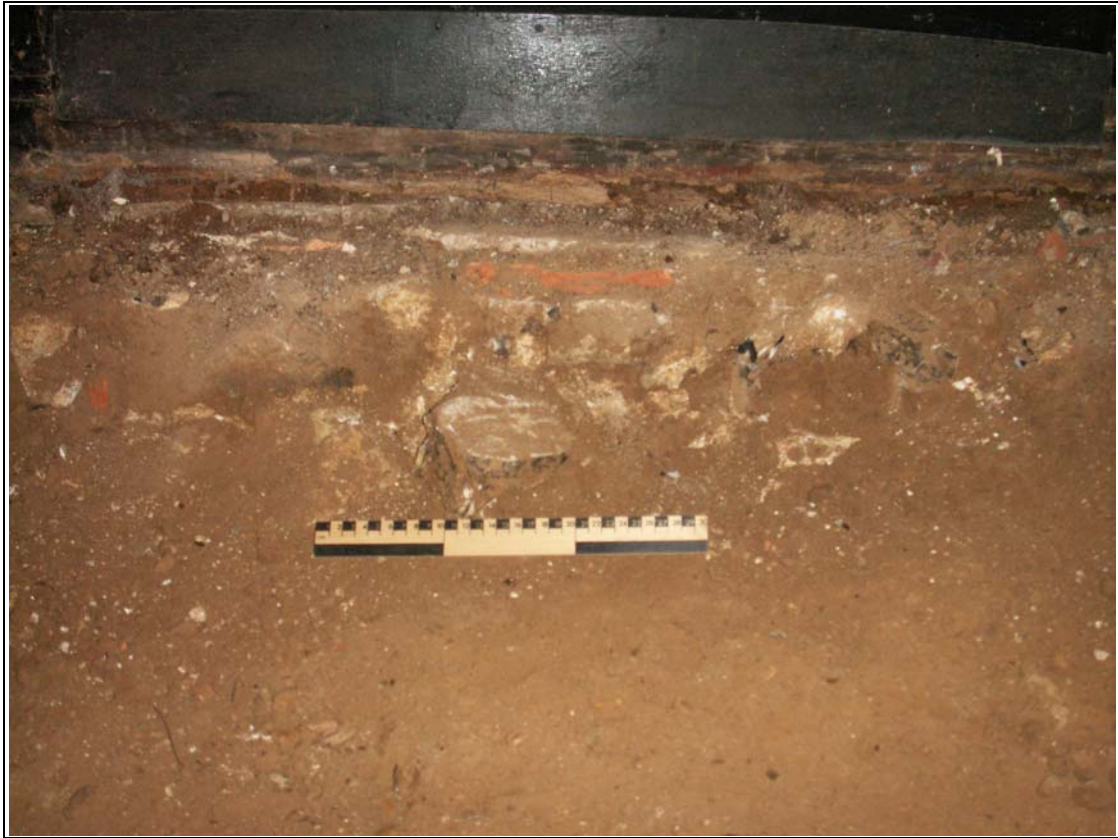
Plate 1 Section 1 looking south west

*Description:* Section 1 faced east and was located along the west wall under the west entrance/doorway within Room 1. Observed within the section was a flint and crushed chalk foundation (M1001) lying on natural subsoil (L1000) at a depth of between 0.03m and 0.20m. Above the flint and chalk foundation was a thin layer of mortar or compacted clay (M1003) that appeared to serve as a sub-floor for a tile floor. The tiles could be seen within the threshold of the doorway. It appeared that 3 or 4 courses of tile comprised the threshold below the wooden door.

<i>Sample Section 1</i>		
0.00 = 106.51m AOD		
0.0 – 0.03m	M1003	Mortar sub-floor or base for tiles.
0.03 – 0.20m	M1001	Flint stone and crushed chalk foundation.
0.20+m	L1000	Subsoil. Light yellow orange silty clay with white chalk flecking.

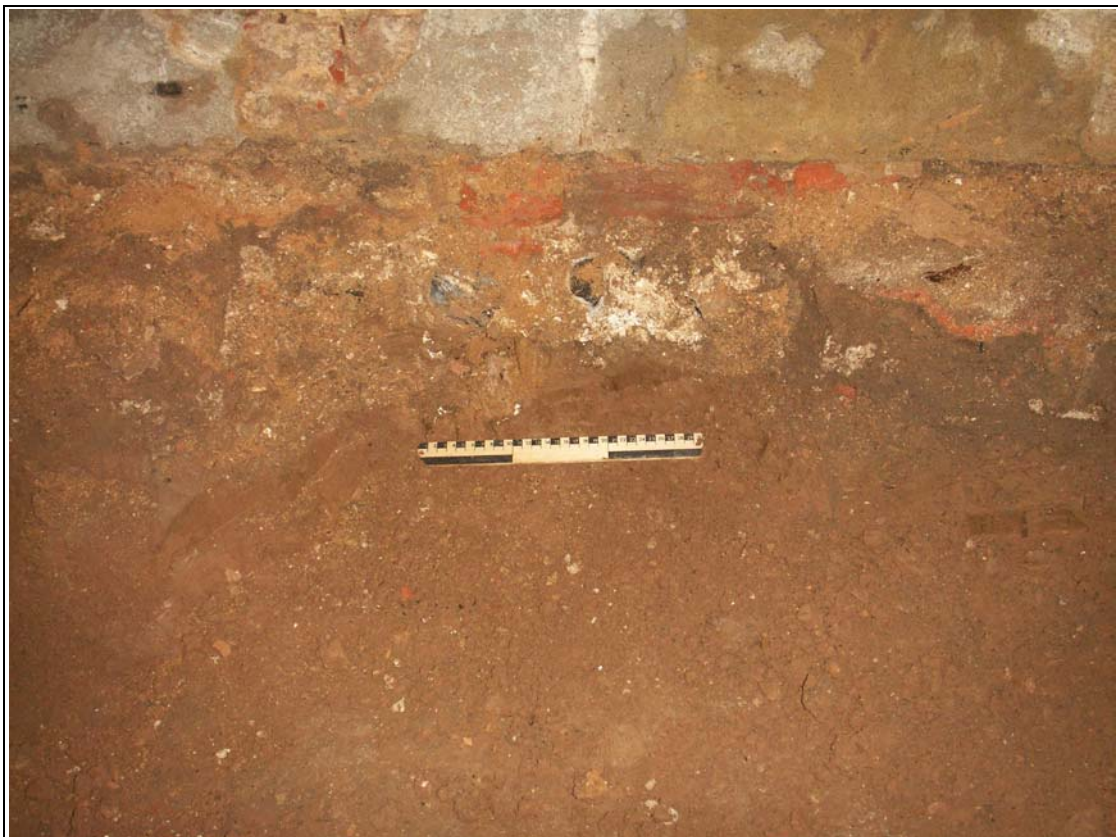
Plate 2 Section 2 looking north west

*Description:* Section 2 faced south and was located along the north wall within Room 2. Observed within the section was the flint stone and crushed chalk foundation (M1001) lying on the natural subsoil (L1000) at a depth between 0.10m and 0.20m. Above the flint stones and chalk was a course of red bricks laid end to end (M1002), which appeared to lay just below the surface of the dirt floor (between approximately 0.03m and 0.10m). Above this course were additional courses of red brick which were rendered with plaster. The mortar sub-floor M1003 was not obvious in this section.

<i>Sample Section 2</i>		
0.00 = 106.36m AOD		
0.03 – 0.10m	M1002	Brick, single course, part of foundation or sub-floor.
0.10 – 0.20m	M1001	Flint stone and crushed chalk foundation.
0.20+m	L1000	Subsoil. Light yellow orange silty clay with white chalk flecking.

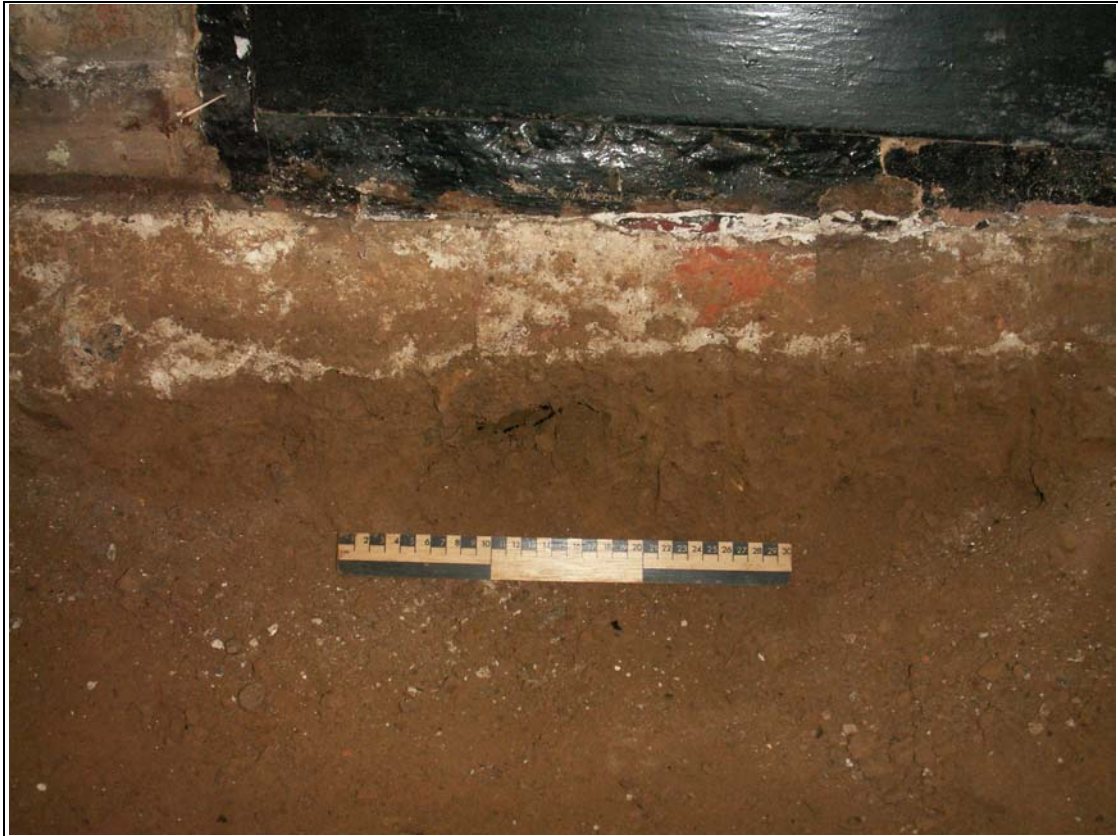
Plate 3 Section 3 looking south east

*Description:* Section 3 faced north and was located along the east to west oriented interior wall between Rooms 1 and 2, partially underneath the west doorway. Observed within the section was the flint stone and crushed chalk foundation (M1001) lying on the natural subsoil (L1000) at a depth of between 0.10m and 0.20m. Above the flint stones and chalk was a course of red bricks laid end to end (M1002), which appeared to lie just below the surface of the dirt floor (between approximately 0.03m and 0.10m). Above the single brick course was a thin layer of mortar or compacted clay (M1003) that possibly served as a sub-floor for a tile floor (0.0m to 0.03m below the surface). A wooden beam lay on top of the mortar sub-floor, which butted up against the door frame of the (west) doorway separating rooms 1 and 2.

<i>Sample Section 3</i>		
0.00m = 106.48m AOD		
0.0 – 0.03m	M1003	Mortar sub-floor or base for tiles.
0.03 – 0.10m	M1002	Brick, single course, part of foundation or sub-floor.
0.10 – 0.20m	M1001	Flint stone and crushed chalk foundation.
0.20+m	L1000	Subsoil. Light yellow orange silty clay with white chalk flecking.

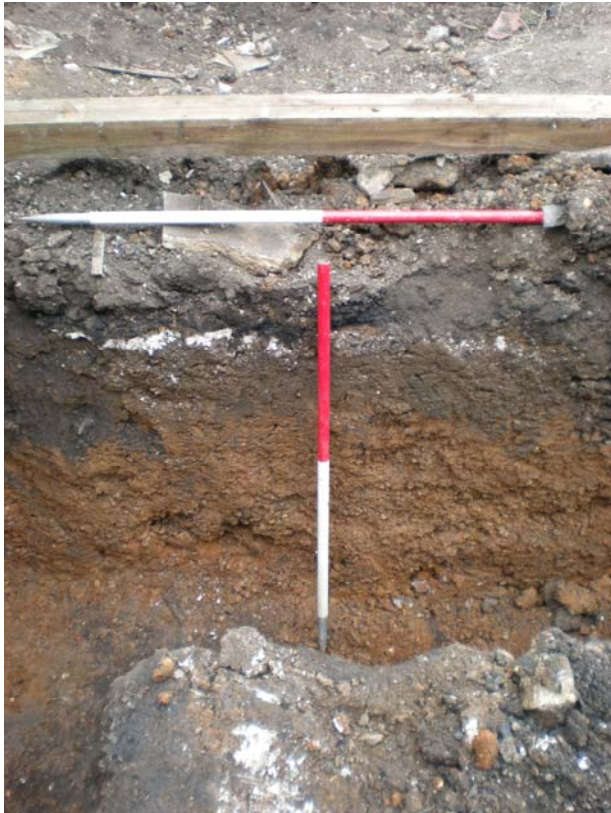
DP 36 Sample section 2. Looking NE.

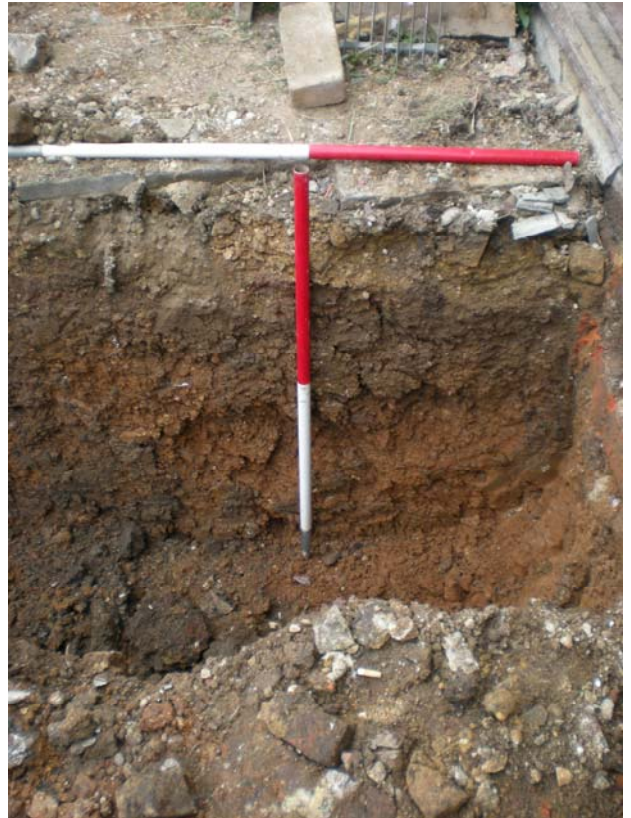
DP 37 Sample section 3. Looking SE.

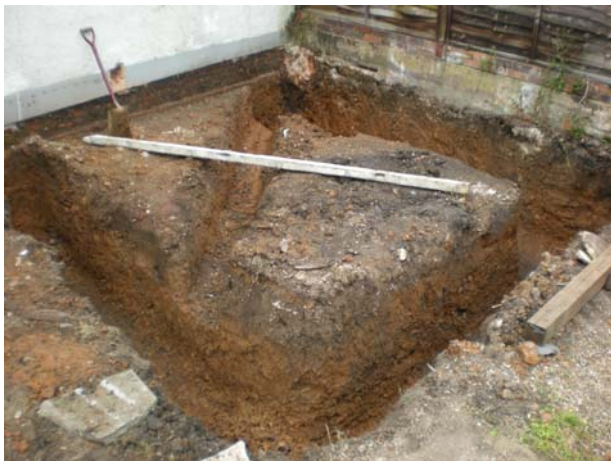
9.1 The archaeological monitoring of the excavation of foundation trenches for the new extension to Hillside cottage comprised the observation of all groundworks (DP 38), inspection of subsoil and natural deposits for archaeological features, the examination of spoil heaps and the recording of soil profiles. Deposits were recorded by means of *pro forma* recording sheets, drawn to scale and photographed as appropriate. Excavated spoil was searched for archaeological finds. A site visit was undertaken to monitor these works on 23/07/08.

DP 38 General view of groundworks. Looking SW.

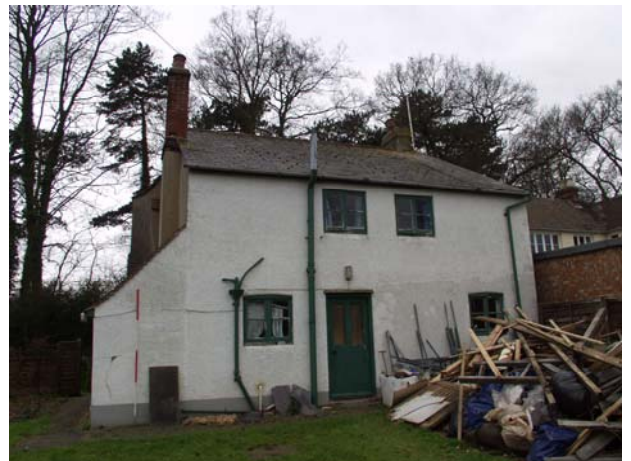
DP 39 Hillside cottage. View of the rear of the building before groundworks commence.
