**OUTBUILDINGS AT POYNDON FARM,  
SILVER STREET, GOFF'S OAK,  
HERTFORDSHIRE**

**HISTORIC BUILDING RECORDING AND  
ARCHAEOLOGICAL MONITORING AND RECORDING**

Author: Matthew Williams MA MSc (HBR text) Zbigniew Pozorski MA (Watching Brief text) Gary Brogan BSc (editor)	
NGR: TL 3225 0252	Report No. 3224
Parish: Cheshunt	Site Code: AS 1180
Approved: Claire Halpin MIFA	Project No. 3269
Signed:	Date: June 2009

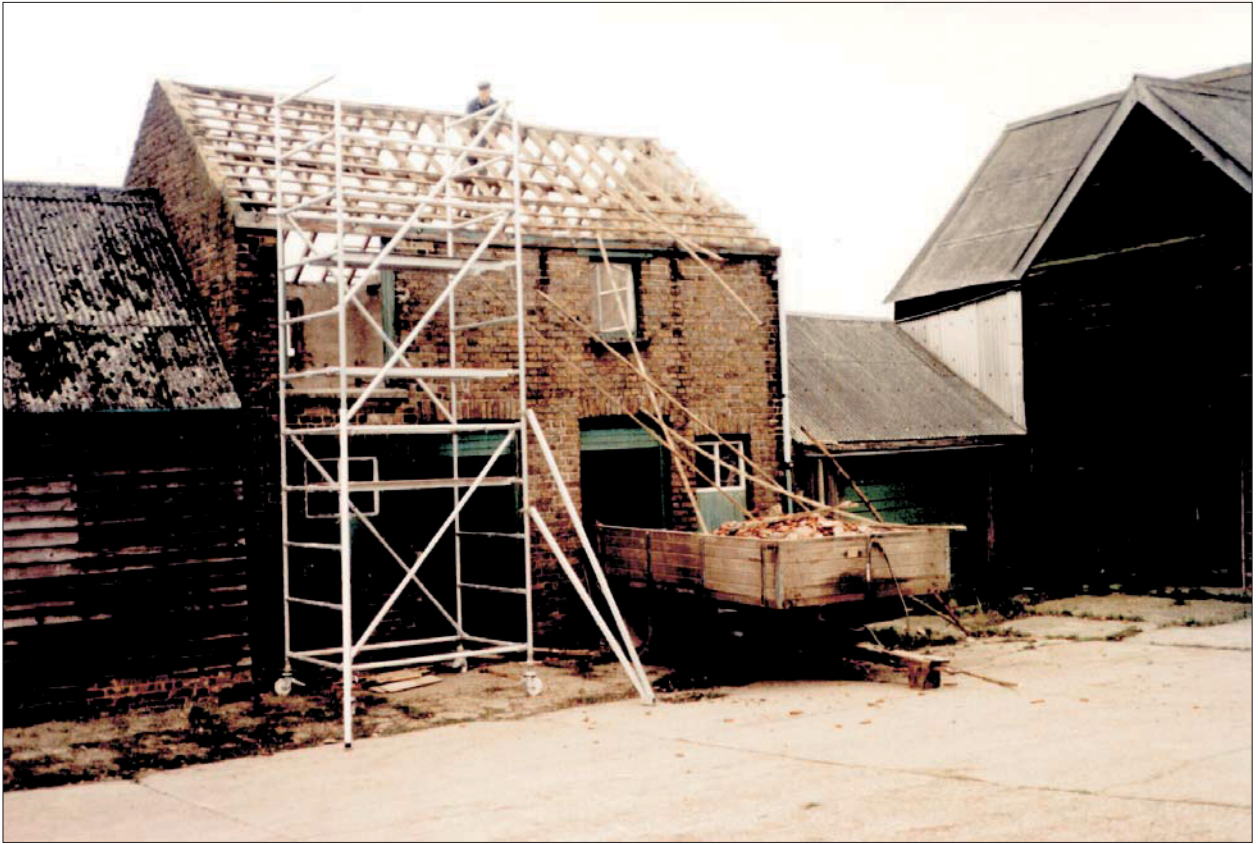
Photograph taken on 5th November 1986

The photograph shows the front (south) elevation of the two-storey section of the Building A (stable block), during its conversion into a garage in 1986. While it shows the first floor much as it is today with a single loading door to the west and a single fixed light window to the right, it also provides information on the original form of the ground floor which has now been lost. The building originally had two entrance doors in the centre with two fixed light windows to the right and left. All four openings had slightly cambered brick arches. To the left the end of a single storey weatherboarded structure can be seen which may correspond with the surviving internal features in Building A (Section 5.2.3 below).

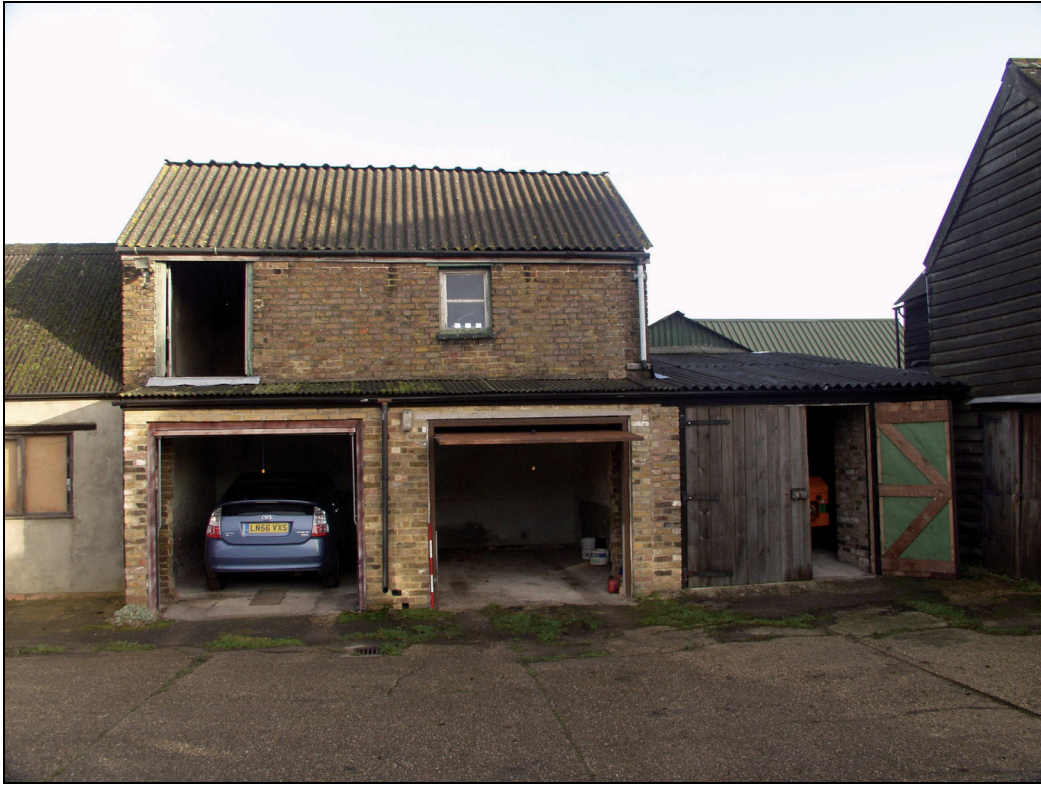
1 Southern elevation of former stable, taken from the south (11)

5.1.3 The first floor retains on the front (south) façade a single loading door to the west along with a single two-light fixed window to the east. These two features are probably not original and are most likely to be replacements of mid-20<sup>th</sup> century date. To the rear (north) façade there is a barred, unglazed opening to the east and a further two-light fixed window to the west which appears to be the only surviving original window in the building (Plate 2).

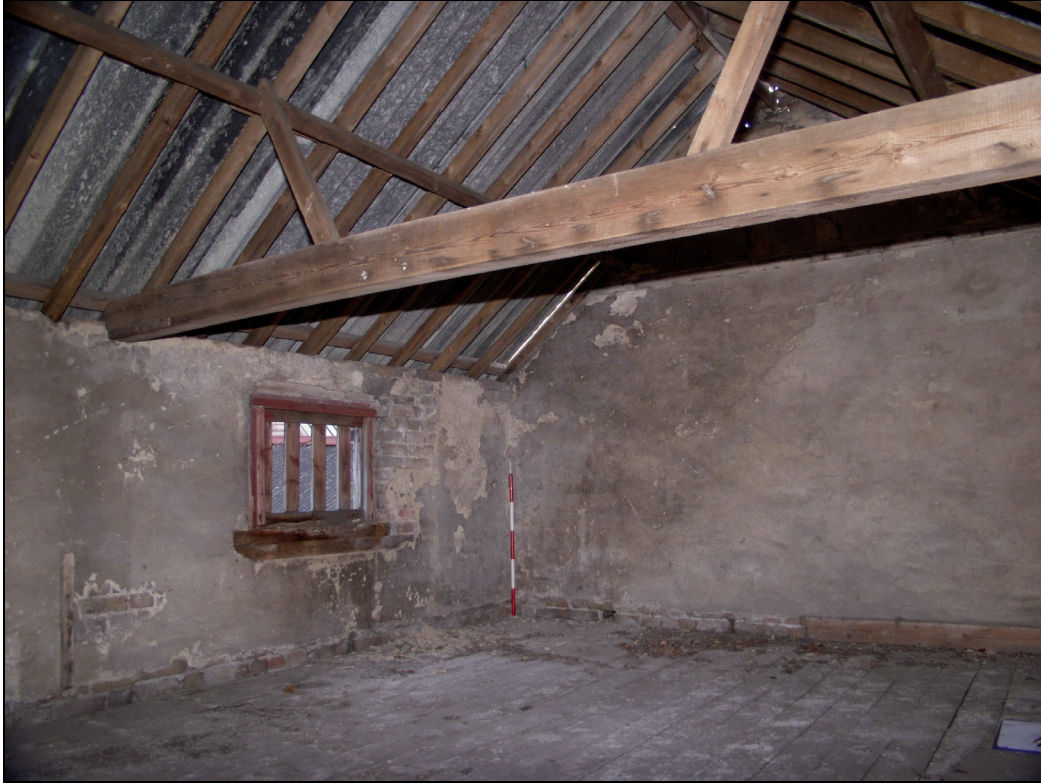
3 Interior of first floor of former stable, taken from the south-west (15)

5.2.1 The two bays to the ground floor of the former stable are plain brickwork cells which are whitewashed throughout. This appears to include some areas of original limewash. There is a modern plasterboard ceiling. The first floor section retains all the original floorboards and joists along with much of the original lime render to the walls. The loading door, two windows and the single unglazed opening to the front and rear elevations are all visible as described above (Plates 3 & 4).

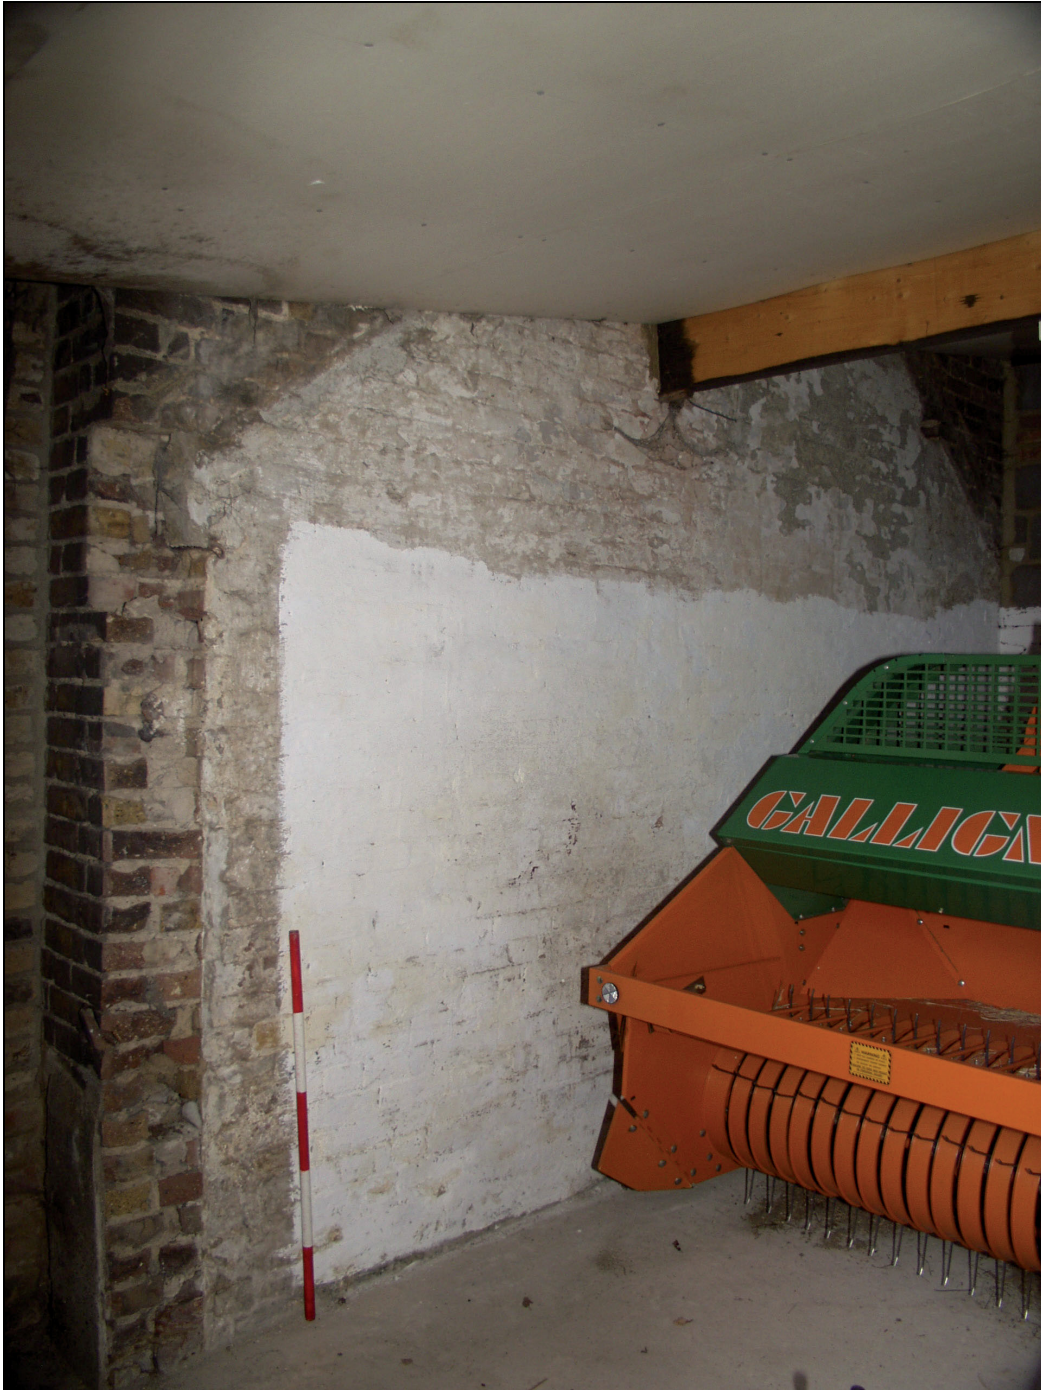
5 East end wall of former stable, taken from the south-east (12)

5.2.2 The interior of the single storey garage linking the former stable to the barn is entirely modern, as it appears on the exterior. It does however enclose the east wall of the ground floor of the adjacent building. On this wall is preserved an area of internal limewash which shows the outline of an earlier building, also single storey although considerably lower in height (Plate 5).

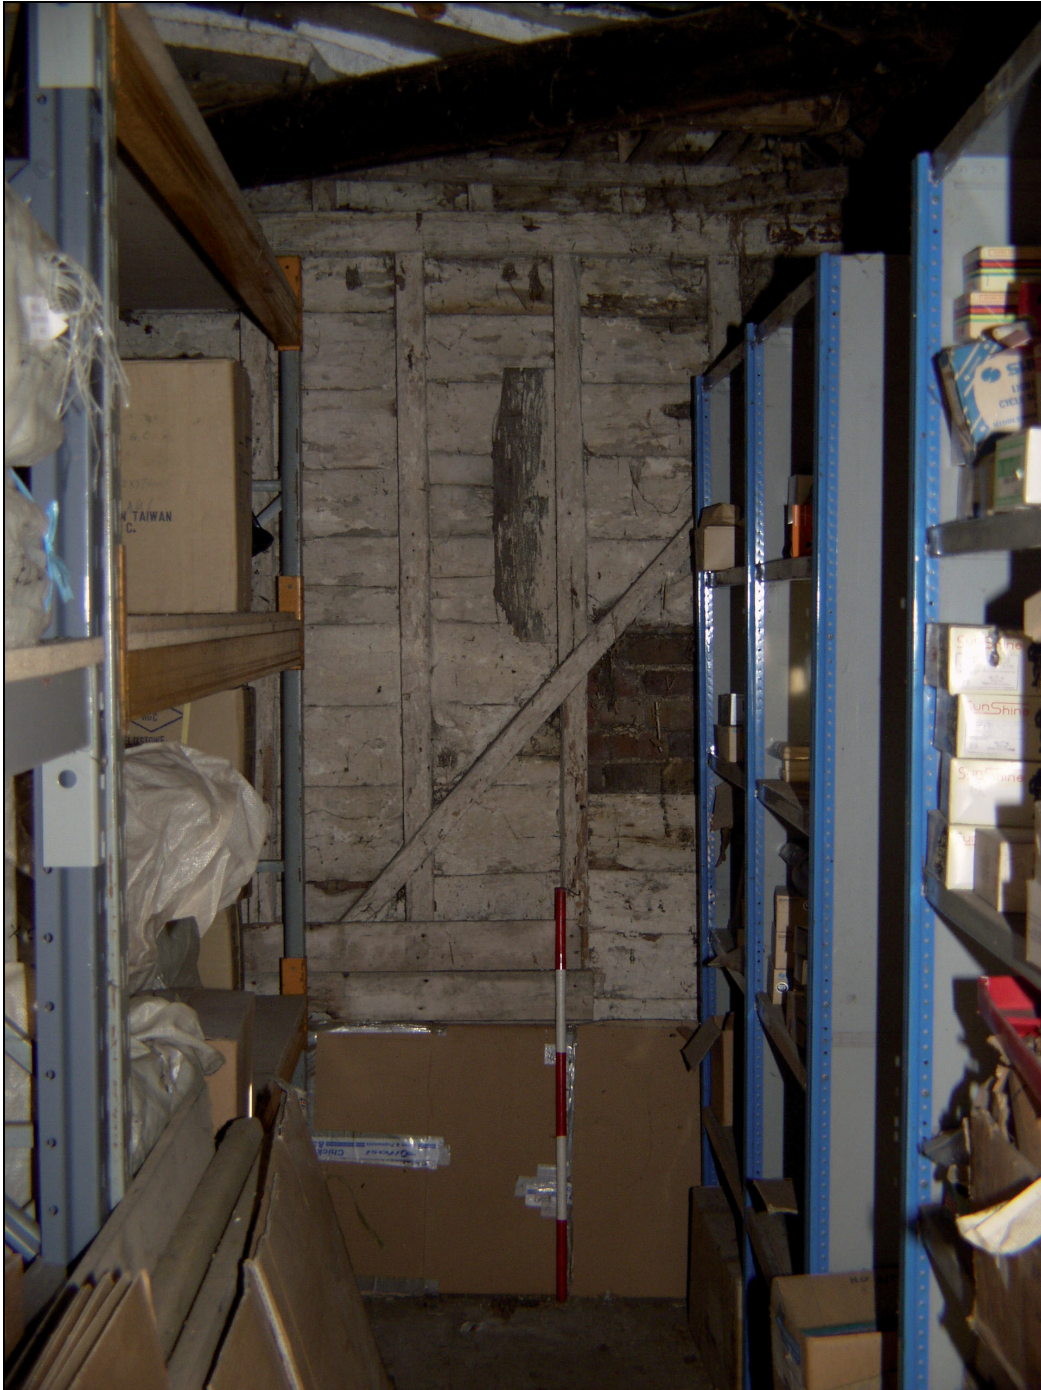
6 Detail of southern section of timber framed wall to east end of single storey section of Building A (17)

5.2.3 The interior of the single storey building to the west of the former cart shed appears largely modern with breezeblock walls and modern doors and windows as described above. At the east end of the structure, however, some early 19<sup>th</sup> century timbers are retained which suggest that this building occupies the site of an older structure. Here a limewashed, primary braced timber framed end wall survives in good condition with weatherboarding on the external face implying that this building predated the adjacent mid-19<sup>th</sup> century stable. It is possible that this represents the only surviving part of the weatherboarded building noted on the historic photograph discussed above. There are also some surviving internal wooden boards which are of greater thickness than those to the exterior (Plate 6 & Elevation E – E1, Fig. 13). This corresponds with a small number of early 19<sup>th</sup> century roof timbers which also survive at this end of the building and which are discussed below. The remainder of the interior of this structure to the west, and the lean-to to the north, is however entirely modern.

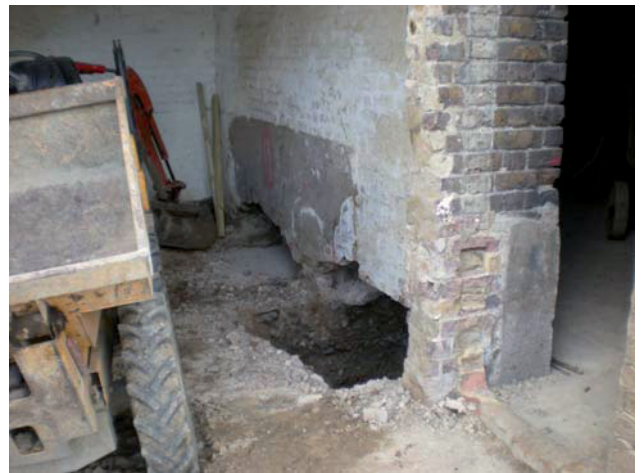
A new foundation trench had been cut at the base of the exterior wall of the former stable at the east end of Building A. No archaeological features or finds were present.

DP 30. E wall of former stable, Building A, showing foundation pit/trench. Taken from SW.

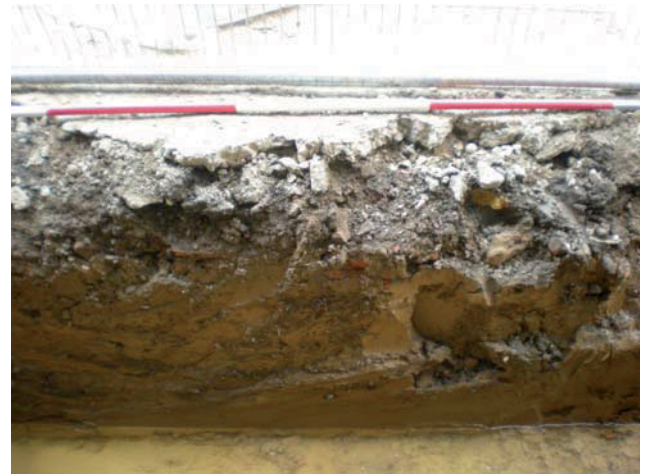
<i>Building A (former stable), S foundation trench, facing N</i>		
<i>0.00 = c. 90.23m AOD</i>		
0.00 – 0.15m	L2000	Concrete yard / floor surface.
0.15 – 0.28m	L2001	Made ground. Dark grey silt and brown/orange concrete and CBM rubble.
0.28m+	L2002	Natural mid/dark yellow clay, with flint gravel.

DP 34. Former stable, Building A, S foundation trench. Sample section. Taken from N.

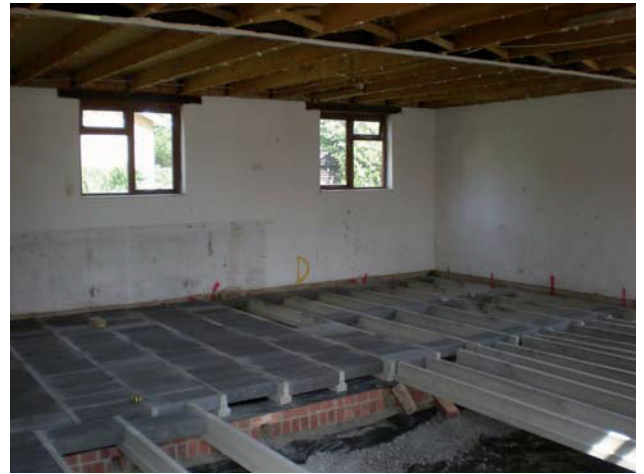
The floor of Building B had been removed and was being replaced (DP 40).

DP 40. Interior of Building B. Taken from SSE.

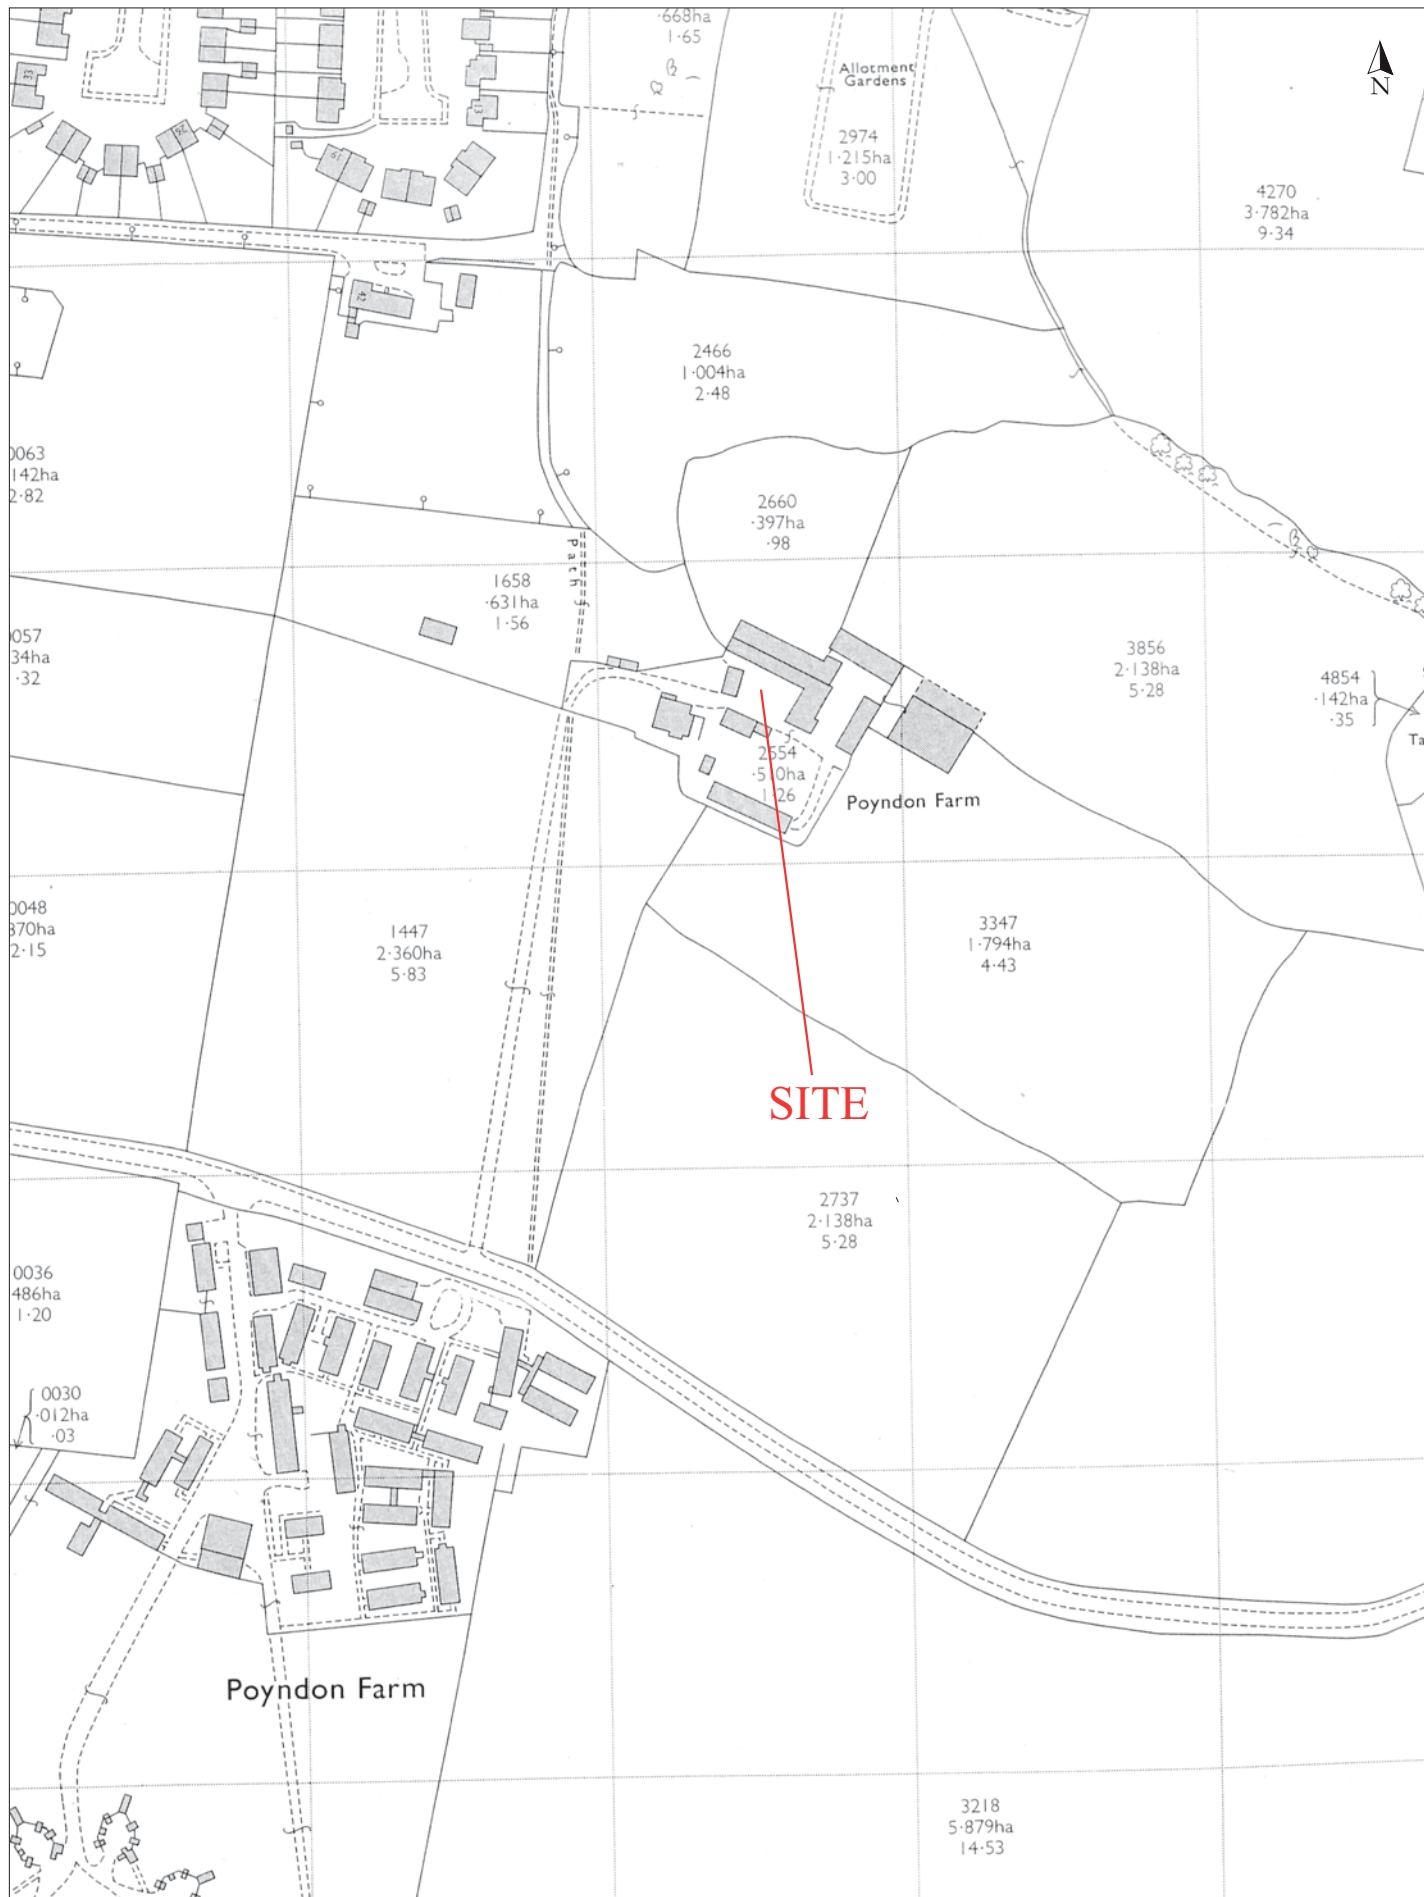
This map shows the farm almost exactly as it is today. Two new buildings have been added. It is the only map in the documentary record to refer to the site by its modern name of Poyndon Farm. While the fields immediately around the site remain unchanged, a short distance to the north-west and south-west there are now large areas of suburban housing.

*Archaeological Solutions Ltd*  
**Fig. 11 OS map, 1971**  
 Scale 1:2500 at A4
