**OUTBUILDING AT RUMBOLDS, SPRING LANE,  
COTTERED, HERTFORDSHIRE**

HISTORIC BUILDING RECORDING AND  
ARCHAEOLOGICAL MONITORING AND RECORDING

| NGR: TL 3255 2848 | Report No. 3223 |

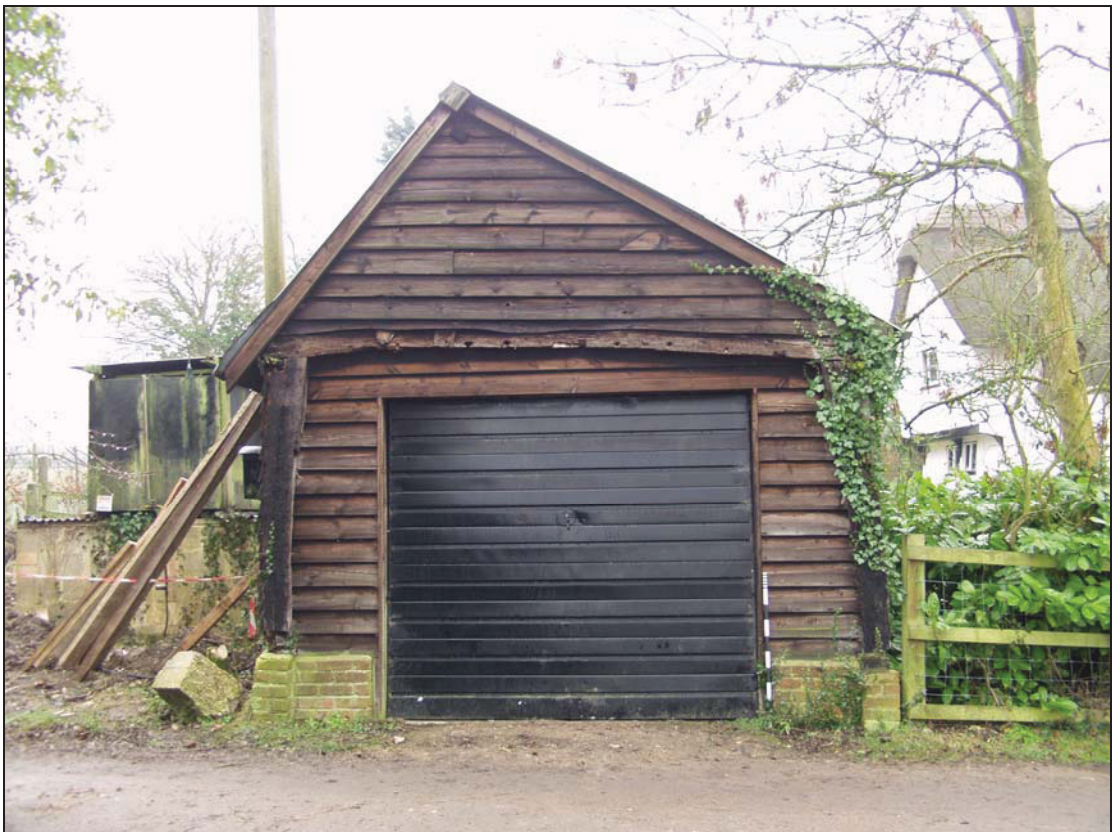
2 West elevation taken from the west (1)

5.1.3 On the west gable end, the timber truss is visible, though heavily weathered. This frames a steel garage door, with modern oak weatherboarding in the gable above (Plate 2). The two principal corner posts swell to gentle jowls with notches. The north sill survives, though the south has been replaced; both rest on dwarf walls of approximately six courses of early to mid-20<sup>th</sup> century brick. The principals are linked by a waney, cambered tie-beam, preserving raking mortices for braces, although these have no corresponding sockets in the posts, but other weathered slots for studs. In addition the principal posts themselves preserve redundant mortices for braces: that to the south having once housed a downward brace, all indicating earlier reuse.

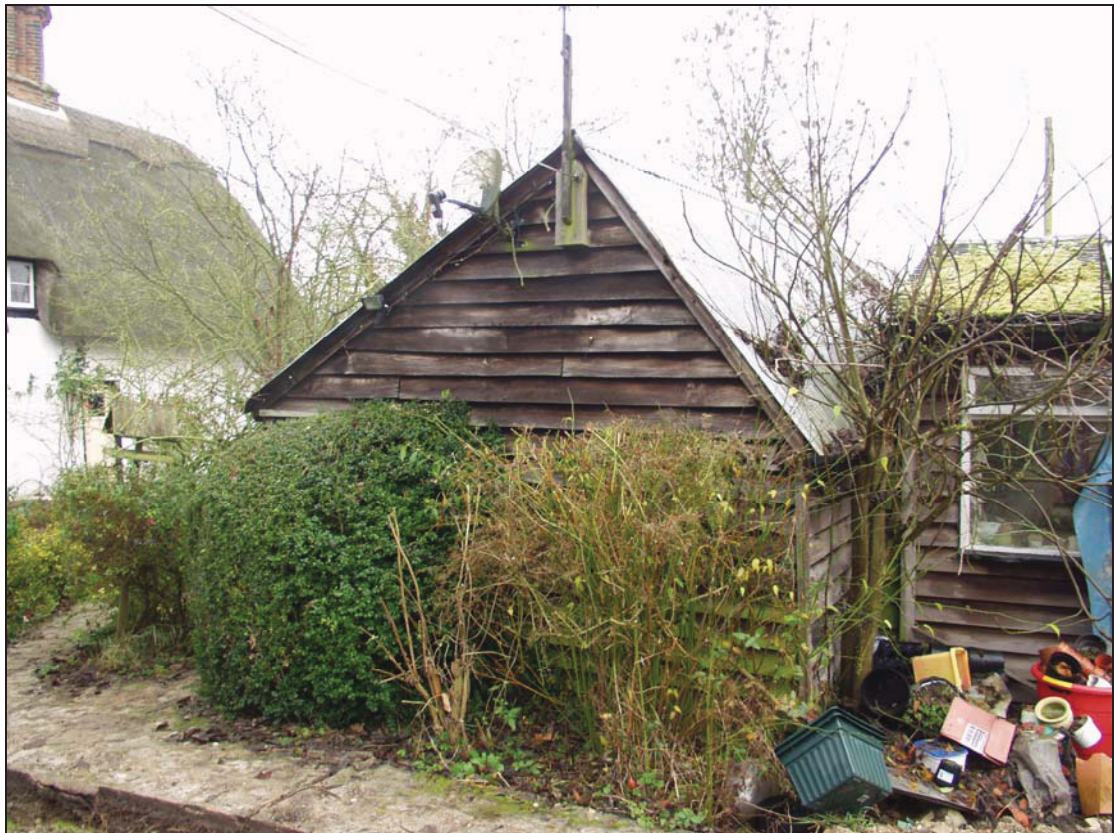
4 East elevation taken from the east (5)

5.2.8 The eastern bays of the building (Bays 5 and 6) are short in length and divided by the final truss. The timber is waney as before but the tie-beam is straighter and more robust than those seen elsewhere. The northern studwork is evenly spaced, regular in size and fairly well preserved. A single primary brace descends from the north-east corner while oak weatherboarding is visible to the exterior. To the south there is a secondary wall plate which is robust and of good quality. Much of the studwork is infilled with expanded mesh and cement, and so decayed, while some light is provided by a single window of 20 rectangular leaded lights.

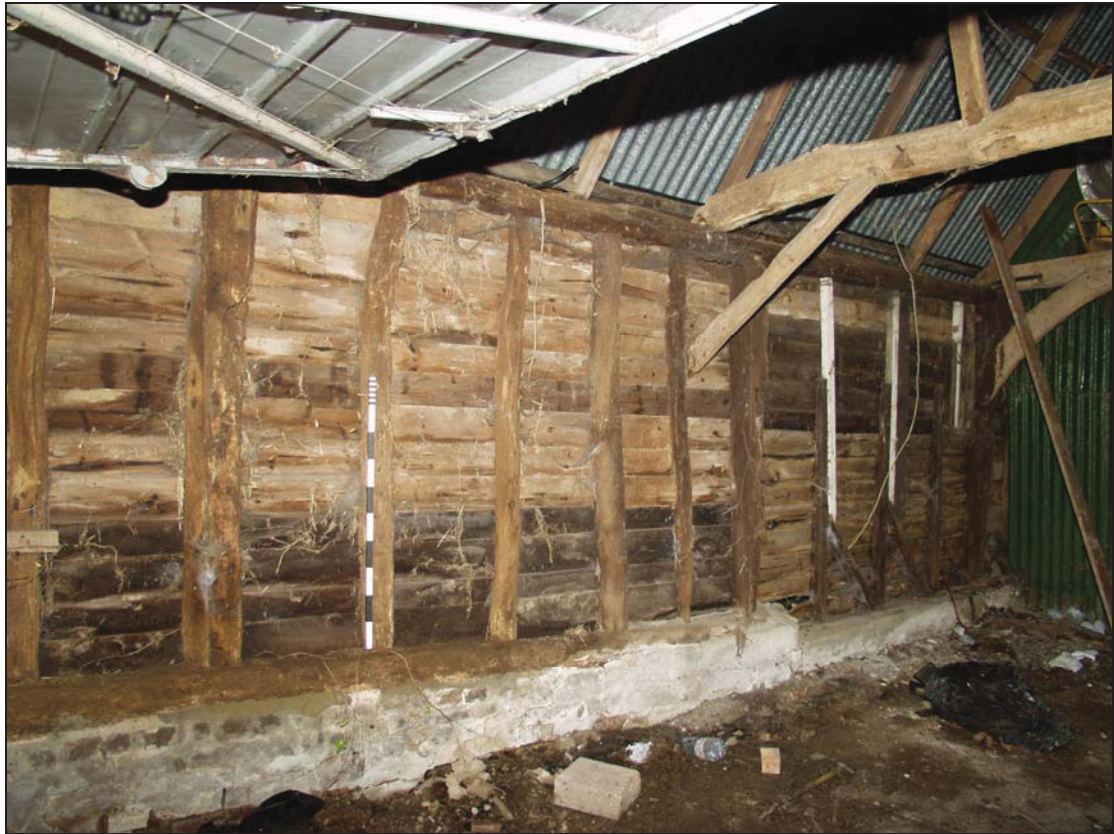
5 North walls of Bays 1 and 2, taken from the south-west (6)

5.2.2 The west gable end uses modern timber of slender scantling with the exception of the principals noted above, and two weathered studs above the tie beam. The north panel of Bay 1 has a decayed sill beam with a wall-plate scarfed at the bay division and seven upright studs of which two appear to be pegged (Plate 5). All of the timber is waney and weathered and is clearly reused. The south side is of similar form although the sill has been replaced in two sections with modern oak with pegged chocks supporting the decayed footings of the studs (Plate 6). The individual panels are filled here and elsewhere on the south by expanded steel mesh and cement render. Liberal amounts of cement have been spread over the sill to provide a weatherproof seal.

5.2.4 Bay 2 is of a similar form although the timbers are generally slender and of much poorer quality. The north wall has been replaced and the studs very small. The south panel is less coherent, with a decayed wall-plate framing a re-used 19<sup>th</sup> century iron lattice window in what appears to be an earlier doorway. Throughout Bays 1 and 2 the dwarf wall supporting the timber frame appears to be composed of entirely modern 20<sup>th</sup> century brickwork supported by thick cement. There is an earth floor across these two bays.

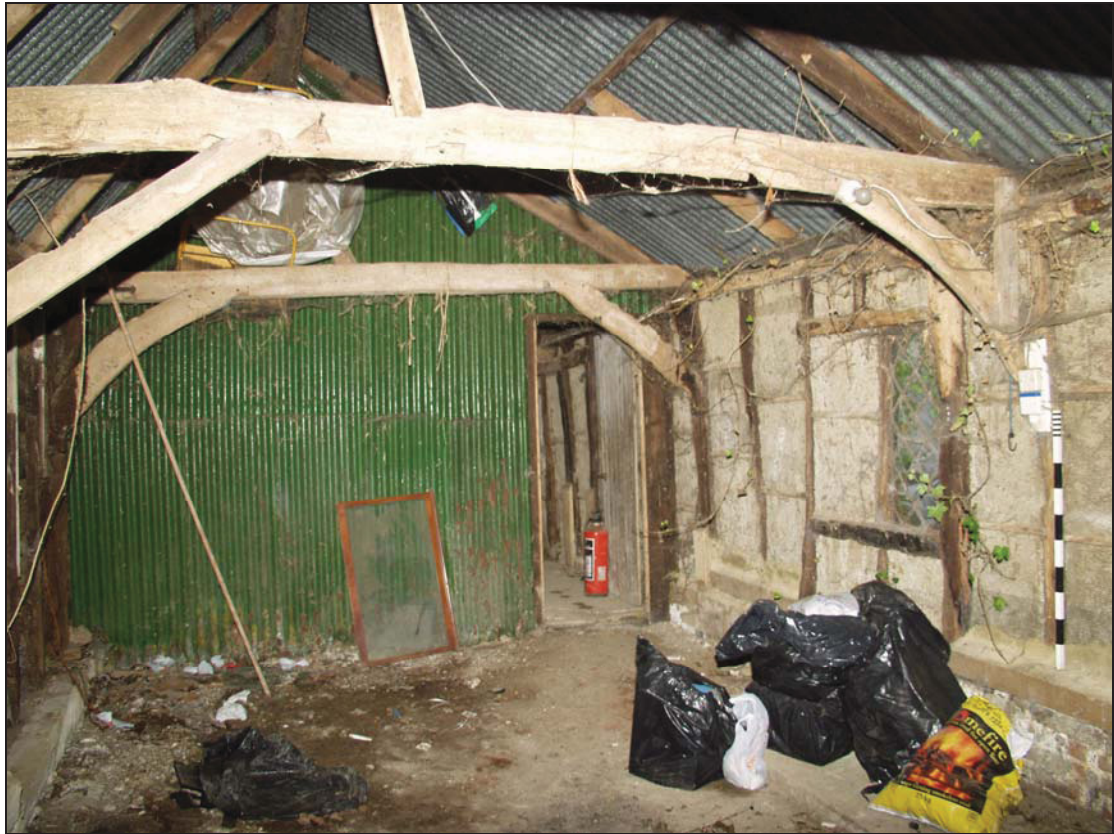
7 Intermediate trusses of Bays 1 – 2 and 3 – 4, taken from the north-west (8)

5.2.5 The truss to Bay 3 is the best preserved, and is represented in drawn section in Fig. 13 below. It retains jowled uprights (though with no notches); that to the north being much decayed and now hanging suspended above the sill. The tie-beam is waney and supported by iron strapping and stapling, but curved braces are notch-lapped and nailed, while the south brace is also properly morticed into the principal post. There are no visible signs of pegging for any struts above, however, although the modern nailed-on support props the existing roof. Bays 2 and 3 are divided by a corrugated metal sheet.

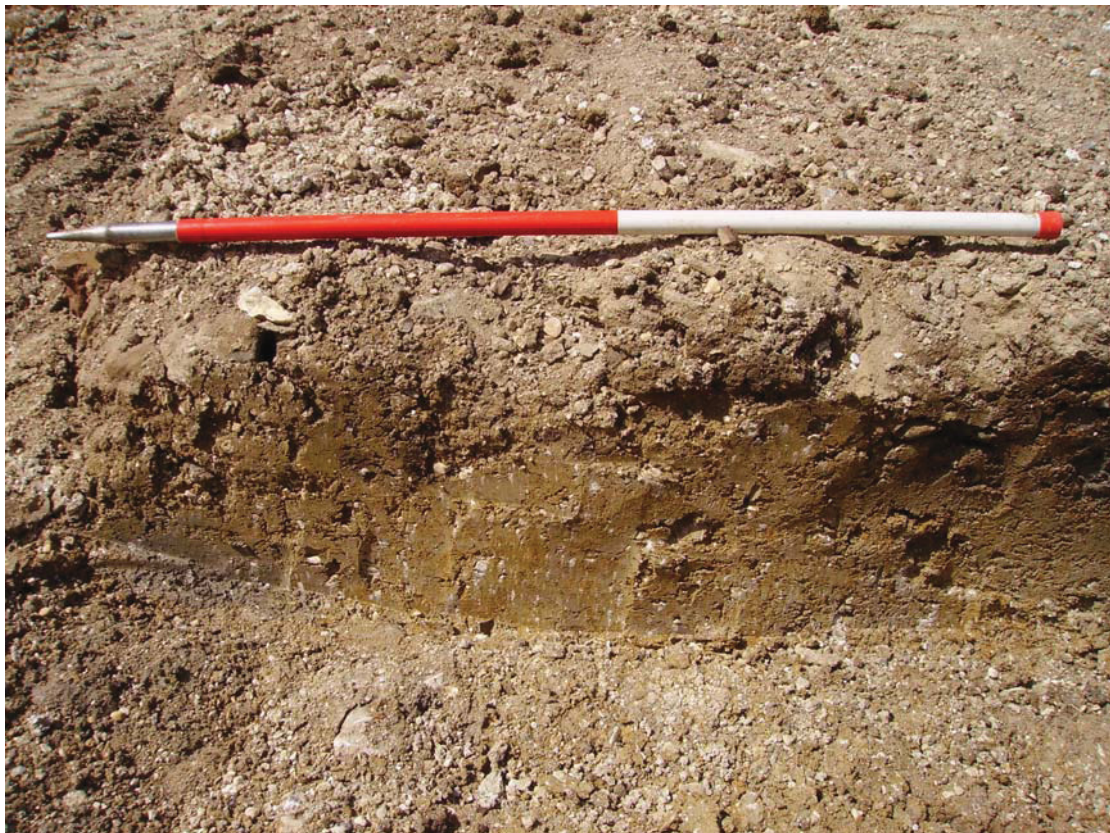
10 Sample section, taken facing north-west

10.1 A uniform deposit model was noted across the entire footprint of the proposed outbuilding. The ground surface was firm brownish grey sandy clay, with modern brick rubble and flint (L1000). This was consistently 0.15m thick. Two modern service trenches were located and these both ran east to west across the site. Natural pale orangey brown, firm chalky clay (L1001) was located directly below the made ground (L1000) and was 0.30m thick. Below this was natural mottled pale grey and pale brown chalky clay (L1002) that continued beyond the 0.45m depth of the trench.

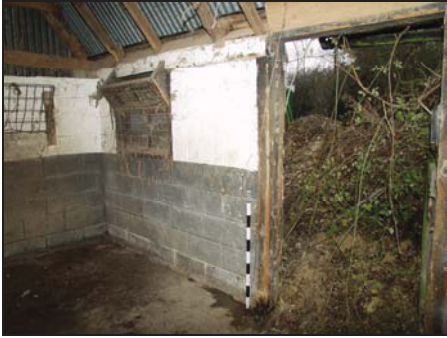
13

5.2.6 Bays 3 and 4 are dominated by the inserted stable which consists of cement breeze-block walls approximately two metres in height along with a window and door to the north and some remaining modern stable features such as a manger and internal horizontal shuttered windows. The original north wall has been removed, but along the south the common construction form remains (Plate 8). The sill has been replaced and while the studs vary in quality and degree of preservation they have all been infilled as before with expanded mesh, cement render and some block work. This section of wall is pierced by three windows, two of which are reused 19<sup>th</sup> century cast iron lattices while the third is composed of small, square leaded panes of 20<sup>th</sup> century date. The original wall plate appears to have survived but is set lower than that to the west, the difference being compensated for by inserting a second, higher beam of modern date extending across the tops of the tie beams to carry the roof.

*Interior of block work stable inserted into Bays 3 and 4, taken from the south-east*
