**THE SPORTSMAN PH, 117 FORE STREET,  
HERTFORD, HERTFORDSHIRE**

**HISTORIC BUILDING MONITORING AND RECORDING  
AND ARCHAEOLOGICAL MONITORING AND  
RECORDING**

Authors:	Amy Williamson BA Tansy Collins BSc	
NGR: TL 3288 1270		Report No. 3034
Parish: Hertford		Site Code: AS 1168
Approved: Claire Halpin MIFA		Project No. 3128
Signed:		Date: May 2009

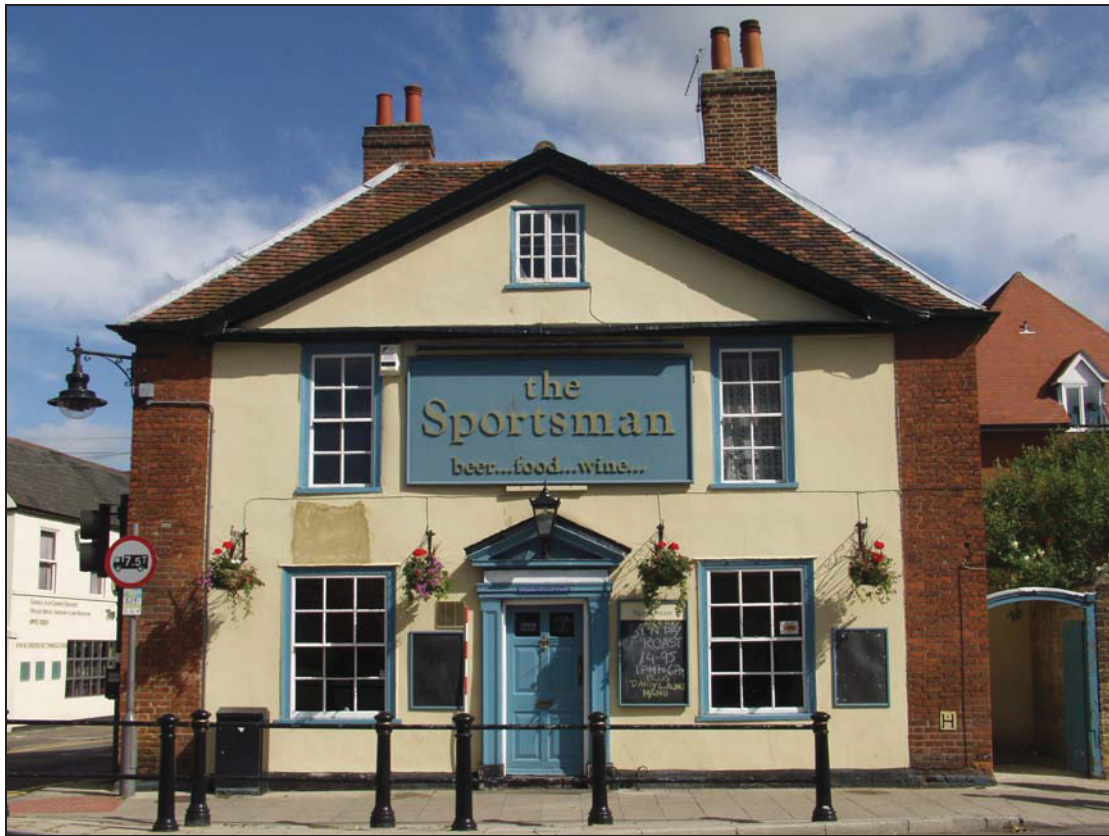
1 South elevation of principal range, taken from the south (1)

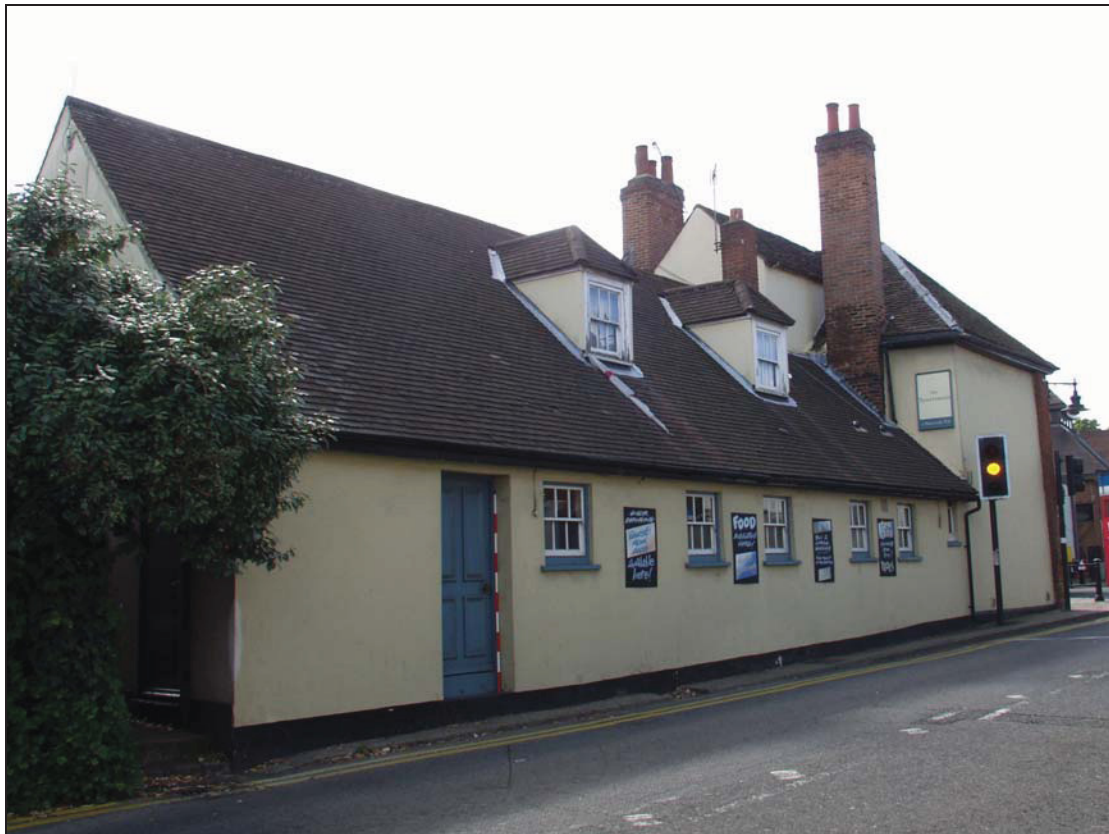
2 West elevation of rear and principal ranges with stair tower just visible between the two 18<sup>th</sup> century chimney stacks, taken from the north-west (5)

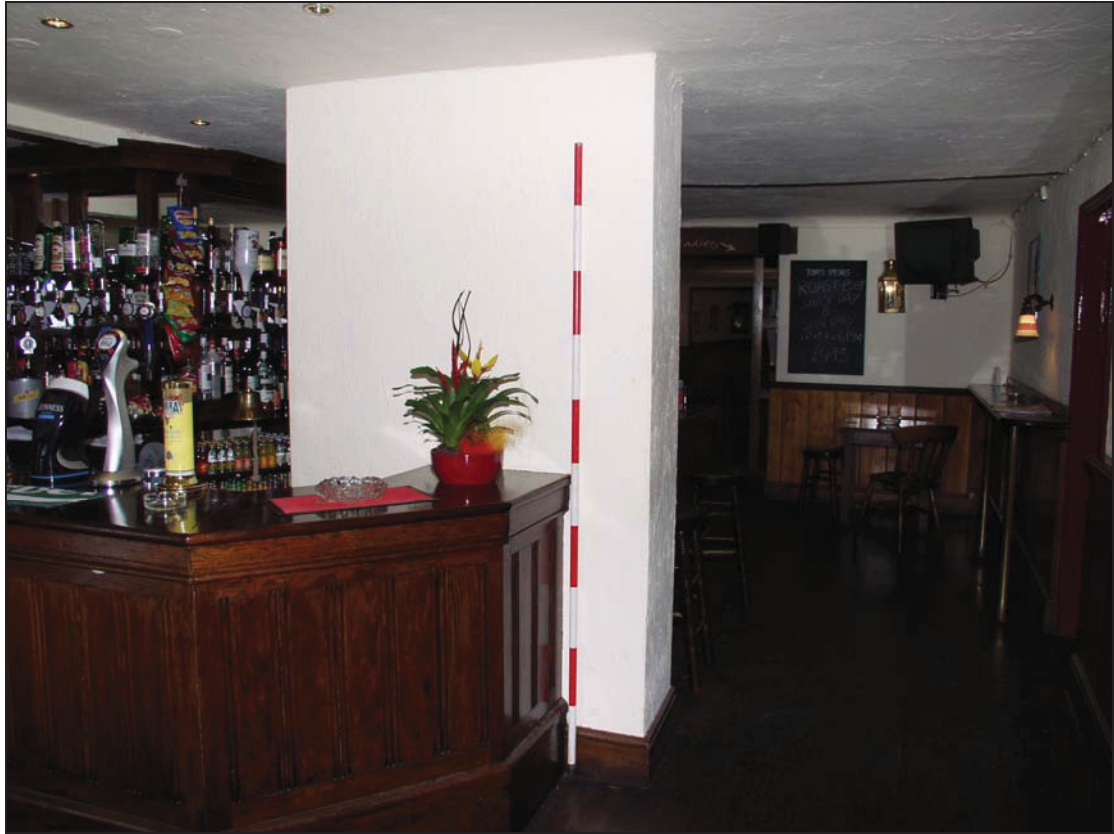
3 Free-standing 18<sup>th</sup> century chimney stack between Rooms 2 and 3, principal range. Taken from the south (8)

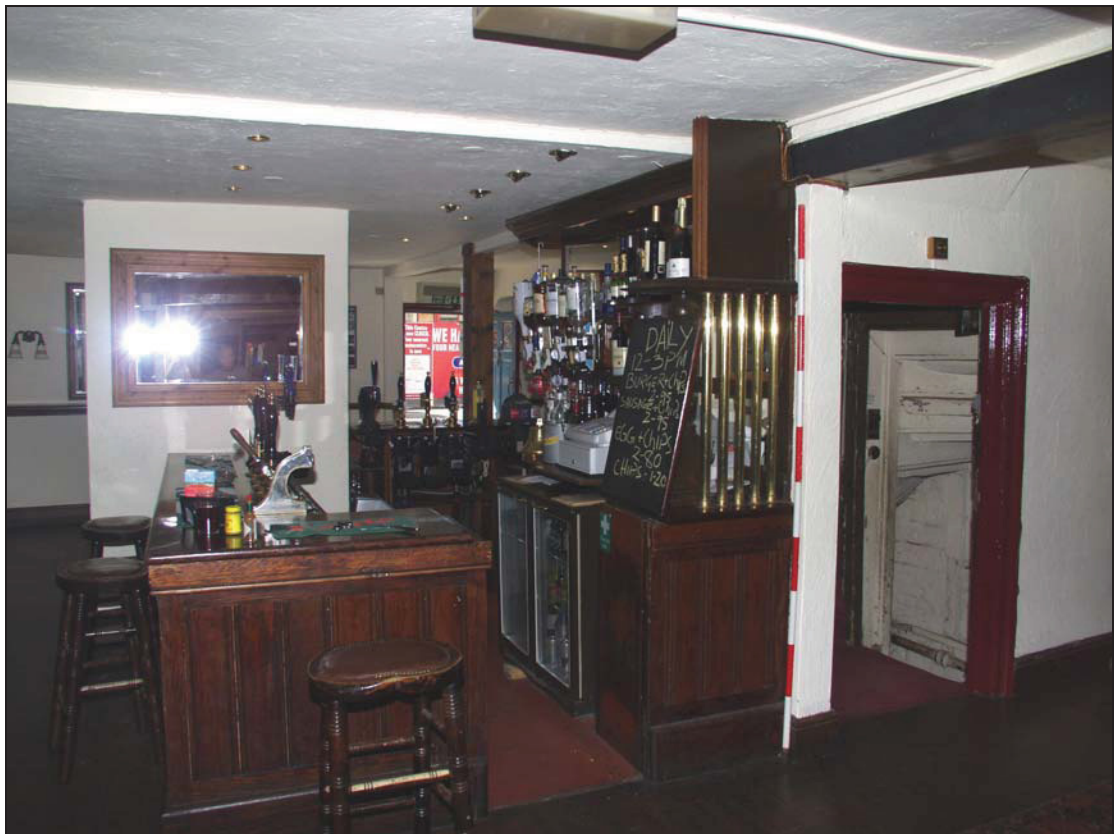
4 Room 3, principal range, looking south towards free-standing chimney stack and entrance to stair tower on the right (7)

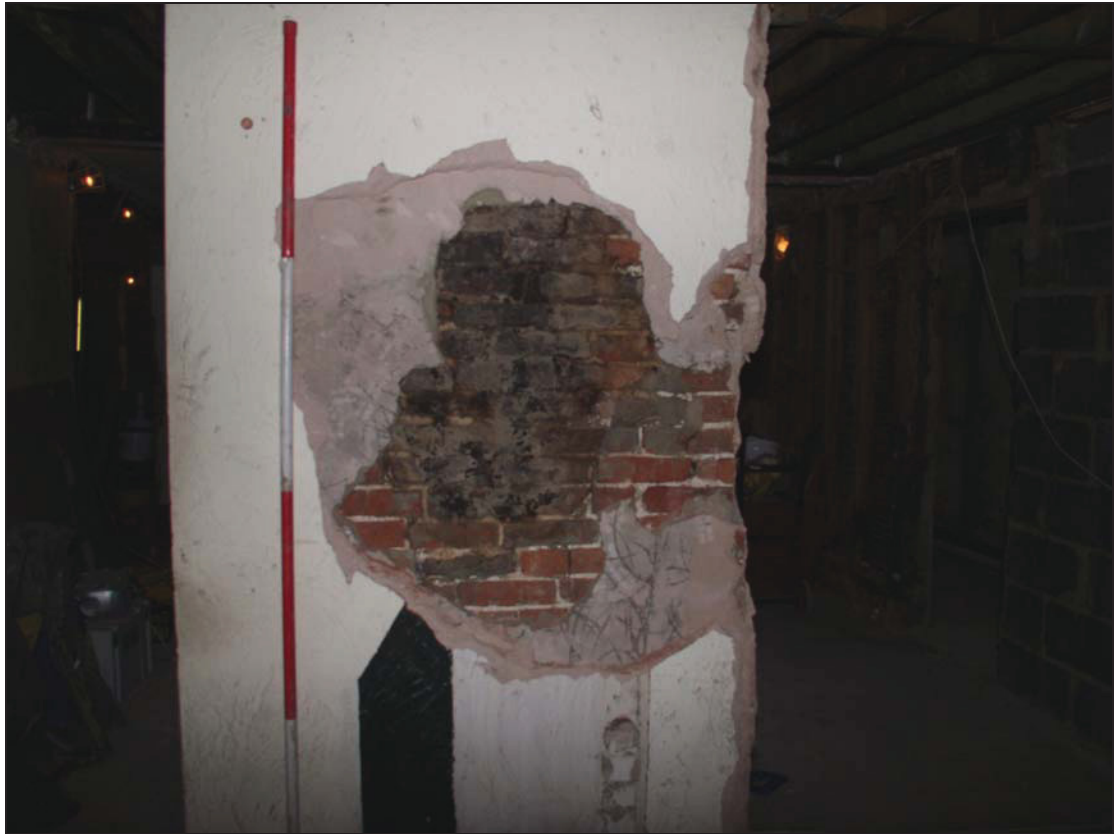
5 Eighteenth century brickwork of free-standing chimney stack plus sooted area marking position of flue, taken from the south (30)

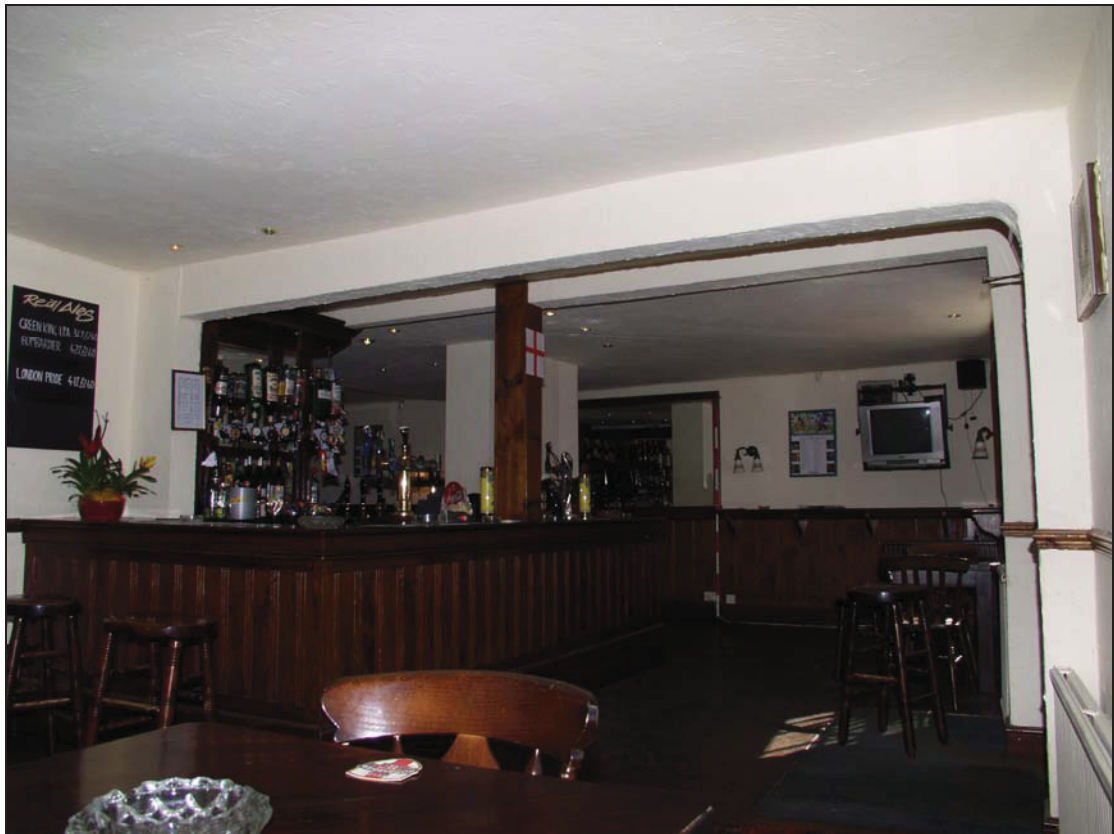
ceiling joists to either side of the door appear to denote the site of a former central passage (Plate 6). Limited investigation during refurbishment has revealed the westernmost of these to be a steel joist, although this probably replaces an original timber member. The joist to the east is original, preserving redundant mortices for a studded partition, but is now afforded additional support by an inserted post.

6 Rooms 1 and 2, principal range, taken from the south-west. Ceiling joists mark former central passage (9)

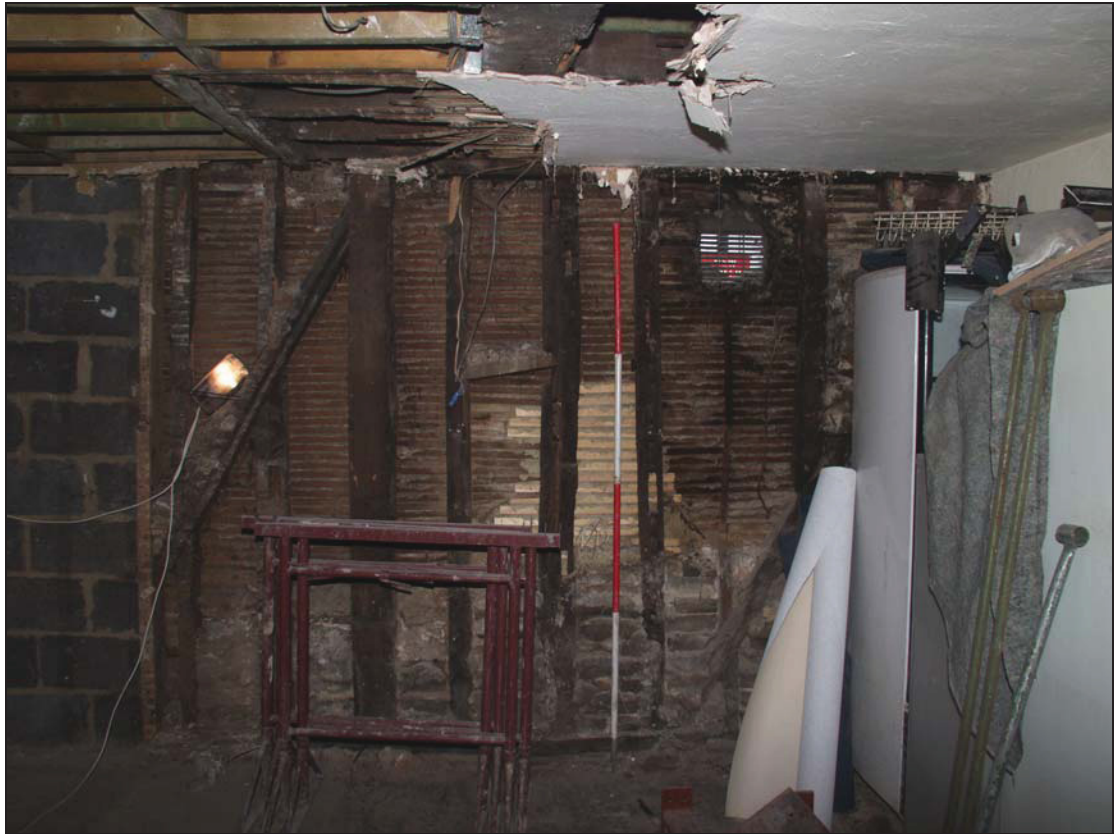
7 Primary braced framing on east wall of Room 2 utilising reused timbers, and bridging joist above, taken from the west (29)

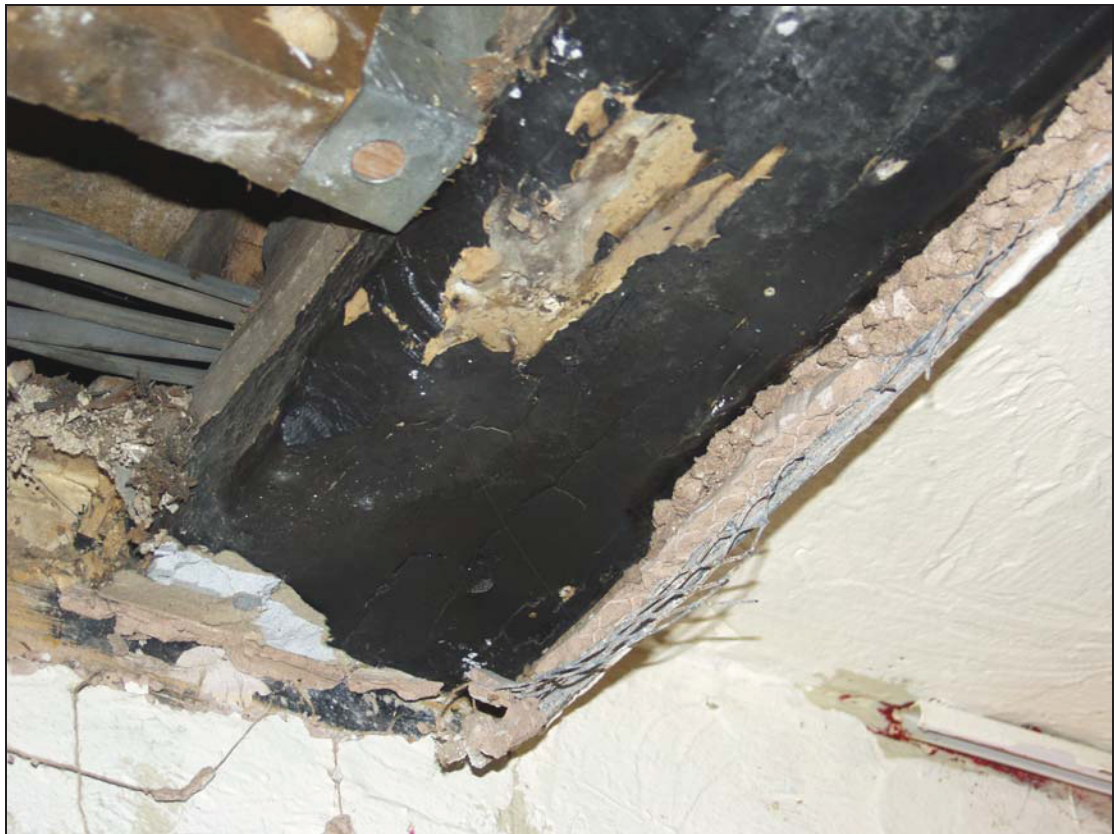
8 Binding joist in Room 3 showing chamfers and run-out stops, taken from the south-east (38)

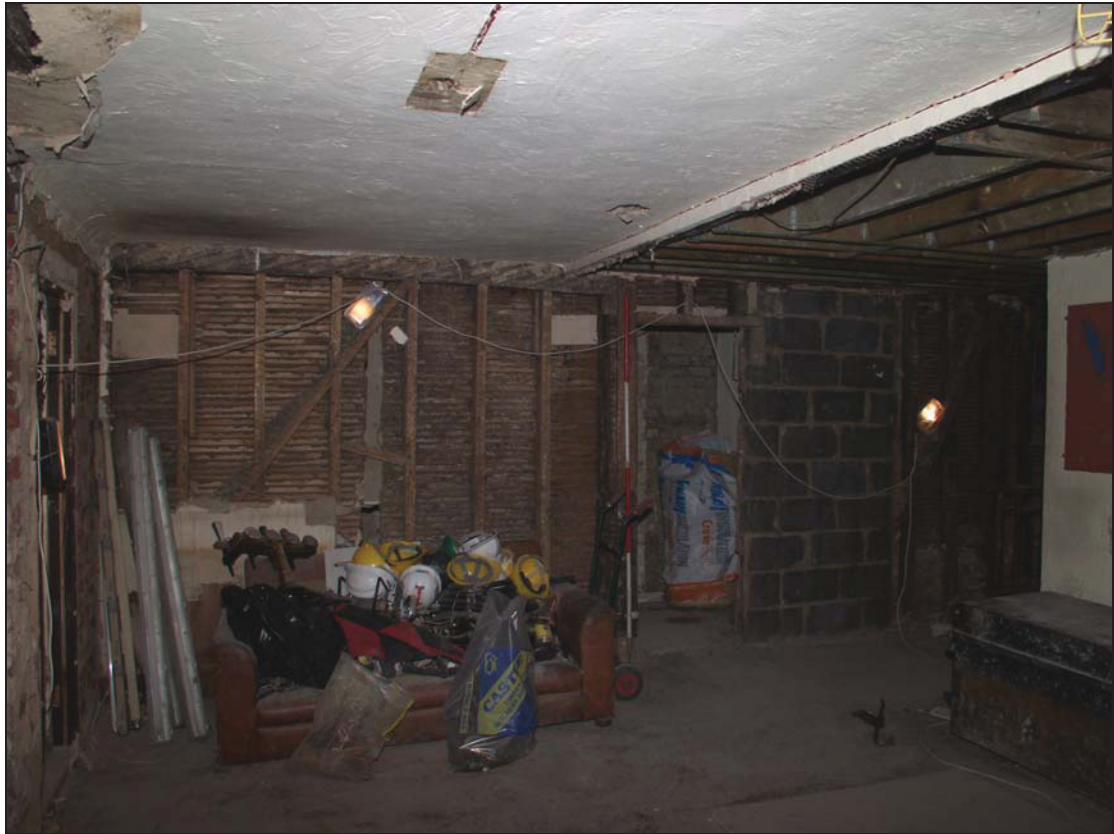
6.10 The framing of the east wall of Room 3 has been replaced with 20<sup>th</sup> century primary braced softwood studding (Plate 9), though the original middle rail and possibly also the original sill survive. An inserted doorway leads east into a 20<sup>th</sup> century WC addition. The opposite wall of Room 3 retains its original middle rail with redundant stud mortices. None of the original framing of the north wall survives, having been replaced with Fletton brickwork and modern supporting joists. The ceiling between here and the binding joist to the south preserves early laths and lime plaster containing animal hair, suggesting that original common ceiling joists may survive above.

9 Twentieth century primary braced framing on east wall of Room 3, with original middle rail visible above, taken from the west (31)

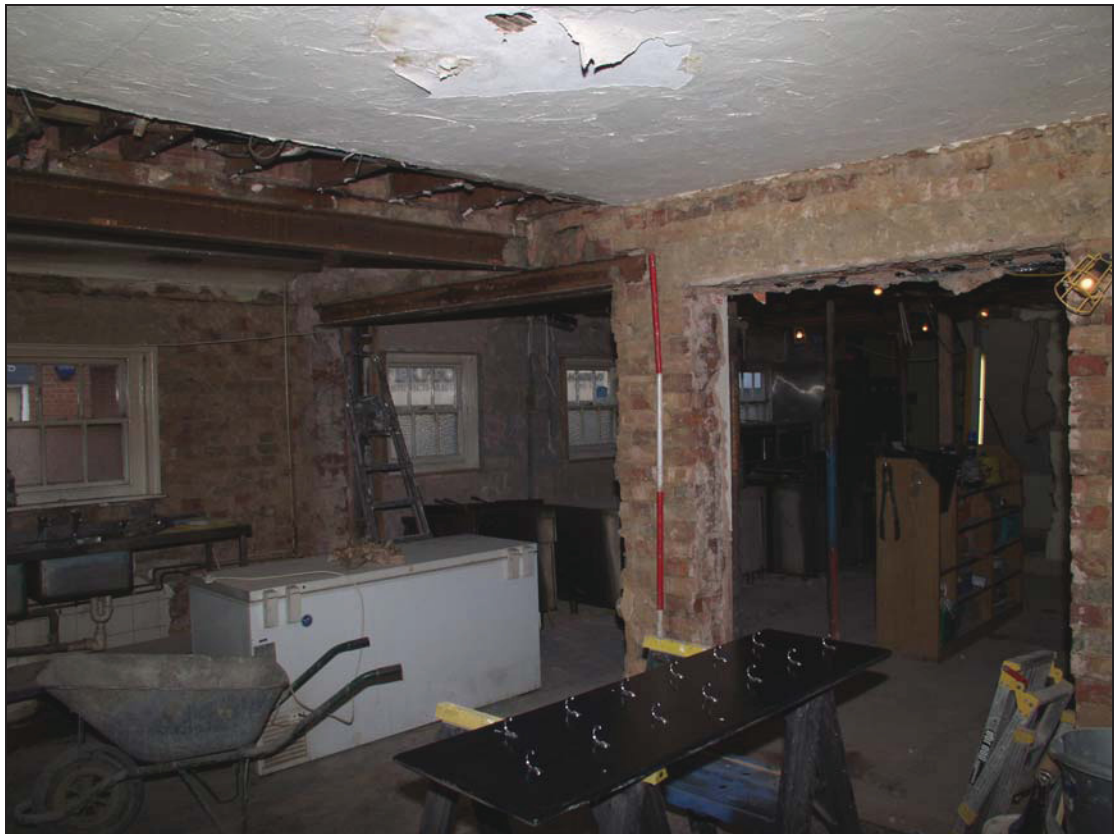
10 Twentieth century Fletton brick addition (Room 4), taken from the south-east (34)

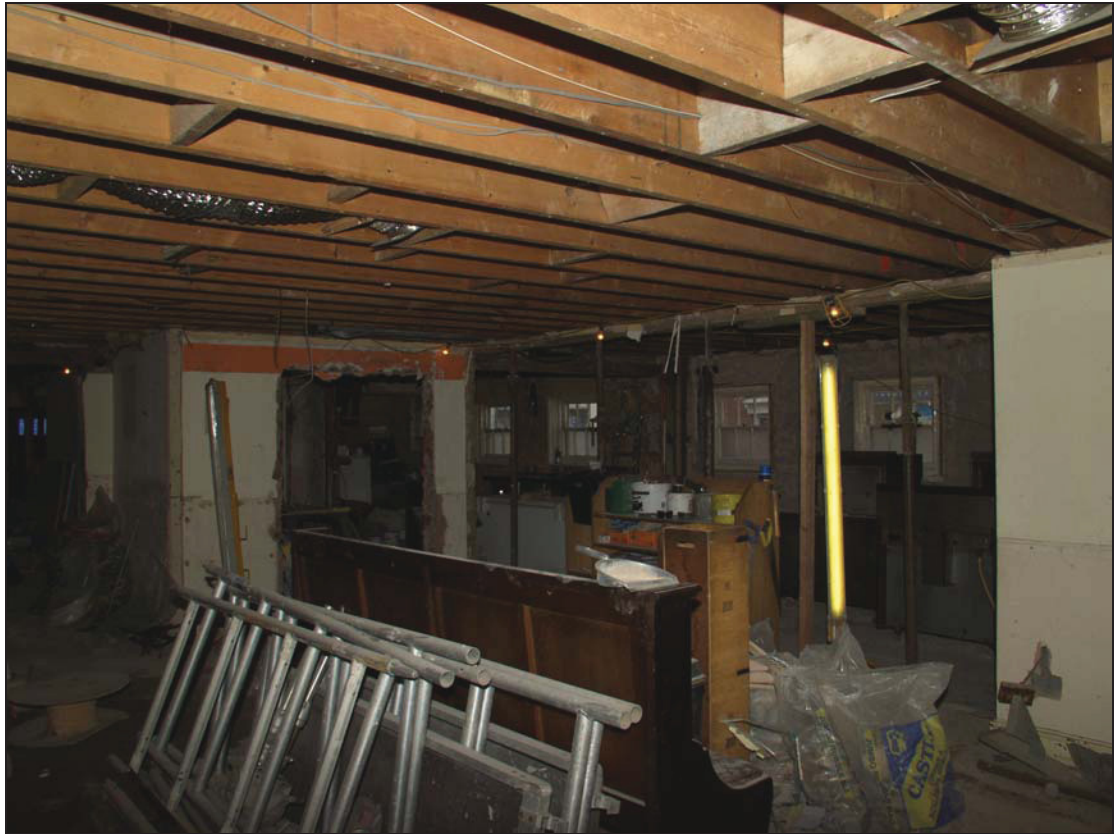
11 1980s extension (Room 5), taken from the north-east (36)

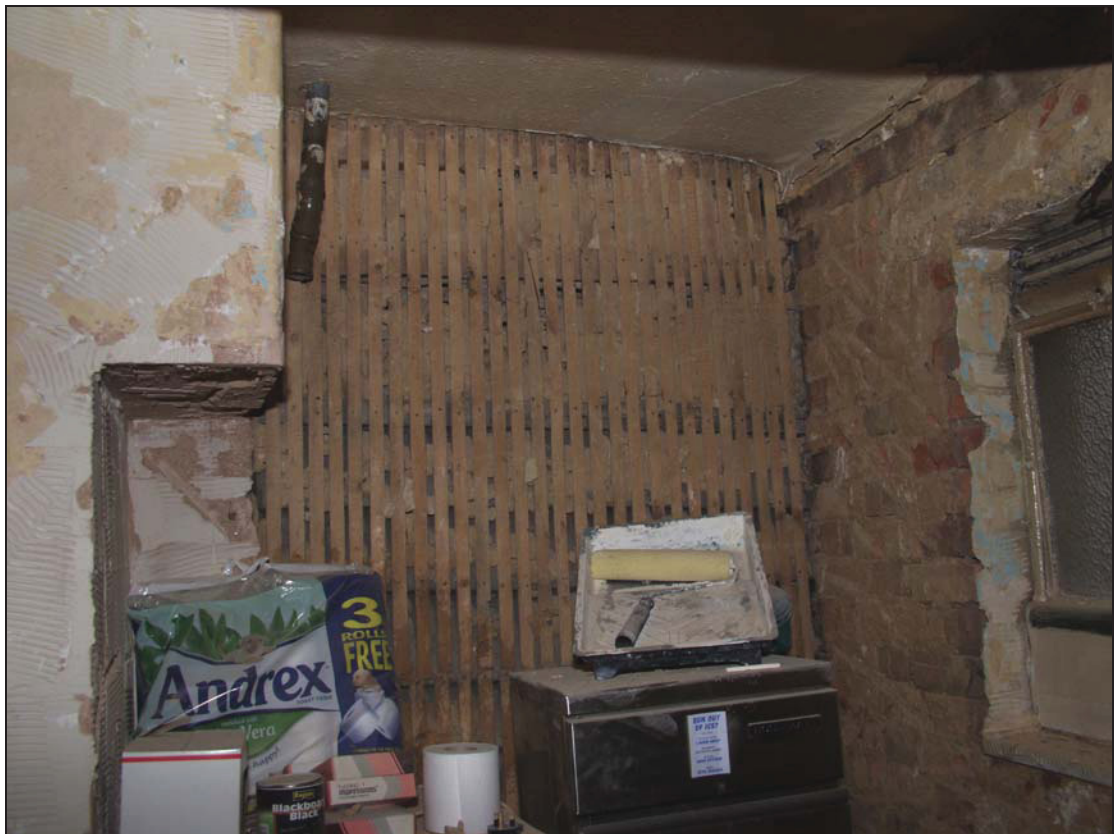
12 20<sup>th</sup> century laths flushing over weather-boarding on north wall of principal range, taken from the north (35)

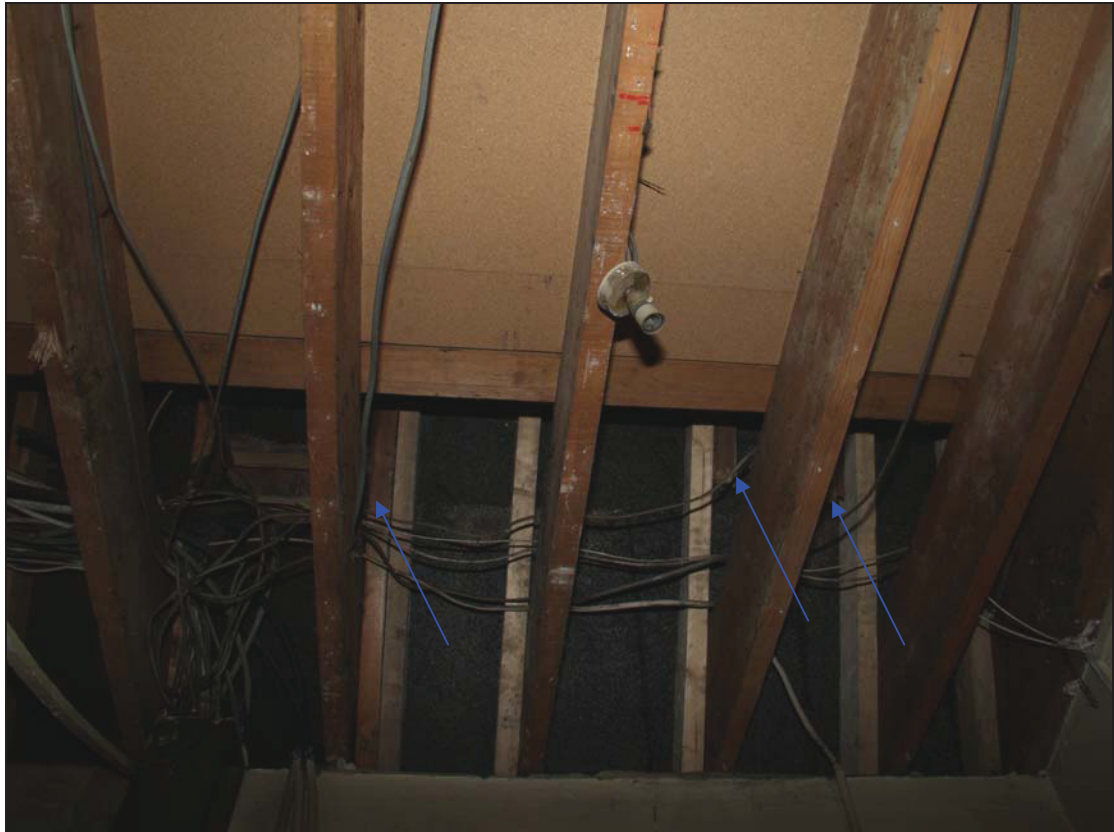
13 Earlier rafters (highlighted) alongside modern rafters over rear range (Room 5), taken from the east (37)

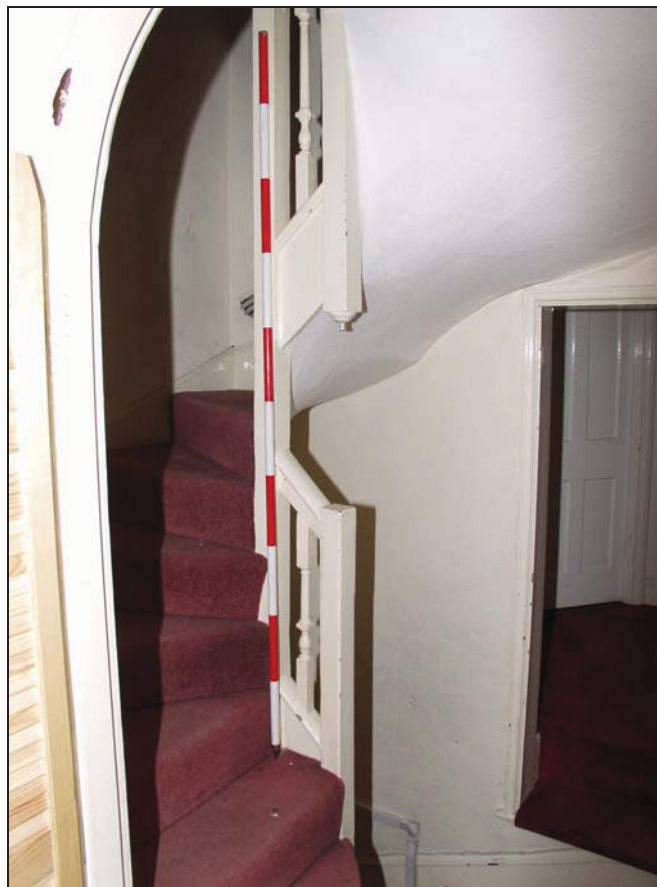
14 Dog-leg stair, first floor, principal range, taken from the south-east (16)

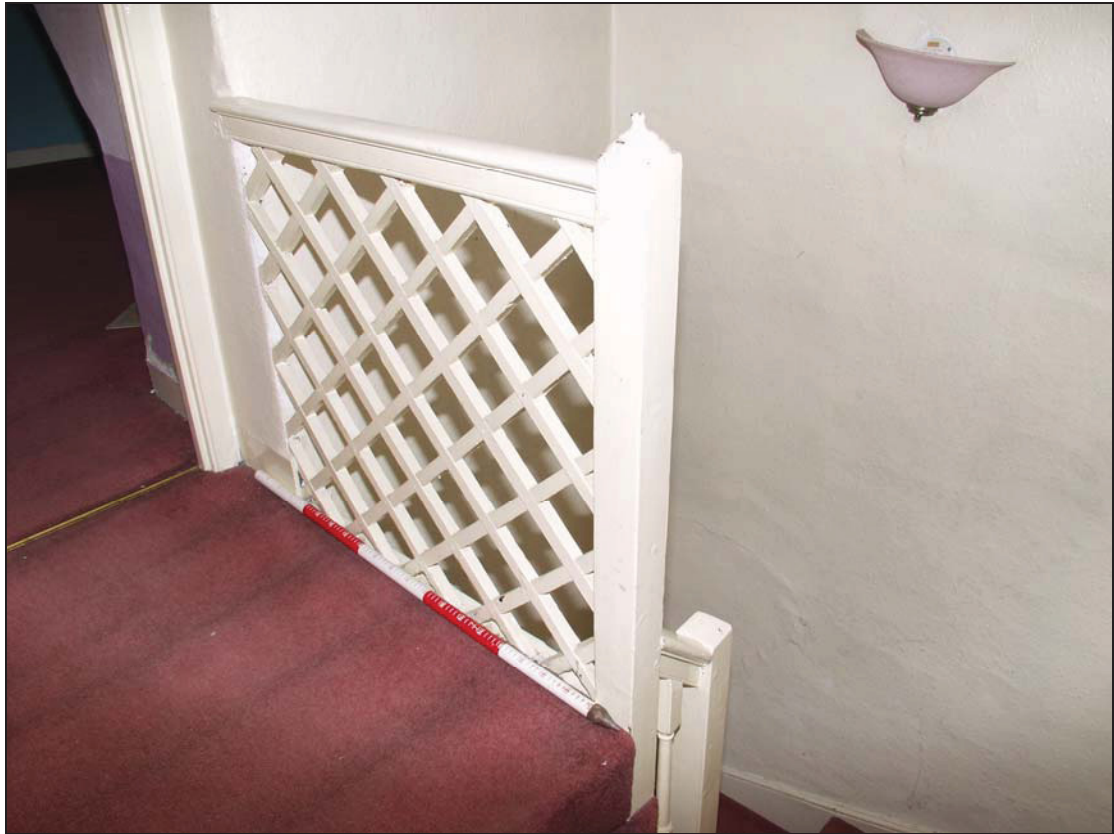
15 Lattice screen in place of balusters on attic landing, principal range, taken from the north-east (22)

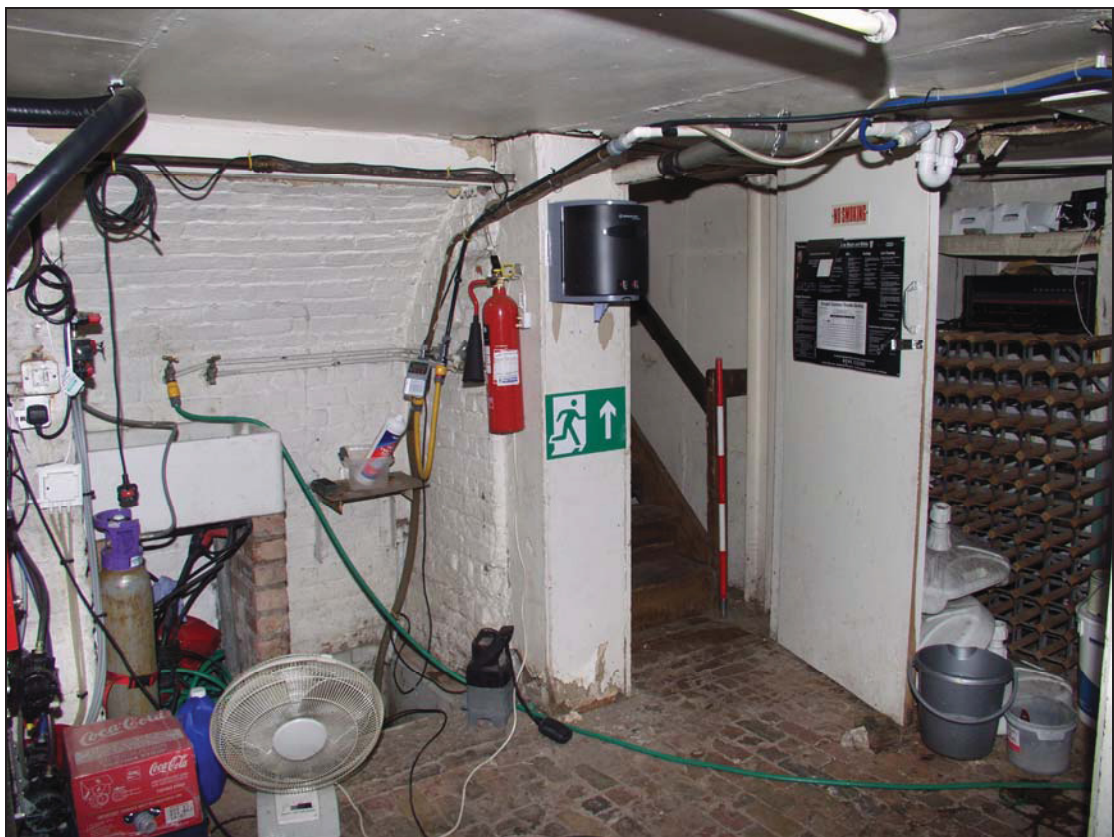
16 Corbelled brickwork to support hearth above and red brick floor in Room 6, taken from the south-west (DP 11)

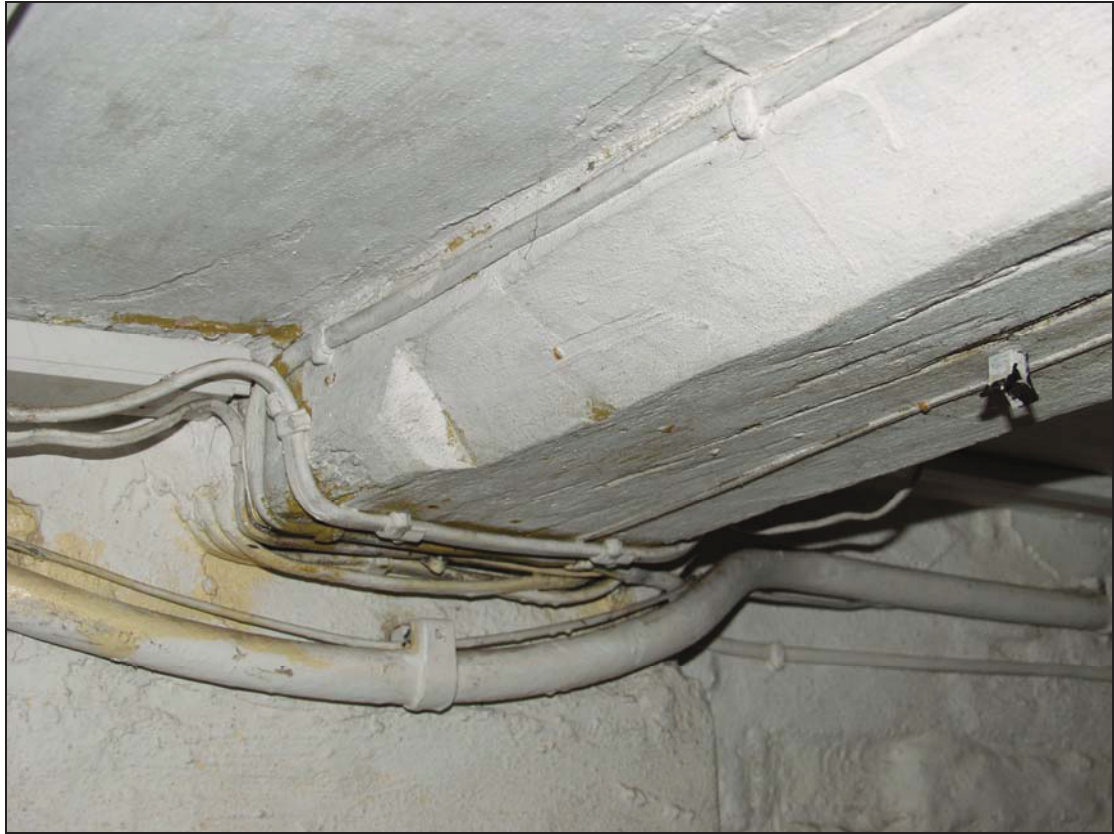
17 Elongated lamb's tongue chamfer stop on ceiling joist above Room 8, cellar, taken from the south-east (13)

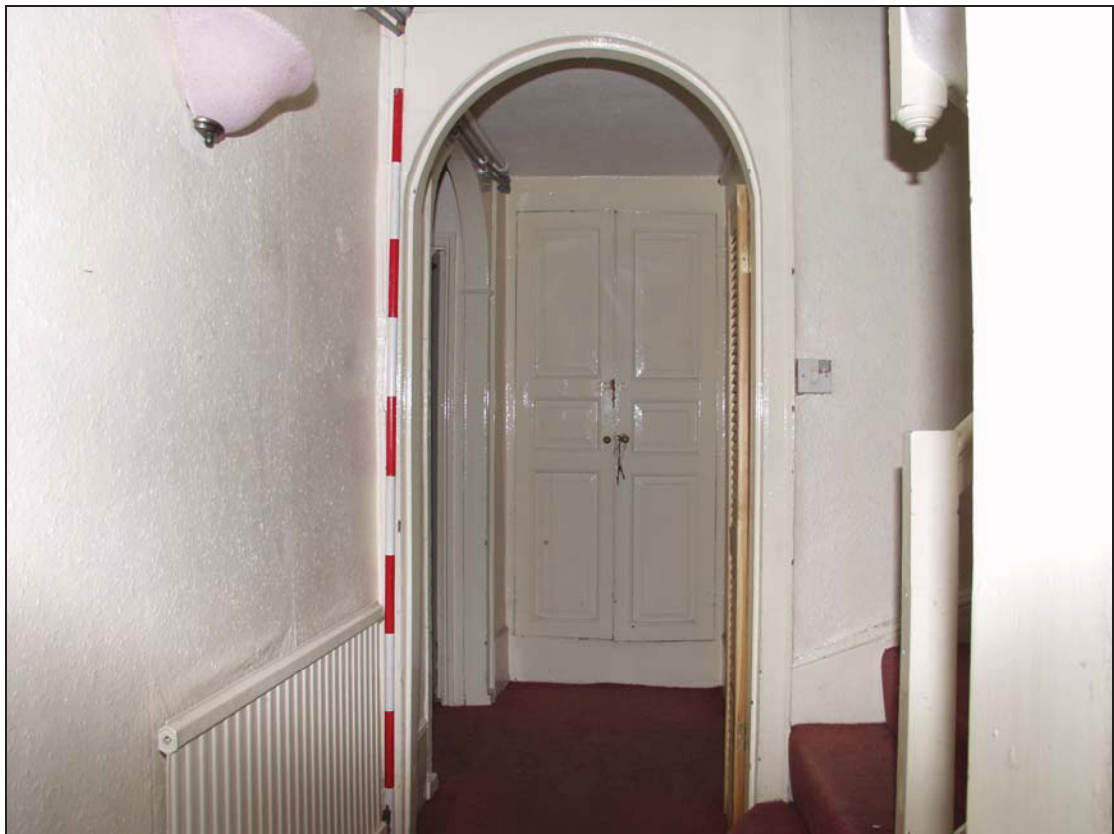
18 Eighteenth century archways and cupboard on first floor landing, principal range, taken from the north (15)

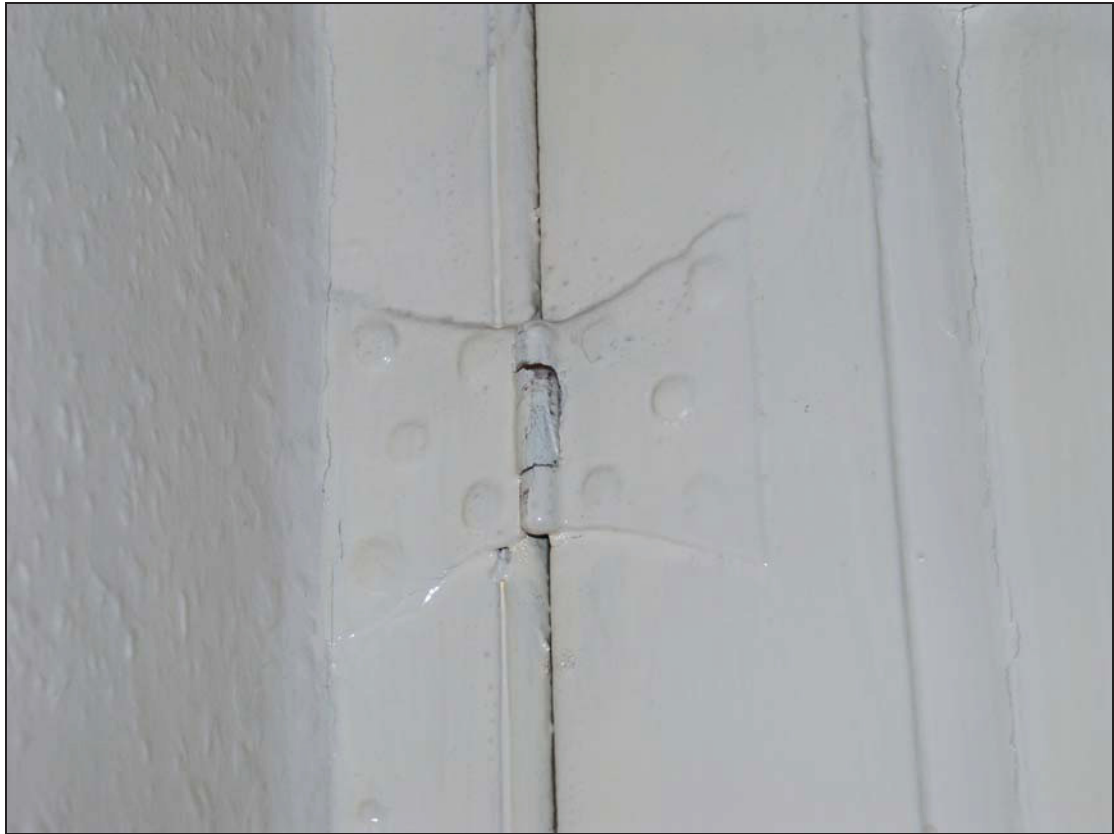
19 Butterfly hinge on cupboard door, first floor landing, principal range, taken from the north (21)

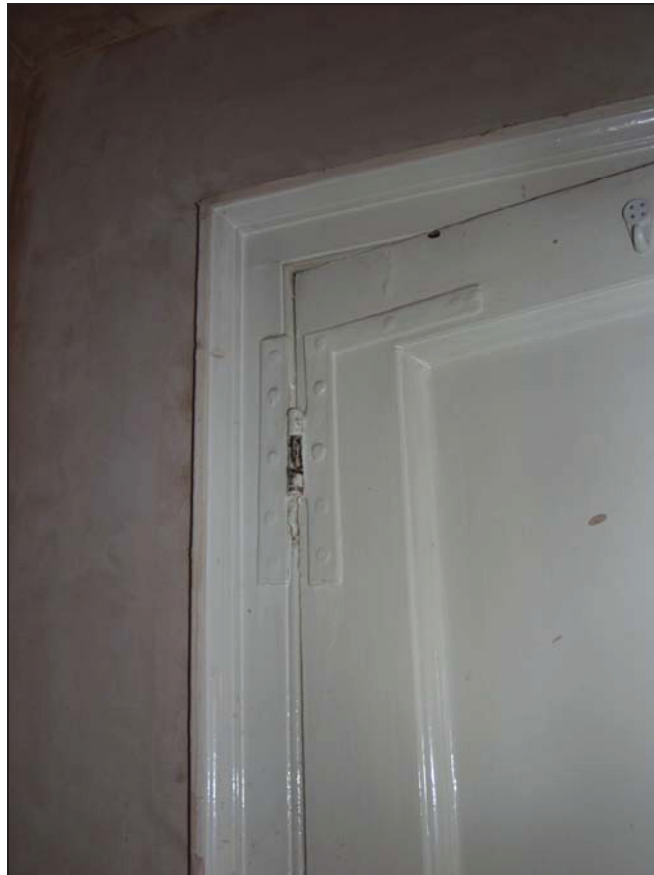
20 Original hinge on 18th century door to Room 9, first floor of principal range, taken from the west (72)

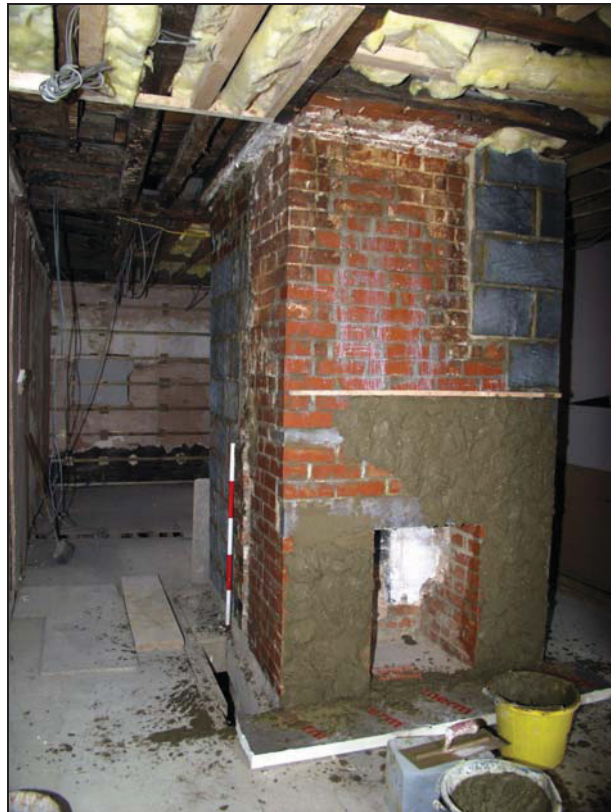
22 South face of free-standing chimney stack (first floor of principal range), taken from the south-west (40)

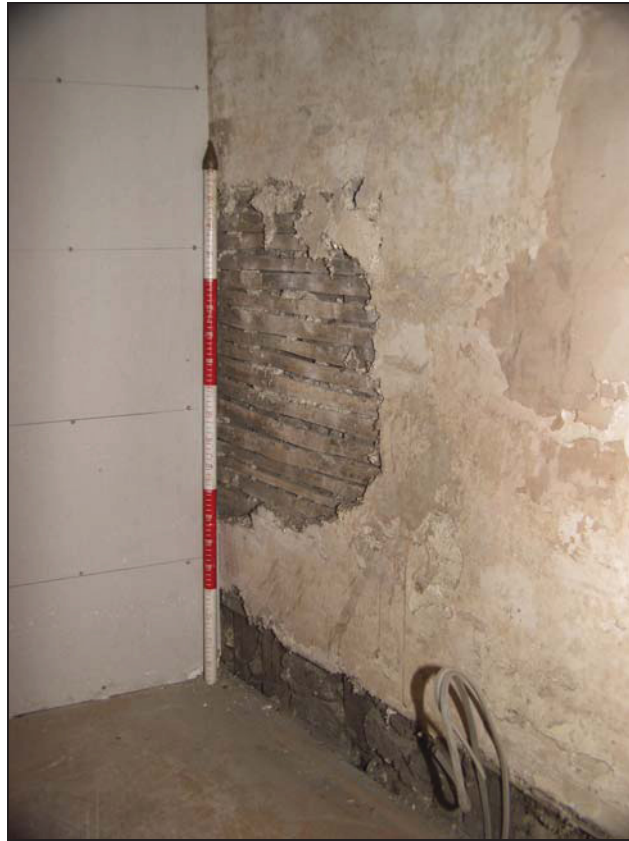
23 South wall of Room 10 (first floor of principal range) showing exposed lath and plaster, taken from the north-west (42)

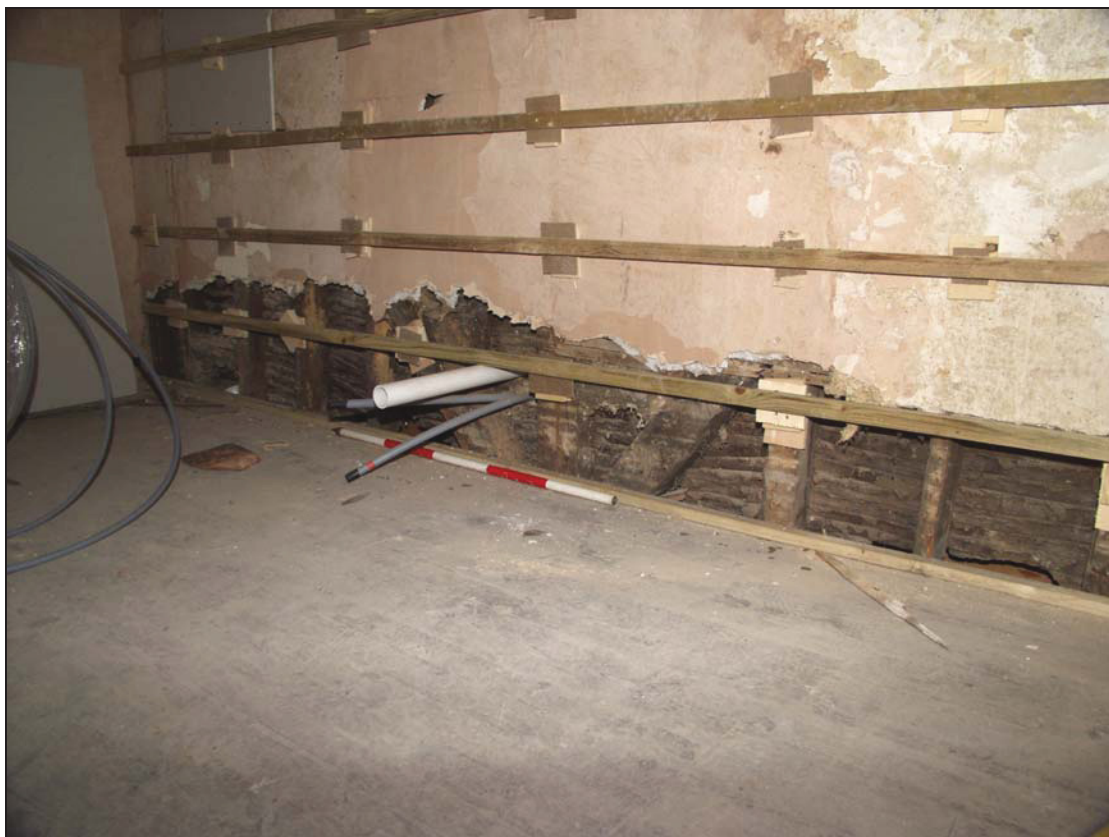
24 North wall of Room 11 (first floor of the principal range) with timber-framing visible at the base, taken from the south-east (51)

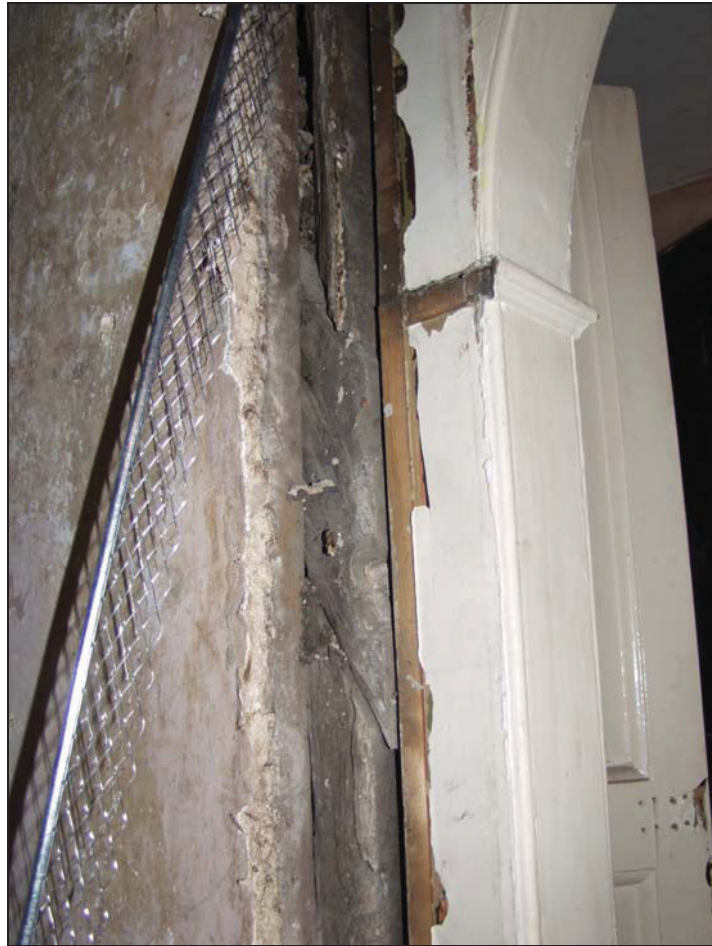
25 Detail on south side of entrance to Rooms 10 and 11 showing possible truncated primary brace, taken from the north-east (73)

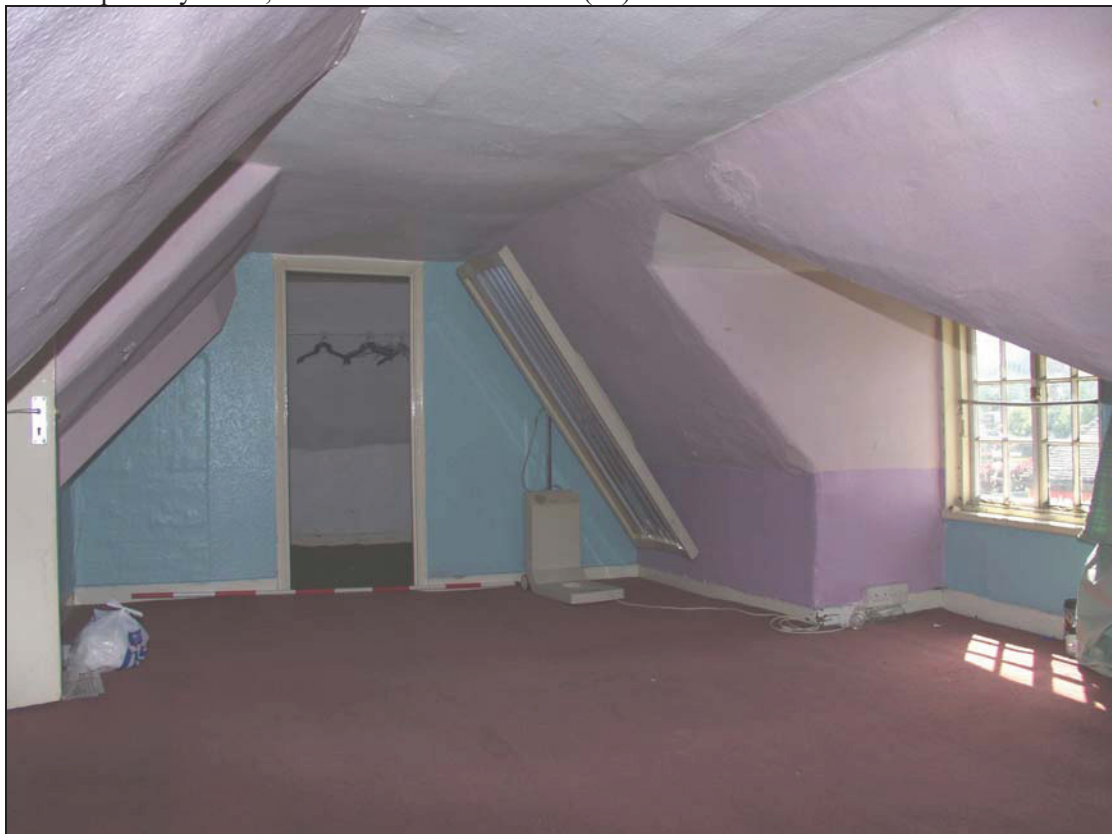
26 Attic (Rooms 12 and 13) with 20<sup>th</sup> century partition wall set against west side of east chimney stack, taken from the west (24)
