**THE SPORTSMAN PH, 117 FORE STREET,  
HERTFORD, HERTFORDSHIRE**

**HISTORIC BUILDING MONITORING AND RECORDING  
AND ARCHAEOLOGICAL MONITORING AND  
RECORDING**

Authors:	Amy Williamson BA Tansy Collins BSc	
NGR: TL 3288 1270		Report No. 3034
Parish: Hertford		Site Code: AS 1168
Approved: Claire Halpin MIFA		Project No. 3128
Signed:		Date: May 2009

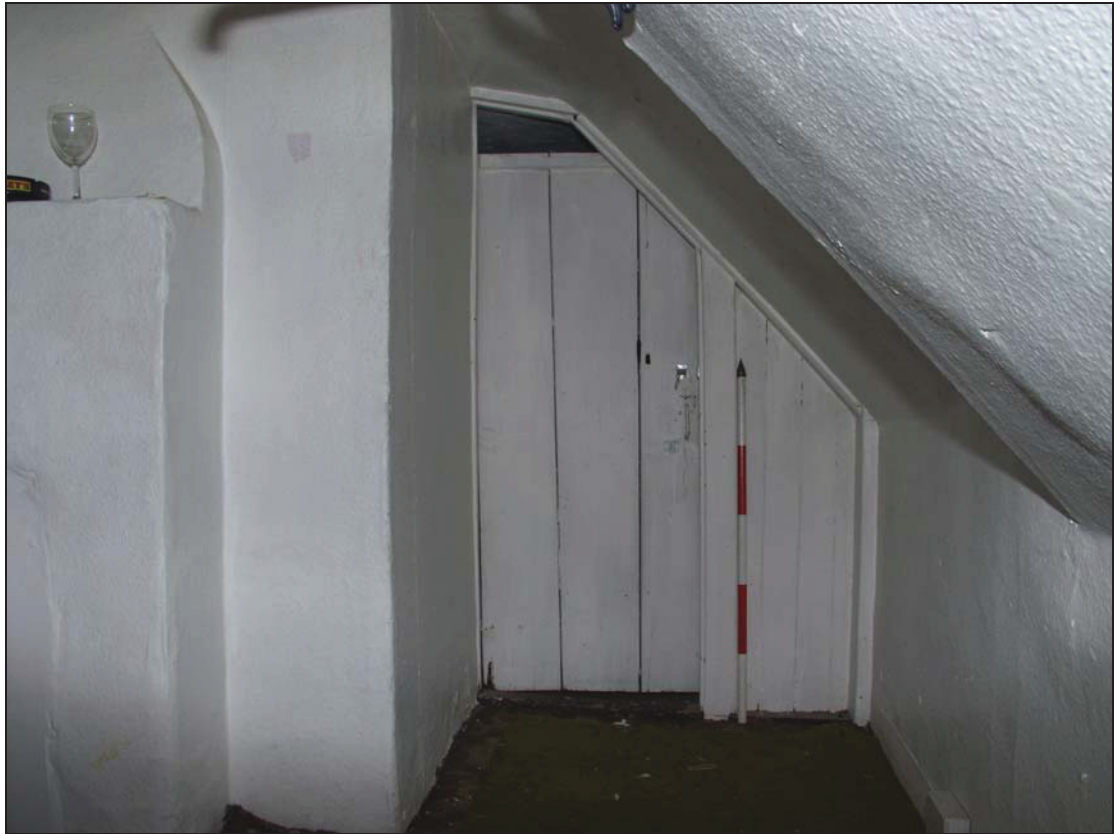
27 Boarded door (possibly of 18<sup>th</sup> century date) to Room 14, principal range, taken from the south (25)

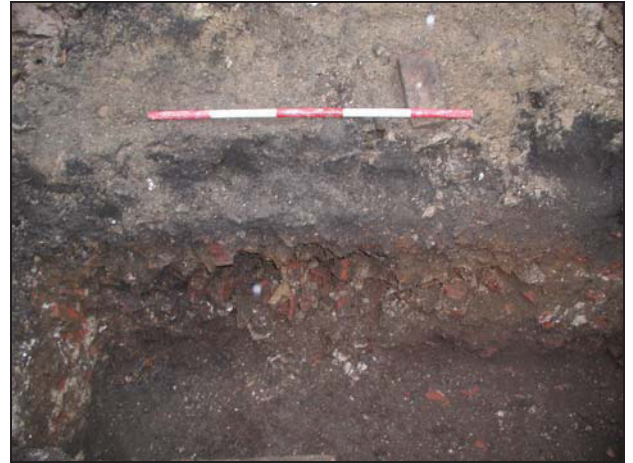
*DP 2*

9.4 Made Ground L1000 was present surrounding and overlying the above foundations in Sample Section 1 (Fig.11). It was present across the entire site and comprised a dark grey black sandy silt with frequent modern CBM, frequent medium sub-rounded stones, moderate rooting and moderate gravel. It was also found to contain a recent spark plug.

*Sample section 1, looking north*

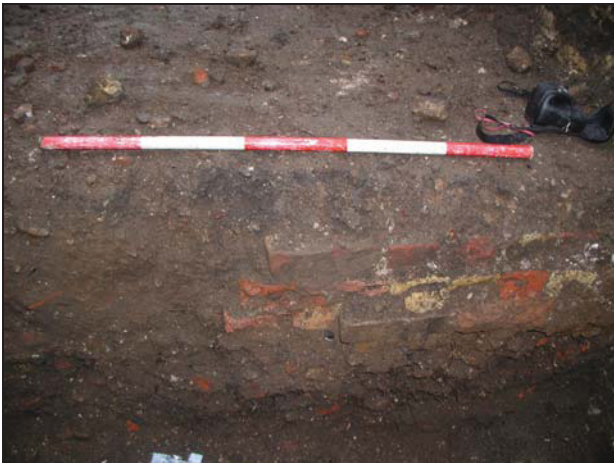
*DP 3*

9.6 Feature M1005 (0.28m deep) comprised three courses of red brick (c.0.21m x 0.10m x 0.09m), which were present in the north facing section of the foundation trench (Sample Section 2). The bricks were bonded with grey sandy mortar.

*Sample Section 2 (west end), looking south*

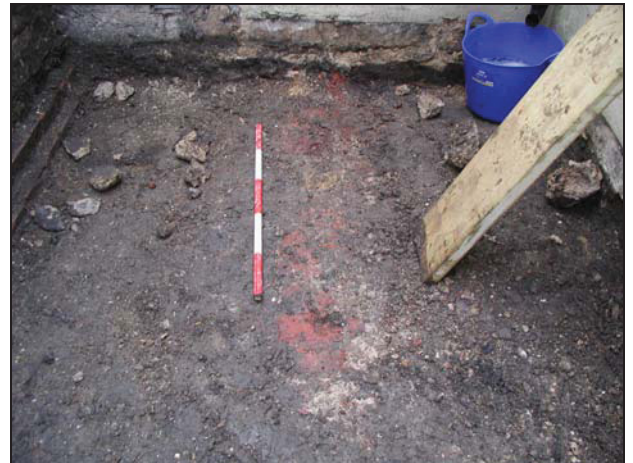
*DP 4*

9.2 A 19<sup>th</sup> century red brick wall foundation (M1001; 2.2m long x 0.29m wide) was found in the south-east end of the area subject to ground reduction (DP 4). It comprised bricks measuring 0.21m x 0.1m, although its depth was not recordable. The foundation measured c. 0.29m wide and is likely reconcilable to the boundary wall at the rear of the building seen on the 1880 and 1898 OS maps (Figs. 3 & 4).

*View of wall foundation M1001, looking south*
