ARCHAEOLOGICAL SOLUTIONS LTD

**HODDESDON LODGE FARM,
LORD STREET, HODDESDON,
HERTFORDSHIRE**

ARCHAEOLOGICAL MONITORING AND RECORDING

Author: Rozwadowski, M	
NGR: TL 35591 08409	Report No: 3212
District East Herts	Site Code: AS1175
Approved: Claire Halpin	Project No: P3235
Signed:	Date: November 2008

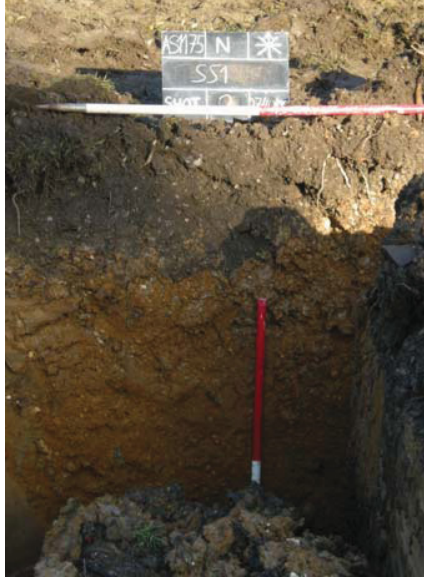
DP 1
Sample Section 1. View North

<i>Sample section 1</i> <i>Facing South East</i> <i>0.00 = 63m AOD</i>		
0.00 – 0.20m	L1000	Topsoil. Dark blackish grey moderately compact clayey silt with moderate pebbles and cobbles.
0.20m+	L1001	Natural. Dark brownish orange compacted clay with occasional pebbles.

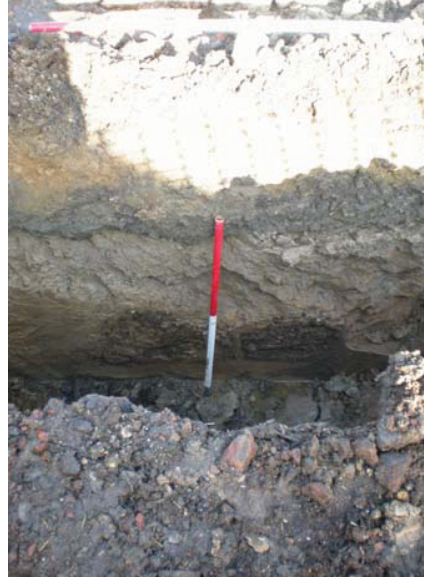
DP 2
Sample Section 2. View North-west

<i>Sample section 2</i> <i>Facing South East</i> <i>0.00 = 63m AOD</i>		
0.00 – 0.15m	L1002	Modern rubble. Mid orangey pinkish red moderately compact clayey silt with frequent CBM.
0.15 – 0.30m	L1003	Made ground. Mid orangey yellow moderately compact sandy silt with moderate amount of pebbles.
0.30 – 0.50m	L1000	Topsoil. As above.
0.50m+	L1001	Natural. As above.

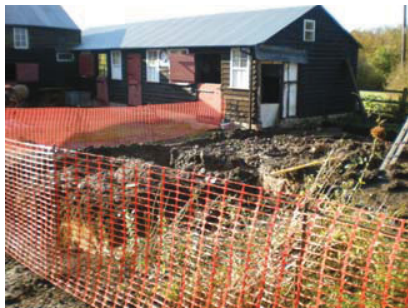
Description: No archaeological features were located in the foundation trenches. No archaeological artefacts were recovered.

DP 3
View across excavated foundations to South-west

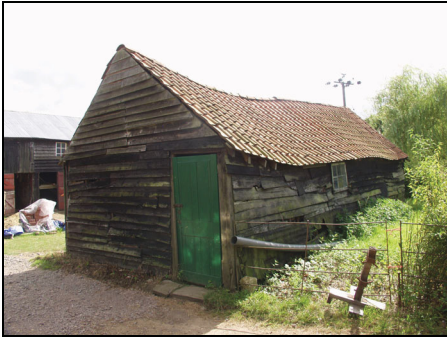
The building is constructed in very poor quality materials, mostly thrown up with hedge timber and other waney, worm-eaten wood, much of it, including studs and rafters no more than tree branches. Its very simplicity and rudimentary nature means that it is now on the verge of collapse, and structurally unsound. Externally, the building is weatherboarded, mostly in modern materials such as spruce, and has a pan-tile roof. Part of the interior is given access through a reused early Victorian kitchen or service door of probable 1830s / 1840s date.

1. View of structure, taken from the north-east

The building was clearly thrown up using any old timber which happened to be at hand. There is no real structural coherence nor any interesting features worth noting. It can not be dated, as there are no distinct structural characteristics, but given its ephemeral nature, it can not be of any great age. Attempting any further work would be a waste of time as the building is no more than the equivalent of a large garden shed. This description and the photographs taken on the visit should suffice on file to provide a simple record of the building.

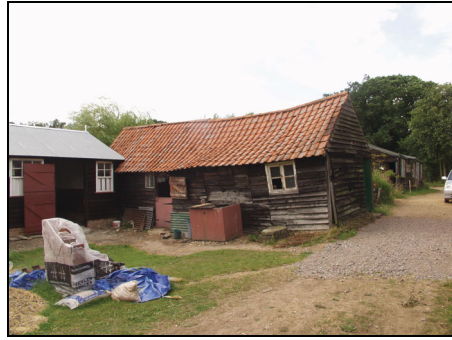
The construction form is very simple; three bays of framed panels, the best timber (though still slender and waney) being reserved for the wall plate and dividing posts, while the in-fill is essentially of simple props, primary-braced after a fashion with planking and other bits of wood. The bay divisions at roof level have become disrupted, probably due to later replacement, so that the tie-beams, which no longer have any structural function, are simply cogged over the wall plates. There is a single purlin in each pitch, clasped by rudimentary boarded collars which have been applied at random, and do not respect the bay divisions. The rafters are of the poorest quality, and the whole roof has needed propping with telephone poles jammed into the apex.

2. View of structure, taken from the south-east

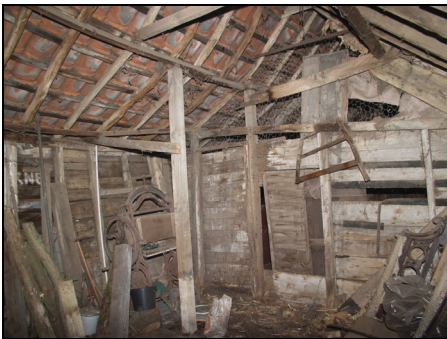
The interior of the barn is divided into rudimentary horse-stalls, using old planking and recycled timbers. It was formerly used as a chicken house.

3. Internal view of east bay, taken from the north-east

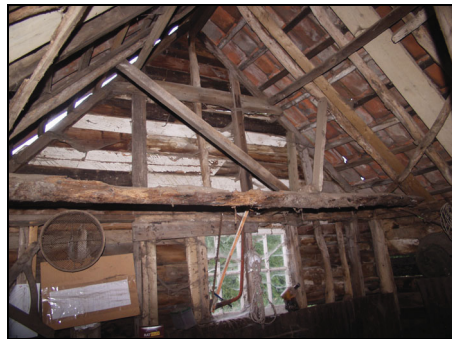
4. Internal view of the west bay, taken from the east

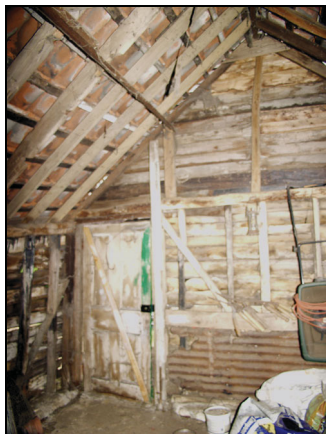
5. Internal view of the east bay, taken from the south-west

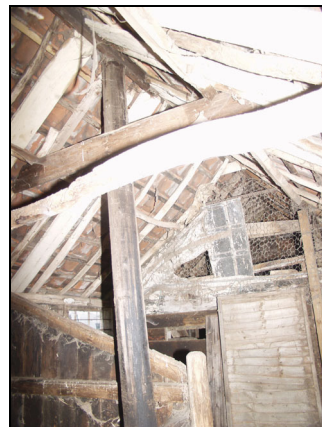
6. Internal view of the central bay, taken from the south-west
