**BUILDING EXTENSION
2-4 MULGRAVE ROAD, CROYDON**

ARCHAEOLOGICAL MONITORING & RECORDING

Authors: Tim Schofield HND BSc PIFA (fieldwork and text)	
NGR: 3265 6495	Report No: 3399
District: LB of Croydon	Site Code:
Approved: Claire Halpin	Project No: P3681
Signed:	Date: October 2009

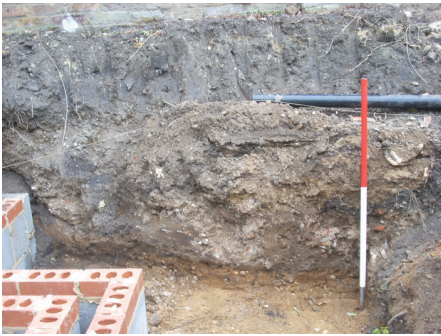
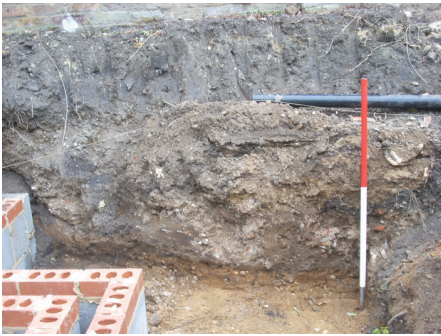
<i>Sample Section 1: Ground reduction east, facing west</i> 0.00 = 61.42m AOD	
0.00 – 0.61m	L1004. Lawn and Topsoil. Dark greyish brown, compact, sandy, silty clay with occasional angular flint stones (0.01-0.05m) and occasional tree roots.
0.61 – 0.97m	L1003. Made Ground. Mid yellowish brown, compact clayey sand with occasional angular flint stones (0.02–0.04m).
0.97 – 1.27m	L1002. Made Ground. Pale brown, loose silty sand and hardcore rubble.
1.27m+	L1001. Natural drift geology. Mid orange yellow, sand and gravel with patches of clayey sand silt and gravel (0.01-0.08m).

Sample Section 1 was recorded in the ground reduction area to the south of the current building. No archaeological features or finds were present.
Sample Section 2 (DP 2)

1. Sample Section 1, facing east

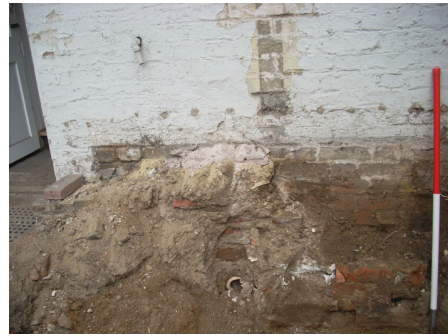
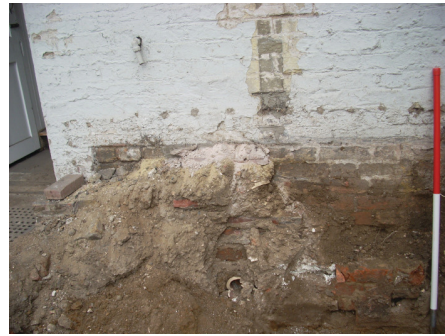
<i>Sample Section 2: Ground reduction at base of building, facing south 0.00 = 61.38m AOD</i>	
0.00 – 0.39m	M1006. Masonry foundation wall. Six brick depths below the ground surface. The bricks were stretcher bonded with a light yellow sand and cement mortar.
0.39 – 0.50m	L1005. Foundation, made ground. Mid orange white, compact, sandy silt and hardcore brick.
0.50m+	L1001. Natural drift geology. Mid orange yellow, loose sand and gravel with patches of clayey sand silt and gravel (0.01-0.08m).

Sample Section 2 was recorded against the wall of the existing building. At the top of the sequence, Foundation Wall M1006 was six brick depths below the old ground level. The bricks measured 21.60 x 6.40 x 10.80cm (8.5 x 2.5 x 4.5"). They were laid on a stretcher bond using a light yellow sand and cement mortar. Below was Foundation Layer L1005 at a depth of between 0.39-0.50m. It comprised primarily brick and hardcore rubble. At the base of the stratigraphic sequence was the natural, L1001. To the south of the sample section were service trenches. No archaeological features or finds were present.

2. Sample Section 2, facing north

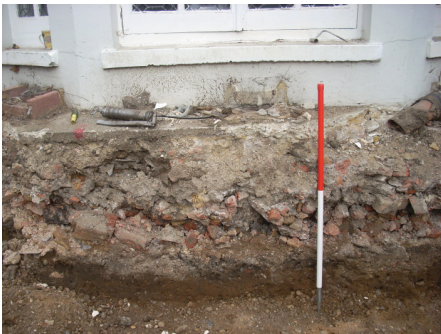
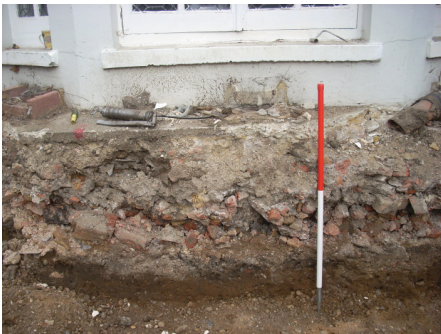
<i>Sample Section 3: Ground reduction at base of building, facing south 0.00 = 61.25m AOD</i>	
0.00 – 0.51m	M1007. Wall Foundation Trench Backfill. Broken bricks with rough light greyish white concrete bond.
0.51m+	L1001. Natural drift geology. Mid orangish yellow, loose sand and gravel with patches of clayey sand silt and gravel (0.01-0.08m).

Sample Section 3 was recorded to the west of SS2. At the top of the sequence was Wall Foundation Trench M1007. It contained broken bricks bonded with a light grey mortar to a depth of 0.51m. At the base of the stratigraphic sequence was the natural, L1001.

3. Sample Section 3, facing north
