MONTROSE CARE HOME, 95 LANGLEY ROAD,  
WATFORD, HERTFORDSHIRE

HISTORIC BUILDING RECORDING

ARCHAEOLOGICAL SOLUTIONS LTD

Authors:	Tansy Collins BSc Lee Prosser PhD Kathren Henry Andrew Peachey BA AIFA	
NGR: TQ 1021 9774	Report No: 3340	
District: Watford	Site Code: AS 1213	
Approved: Claire Halpin	Project No: 3497	
Signed:	Date: July 2009

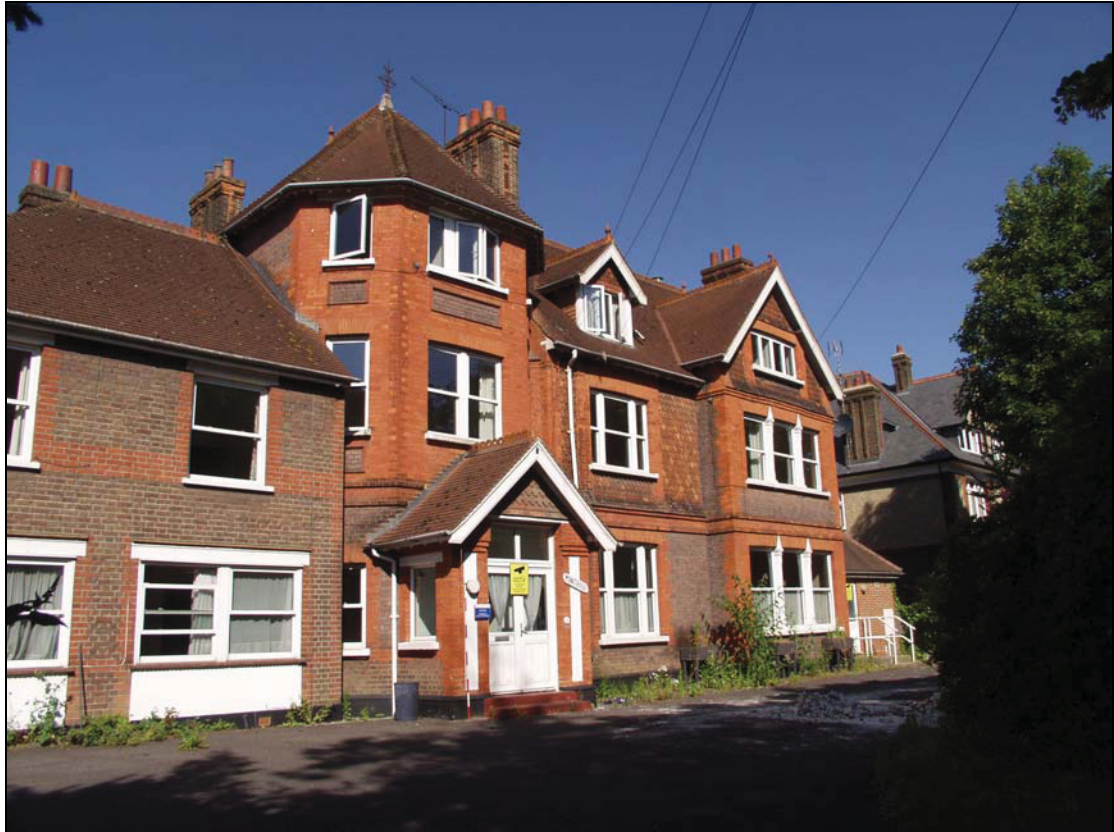
Plate 1 East main façade of the assessment building, taken from south-east (DP 1)

5.2.1 The building presents an irregular façade comprising two storeys plus attic rooms (Plate 1). A central bay is flanked by a projecting cross-wing to the north and a canted bay to the south which rises to a hipped roof and presents a projecting gabled porch at this point. The north cross-wing comprises a mixture of common Luton grey stocks relieved by fine red brick dressings with flush quoins to the corners. In contrast, the south canted bay is entirely of the finer red brick but with panels of Luton greys at the window aprons, while the upper storey of the central bay and the gable end of the north cross-wing are hung with fish-scale tiles. The windows, though replaced, exhibit their original form of one-over-one sashes with margin-lights in the central bay, double sashes to the cant bay and to the north cross-wing robust stone piers dividing the windows into a three sash arrangement. These piers have decorative chamfer stops and Doric capitals.

5.2.2 The finer detail of this façade has characteristics entirely consistent with the Arts and Crafts style, with mass produced but congruous features utilising a mixture of materials and techniques. We see moulded bricks to the apron panels below the window sills in the canted bay, shaped though simple bargeboards to the gables along with terracotta finials, although a decorative ironwork finial is used on the roof of the canted bay. The care and craftsmanship is evident with the use of the gauged brick arches for the windows and the careful tuck pointing of finer brickwork. The chimneystacks are typically given careful treatment with red brick ribs and an oversail over the top.

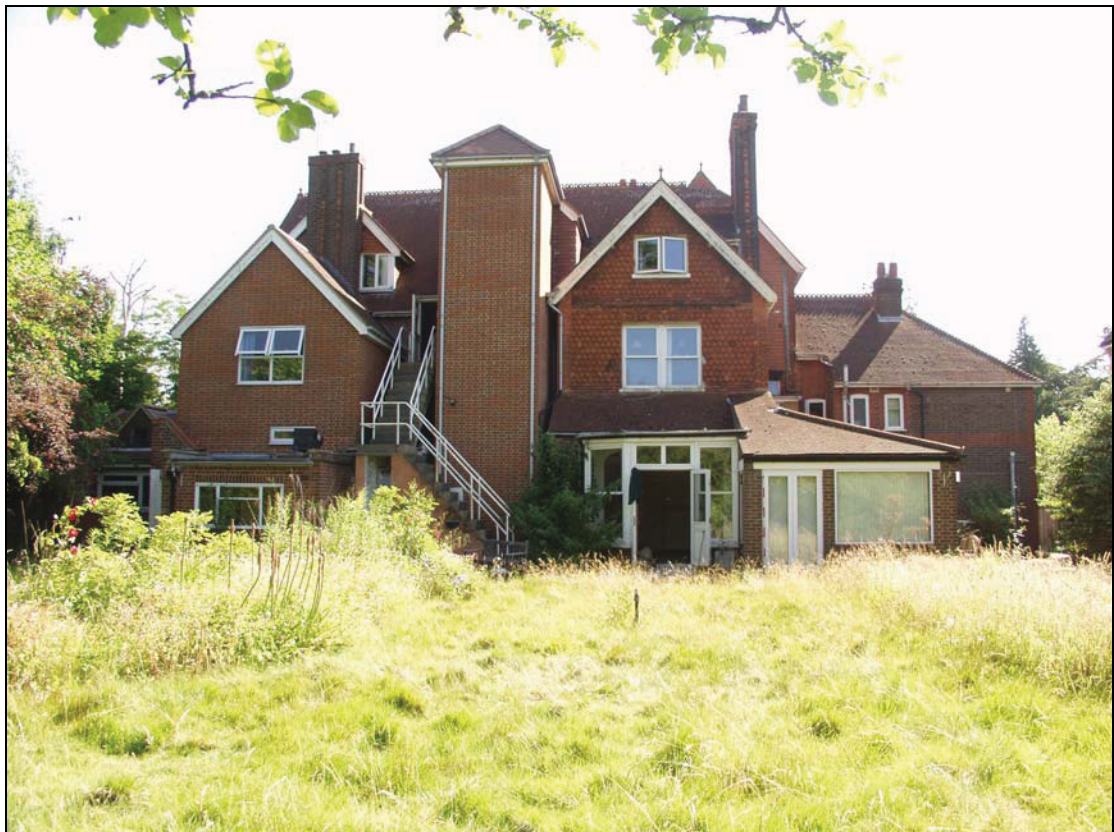
Plate 2 Rear west façade of the building with later additions, taken from the west (DP 5)

5.2.5 The rear garden façade (Plate 2) is a jumbled accretion of units obscuring much of the principal range, including the cross-wing to the north which perhaps has been raised to two storeys, a central lift shaft, concrete fire escape and other small additions to a south wing which is still expressed in original materials at first floor level. As elsewhere we see a combination of materials; the south wing is

hung at first floor and gable level with fish-scale tiles, while two very tall chimneystacks have brick ribs and over sailing tops. All windows represent uPVC replacements with the exception of a small single-light casement at ground floor level on the north cross-wing which has four panes.

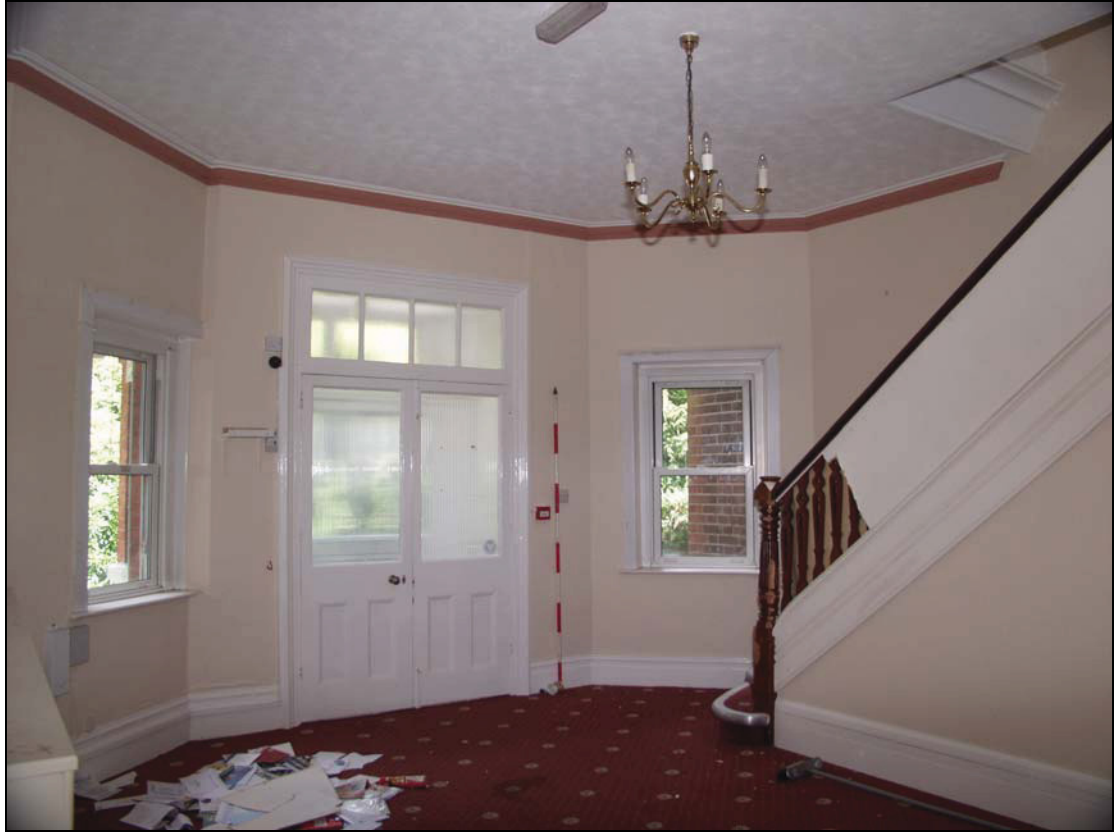
Plate 3 View of entrance hall, taken from the north-west (DP 16)

5.3.3 The front door on the east elevation leads into the porch which retains an original two-leaf inner door giving access to the entrance hall. Each leaf has two lower heavily moulded panels with single upper panels, now glazed with 1950s reeded glass, and a four-pane overlight with simple yet heavy late Victorian glazing bars, all set in a heavily moulded architrave. The knob and key escutcheon plate appear to be original. This area (Plate 3) has bevelled walls reflecting the canted bay seen from the exterior, while two corridors give access to the remaining areas of the house. The staircase is situated on the south wall and retains its heavily moulded softwood newel although this has been heavily damaged where it was previously boxed-in. A shaped handrail and splat balusters are present, in a 17<sup>th</sup> century style.

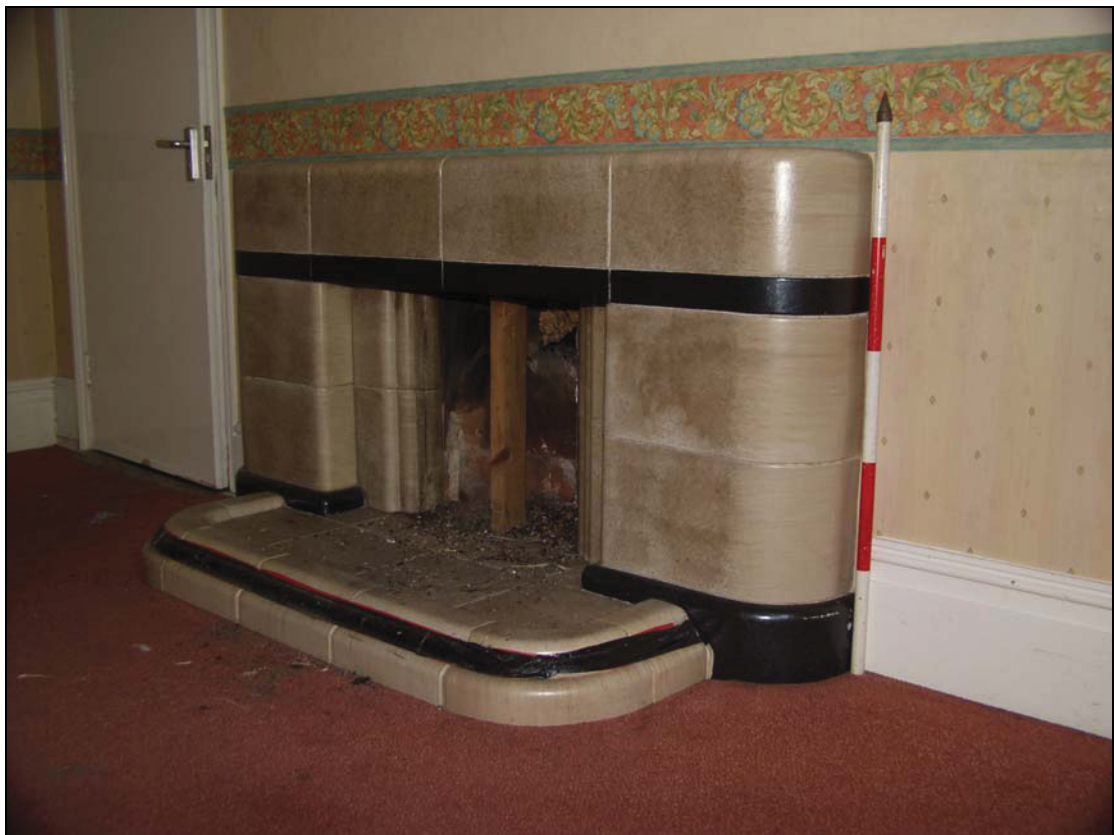
Plate 4 Fireplace on the north wall of the ground floor parlour, taken from the south-east (DP 10)

5.3.4 As noted above there has been a similar attrition of features in all rooms throughout the building. In the former study for example (Bedroom 4) only the skirting board, door architrave and part of the ceiling cornice survive. The dining area retains a heavy coved and moulded cornice and high skirting board, a detail which reflects the status of the room as a former parlour. One notable feature is a 1930s lustre-ware fireplace with heavy ceramic tiling, made by 'THE DEVON FIRE COMPANY L<sup>TD</sup>' (Plate 4).

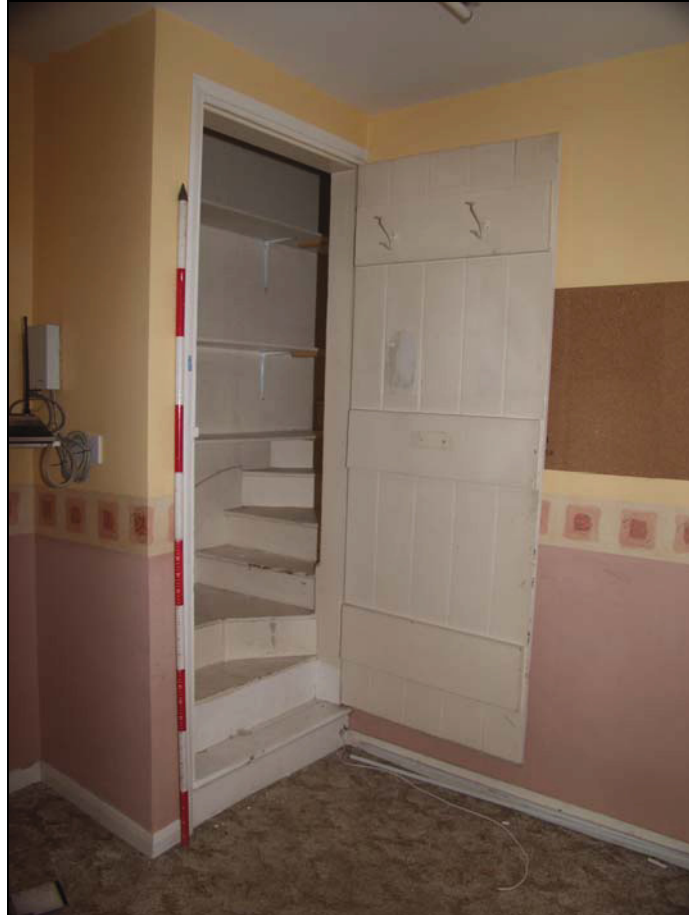
Plate 5 View of truncated stair in ground floor office, taken from the north-west (DP 12)

5.3.7 The first floor was originally reached by two stairs; the main stair leading from the entrance hall and a back stair leading from the service end which is now truncated and no longer in use. The main staircase rises to a half-landing where a further short flight of steps opens into an upper corridor. The corridor at this level extends to the north, off which a number of rooms and the lift are reached, along with a continuation of the back stair which gives access to the second floor. The first floor of the south extension is given access from the half landing where little of interest is visible. A small WC has been added to the exterior on the west. This was facilitated by the enlargement of an earlier window aperture, the head and voussoir of which can be seen from the exterior.

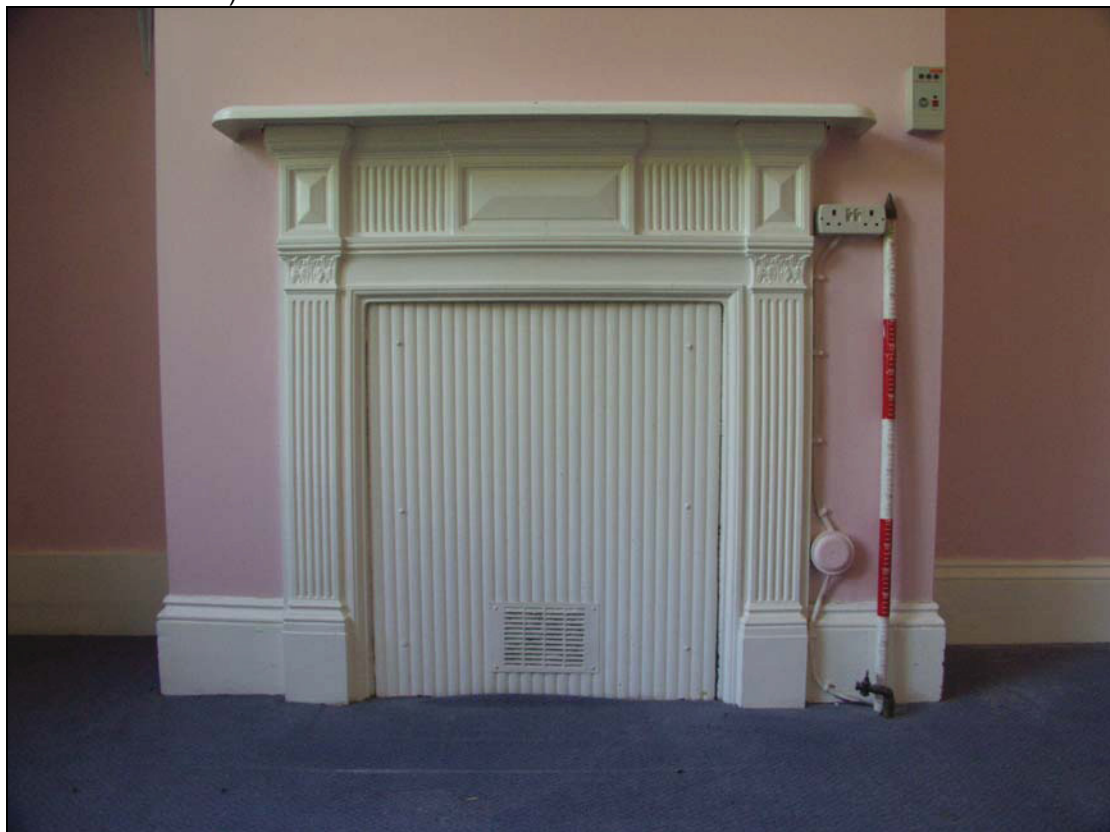
Plate 6 Detail of fireplace in Bedroom 10, taken from the north (DP 26)

5.3.11 Bedroom 10 occupies the central bay at the front of the building and is of original proportions, retaining a picture rail in addition to the skirting board and cornice. The architrave to the door also survives as well as a second late Victorian decorative chimneypiece of painted timber (Plate 6).

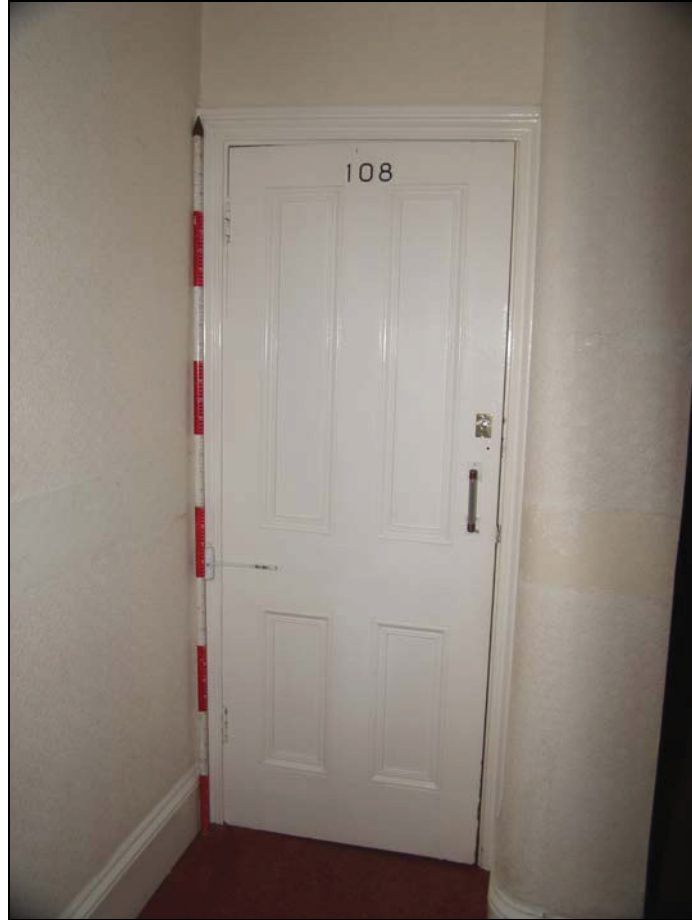
Plate 7 Original door to WC 2 (first floor), taken from the east (DP 23)

5.3.12 WC 2 within the corridor retains an original door with four heavily moulded panels (Plate 7), identical in form to the door to WC 1 on the ground floor.

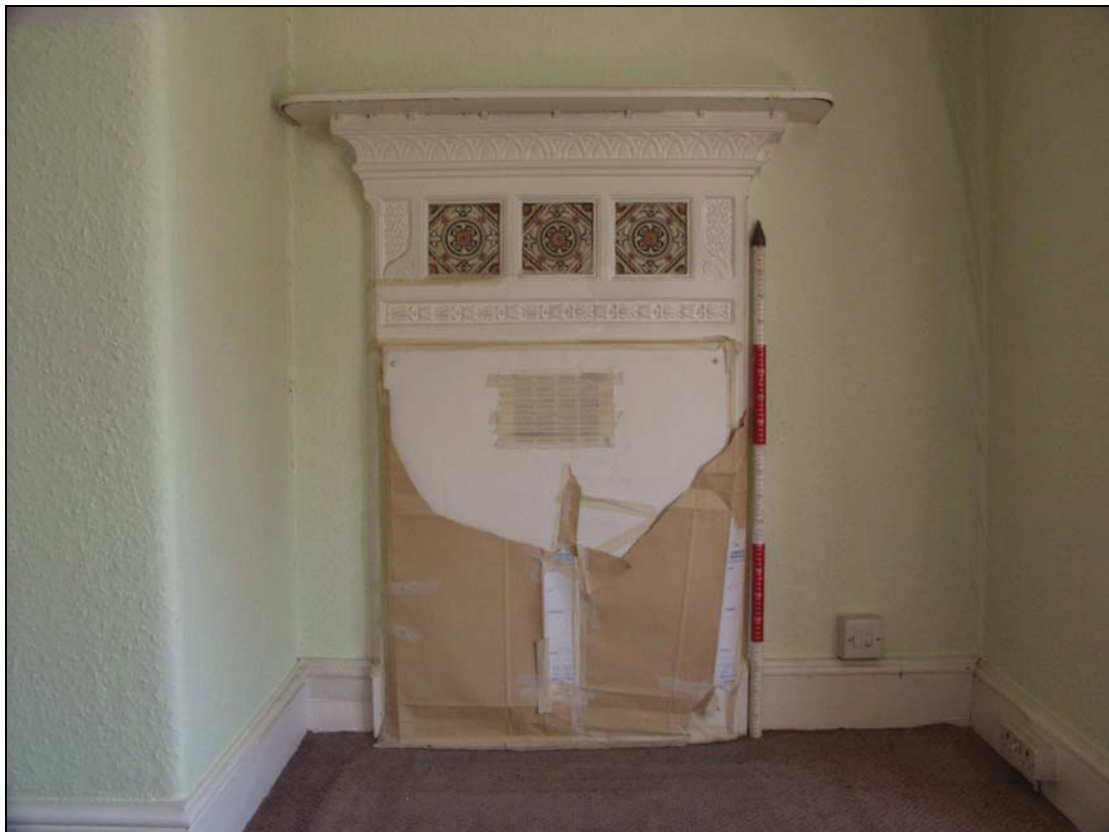
Plate 8 Detail of fireplace in Bedroom 22, taken from the north (DP 33)

5.3.16 The upper landing is spacious although modified as elsewhere. The bedrooms at this level have undergone similar treatment as the floor below with subdivision and modification, and similarly it is only a number of architraves and skirting boards that survive, along with two chimney surrounds. The former room occupying the south-east area, now comprising two rooms (Bedrooms 20 and 21), retains a picture rail, while Bedroom 22 to the rear has an attractive late 19<sup>th</sup>

century chimneypiece with inlaid tiles (Plate 8). Similarly Bedroom 17 to the north-east has a decorative chimneypiece with a timber surround.
