ST MARY'S CHURCH HALL, WALTON,  
FELIXSTOWE, SUFFOLK

ARCHAEOLOGICAL  
MONITORING AND RECORDING

# ST MARY'S CHURCH HALL, WALTON, FELIXSTOWE SUFFOLK

## ARCHAEOLOGICAL MONITORING AND RECORDING

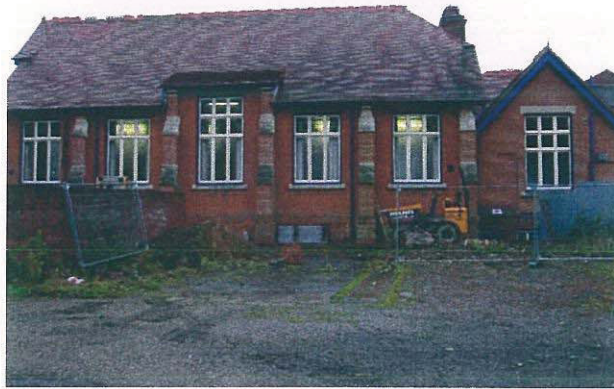
1

*General view of the site. Looking East*

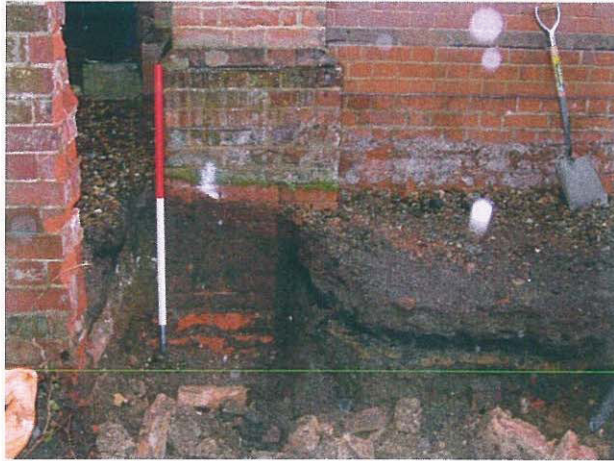
2

South-east side, north-west facing (Fig 3 DP 2)		
0.00m = 21.93m AOD		
0.00 – 0.89m	L1008	Wall foundation backfill. Hardcore and brick within a compact, mid brown yellow sandy clay.
0.89 – 1.10m	L1003	Made ground. Compact, mid grey brown clayey silt and sand with hardcore rubble and occasional broken brick and cement.
1.10m+	L1004	Sandy Clay Natural. Friable, mid brown yellow, sandy clay and gravel.

*Description:* The church hall wall foundations (M1006 and M1007) were contained within the backfill (L1008) of the construction cut.

Foundation M1006 consisted of nine brick courses (0.22m x 0.08m) in stretcher bond. The foundations extended 0.80m below the ground surface and rested on a single levelling course (M1007). It was directly above Made

Ground L1003. The backfill of the construction cut for M1006 comprised hardcore and brick within a compact, mid brown yellow sandy clay (L1008).

*Sample Section 1. Looking South-East.*

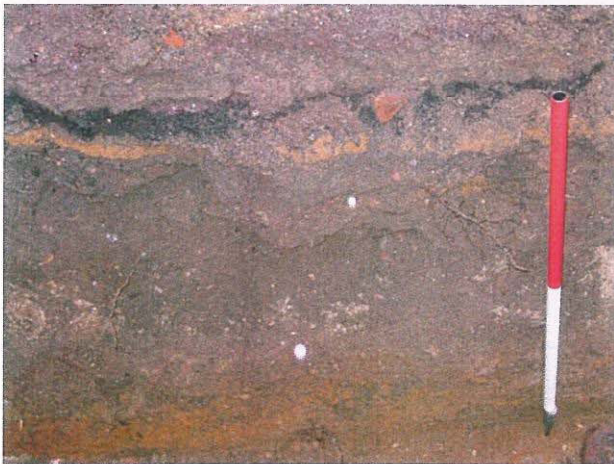
South-east side, North-west facing (Fig 3 DP3) 0.00m = 21.85m AOD		
0.00 – 0.09m	L1000	Made ground. As above.
0.09 – 0.16m	L1001	Made ground. As above.
0.15 – 0.18m	L1002	Made ground. As above.
0.17 – 0.86m	L1003	Made ground. As above.
0.86m+	L1004	Sandy Clay Natural. As above.

*Description:* No archaeological finds or features were present.

*Sample Section 5. Looking South- East.*
