**HODDESDON LODGE FARM, LORD STREET,  
HODDESDON, HERTFORDSHIRE**

**ARCHAEOLOGICAL MONITORING AND RECORDING**

Authors: Zbigniew Pozorski MA (Fieldwork & Report) Hannah Tweedie MPhil (Archaeological background)	
NGR: TL 35603 08416	Report No. 3486
District: Broxbourne	Site Code: AS 1175
Approved: Claire Halpin MIFA	Project No. 3235
Signed:	Date: February 2010

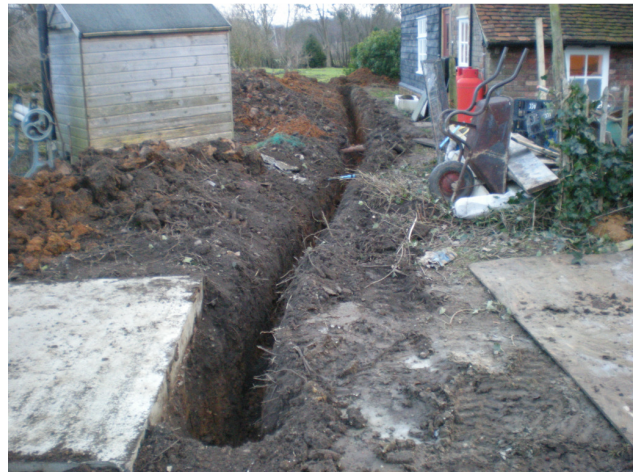
DP 2. Service trench, E part. View SSE.

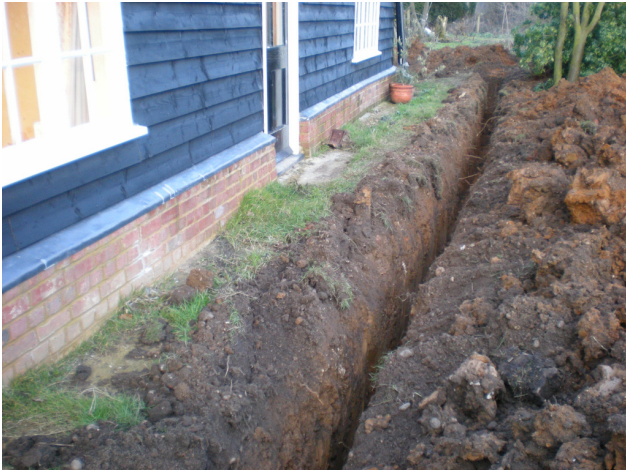
DP 3. Service trench, S part. View ENE.

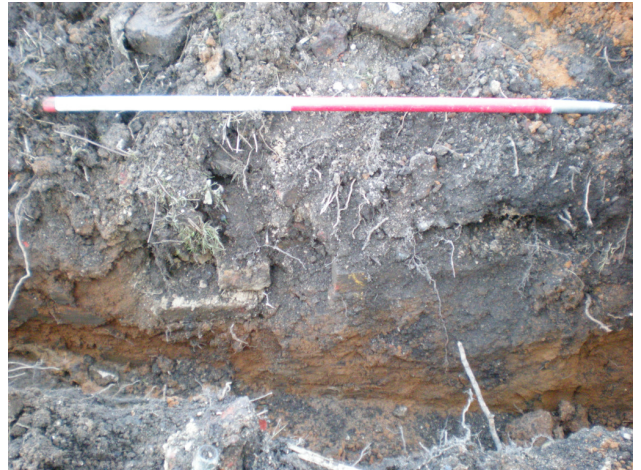
<i>NE part of service trench, sample section 1, facing WSW (DP 4)</i> <i>0.00 = 63.26m AOD</i>		
0.00 – 0.27m	L2000	Made ground. Dark grey to black, loose, clayey silt with sand and CBM rubble.
0.27 – 0.45m	L2001	Blackish grey, loose, sandy silt.
0.60m+	L2002	Natural mid to dark, compact, clay.

*Description:* The monitoring revealed the remains of a possible garden or boundary wall M2003 (Sample Section 1; Figs.3-4, DP 4). It was located in the

north-eastern length of the service trench and shared the same alignment as the northern wall of the house. It was constructed of red bricks (0.22 x 0.11 x 0.10m) bonded with creamy, chalky mortar. Two courses of bricks were present, and survived in poor condition at c. 0.30m below the existing ground level. The wall was of possible Victorian/ early 20<sup>th</sup> century date.

DP 4. NE part of service trench, sample section 1. View ENE.

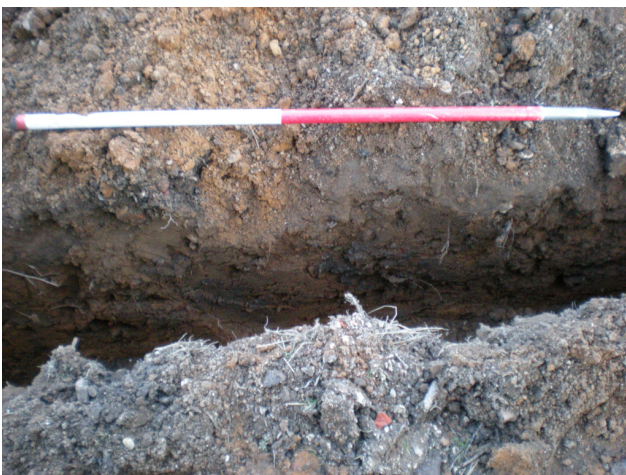
<i>SE part of service trench, sample section 2, facing NNW (DP 5)</i> <i>0.00 = 63.41m AOD</i>		
0.00 – 0.15m	L2000	Made ground. As above.
0.15 – 0.41m	L2001	Sandy silt. As above.
0.60m+	L2002	Natural clay. As above.

DP 5. SE part of service trench, sample section 2. View SSE.

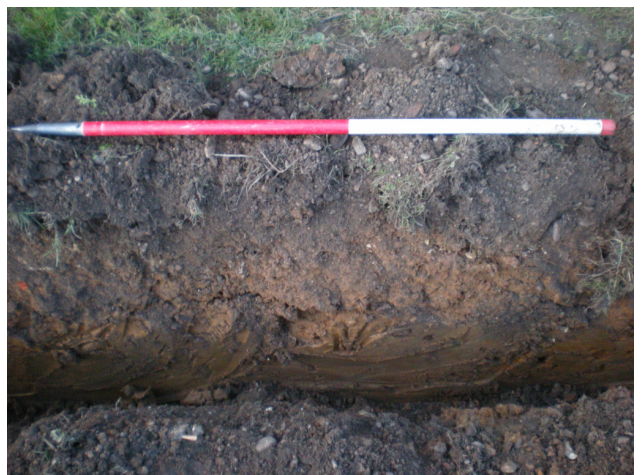
<i>S part of service trench, sample section 3, facing SSE (DP 6)</i> <i>0.00 = 63.38m AOD</i>		
0.00 – 0.12m	L2000	Made ground. As above.
0.21 – 0.21m	L2001	Sandy silt. As above.
0.65m+	L2002	Natural clay. As above.

DP 6. S/central part of service trench, sample section 3. View NNW.
