**PICCOTTS END HOUSE, 106 PICCOTTS END,
HEMEL HEMPSTEAD, HERTFORDSHIRE**

**ARCHAEOLOGICAL IMPACT ASSESSMENT &
HISTORIC BUILDING IMPACT ASSESSMENT**

Authors:	Tansy Collins BSc Lee Prosser PhD Kate Higgs BA	
NGR: TL 0518 0902		Report No. 3276
District: Dacorum		Site Code: AS 1201
Approved: Claire Halpin MIFA		Project No. 3445
Signed:		Date: April 2009

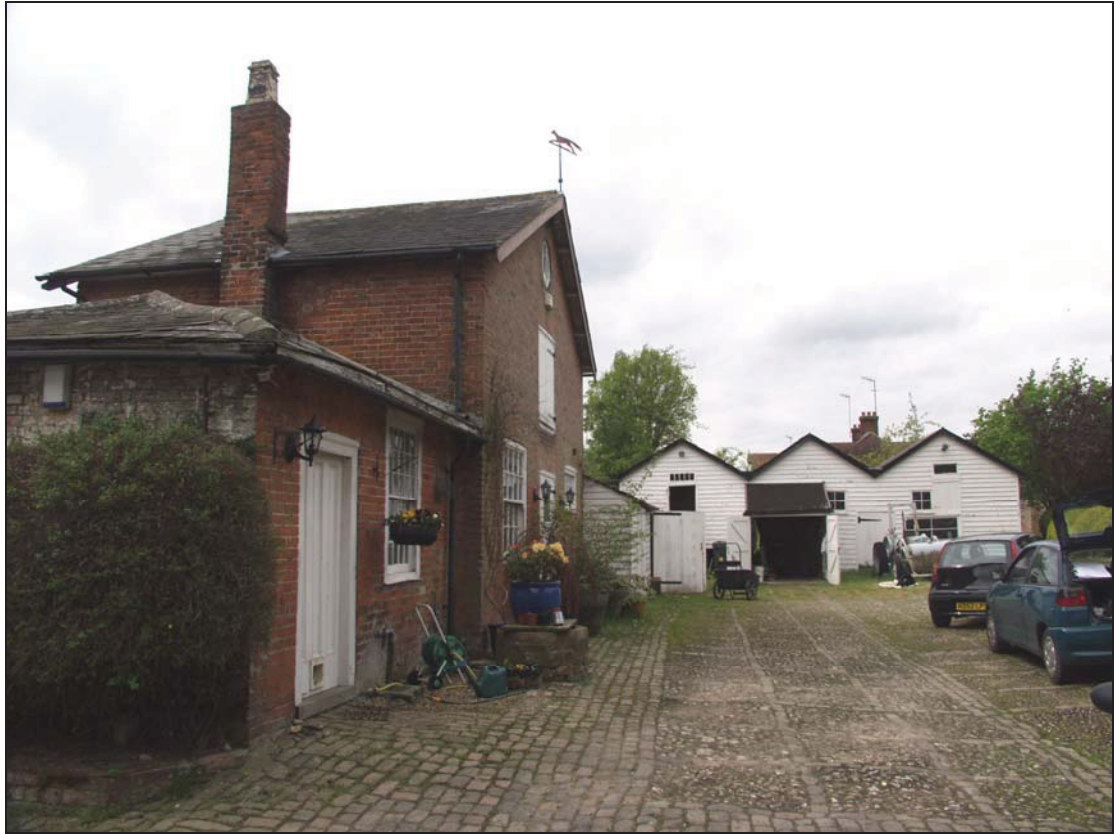
Plate 1 General view of the assessment buildings, taken from the south (39)

5.1.1 The outbuildings form an interesting and linked collection of typical late 18th / early 19th century structures appropriate to a minor country estate (Plate 1). The intended function is still easily discernible and comprised a large, brick, two-storey stable with blocked apertures for a dovecote in the gable, with flanking single-storey tack room and carriage house forming a modest, symmetrical ensemble. A second carriage house, store and stable extends this to the north, with a timber-fronted return comprising a raised, three-bay

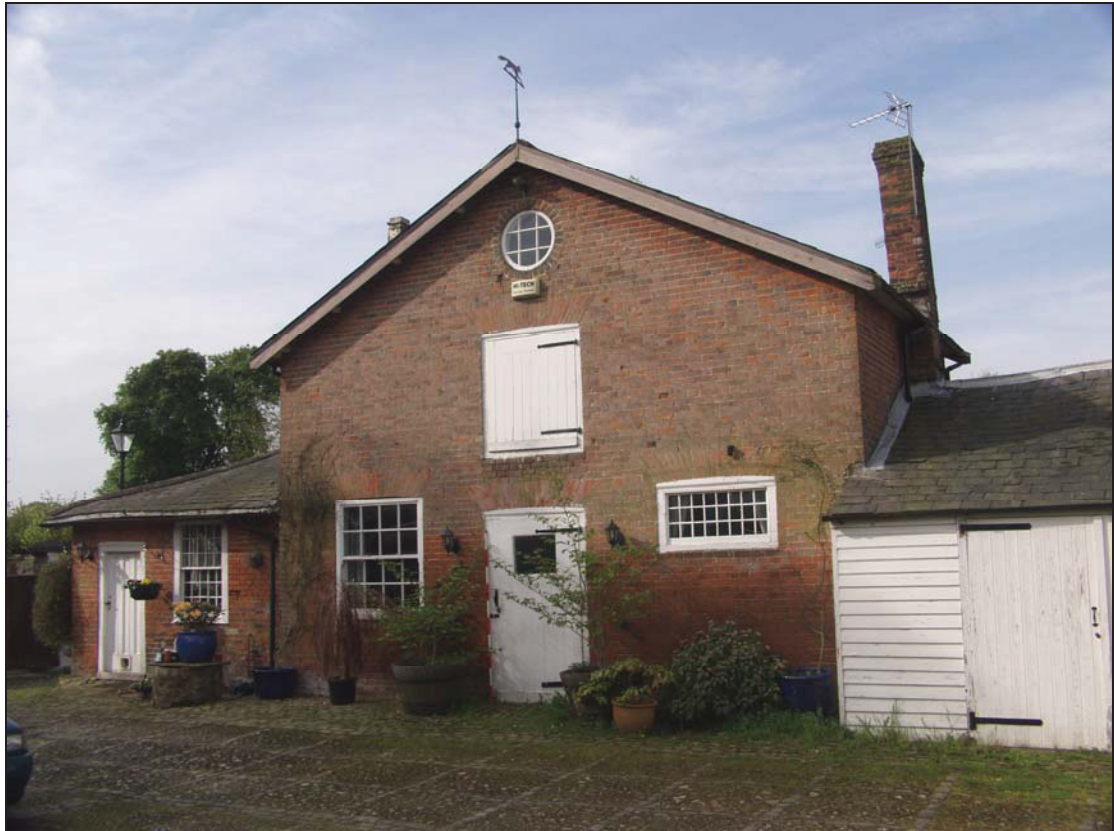
Plate 2 East façade of Building 1, taken from the east (5)

5.2.1 Building 1 (Plate 2) is a substantial and impressive stable block of two storeys in brick with a grey slate roof. The brick is a very fine sandy orange-red fabric with straight skintles, preserving much of the original pointing. A few kiss marks are visible along with a few darkened headers. The bricks measure an average of 8½" x 2½" 4¼" (216mm x 64mm x 108mm) laid in Flemish bond with ½" wide joints of buff-coloured lime mortar.

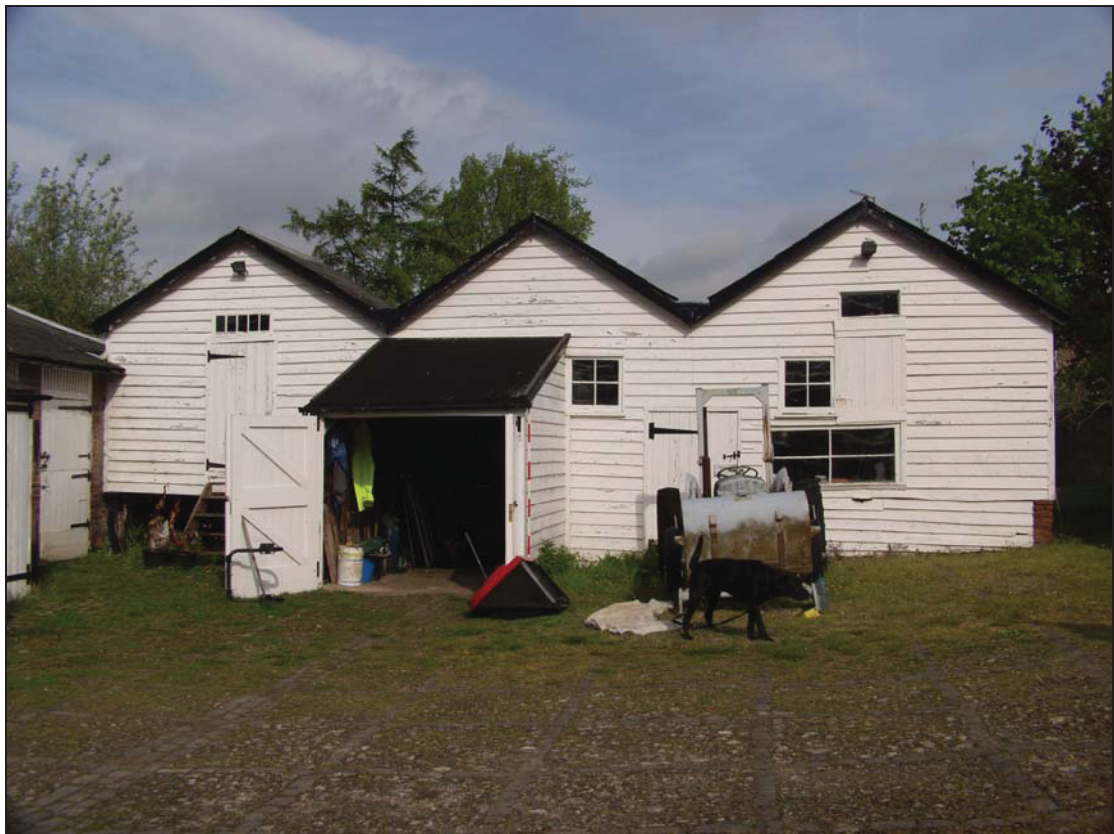
Plate 4 South elevation of Building 5, taken from the south (8)

5.2.12 The main frontage (Plate 4), is as noted above, of painted weatherboarding with a slate roof. This is fairly robust, and appears to be of softwood. The gables are framed by simple bargeboards which disguise shaped purlin-ends. The west retains its original raised floor, preserving six tapering stylobates with discus-shaped heads; the paving seen in the courtyard extending beneath. Access is given from a rudimentary timber stair, now in poor condition which preserves an original 19th century cast-iron handrail with a scrolled end. The door is probably modern but has a little five-paned over-light. The central and east units have had their floors dropped, though internally some stylobates remain together with redundant mortices for the earlier floor joisting. The central unit is marred by a 20th century outshut construction, but the main façade preserves an original window of four fixed panes. At the junction of central and east bays is a boarded door, no longer used but which has an early latch and single pane overlight. In its earlier configuration, the east bay was probably reached by a stair and door as on the west. The stair has gone, leaving a redundant door set at high level, which has been chopped at the base to insert an unusually wide and low window of four panes, lighting the workbench within.

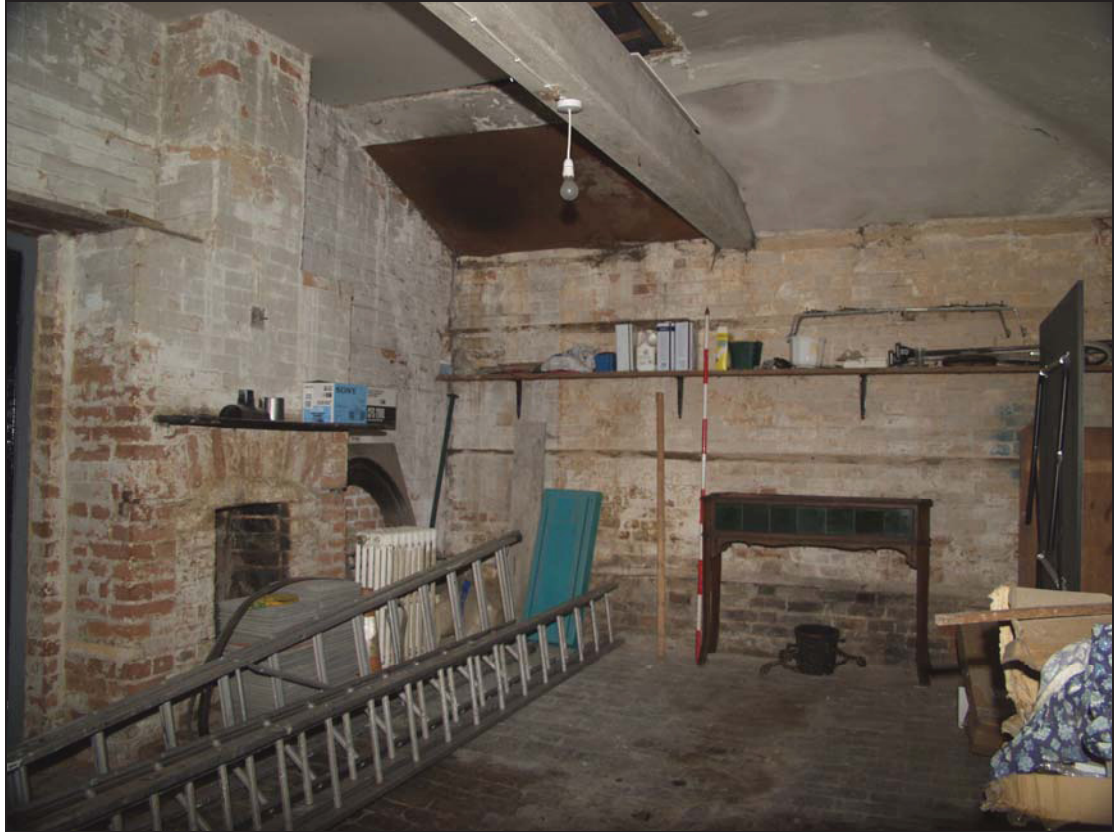
Plate 5 Interior of Building 3, taken from the north-west (22)

5.3.9 The interior of the south carriage house (Building 3; Plate 5)) is floored with paviers. The walls have exposed brick, latterly lime-washed or painted, preserving in the south-east corner some wide vertical boarding which may once have been more extensive. The little windows flanking the doors have typically early 19th century style glazing bars and differ from the more archaic windows in the adjoining wings. The original door from the stable is overhung by a large wide shelf that rests on the shoulder of the adjacent chimneystack. This is identical in form with its companion in Building 2 but here less modified and preserving a simple shelf and iron restraints to the head of the grate. The original grate has been removed. Timber wall bearers form a matrix for various fixtures such as hooks and similar.

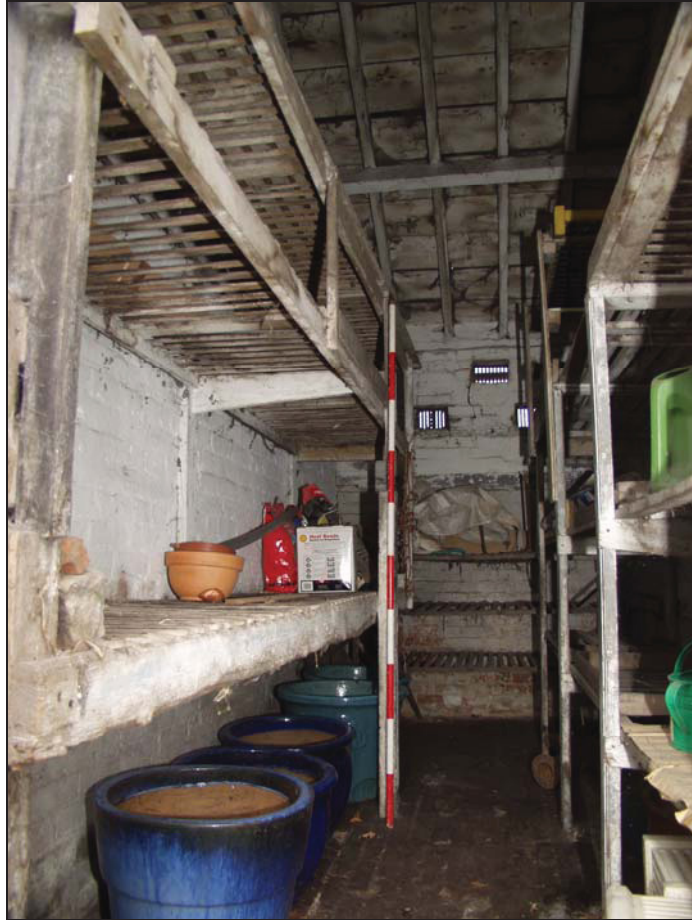
Plate 7 Interior of storage unit (central area of Building 4), taken from the east (25)

5.3.13 The north end of Building 4 forms a stable and adjoining store. The store door has a heavy frame with two ledges to the rear along with a large timber-cased rim-lock and housing for a slatted door to the upper hatch. A simple locking system for lower boards survives on the architraves (Plate 6). The interior is paved, while we see an identical roof structure running through. The space is now fitted with a racking system on either side with moveable trays (Plate 7).

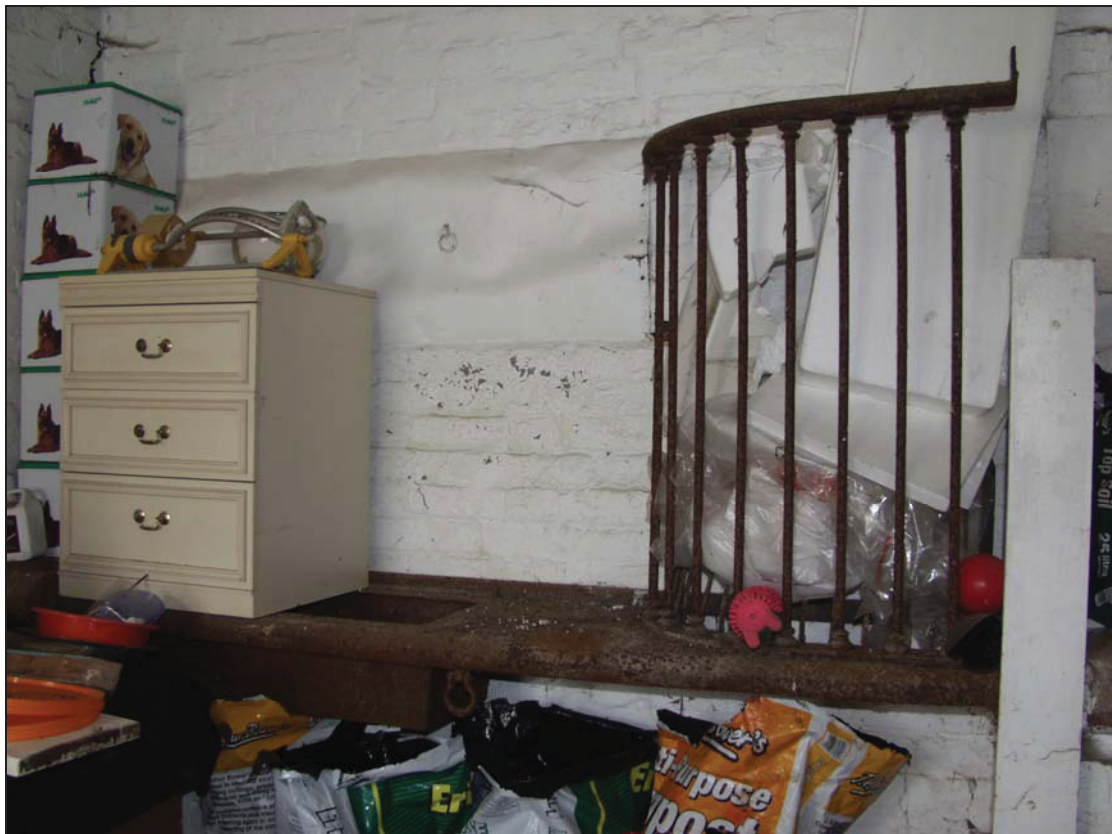
Plate 8 Detail of manger in Building 4, taken from the east (29)

5.3.14 The stable is paved in fine yellow paviers and was formerly divided into two stalls. Although mostly removed, the mangers and troughs, which are of cast iron, typically 19th century and mass-produced, survive on the west wall (Plate 8). There is a single purlin to a hipped underboarded roof which apparently preserves a lath and plaster ceiling.

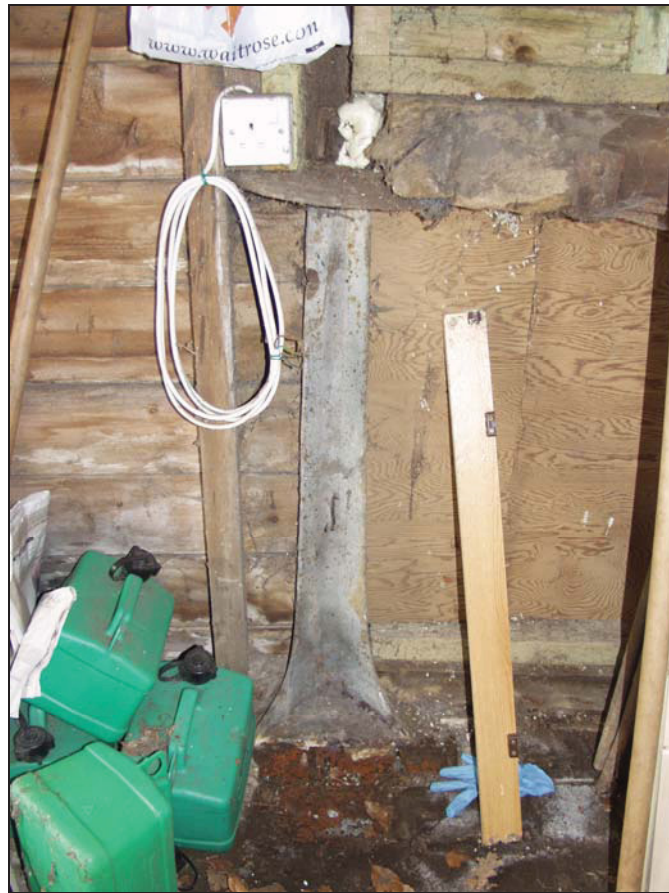
Plate 9 Detail of surviving stylobate in central unit of Building 5 (west wall), taken from the east (34)

5.3.16 The central and east units are now consolidated into a single workshop, but this area was clearly once also raised as part of a continuous granary. The original outer floor joists still rest on iron stylobates (Plate 9) though some have clearly been lost. The roof of the central section has probably been replaced, but the east bay retains its interior bead-moulded boarding and fine roof structure. Similarly the central bay preserves traces of lath and plaster walling (Plate 10), and may have had a slightly different original function.

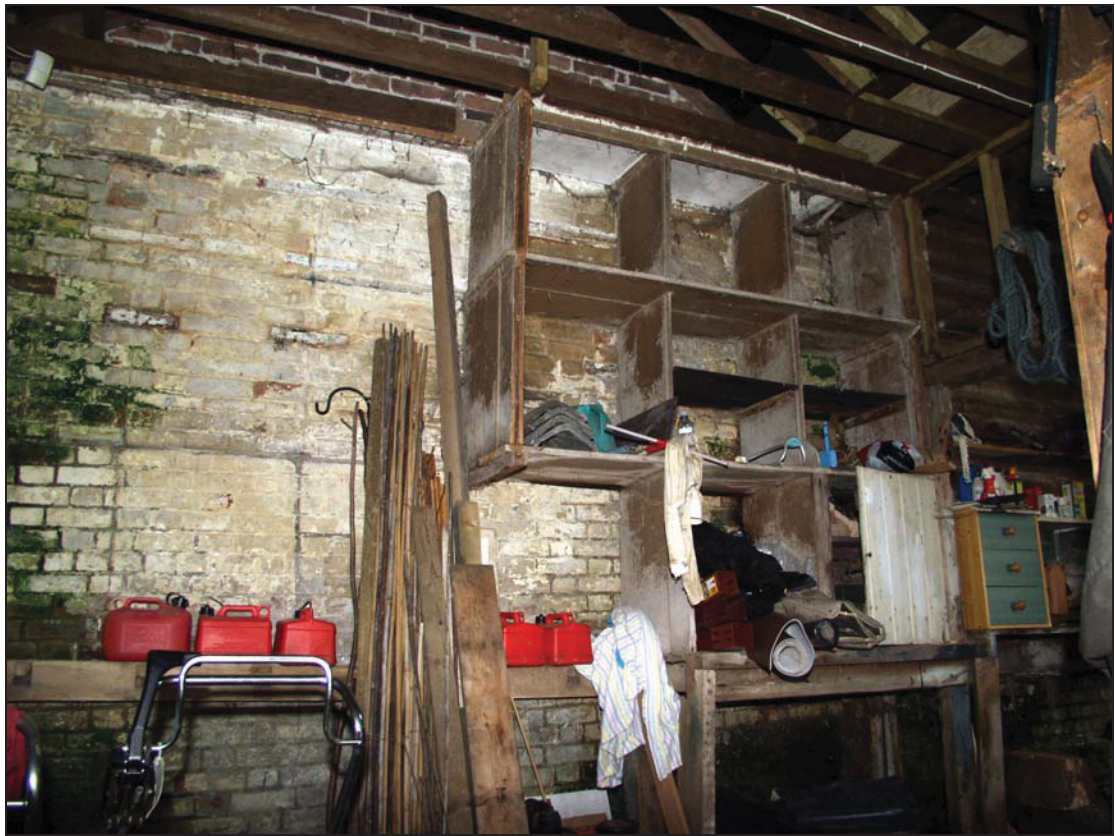
Plate 11 North wall of the central unit of Building 5, taken from the south (35)

5.3.18 There are a few other fixtures and fittings worth mentioning. The disused door is probably of early 20th century date, while the central bay preserves some built-in timber storage units, which seem to relate to the earlier raised floor, and so must be of some age (Plate 11). These may have been seed bins or something similar. At the upper section we see truncated remnants of a lath and plaster ceiling.

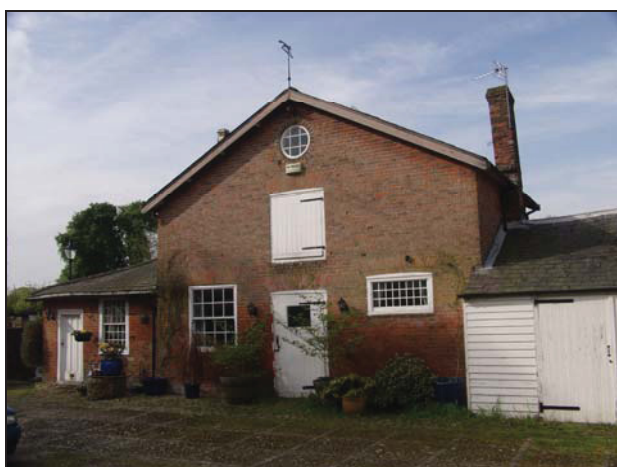
5

East façade of Building 1, taken from the east

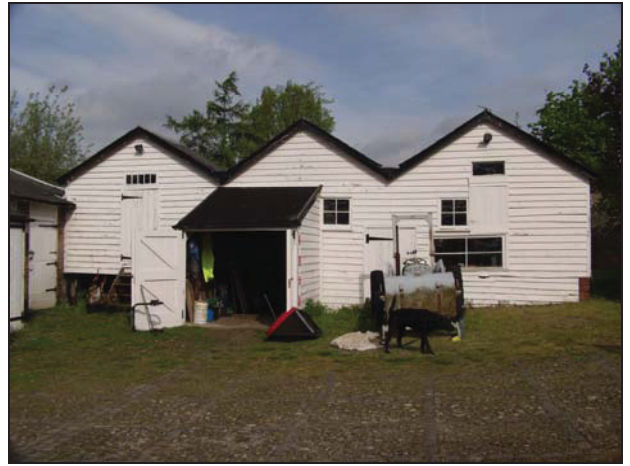
8
South elevation of Building 5, taken from the south

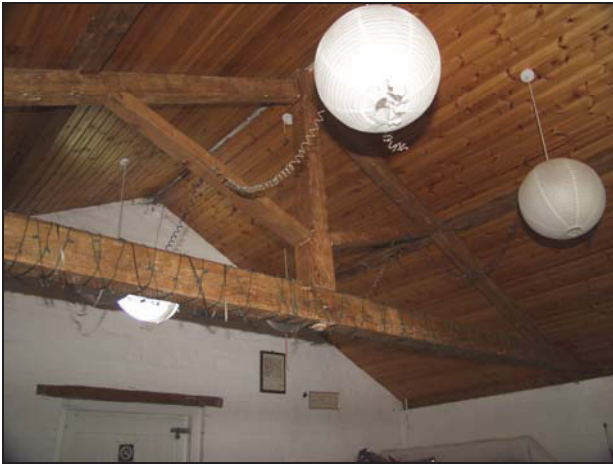
15

View of king post truss of Building 1, taken from the north-west

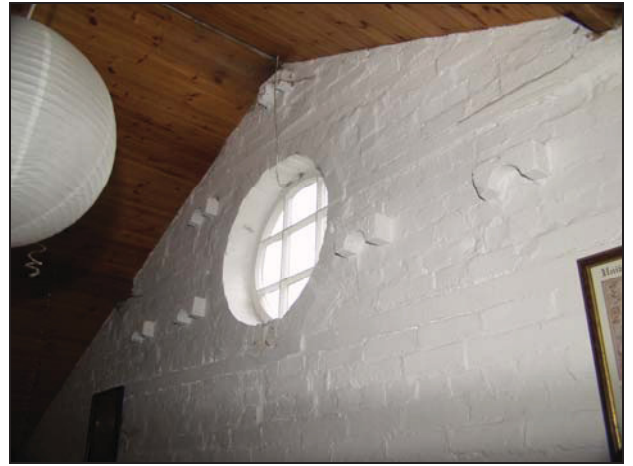
16

View of east gable of Building 1 showing arched heads of the blocked dove holes, taken from the south-west

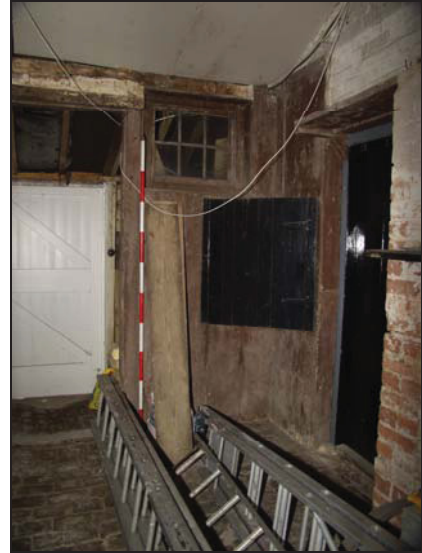
20
South-east corner of Building 3 showing wide vertical boarding, taken from the north-west

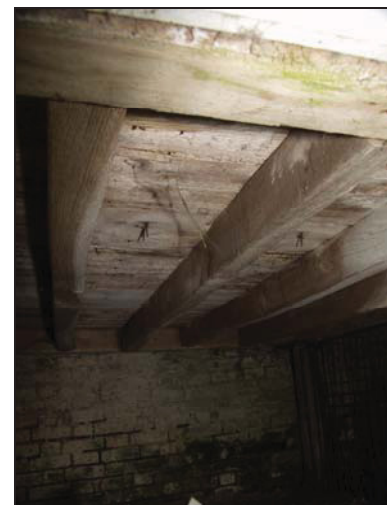
30
Detail of joists beneath granary (west end of Building 5), taken from the south

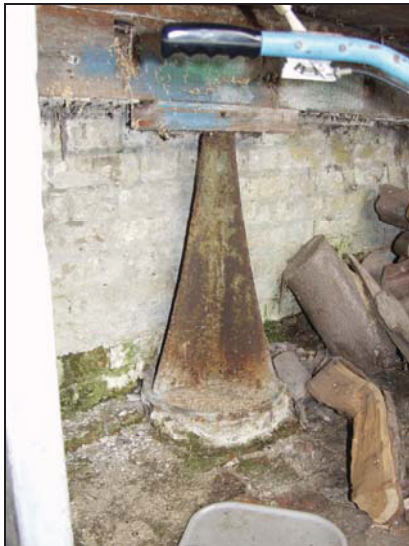
33
Detail of surviving stylobate in the east unit of Building 5 (north wall), taken from south-west

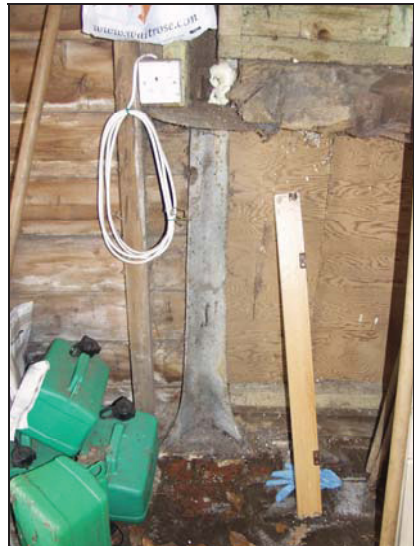
34
Detail of surviving stylobate in central unit of Building 5 (west wall), taken from the east

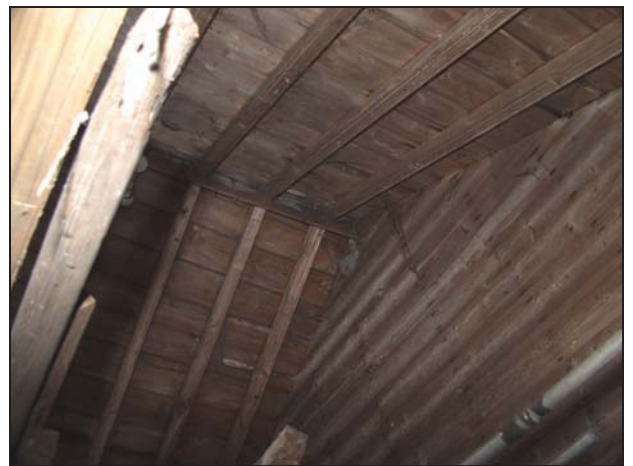
36
Roof space of east unit of Building 5, taken from the south-east

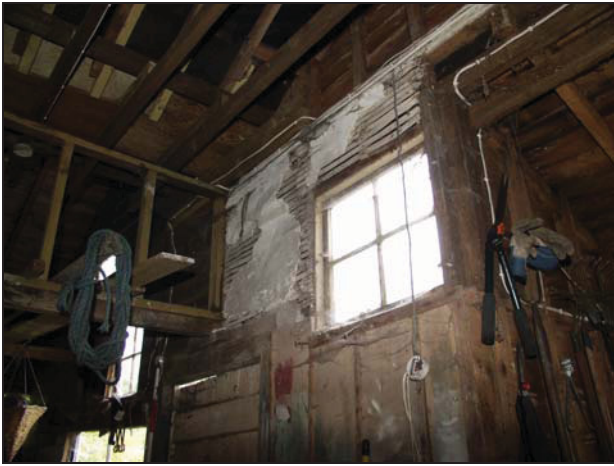
37

South wall of the central unit of Building 5, taken from the north-west

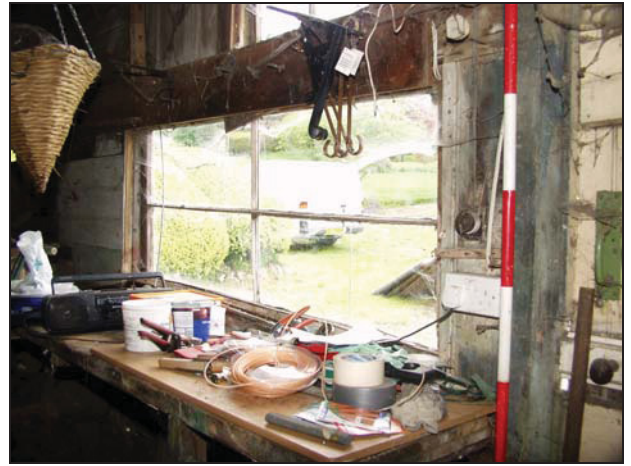
38

Detail of inserted 19th century window in east unit of Building 5, taken from the north-west

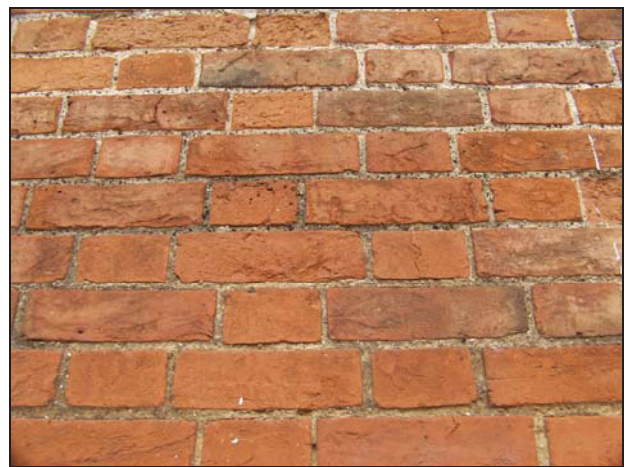
42

Typical brickwork of the former garden wall now forming part of Building 4, and additional brickwork above, taken from the west
