**MARIGOLDS, 64 HIGH STREET,
OLD HARLOW, ESSEX**

AN ARCHAEOLOGICAL EVALUATION

Authors: Zbigniew Pozorski MA (Field work & report) Hannah Tweedie MPhil (Editor)	
NGR: TL 4745 1159	Report No. 3372
District: Harlow	Site Code: HAHS 09
Approved: Claire Halpin MIFA	Project No. 3619
Signed:	Date: September 2009

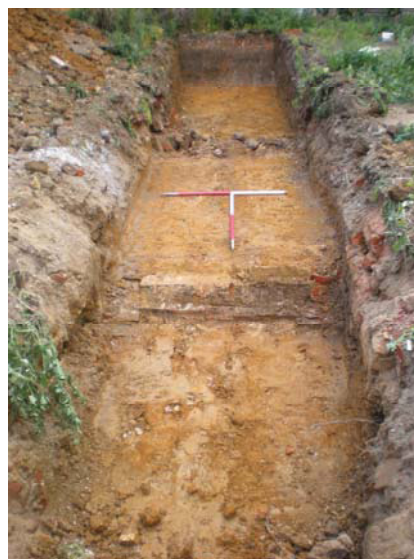
DP 2. Trench 1. View E.

Trench 1 contained remains of a wall, M1006, and F1004 which probably formed the foundation trench for an additional wall.

Wall M1006, aligned NE/SW, was located in the western part of the trench (DP 4). A length of wall 2m+ was revealed in section (Sample Section 3) with a maximum height of 0.57m. The wall was constructed of mid to dark red bricks (0.23 x 0.11 x 0.065m/ 9.05"x4.33"x2.56") bonded with sandy mortar with chalk fragments. The wall survived to a maximum of 8 courses which did not conform to a uniform coursing. The lower courses of the wall within the trench were constructed of smaller red bricks (0.195 x 0.095 x 0.055m/ 2.56"x3.74"x2.17"). A second part of the same wall, aligned NW/SE (1.80 x 0.90m), traversed the trench (DP 2), only a single course of the wall was revealed, constructed of three lines of stretcher bricks.

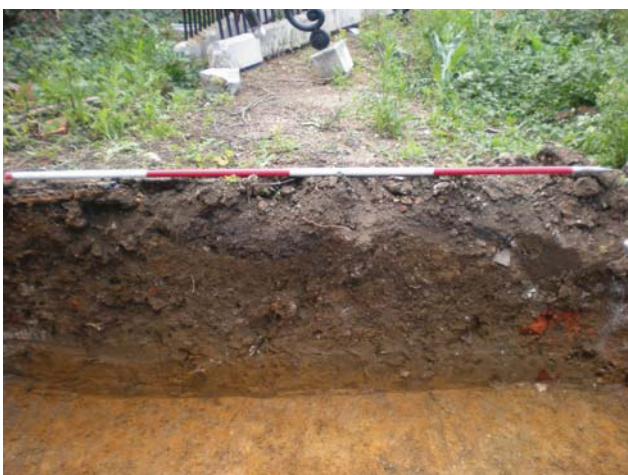
DP 3. Trench 1, E end. Sample section. View S.

<i>Sample section 2 (DP 3)</i> <i>NE end, NW facing</i> <i>0.00 = 59.23m AOD</i>		
0.00 – 0.06m	L1000	Topsoil. Blackish grey soft sandy silt.
0.06 – 0.55m	L1001	Layer of CBM rubble mixed with grey sandy silt.
0.55 – 0/65m	L1002	Grey brown, compact silty clay.
0.65m +	L1003	Natural yellow, compact silty clay.

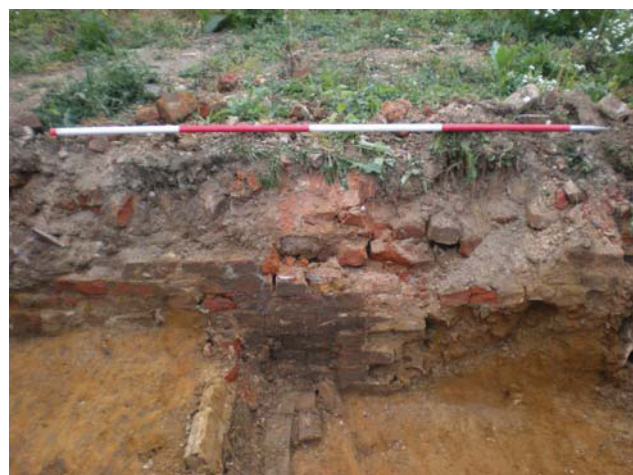
DP 4. Trench 1, W end. Sample section. View S.

<i>Sample section 3 (DP 4)</i> <i>SW end, NW facing</i> <i>0.00 = 59.36m AOD</i>		
0.00 – 0.05m	L1000	Topsoil. As above.
0.05 – 0.15m	L1001	As above.
0.15 – 0.75m	M1006	A wall constructed of red bricks.
0.75m +	L1003	Natural clay. As above.

9.2 In the event the evaluation revealed only masonry features of relatively recent date. Based on the brickwork, Wall M1006 was probably constructed in the 19th century with possibly some re-used earlier bricks. Well M1010 was Victorian and probably served the house over a long period; it was relatively well preserved. M1008, the pumping chamber, was a later alteration.

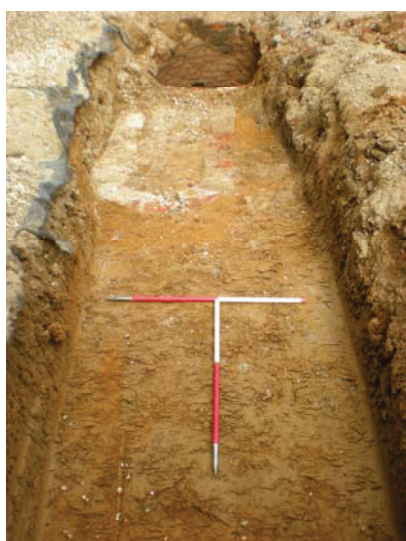
DP 5. Trench 2. View N.

Trench 2 contained the remains of two masonry structures.

M1010 was a well (1.50m in diameter; DP 8) located in the northern end of Trench 2. It was constructed of dark red bricks (0.225 x 0.105 x 0.065m/ 8.86"x4.13"x 2.56") in stretcher bond, with whitish grey mortar with chalk chunks. The well had been covered by a concrete cap, beneath which it was fairly well preserved and measured at least 6.50m in depth with the watertable at c. 5m below existing. A later alteration comprised a lead water pipe, which is believed to have been added at the same time as structure M1008.

M1008 was a wall, 'horseshoe' in plan (DP 7), located immediately north of the well. It probably represents the remains of a modern pumping chamber. It measured 1.90 x 1.10 x 0.22m and was aligned N/S. It was constructed using dark red bricks (0.225 x 0.105 x 0.065m/ 8.86"x 4.13"x 2.56"), similar to those of the well, with dark grey mortar with small chalk chunks and charcoal. Only a single course of the wall was revealed, it was constructed of a single line of header bricks. The pumping chamber was thought to be of a later date than the well as it had been built with a specific gap to accommodate the lead waterpipe, whereas the well had been subject to localised destruction and subsequent repair in order to accommodate the waterpipe. Internally M1008 contained L1009, a mid yellow, loose sand and CBM rubble. No finds were present.

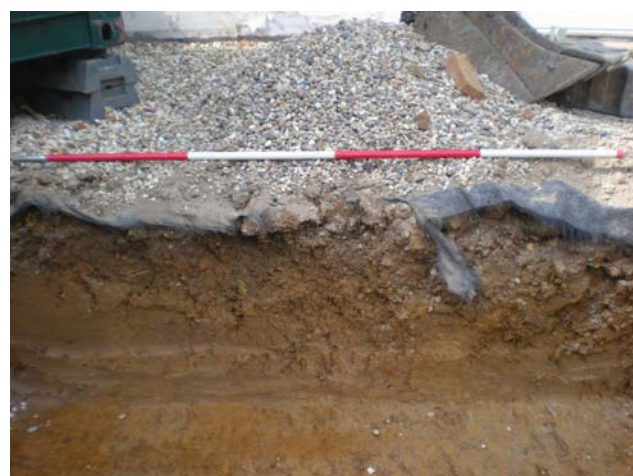
DP 6. Trench 2, S end. Sample section. View W.

Trench 2, sample section 1 (DP 5) SE end, NE facing 0.00 = 59.27m AOD		
0.00 – 0.08m	L1007	Gravel surface of a drive.
0.08 – 0.20m	L1001	As above.
0.20 – 0.75m	L1002	As above.
0.75m +	L1003	Natural clay. As above.
