**THE OLD PARADE GROUND (STAND-BY SET HOUSE),
NORTH WEALD AIRFIELD,
NORTH WEALD, ESSEX**

HISTORIC BUILDING RECORDING

Authors: Dr Lee Prosser BA PhD (Fieldwork and report) Lisa Smith BA (Fieldwork and report) Kathren Henry (Graphics) Fred Nash (DBA)	
NGR: TL 49265 03884	Report No. 3456
District: Epping Forest	Site Code: NWBPG 09
Approved: Claire Halpin MIFA	Project No. 2779
Signed:	Date: December 2009

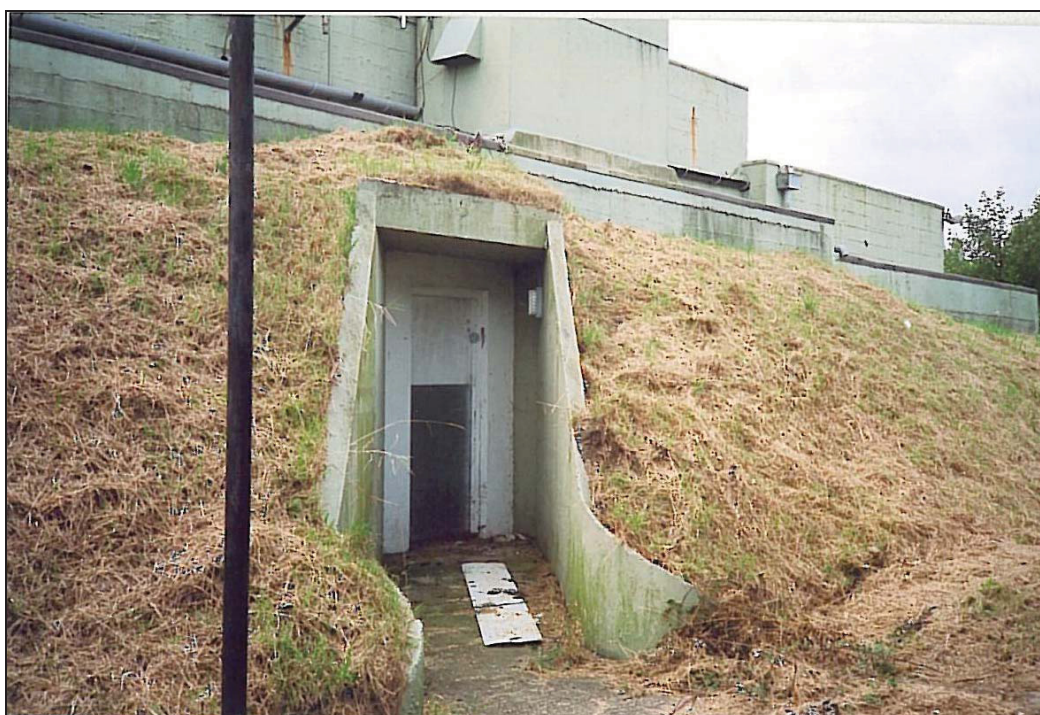
2002: As extra protection, earth was piled up all round the thick walls of the Operations Block and then grassed over. The entrance came in through the embankment.

The building drawing shows a substantial construction with a thick cavity roof filled with sand and shingle as a bomb proofing measure. Wide soil banking around the structure, known as a traverse, protected it against near misses. Inside, was the main Operations Room encircled by the Receiving Room, the Plotting Room, Meteorological Office, Searchlight Room, Teleprinter Chamber and a variety of ancillary rooms.

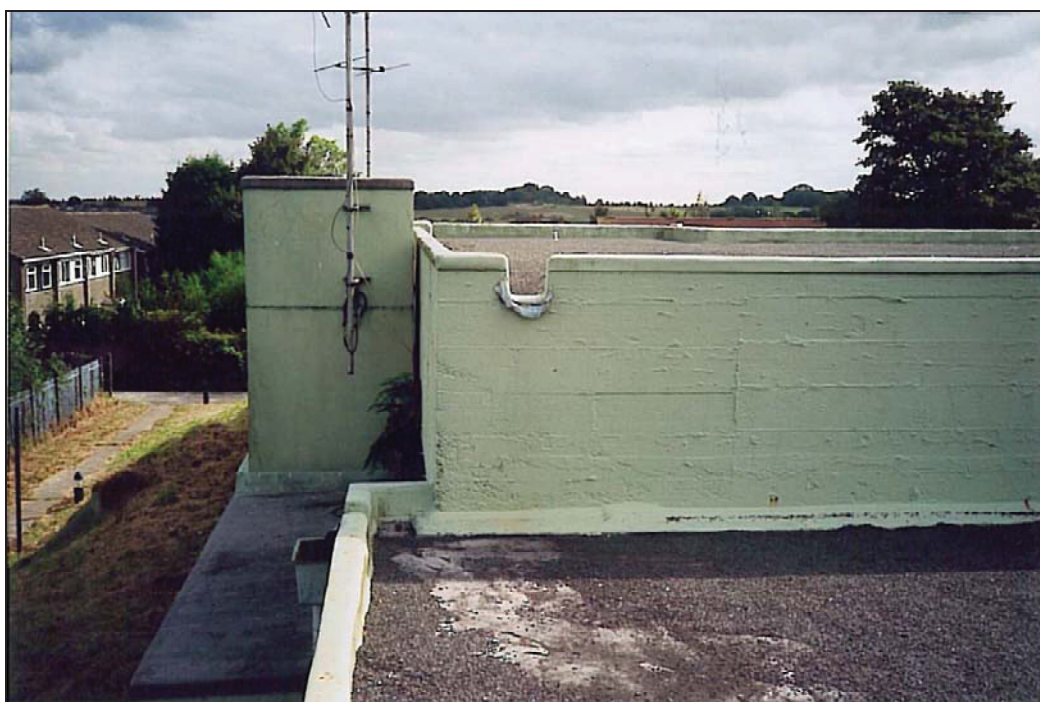
2002: The roof of the Operations Block, converted to an Emergency Planning Centre in 1989. Note the air intake/filtration unit on the left.

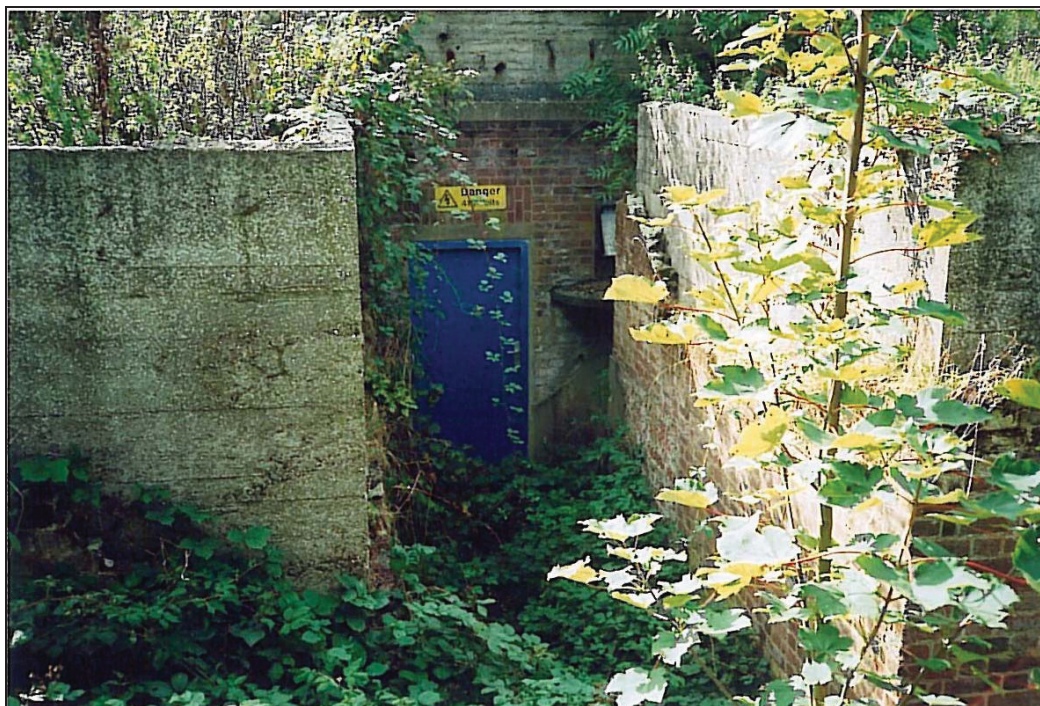
2002: The north entrance to the Sick Quarters Annex, or Decontamination Centre, protected by concrete and earth traverses.

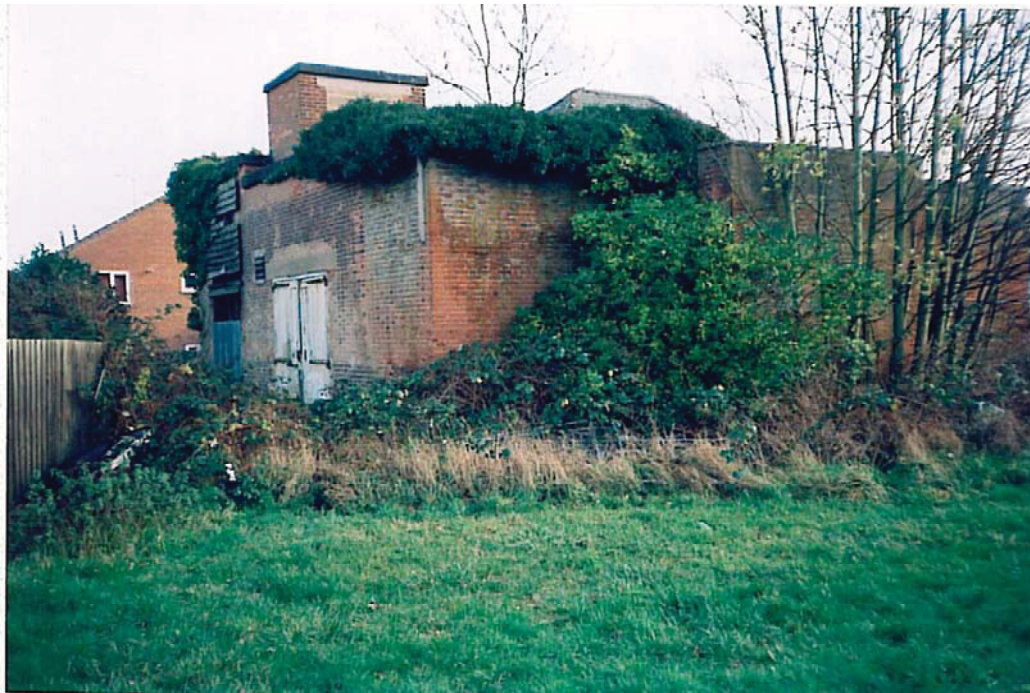
2009: The doorway on the left was driven through the encompassing blast wall when it was absorbed into the central building. The addition of the flat-roofed tower was part of the redevelopment.

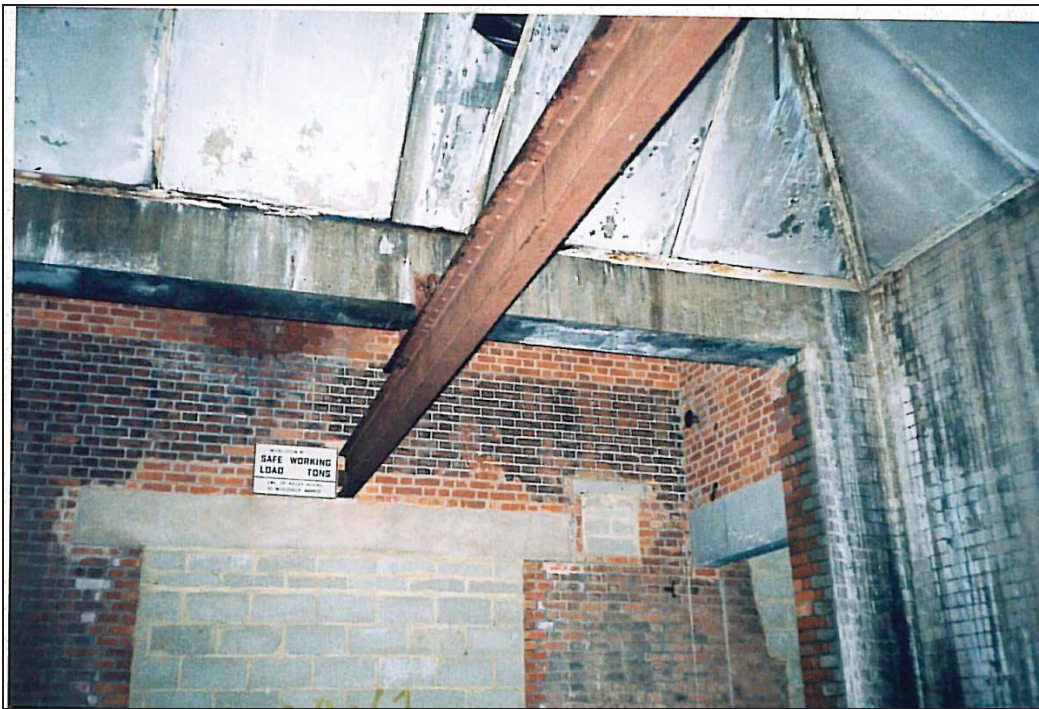
2009: Inside the expanded engine room a crane rail was installed. This allowed the heavy diesel engines to be lifted in and out through the new entrance.

4.6 Large apertures supported by concrete lintels frame the north and south walls of the engine room as shallow apses, and additionally support a large lateral steel girder manufactured by 'Dorman Long & Co' of Middlesbrough. This continues to the outer wall where it terminates above the lintel for the double doors. It would have functioned as a crane system for moving machinery within the building.

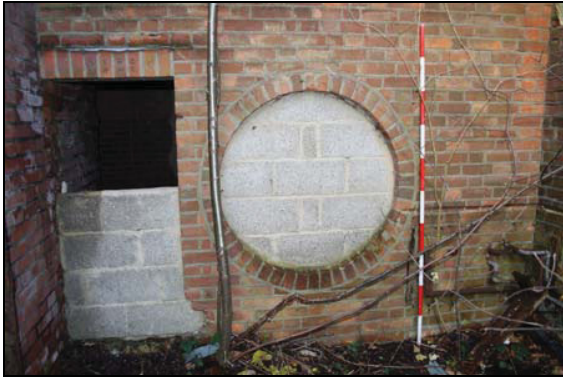
21
Blocked apertures from fuel tank storage area into transformer chamber, taken from the south

4.10 Substantial modification is evident in the area. The upper walls have clearly been raised by 14 courses in pink Flettons, while the south wall appears to have been constructed at the same time. The lower, earlier walling corresponds with the height of the external yards, suggesting that the chamber has been taken in from the yard at some point.

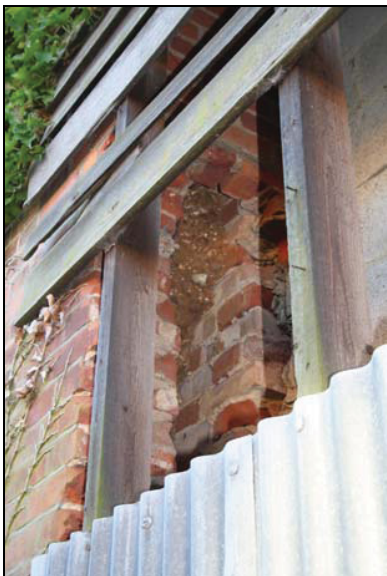
23
External blast walls showing filled cavity, taken from north-west

west, while a pair of double doors on the north side allowed the installation of the plant, though these are now rendered redundant by internal blocking with concrete bricks. The surviving doors are vertically-boarded with strap hinges stamped 'Charles Collinge, Lambeth' (Plate 2). Adjacent to the east, a full-height aperture has been partially weather-boarded at its upper extent. Where it has pierced the original fabric, the construction make-up is exposed, showing a wide internal cavity, filled with gravelly ballast as would be expected.

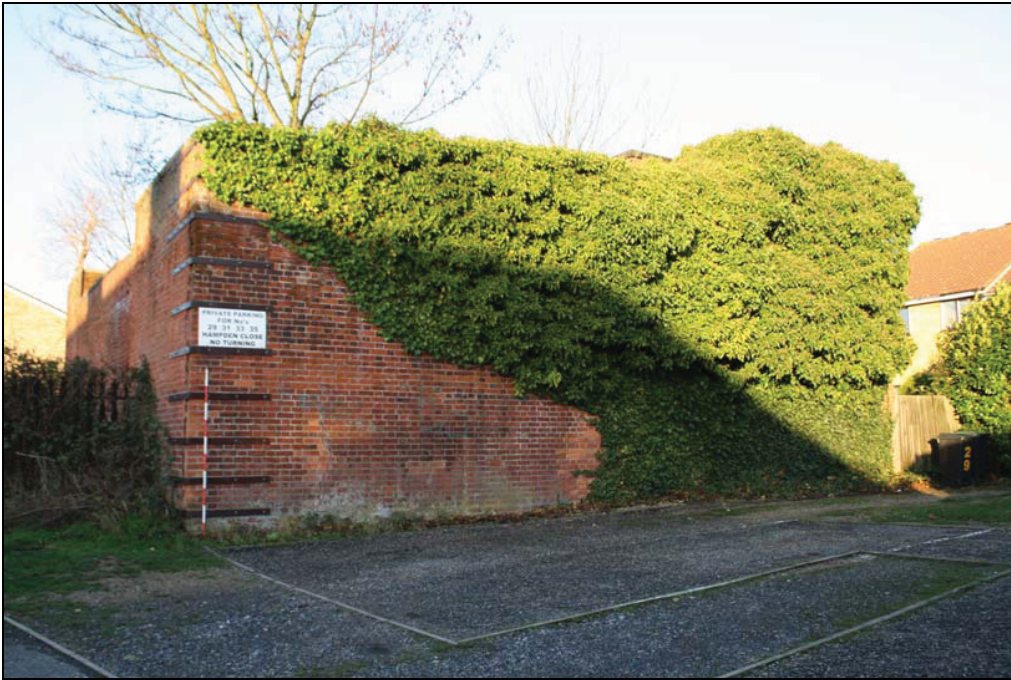
Plate 1 East elevation, taken from the south-east (DP 1)

4.1 From the exterior, the Stand-by Set House appears as an anonymous, utilitarian structure of red brick with few features, much colonised by vegetation and characterised by neglect and vandalism (Plate 1). However, closer inspection reveals subtlety in architectural and material detailing and some sophistication in its layout. The brick is of fine quality while a central block with a low-pitched slate roof seems to rise from inside the high perimeter wall.

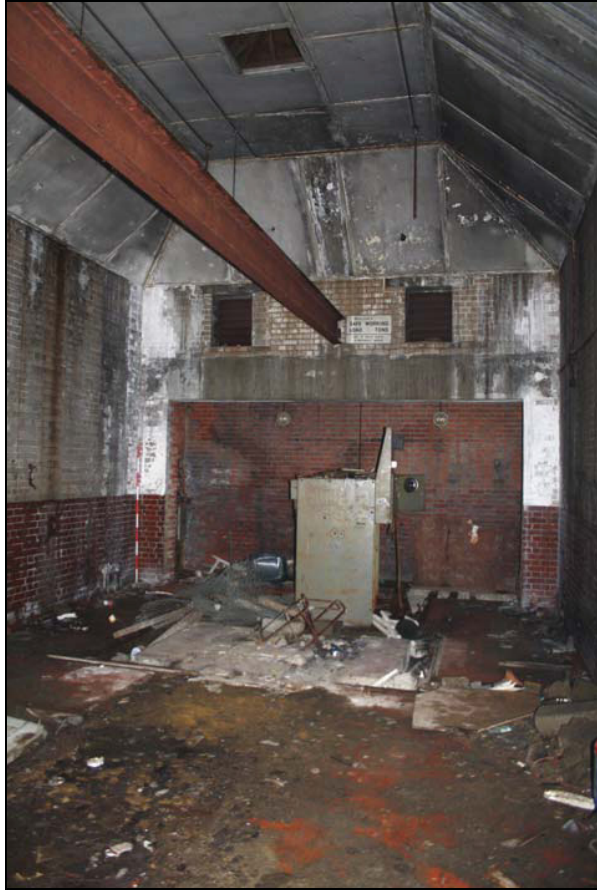
Plate 3 Engine room and machinery, taken from the north-west (DP 9)

4.4 A large central chamber dominates the internal space and would have housed 3 or 4 Lister generators (Fred Nash *pers. comm.*) (Plate 3). The inner face of the walls rise to c. 1.35m in glazed bricks. Where fractured these appear to be yellow gault-clay, wire-cut bricks, probably from the Arlesey brick-fields, but the upper areas consist of a pale, grey/white fabric, probably of Fletton-type shales, which is granular. The roof is hipped and constructed of softwood rafter-couples clasping a ridge-board, though this is only visible through apertures in an asbestos-boarded ceiling (Plate 4).

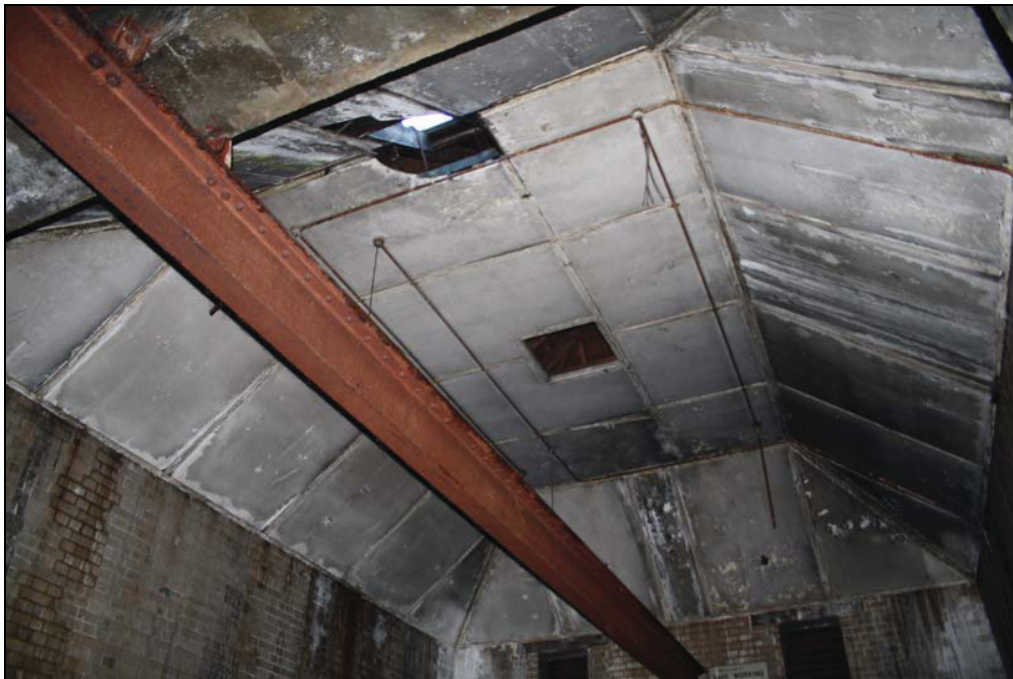
Plate 4 Engine room ceiling, taken from the north-west (DP 8)

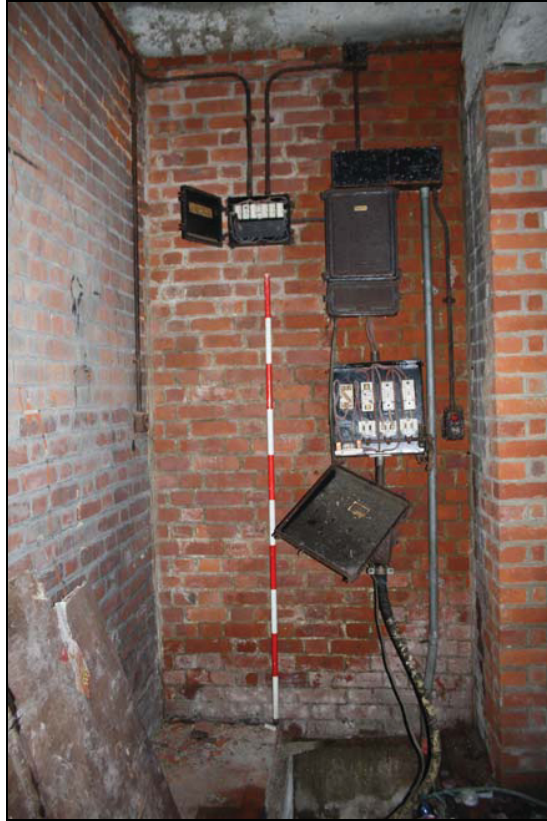
Plate 5 Switching gear, taken from the east (DP 11)

4.8 The shallow concrete-roofed apse to the south housed the switching gear which remains *in situ* within iron fuse-boxes on the east and west walls. Although in poor condition, ceramic fuse holders and lengths of cabling supplied by the Enfield Cable Co. survive (Plate 5). Two bulkhead lights are mounted on the south wall; elsewhere pendant lighting was once present but now removed. Residual fixtures and fittings can be seen throughout the building including electric cables, pipes and safety signs, but these now allow for no meaningful interpretation or appear as later additions.

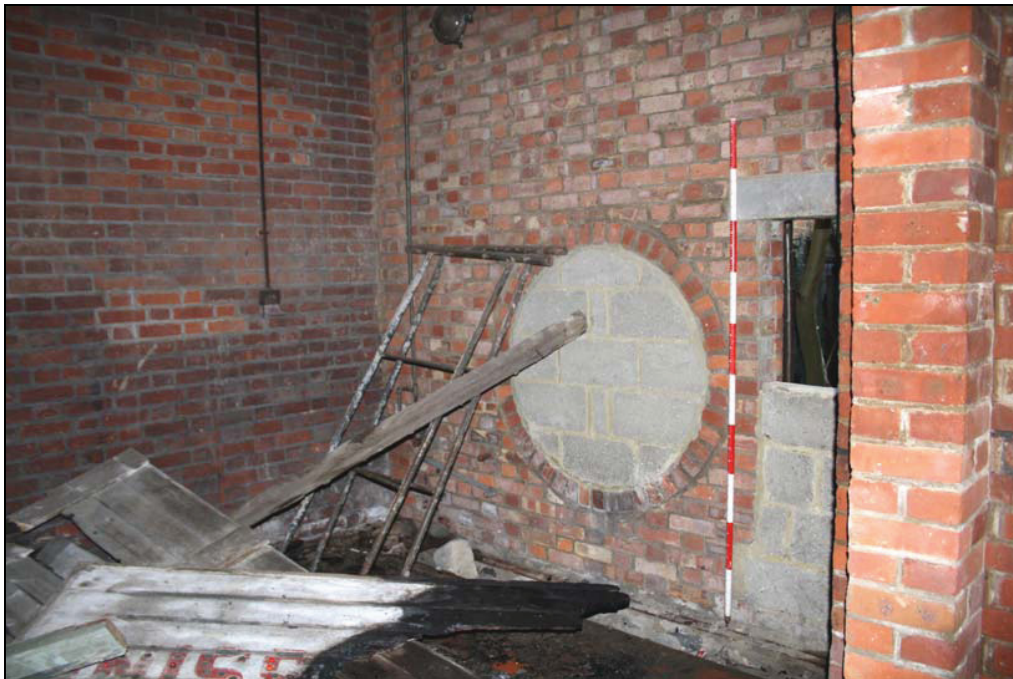
Plate 6 Transformer chamber, taken from the north-west (DP 15)

4.9 A small chamber in the north-east corner of the complex may have housed the transformer. Remains of a collapsed and partially-burned timber screen may have formed a timber partition from the main generators, but this can not be ascertained with certainty. To the north ventilation was once provided by a large weatherboarded aperture, now blocked but expressed on the exterior as noted above. To the south, a low circular aperture and doorway led to the fuel yard adjacent (Plate 6). The door was latterly blocked, but subsequent partial unblocking allows access.

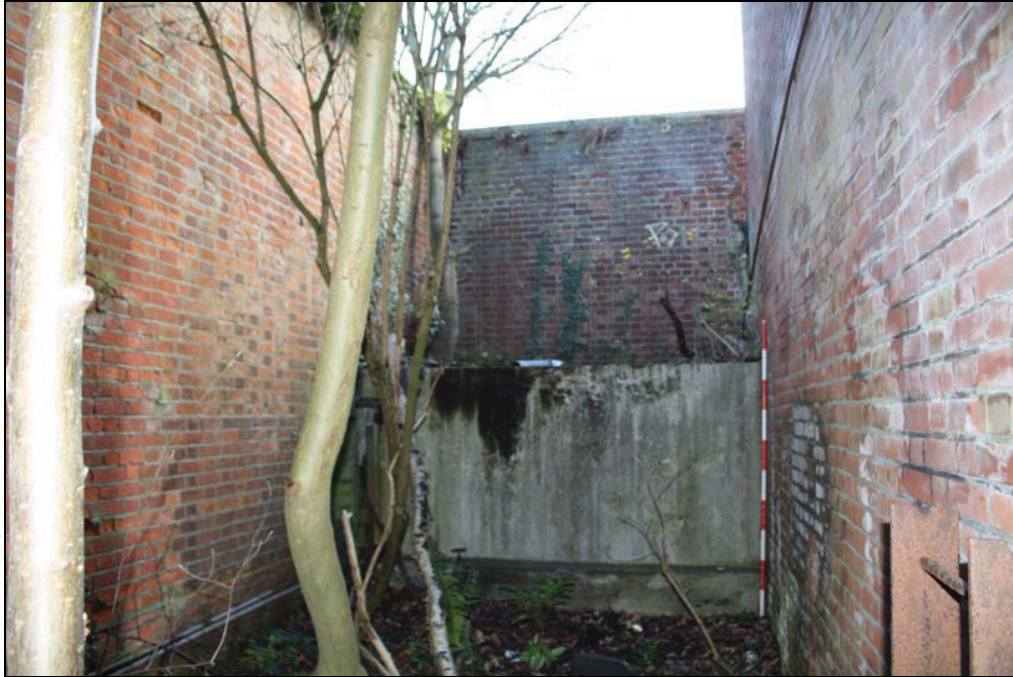
Plate 7 Fuel tank storage area, taken from the north-west (DP 16)

4.11 The fuel storage area once supported a large tank on a concrete base to the south (Plate 7). This has entirely disappeared, though some pipes and a stop-cock remain. A vertical steel ladder on the east (Plate 8) once gave access to the roof where a small brick shelter survives, though this is now truncated and the roof is no longer safely accessible.

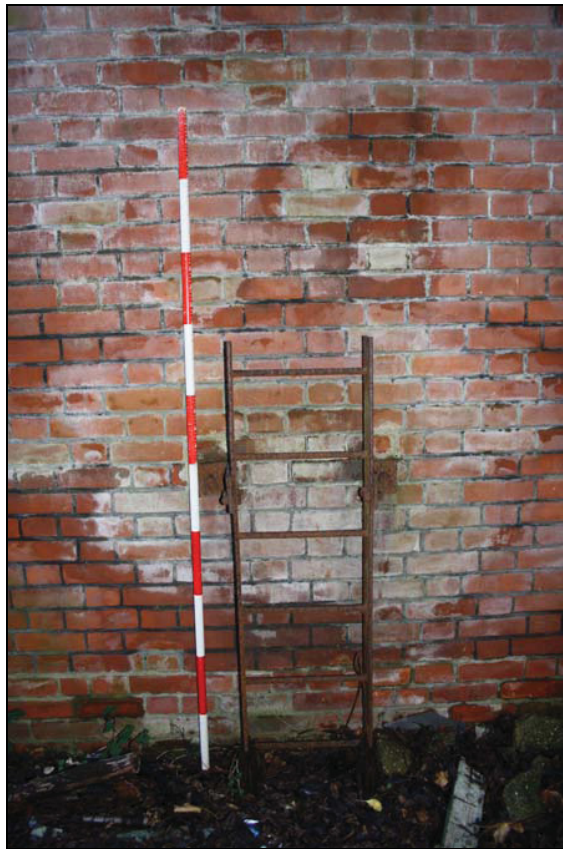
Plate 8 Metal ladder for roof access, taken from the east
