**SPROUGHTON MILL, LOWER STREET,  
SPROUGHTON, IPSWICH, SUFFOLK**

**HISTORIC BUILDING RECORDING &  
ARCHAEOLOGICAL MONITORING & RECORDING**

Authors: Lee Prosser PhD (Fieldwork and Report) Lisa Smith BA (Fieldwork and Report) Peter Thompson MA (Research) Kathren Henry (Figures)	
NGR: TM 12480 45103	Report No: 3474
District: Babergh	Site Code: SPT 036
Approved: Claire Halpin	Project No: 3664
Signed:	Date: Jan 2010

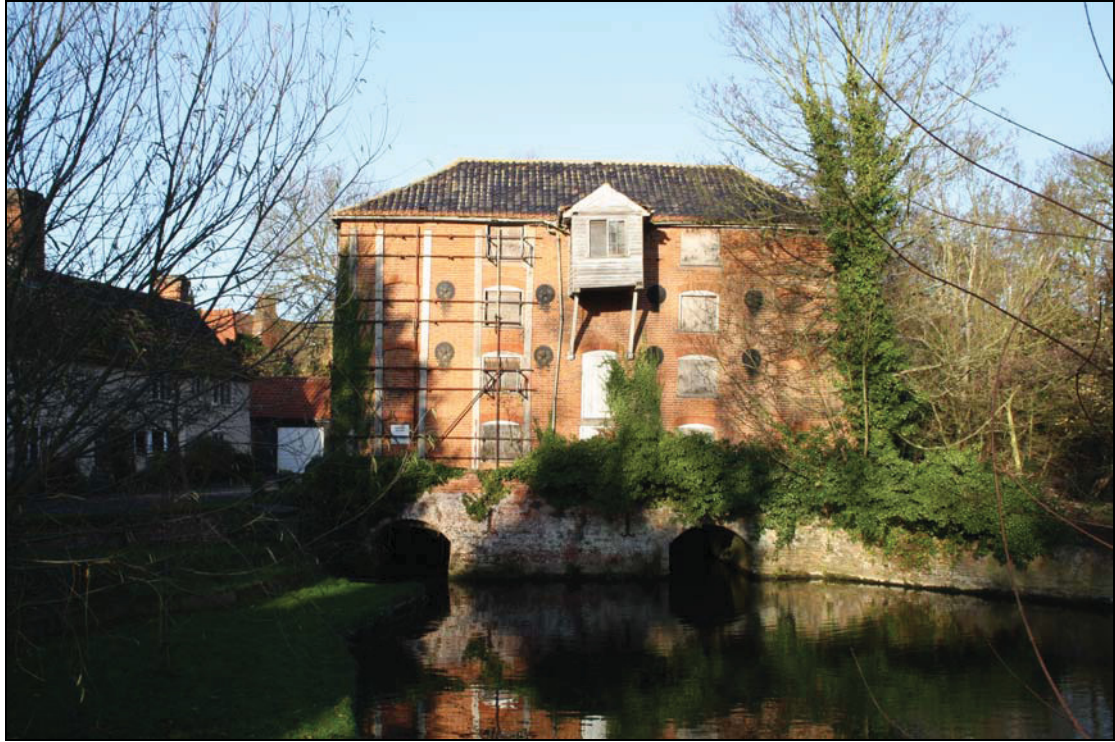
Plate 1 South-east elevation of mill, taken from the south-east (DP1)

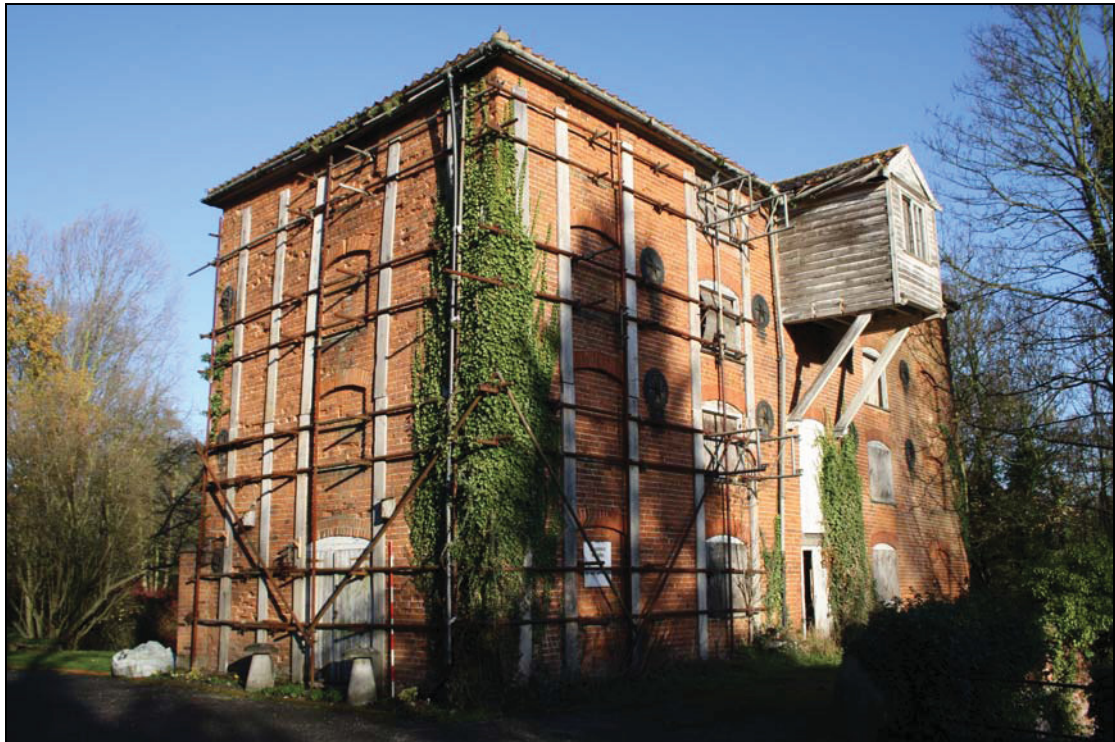
Plate 2 South-west and south-east elevations of mill, taken from the south (DP 4)

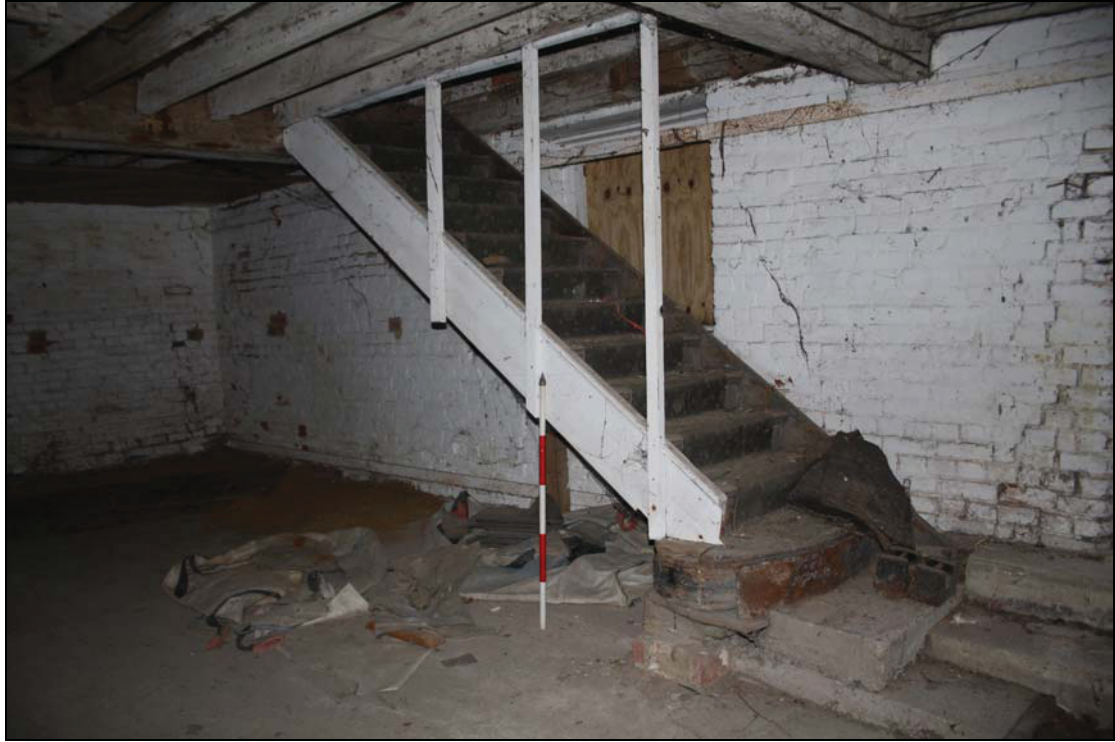
Plate 3 Ground floor reused domestic staircase, taken from the west (DP 29)

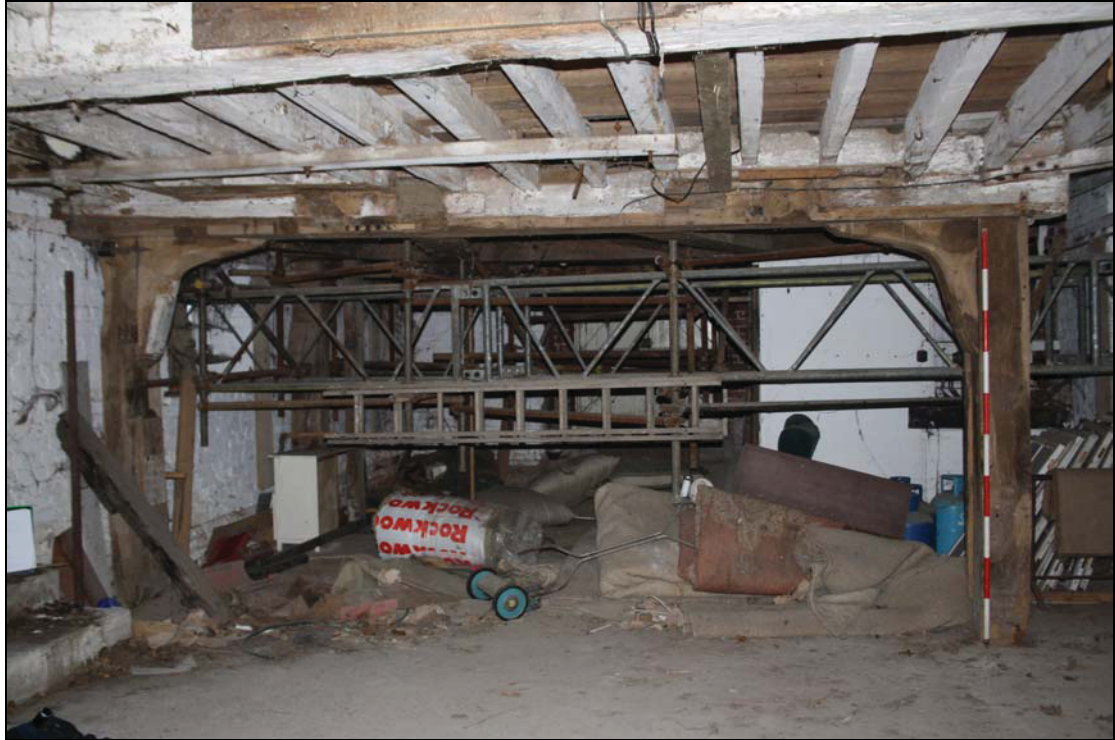
Plate 5 Ground floor oak timber framing to house mill machinery, taken from the north-east (DP 22)

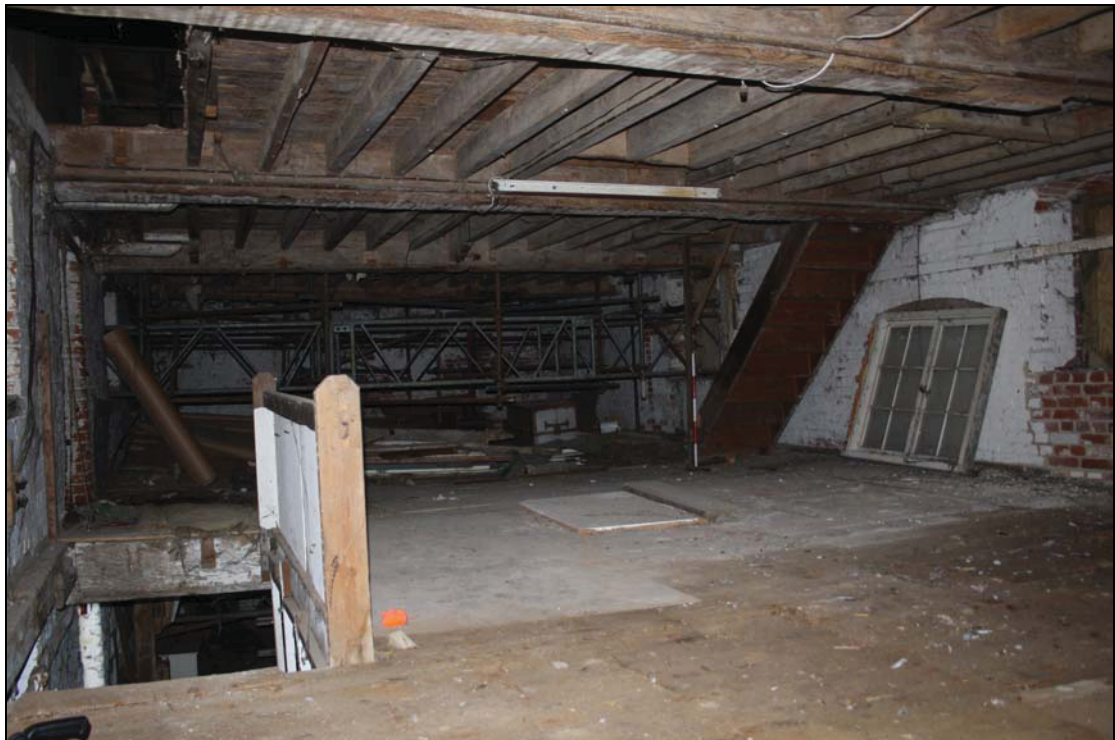
5.21 The first floor is open-plan, like its companions, with plain brick walls, housing bearer timbers at low level and given additional support by an iron band located at c. 1.50m above the floor level (Plate 6). The walls have been white washed except in the north western corner where the structure has been repaired. A central loading hatch and a number of smaller openings pierce the floor which consists of a mixture of boarding, much patched and repaired.

Plate 6 First floor, taken from the north-east (DP 10)

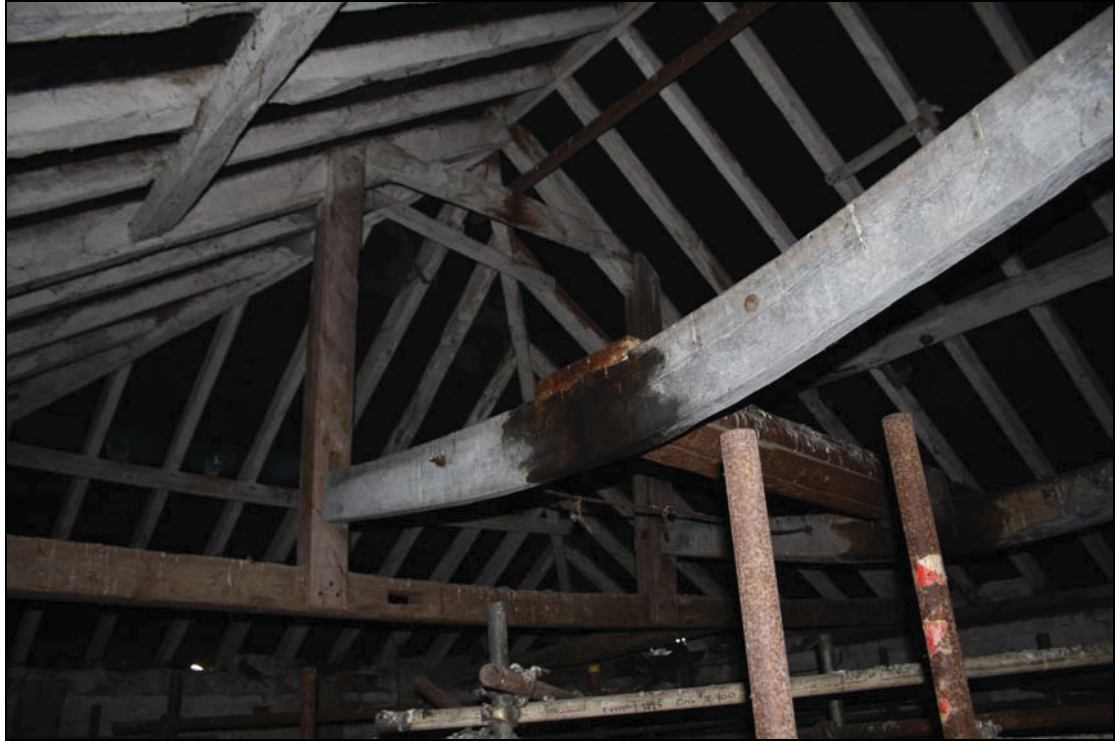
Plate 9 Queen post roof construction with cambered hanging joists, taken from the north-east (DP16)

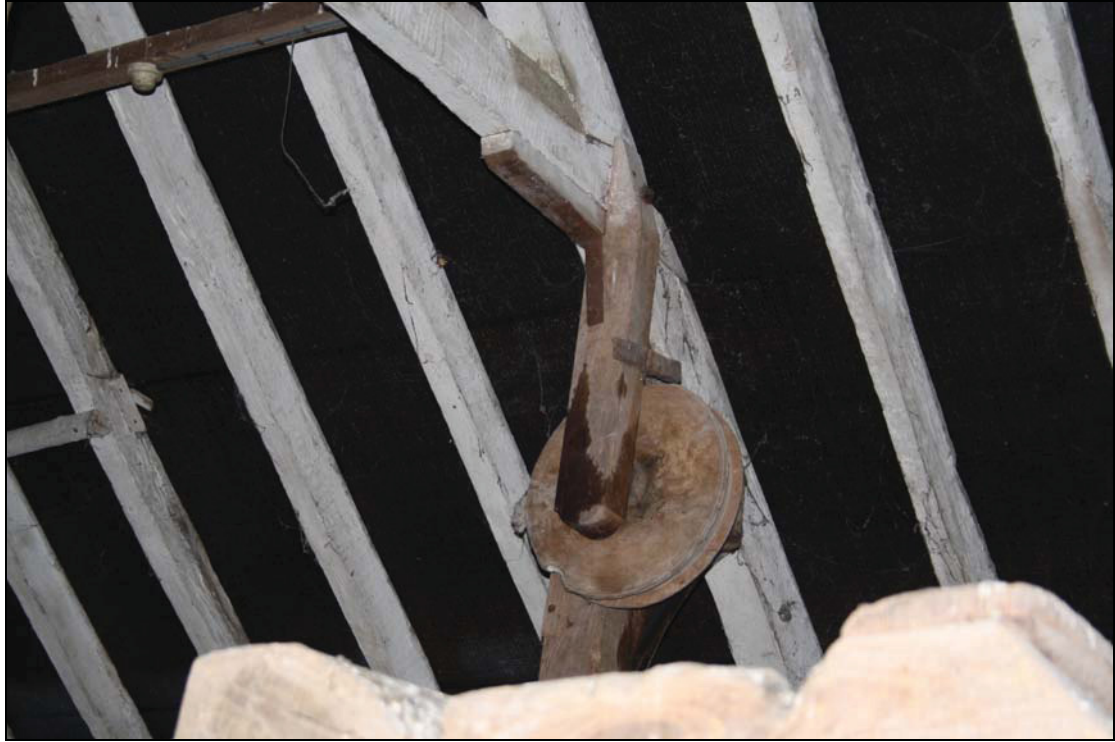
Plate 11 Pulley wheel located in roof space, taken from the east (DP 17)

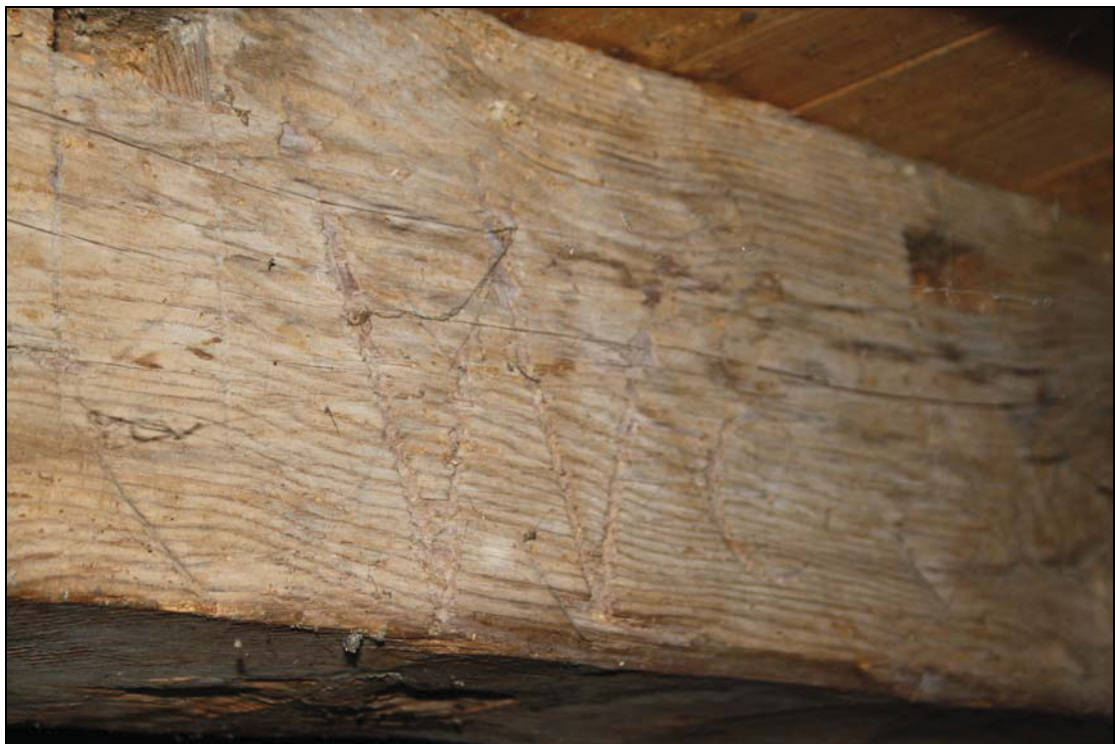
6.2 Structurally, the mill was probably over-ambitious. It is rather high to its depth ratio, but this may have been an attempt to show off, and many of these deficiencies were made up by the strength of materials used for its construction. The internal layout is systematic, in line with the industrial thinking of the time, though this was clearly constructed before the widespread use of cast iron. The lateral binding joists which express the internal bay divisions are of massive proportions, required both to tie the external walls together but also to support the heavy sacks of grain stored on several floors. Much of this softwood is probably Baltic in origin – knot-free and bearing on occasion the scribed initials 'Wc' which are characteristic of the type of marking seen from the late 18<sup>th</sup> to the late 19<sup>th</sup> century, particularly in industrial buildings (Plate 12).

Plate 12 Detail of Baltic mark from second floor joist, taken from the north (DP 20)

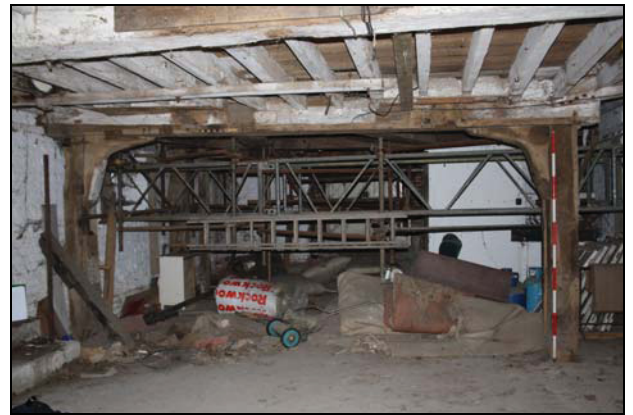
22

*Oak timber framing to house mill machinery, taken from the north-east*

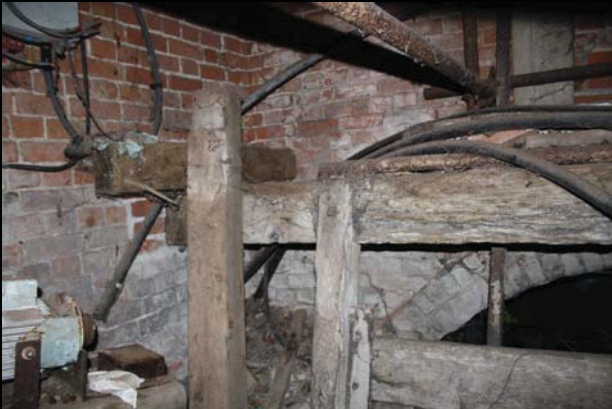
27

5.16 The mill race still flows beneath the southern bay where the water wheel was located. At present it is covered by a rough boarded floor. A sluice gate constructed of timber and metal survives but in poor condition. A few minor components of the original machinery, such as a cog-wheel and small drive-wheel for Machinery associated with the working of the sluice gate also survive.

*Sluice gate, taken from the east*

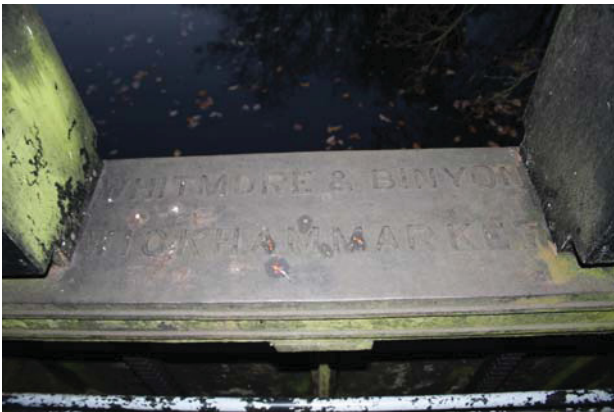
33

5.9 A cast iron sluice gate controls water-flow through the northern arch. It consists of two vertical gates on a frame with decorative ball-finials, elsewhere copying the radial spokes seen on the disc-ties. It is stamped with the mark of 'Whitmore and Binyon' of Wickham Market (See Appendix 4). A similar pair of gates is located to the west and may have been fitted some after 1868.

*Detailed shot of sluice gates stamped 'Whitmore and Binyon, Wickham Market', taken from the east*

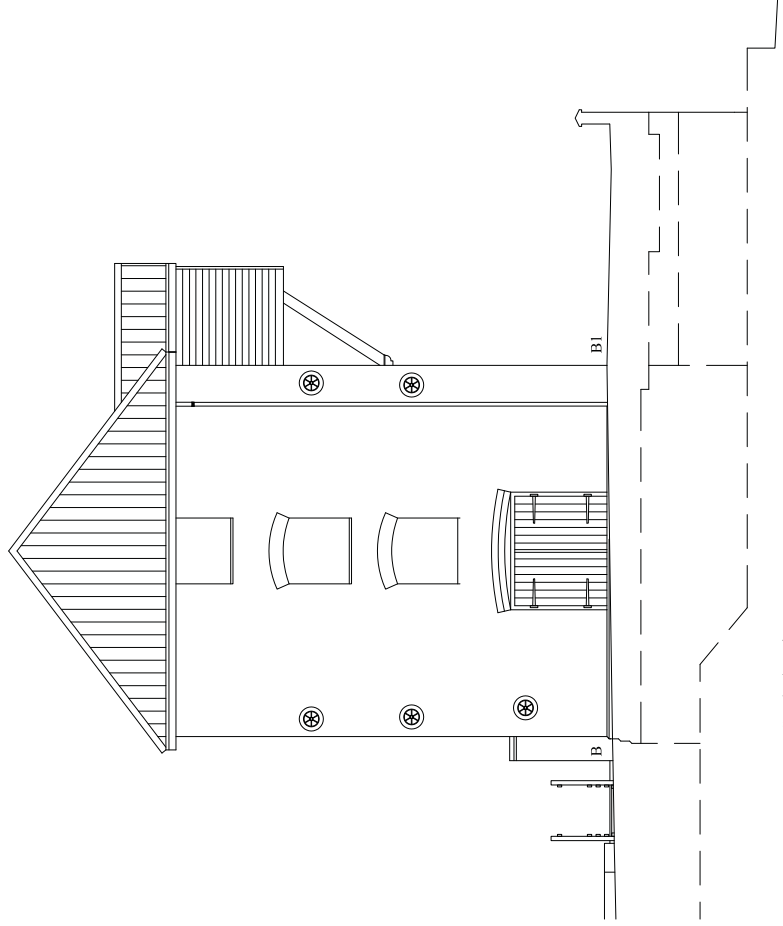
South elevation

5.7 The southern or thin elevation of the building is of two bays, having a single blind window to each level, though these are set off-centre to the east. On the ground floor access is given by a wide double loading door, vertically

boarded with modern hinges. The door arch here has been repointed crudely with cement, while the brickwork shows some damage from water up-cast.

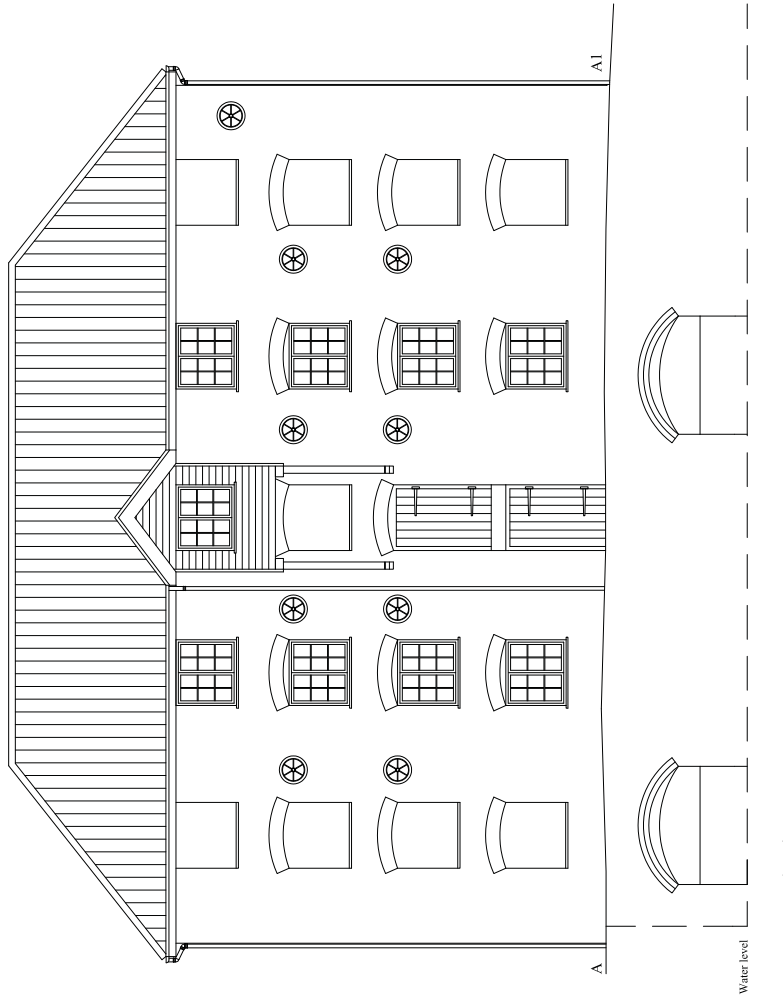
East elevation

5.4 The eastern elevation was clearly designed to be both functional and impressive. The central bay frames the doorways, flanked by windows on each floor, with a similar arrangement of blind windows in the outer bays (Plate 2). Entry is given at the centre by a simple vertically boarded door of domestic proportions, ledged and braced to the rear. This is of no great age. A small niche in the adjoining brickwork houses a rudimentary, but original boot scraper.

5.5 Directly above the entrance, a loading door leads directly to the first floor. This has a cambered arch in keeping with the general style, and is likewise composed of vertical boarding, attached to the door frame with hand-made strap hinges. It appears to be a 20<sup>th</sup> century replacement.

5.6 A hoist loft (noted as a 'lucum' on the listing) protrudes from the upper level on two large joists, supported on long, straight brackets which sit on lower timber corbels with shaped ends. The structure is weather-boarded with a window in the gable end. Some disturbance is visible to the brickwork immediately below the area and one of the corbels has been replaced in the recent past.
