**PROPOSED SWIMMING POOL,
CHEDDINGTON MANOR, CHEDDINGTON,
BUCKINGHAMSHIRE**

AN ARCHAEOLOGICAL EVALUATION

Authors: Adam Dyson BA (field work & archaeological description) Hannah Tweedie MPhil (Background research)	
NGR: SP 9165 1740	Report No. 3517
District: Aylesbury Vale	Site Code: AS 1294
Approved: Claire Halpin MIFA	Project No. 2908
Signed:	Date: April 2010

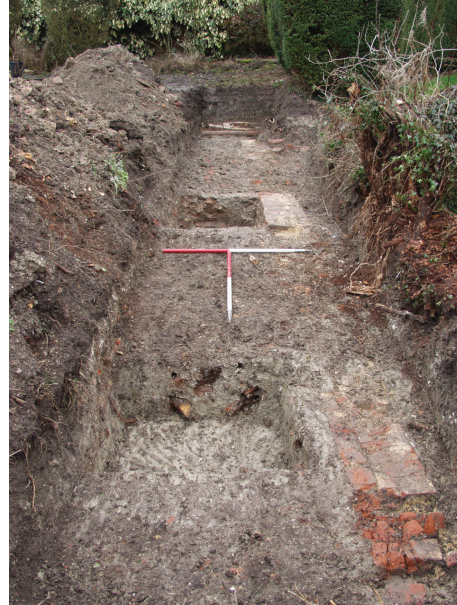
DP2. Post-excavation view of trench, wall M1004 running the length of the trench, looking SE (01/04/2010)

M1004 was a brick wall oriented NW/SE (7.90 x 0.36 x 0.27m). Its construction cut, F1006, was revealed within a one-metre long test pit dug against its NE face (Fig. 8 and DPs 4, 5 and 6).

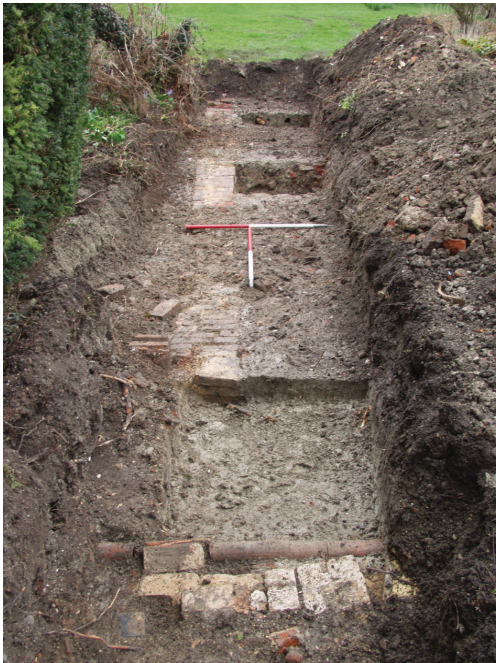
DP3. Post-excavation view of trench, wall M1005 in foreground, looking NW (01/04/2010)

M1005 was a brick wall oriented NE/SW located at the SE end of the trench. It was only recorded in plan; therefore no construction cut can be described. It consisted of at least two courses of mid reddish orange brick (225 x 100 x 65 mm) laid 'on bed'. The bricks were jointed with mortar that varied between a light whitish yellow sandy mortar and a white cement based mortar. The wall may have a function similar to that of wall M1004, namely a garden feature.

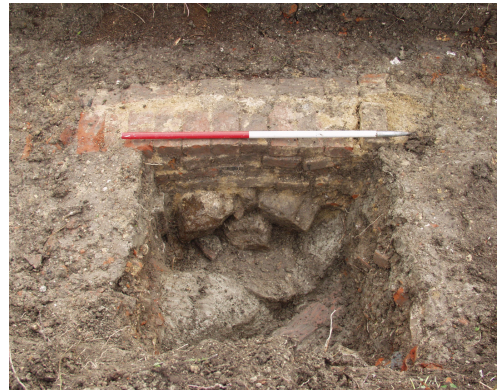
DP4. NE face of wall M1004 within test pit 2, looking SW (01/04/2010)

four courses of mid reddish orange machine-made brick (225 x 100 x 65 mm). Its bonding type was English Garden Wall with a rough finish. The bricks were jointed with a light whitish yellow sandy lime mortar, with bed joints ranging from 0 to 30mm thick (Fig. 8 and DP 4). The final fill of F1006 was Backfill L1008 which was a light brownish grey compact silty clay with moderate CBM fragments and small stones. The wall appears to be a retaining wall for garden terracing.

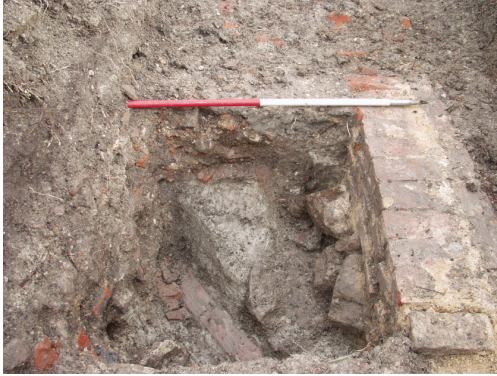
DP5. Drain F1010, drain lining L1011 and wall construction cut F1006 within test pit 2, looking SE (01/04/2010)

L1009 was a mid greyish brown compact clayey silt and building rubble. It was excavated within Test Pit 2 and had a depth of 0.30m. The rubble consisted of modern brick, tile and mortar fragments. This layer was not visible in plan and only recorded within the test pit sections. It pre-dates Wall Construction Cut F1006 (Fig. 8 Section 4; DP 5).

F1010 was a drain oriented E/W (1.20+ x 0.72+ x 0.34m+). It was also located within Test Pit 2 and represents the earliest feature within the trench (Fig.8; DPs 5 and 6). It contained two fills. Its basal fill, L1011, was a lining of re-used ceramic building materials; mid reddish orange machine made bricks (225 x 100 x 65 mm) placed 'on bed' along the base of the cut, and then mid reddish orange roof tiles placed against the edge of the cut. The final fill of F1010 was Backfill L1012 which was a mid greyish brown compact clayey silt with moderate CBM and mortar fragments.

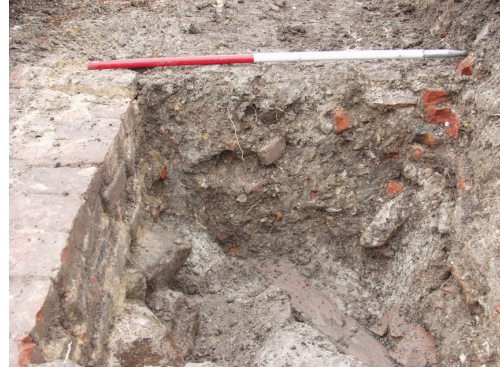
DP6. Drain F1010 within test pit 2, looking NW (01/04/2010)

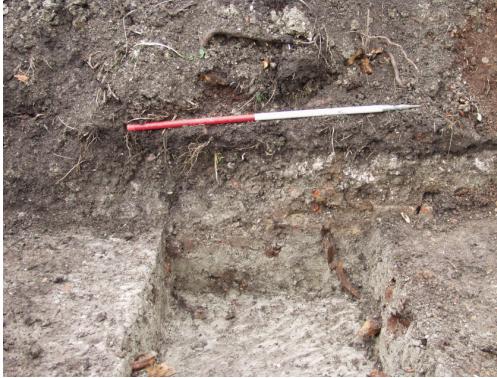
DP7. Sample section and test pit 1, NW end SW facing, looking NE (01/04/2010)

<i>Sample section 1 (DP 7): NW end, SW facing</i> <i>0.00 = 101.12m AOD</i>		
0.00 – 0.14m	L1000	Topsoil. Dark blackish grey, loose clayey silt.
0.14 – 0.54m	L1002	Demolition deposit. Mid greyish brown, compact clayey silt with frequent medium angular stones and frequent building rubble.
0.54 m+	L1003	Natural clay. Light bluish grey compact clay.

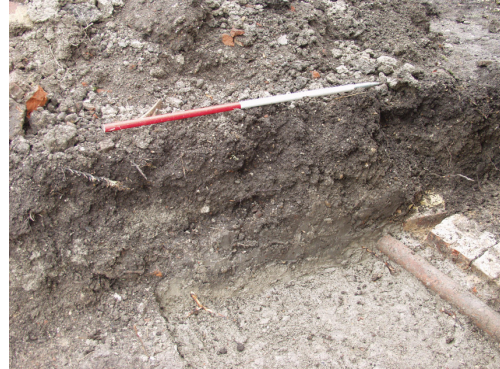
DP8. Sample section and test pit 3, SE end SW facing, looking ENE (01/04/2010).

<i>Sample section 2 (DP 8): SE end, SW facing</i> <i>0.00 = 101.64m AOD</i>		
0.00 – 0.17m	L1000	Topsoil. As above.
0.17 – 0.30m	L1001	Levelling deposit. Light bluish grey moderately compact silty clay.
0.30 – 0.80m	L1002	Demolition deposit. As above.
0.80m +	L1003	Natural clay. As above.

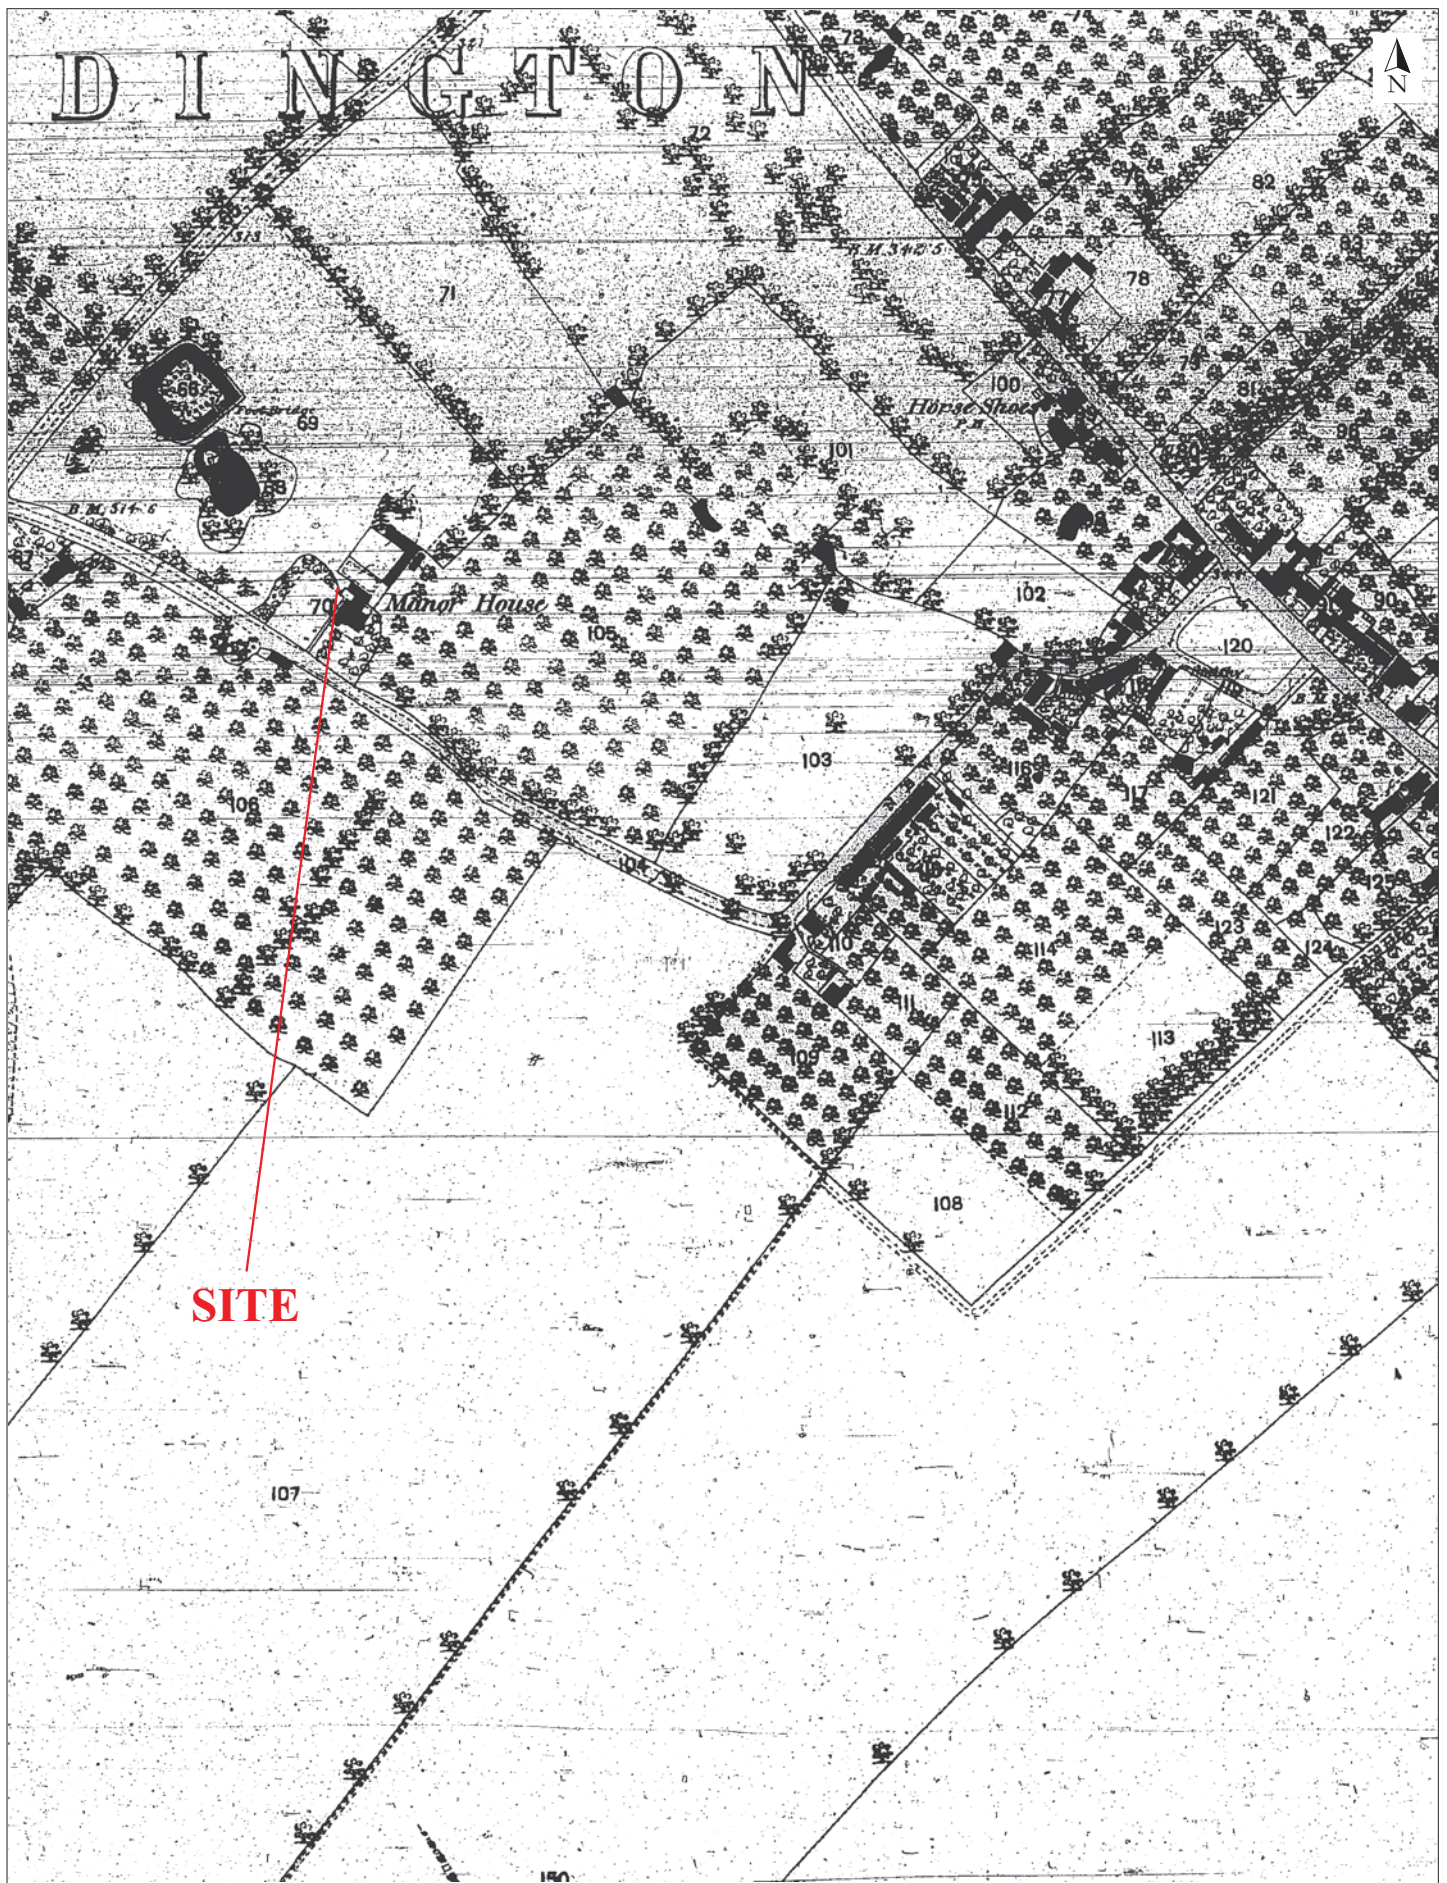
Archaeological Solutions Ltd
Fig. 5 OS map, 1881
 Scale 25 inch to 1 mile at A4

The First Edition Ordnance Survey Map is the first detailed depiction of the site. The buildings of Manor House and its outbuildings are clearly depicted. As mentioned above the buildings depicted do not correspond very closely with the buildings in the previous cartographic source. The area to the south of Manor House is shown to be wooded.
