**FORMER YHA, 7 FALCON SQUARE  
CASTLE HEDINGHAM, ESSEX**

**ARCHAEOLOGICAL  
MONITORING & RECORDING**

Authors: Matthew Adams BA (Report) Gareth Barlow MA (Fieldwork)	
NGR: TL 7856 3560	Report No. 3419
Parish: Castle Hedingham	Site Code: CH7
Approved: Claire Halpin MIFA	Project No. 3638
Signed:

Date: Nov 2009

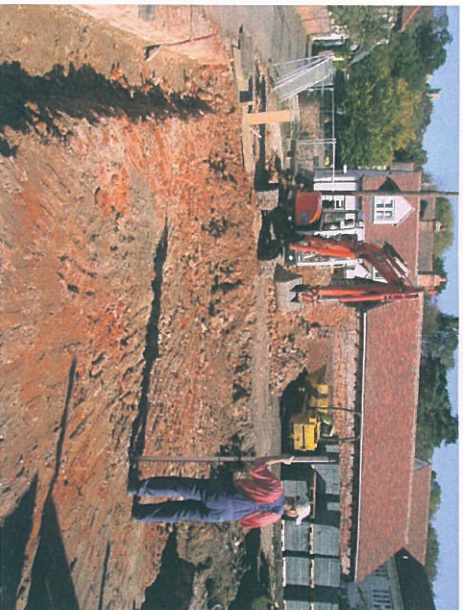
1  
General view of the site. Looking East

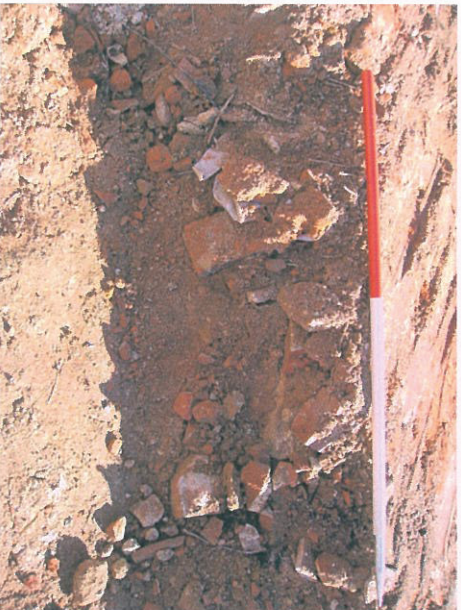
Sample Section 1 (DP2)	
0.00m = 50.26m AOD	
0.00 – 0.40m+	L1000. Modern Demolition/levelling. Friable mid orange brown clayey sand. Mixed lenses of pale grey crushed concrete and yellow grey sand

2  
Sample Section 1. Looking East.

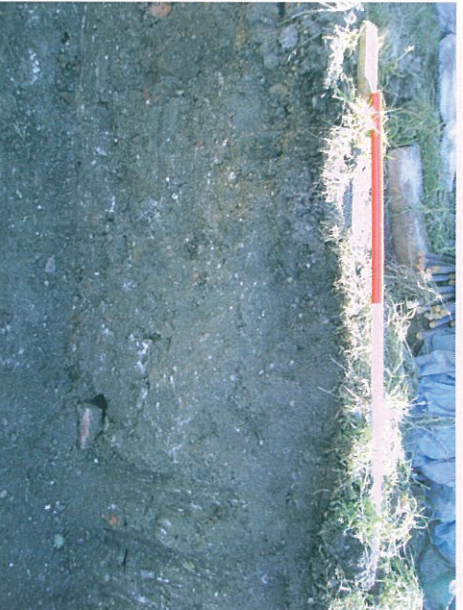
Sample Section 2 (DP3)	
0.0m = 50.37m AOD	
0.00 – 0.15m	L1001. Topsoil. Friable dark grey brown organic sandy silt with occasional small round flint
0.15 – 0.35m	L1002. Subsoil. Firm mid grey brown sandy silt with occasional small flint and chalk fleck

No archaeological features or finds were present.

3  
Sample Section 2. Looking East.

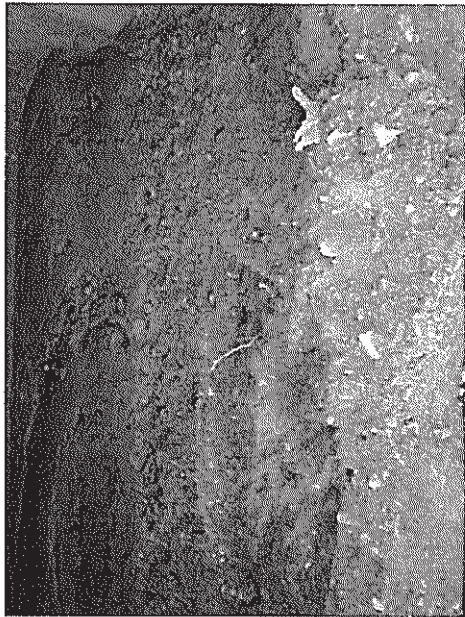
4

Sample Section 3 (DP4)	
0.00m = 50.63m AOD	
0.00 – 0.12m	L1000. Modern Demolition/Leveling. Friable mid orange brown clayey sand. Mixed lenses of pale grey crushed concrete and yellow grey sand
0.13 - 0.50m	L1003. Modern Made Ground. Friable mid grey brown sand.
0.51 – 1.21m	L1005. Modern Made Ground. Friable mid orange brown sand. Mixed lenses of crushed concrete and pebbles.
1.21m +	L1004. Natural Clay

*Sample Section 3. Looking North*

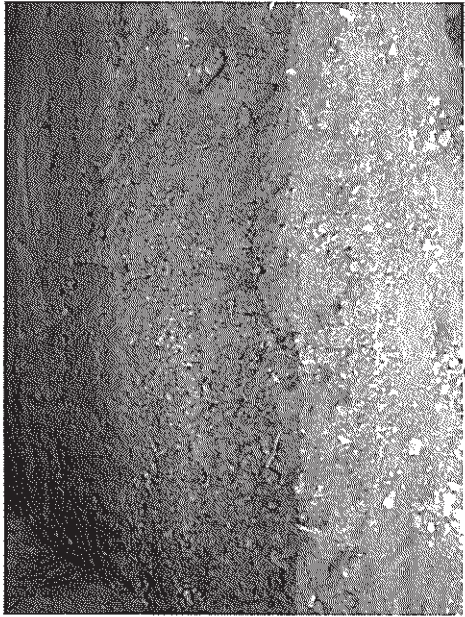
5

Sample Section 4 (DP5)	
0.00m = 50.58m AOD	
0.00 – 0.10m+	L1000. Modern Demolition/Leveling. Friable mid orange brown clayey sand. Mixed lenses of pale grey crushed concrete and yellow grey sand
0.11 – 0.34m	L1003. As above, Sample Section 3.
0.35 – 1.01m	L1005. As above, Sample Section 3.
0.101m +	L1004. As above, Sample Section 3.

No archaeological features or finds were present.

*Sample Section 4. Looking North*
