**PROPOSED FISHING LAKE,
HANROX MEADOW, BLUNTS LANE,
POTTERS CROUCH, ST ALBANS,
HERTFORDSHIRE**

AN ARCHAEOLOGICAL EVALUATION

Authors: Walter McCall (Fieldwork & report)	
NGR: TL 1187 0374	Report No: 3586
District: St Albans	Site Code: AS1327
Approved:	Project No: P3916
Claire Halpin MIFA	Date: July 2010
Signed:

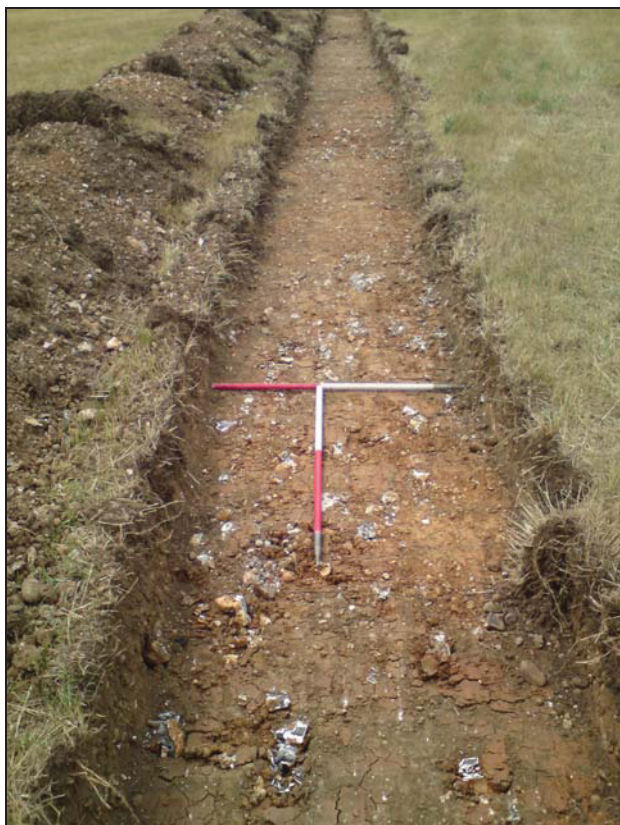
*DP 1
Trench 1*

Sample Section 1: E end, S facing 0.00 = 94.19m AOD		
0.00 – 0.23m	L1000	Topsoil. Dark grey brown silt with frequent small stones and roots
0.23 – 0.35m	L1001	Subsoil. Light grey brown clayey silt with frequent small stones
0.35m+	L1003	Natural. Mid orange brown clayey silt with pockets of flint gravel.

Description: No archaeological features or finds were present

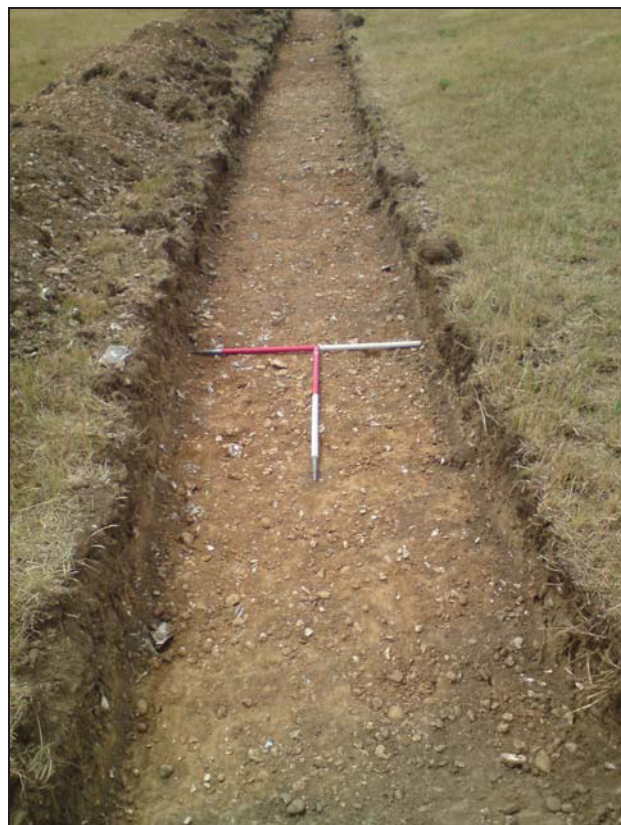
*DP 2
Trench 2*

Sample Section 2: E end, S facing 0.00 = 92.76m AOD		
0.00 – 0.17m	L1000	Topsoil. As Tr.1.
0.17 – 0.32m	L1001	Subsoil. As Tr.1.
0.32m+	L1003	Natural. As Tr.1.

Description: No archaeological features or finds were present

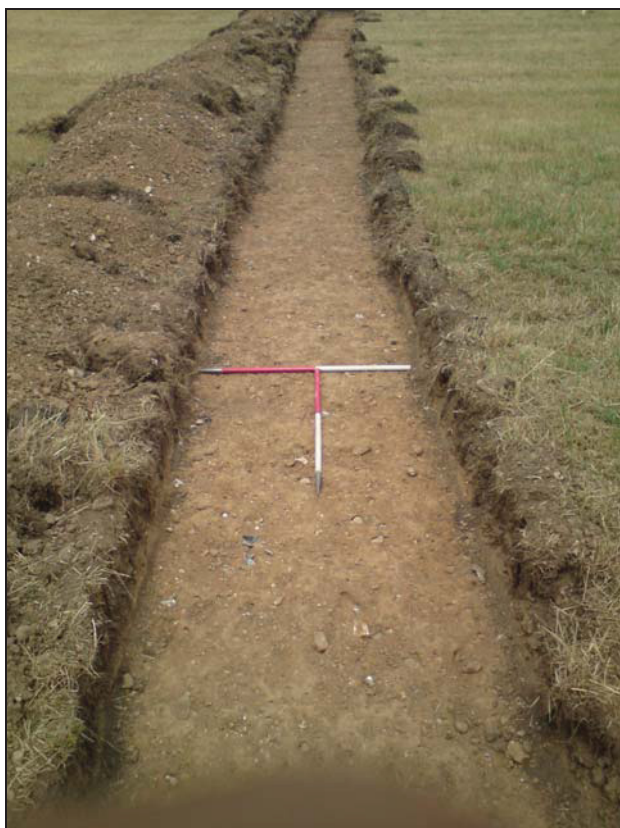
*DP 3
Trench 3*

Sample Section 3: N end, E facing 0.00 = 94.22m AOD		
0.00 – 0.19m	L1000	Topsoil. As Tr.1.
0.19 – 0.27m	L1001	Subsoil. As Tr.1.
0.27m+	L1003	Natural. As Tr.1.

Description: No archaeological features or finds were present

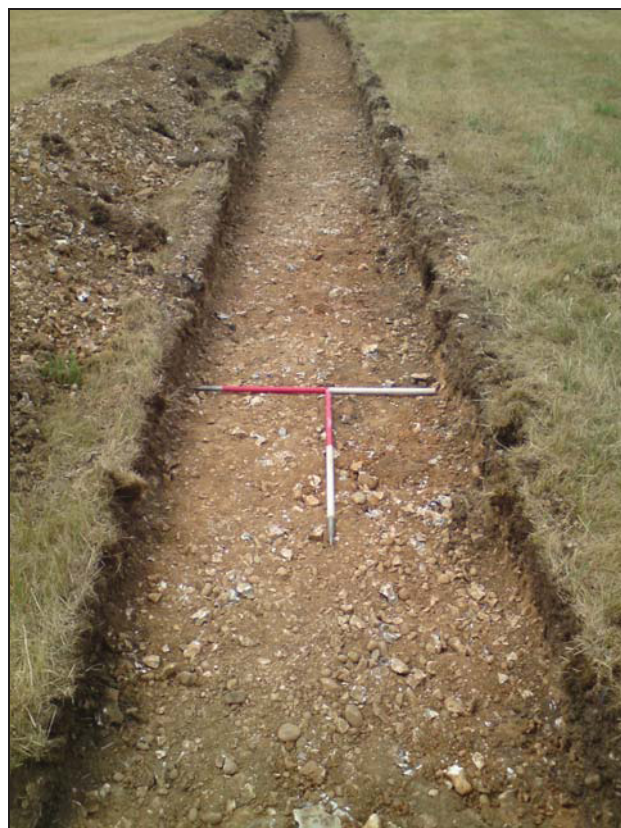
*DP 4
Trench 4*

Sample Section 4: E end, S facing 0.00 = 94.58m AOD		
0.00 – 0.22m	L1000	Topsoil. As Tr.1.
0.22 – 0.30m	L1001	Subsoil. As Tr.1.
0.30m+	L1003	Natural. As Tr.1.

Description: No archaeological features or finds were present

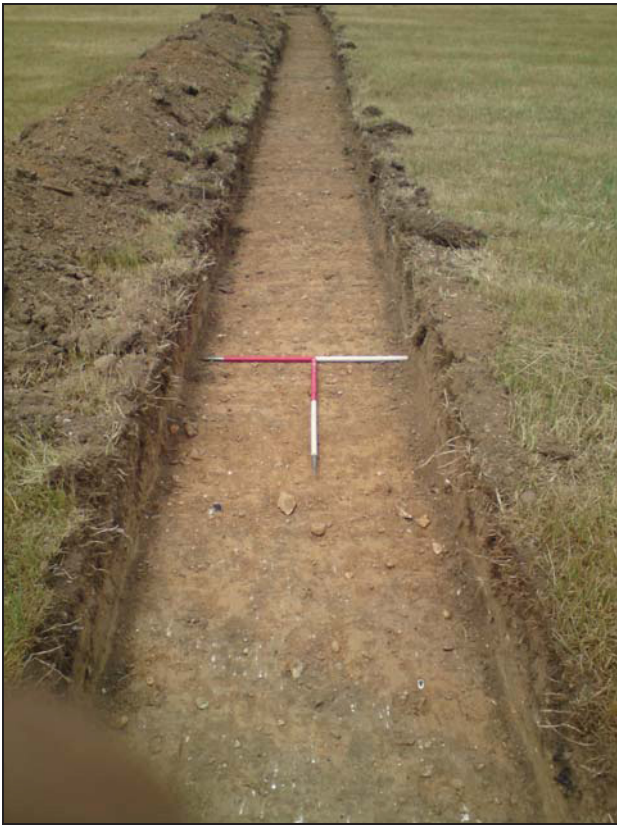
*DP 5
Trench 5*

Sample Section 5: N end, E facing 0.00 = 91.91m AOD		
0.00 – 0.15m	L1000	Topsoil. As Tr.1.
0.15 – 0.28m	L1001	Subsoil. As Tr.1.
0.28m+	L1003	Natural. As Tr.1.

Description: No archaeological features or finds were present

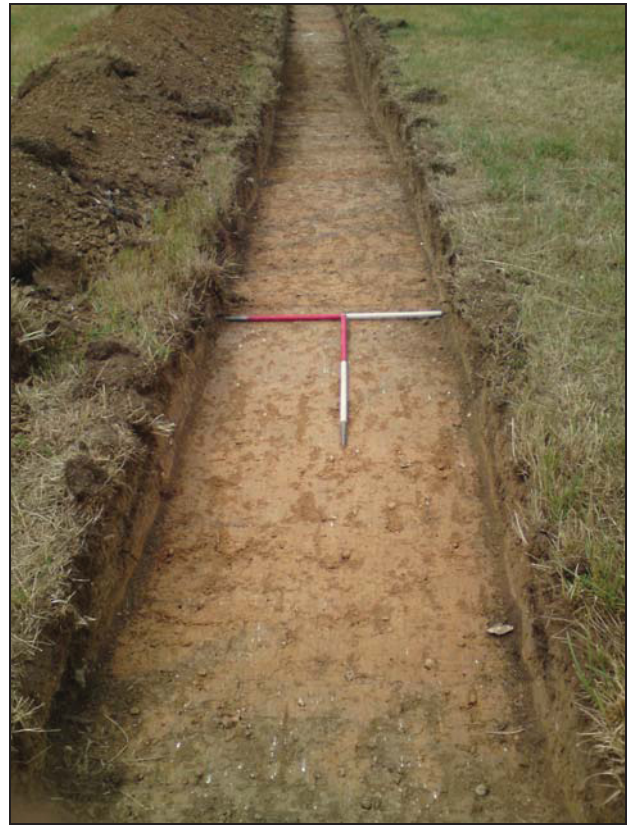
*DP 6
Trench 6*

Sample Section 6: E end, S facing 0.00 = 94.13m AOD		
0.00 – 0.17m	L1000	Topsoil. As Tr.1.
0.17 – 0.39m	L1001	Subsoil. As Tr.1.
0.39m+	L1003	Natural. As Tr.1.

Sample Section 7: Centre, S facing 0.00 = 94.14m AOD		
0.00 – 0.27m	L1000	Topsoil. As Tr.1.
0.27 – 0.44m	L1001	Subsoil. As Tr.1.
0.44 – 0.60m	L1002	Colluvium. Mid grey brown clayey silt with moderate small stones near base
0.60m+	L1003	Natural. As Tr.1.

Description: No archaeological features or finds were present

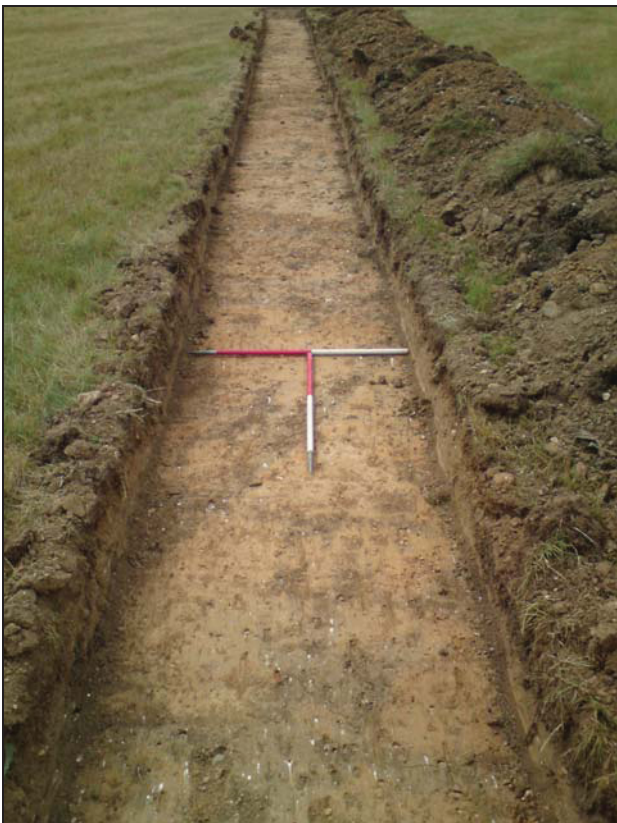
*DP 7
Trench 7*

Sample Section 8: E end, S facing 0.00 = 93.13m AOD		
0.00 – 0.20m	L1000	Topsoil. As Tr.1.
0.20 – 0.33m	L1001	Subsoil. As Tr.1.
0.33m+	L1003	Natural. As Tr.1.

Description: No archaeological features or finds were present

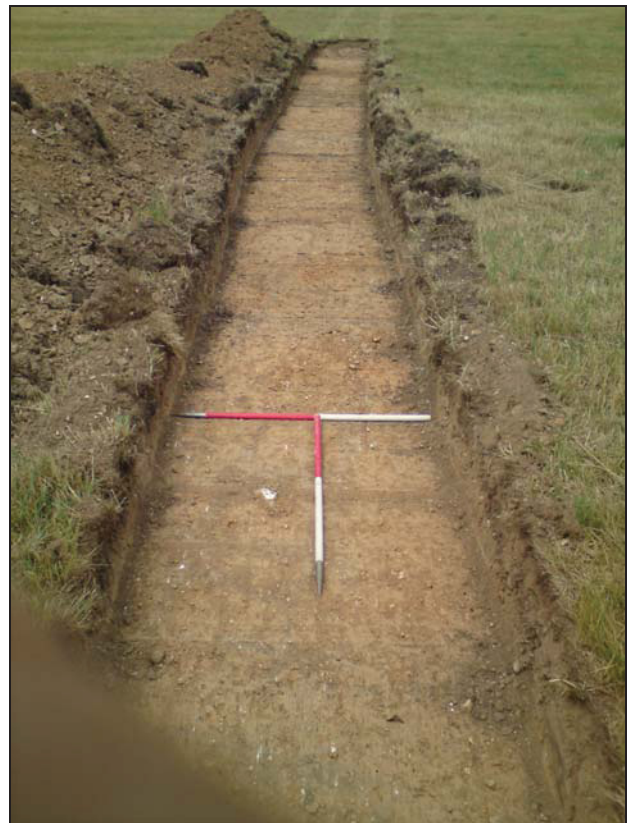
*DP 8
Trench 8*

Sample Section 9: N end, E facing 0.00 = 92.70m AOD		
0.00 – 0.16m	L1000	Topsoil. As Tr.1.
0.16 - 0.30m	L1001	Subsoil. As Tr.1.
0.30m+	L1003	Natural. As Tr.1.

Description: No archaeological features or finds were present

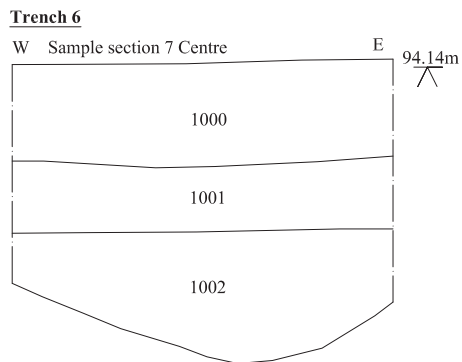
Archaeological Solutions Ltd
Fig. 3 Sample sections
 Scale 1:20 at A4

6.1 Topsoil L1000 overlay Subsoil L1001. The topsoil comprised a dark grey brown silt with frequent small stones and roots (0.15-0.23m thick). Subsoil L1001 was a light grey brown clayey silt with frequent small stones (0.08-0.22m thick). L1001 overlay the natural, L1003. The latter comprised a mid orange brown clayey silt with pockets of flint gravel (c.0.35m below the present day ground surface). In the middle of Trench 6 shallow colluvium, L1002, was present between the subsoil and the natural. It comprised a mid grey brown clayey silt with moderate small stones near base (0.16m thick)
