**LAND AT ST ANNE'S CONVENT, THE DOWNS,  
WEST WIMBLEDON SW20 8HS**

**HISTORIC BUILDING RECORDING**

Authors:	Tansy Collins BSc Kathren Henry Andrew Peachey BA AIFA	
NGR: TQ 2372 7016	Report No: 3488	
District: Merton	Site Code: TDW 10	
Approved: Claire Halpin	Project No: 3722	
Signed:	Date: February 2010

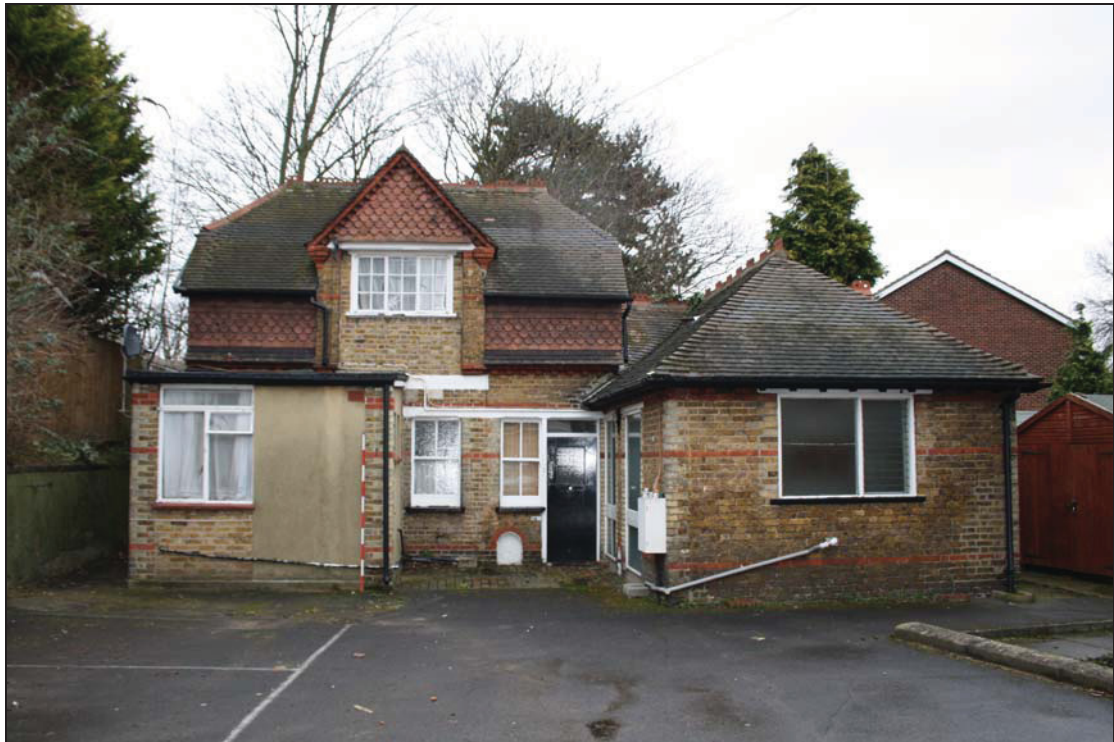
5.1 Building 1 is a small L-shaped building formerly comprising a carriage house and stabling (Plate 1). It lies to the north-east of the main house and occupies the corner of the property. It is bounded on the northern side by a retaining wall, approximately 1.5m high, which is rendered with a soldier course of Staffordshire blue bull-nosed bricks. The rear of the building was not accessible at the time of recording.

5.2 The main range rises over two storeys and is aligned approximately north to south, with a small single-storey cross-wing at the south end projecting into an open yard area on the west. The main frontage rises to a half-hipped roof with a central gable rising above the roof pitch on the west side. The roof of the lower cross-wing is also hipped and both roofs are covered in peg-tiles. A small unit on the west side represents a reconfiguring of an earlier arrangement, which likely comprised an open porch to the carriage house.

Plate 1 West elevation of Building 1, taken from west (DP 01)

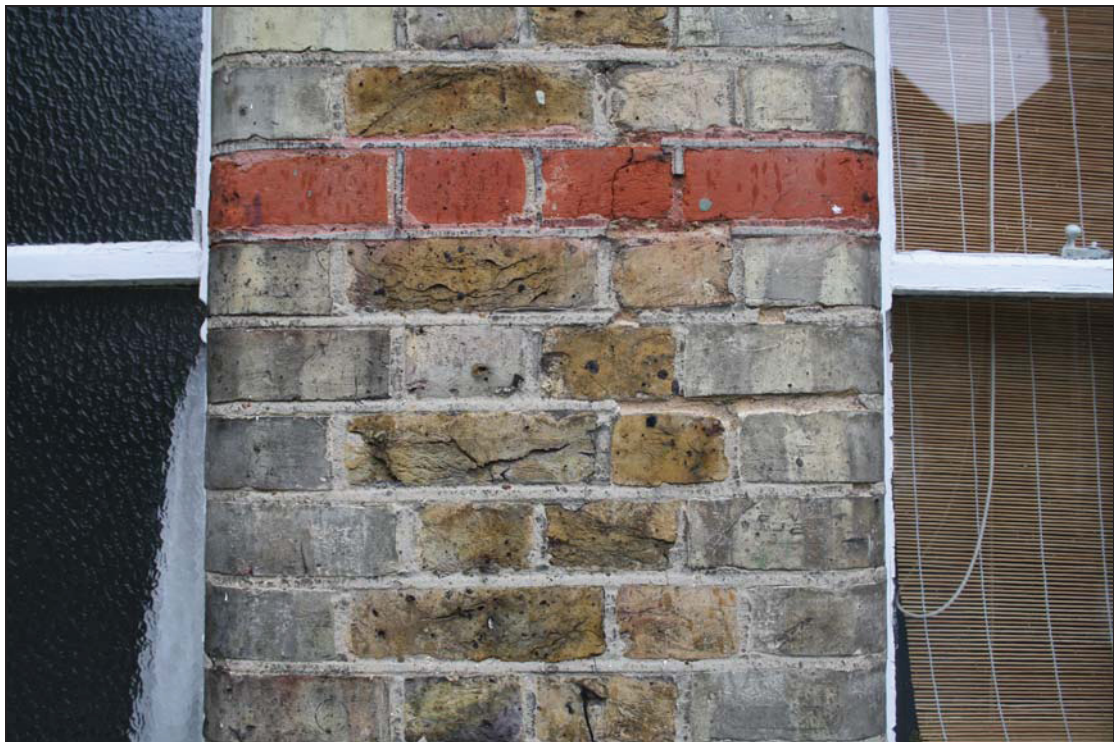
5.5 At first floor level the main range is more decorative and comprises a central panel rising to the gable noted above. Between the lower and upper area a red brick dentilated stringcourse extends across the façade and terminates at two projecting yellow brick piers which frame the central panel and rise to the gable protruding above the roof pitch on this side. The piers are topped with little red brick corbels and the gable itself is framed by red brick dog-tooth dentilation and infilled with red terracotta tile-hanging with a fish-scale profile. The remainder of the façade flanking the central gable is hung with fish-scale tiles, as the gable, with lower plain tiles extending over the stringcourse. In addition rafter feet protrude below the eaves, all painted. The central panel has clearly been rebuilt although in like style with a lower section of rough yellow stock brick. There is a three-light metal-framed window above, each light with six panes, the central light fixed and the flanking lights forming side-hung casements. The timber lintel above, however, is original and gives an indication of the original form. Here two sections of chamfering with run-outs indicate the position of two windows which likely followed the same form visible on the ground floor.

Plate 2 Sample of pilaster between windows on the west side of Building 1 showing bevelled corners to the jambs, taken from the west (DP 27)

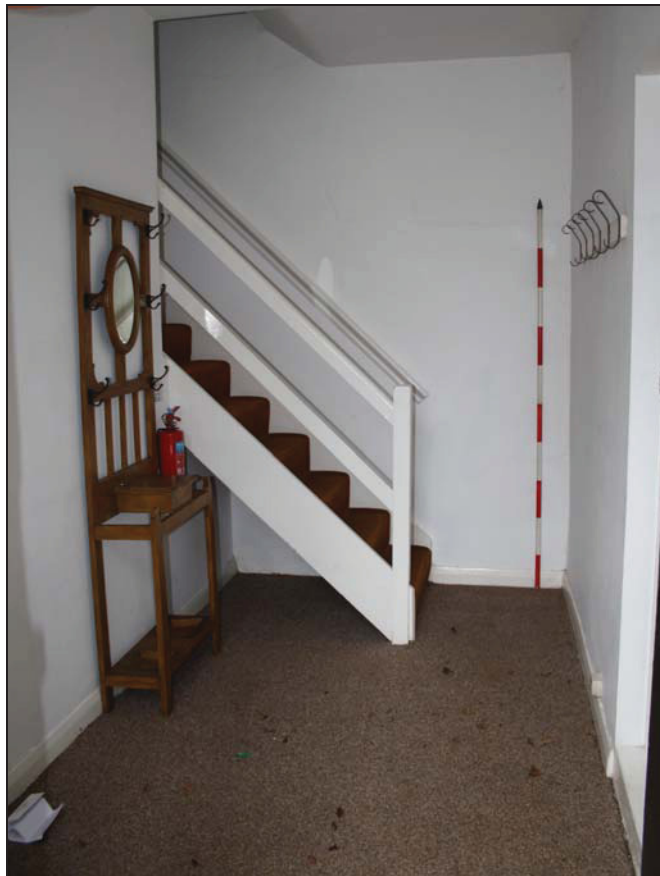
5.12 The entrance hall comprises is plain and houses the stair on the east side (Plate 3). The stair is early 20<sup>th</sup> century in date with a square newel on a closed string with a simple handrail with an intermediate rail below and no balusters. It turns a dog-leg at half-landing level and rises to the first floor where it is enclosed. Infilling the space between the stair and the front wall is a bathroom. The room is lit from the west by a sash window containing textured glass with plain glazing bars. Immediately to the north of the window we see a bevelled corner to the wall defining the original jamb of the carriage entrance, and clearly indicating the north partition is a later insertion.

Plate 3 Entrance hall of Building 1, taken from the west (DP 07)

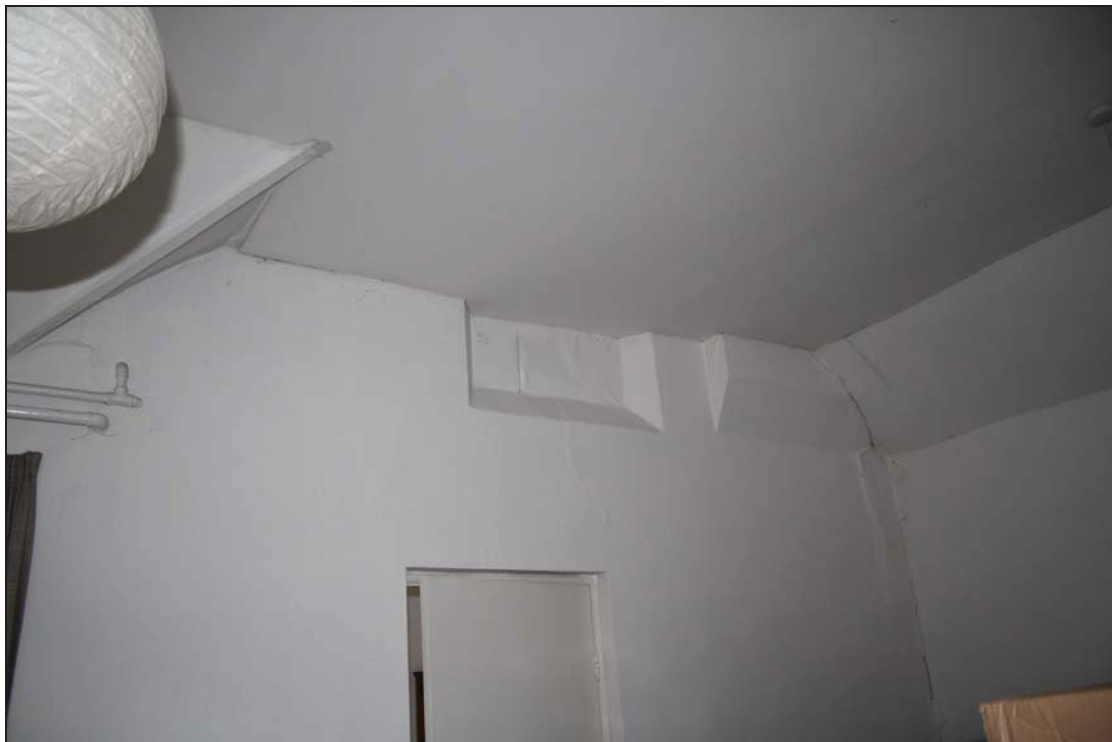
5.13 The cross-wing, reached through a modern door on the south side of the entrance hall now comprises two rooms, although formerly was occupied by a stable. The two blocked doorways on the north side, originally entrances to the stalls, flank the wall dividing this area and perhaps suggest it is original to the building. The room adjoining the entrance hall (Room 1) is now a large plain space with modern plastered walls all round and a plastered ceiling which includes part of the roof space. On the south, the inserted windows noted from the exterior are visible. There is little else of note, apart the base of a high-set aperture visible on the north wall (Plate 4), this likely comprising a loading door from a hay loft, which has been blocked with the insertion of the current ceiling which bisects the aperture.

Plate 4 North wall of Room 1 (Building 1) showing high-level blocked aperture, taken from the south-west (DP 17)

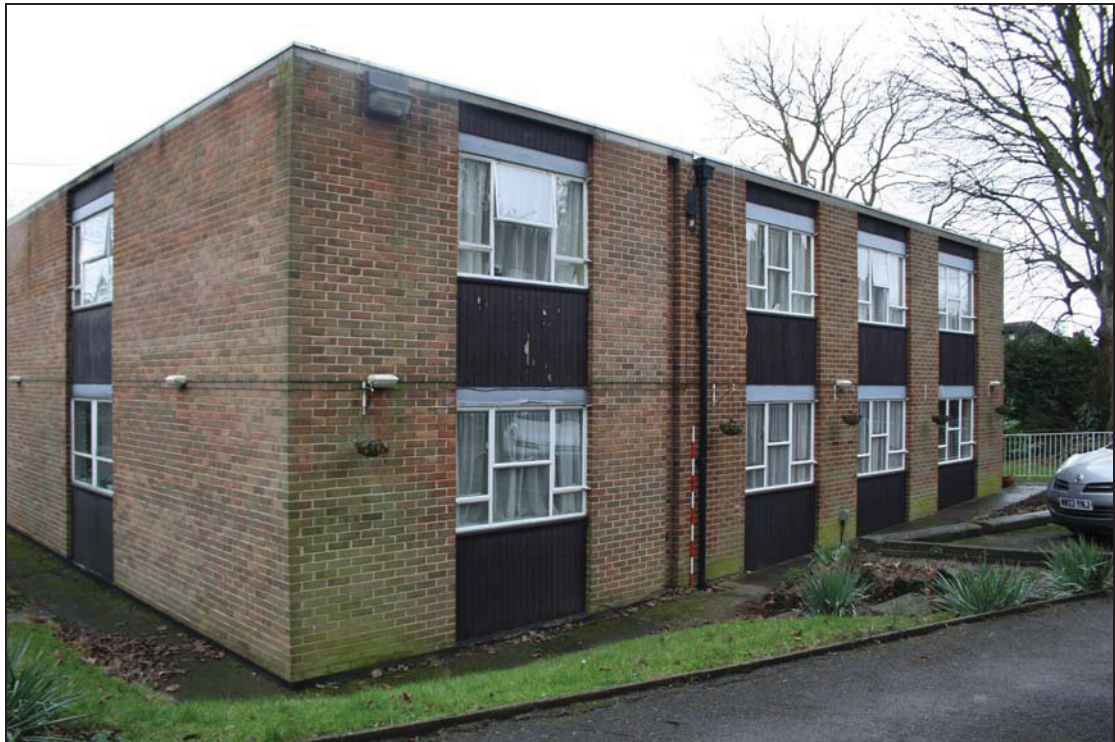
5.20 Building 2 is generally rectangular in plan apart from a recessed section on the southern side. It is constructed of brick rising over two storeys to a flat roof, the brick varying in colour from red to a dull grey. Access is given from the west side where a raised walkway with metal railings leads to a covered porch and the entrance. The remaining elevations present large metal-framed windows to bedrooms and similar, punctuated above and below by narrow vertical boarding (Plate 5). The windows comprise simple side-hung casements with small lower fixed lights flanking a central two-light section with an upper top-hung casement. The only variation can be seen on the south within the recessed section where the window form is of small casements, set beneath concrete lintels, which give light to the interior.

Plate 5 North elevation of Building 2, taken from the north-east (DP 05)

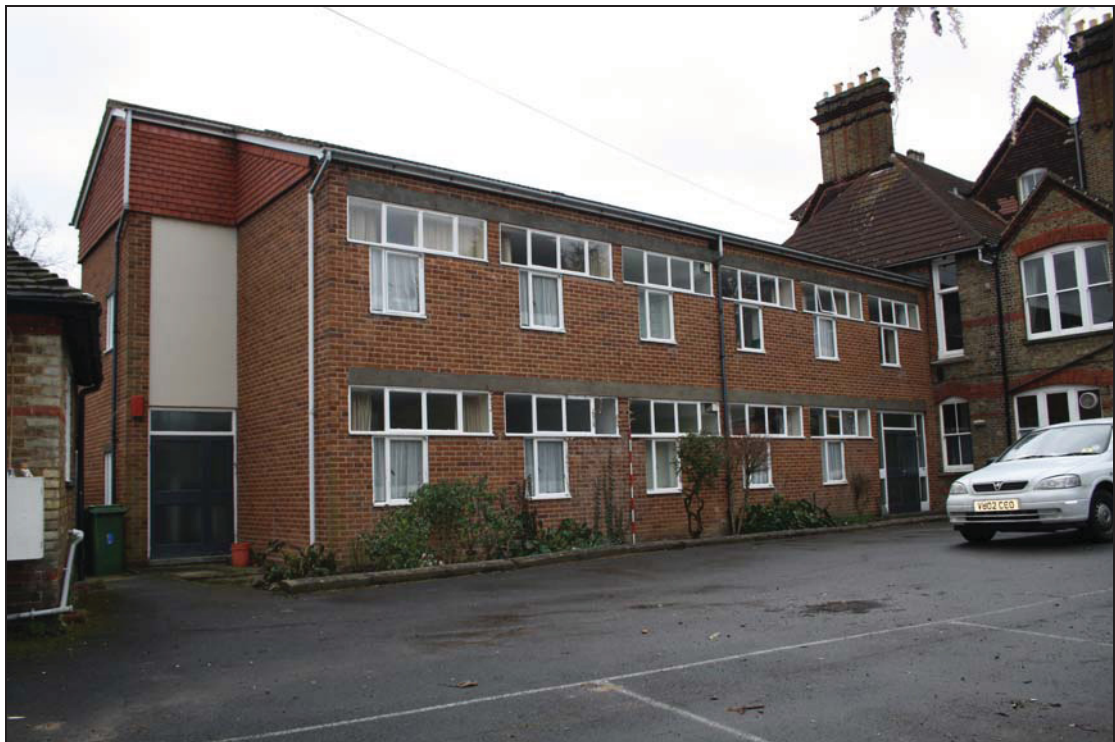
5.22 Building 3 is constructed of red brick and comprises a long range reached from within the convent building and from the exterior on the northern side (Plate 6). It rises over two storeys to a pitched roof covered with machine-made tiles. The building breaks forward slightly at the north-east gable end where a staircase is housed. Both long elevations are symmetrical and present a series of metal-framed windows set beneath continuous concrete lintels at both ground and first floor level. The windows provide light to each room through a single side-hung casement with a narrow fixed margin light. Above these, high-set wide windows of four lights apparently span the width of each room. The north-east end of the building at upper level along with the gable is tile-hung.

Plate 6 North elevation of Building 3, taken from the north-east (DP 04)
