**GYFRES FARM, BUCKS HILL, CHIPPERFIELD,  
HERTFORDSHIRE**

**HISTORIC BUILDING RECORDING**

**ARCHAEOLOGICAL SOLUTIONS LTD**

Authors: Lee Prosser PhD Lisa Smith BA Hannah Tweedie MPhil Kathren Henry	
NGR: TL 5056 2057	Report No: 3465
District: Three Rivers	Site Code: AS1265
Approved: Claire Halpin	Project No: 3649
Signed:	Date: January 2010

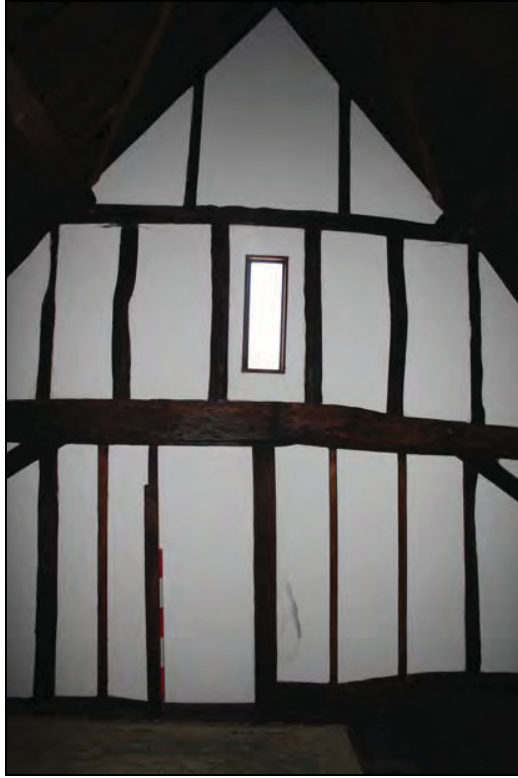
Plate 24

Southern bay, studs and wall panelling, taken from the south-east (DP 79)

5.2.17 The southern gable end is obscured at the lower levels though displays a consistent arrangement at the upper level (Plate 24). The principal posts are in good condition providing support for a large tie beam braced as before. A series of studs some waney some reused members rise from the mid –rail to the tie beam. A more regular pattern of studs extend to a lateral member supporting the purlins in each pitch.
