**CLAVERING HALL BARNS, CLAVERING,
ESSEX**

HISTORIC BUILDING RECORDING

Authors: Dr Lee Prosser PhD Lisa Smith BA Hannah Tweedie MPhil Kathren Henry	
NGR: TL 47615 30815	Report No. 3481
District: Uttlesford	Site Code: CVCH10
Approved: Claire Halpin MIFA	Project No. 3534
Signed:	Date: February 2010

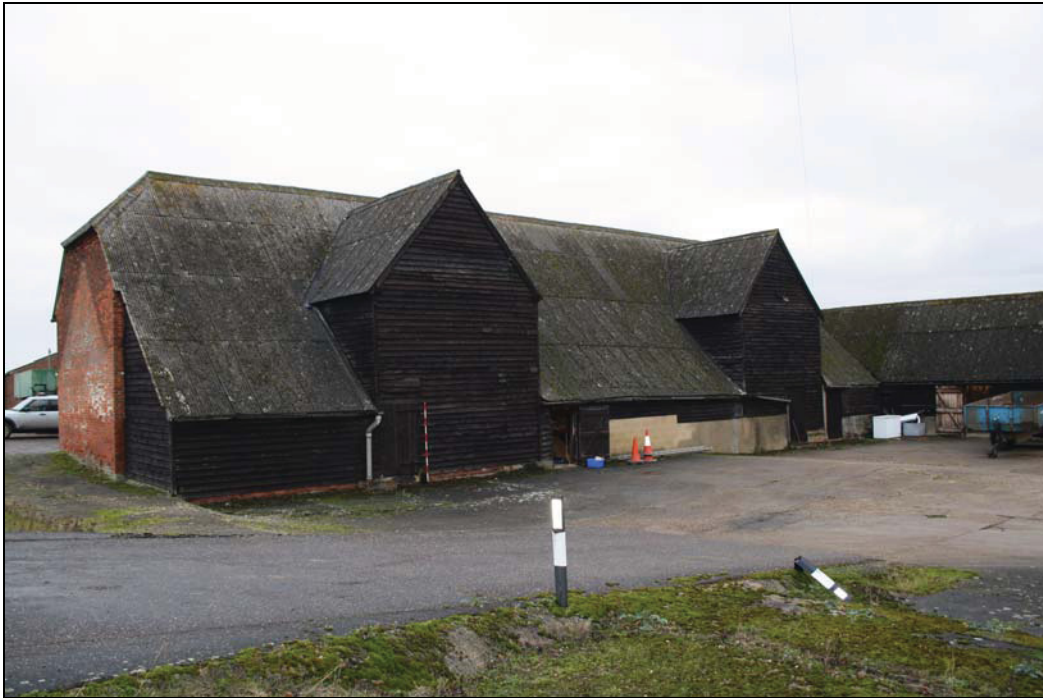
Plate 1 The Old Barn, south-eastern elevation, taken from the south (DP 2)

5.7 The southern façade is dominated by two gabled midstreys which have been partly subsumed by pent-roofed outshuts which bring the roofline and external walls flush with the midstreys. A substantial quantity of oak or elm weather-boarding survives, all stained, though with some softwood replacement, particularly at the western end. The outshut walls are partly rebuilt in blockwork. Conventional vertically boarded doors give access to both midstreys and central and eastern outshuts, while two windows light the central outshut.

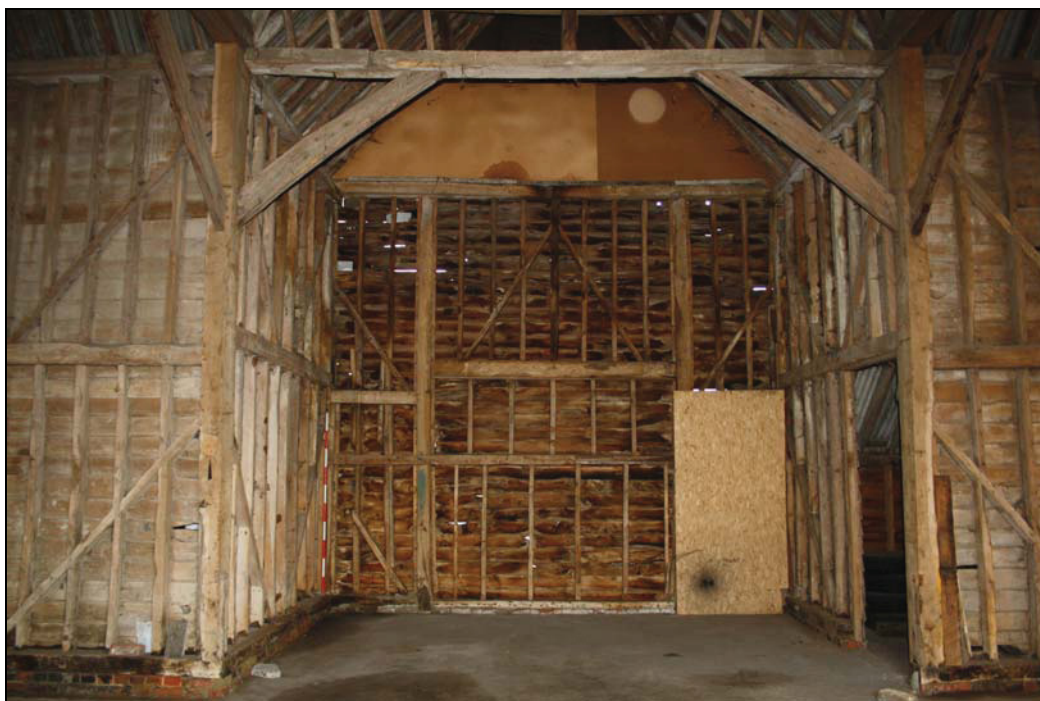
Plate 6 The Old Barn, south-western midstrey internal timber framing, taken from the north-west (DP 22)

5.15 In the midstrey gables large subsidiary uprights are framed in the position of conventional wide door jambs, but a properly pegged mid-rail at low level with upper primary-braced studwork show that these were never designed to accommodate large doors (Plate 6). Below the lintel, studwork is also present, but it could not be ascertained whether these replace earlier doors. The roof apex on both midstreys has been altered and formerly half-hipped gables straightened with softwood. The east midstrey gable has suffered modification following damage from fire and subsequent decay. This extends along the wall-

plate and corner post, while most of the western jamb-upright and mid-rail have been replaced with waney timber. The roof purlins also show signs of charring.

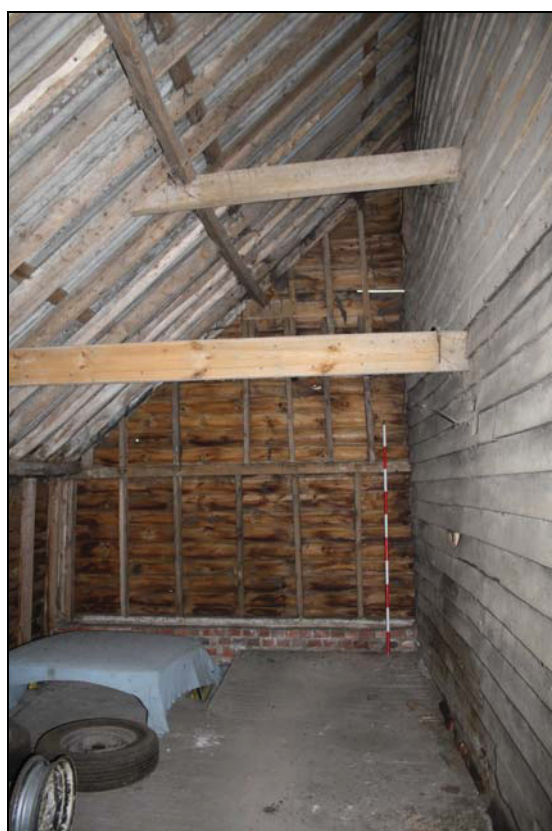
Plate 8 South-western outshut, taken from the north-east (DP 25)

5.19 The central outshut spanning the midstreys was latterly used as a workshop and store. The south wall has been replaced with masonry, but elements of the earlier timber-framing remain apparent, including the wall-plate and waney rafters. Three lower ties ride over the wall plate while upper ties are pegged to a purlin for support. Most of the studwork now visible is modern, but pegs remain in the wall-plate to indicate the presence of earlier members. Light is provided by a four-light fixed window to the west and an early 20th century single light with four panes to the east.

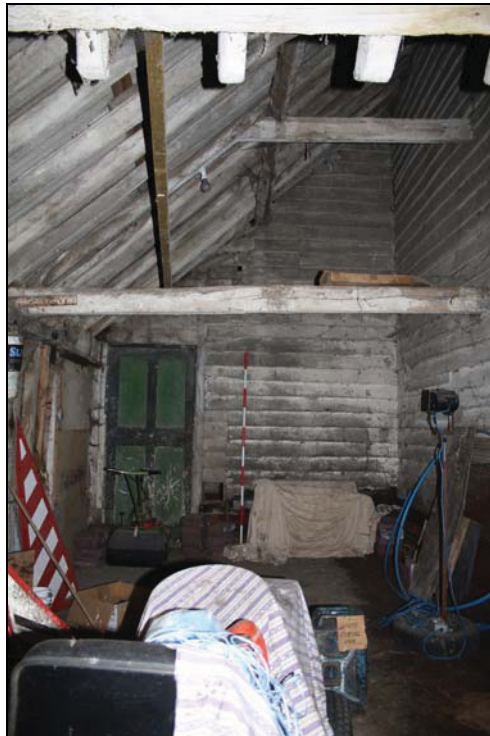
Plate 13 North-eastern outshut, accessed from the Old Dairy, taken from the north-East (DP 42)

5.29 The eastern outshut appears to have been constructed as an open-fronted lean-to. The external wall retains its original posts and braced wall-plate, subsequently infilled with modern masonry and weather-boarding. A modern door gives external access, while a 19th century domestic door leads to the barn midstre (as noted above)(Plate 13).

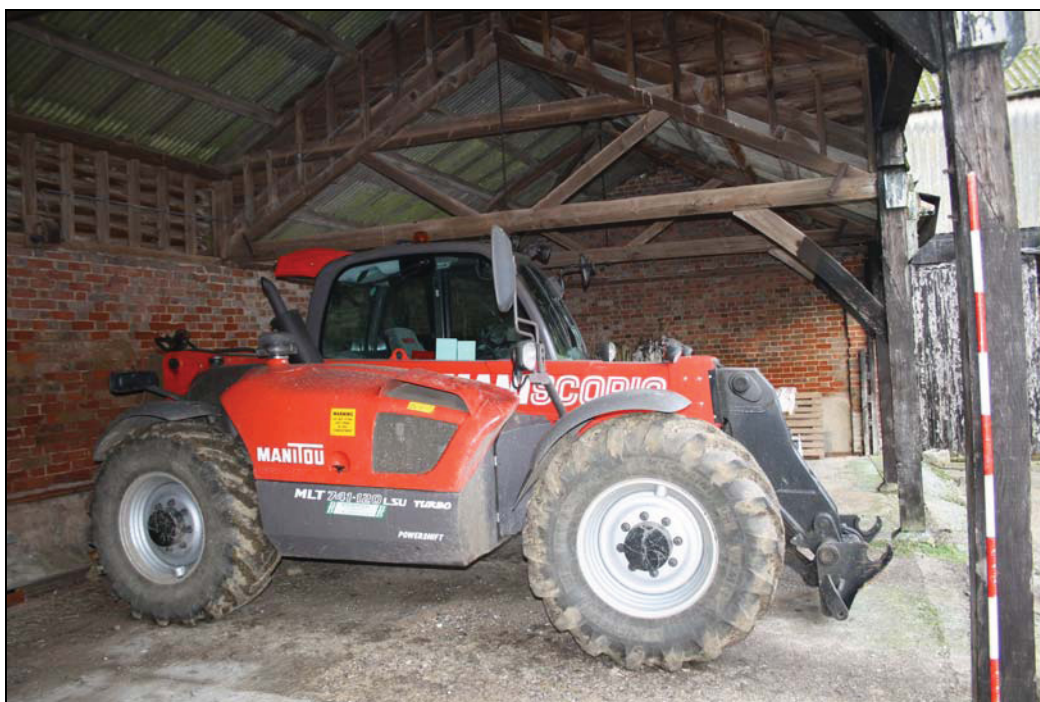
Plate 17 Drovers barn, four open bays to the north-east, taken from the south-west (DP 36)

5.35 The open frontage is framed with softwood principal posts, two of which have been scarfed and repaired at lower level. The roof trusses are of similar form; slightly curved braces are pegged to the principals while a central tensioned king-rod and two steep raking struts triangulate the truss with the principal rafters (Plate 17). Three purlins in each pitch and an additional ridge-purlin are coggd over the principal rafters and held by cleats. Where the central bays rise to a higher level, the rear wall has been built up with evenly-spaced studwork. Diagonal wind-braces have been nailed across the purlins of the eastern, lower bays.
