ARCHAEOLOGICAL SOLUTIONS LTD

LAND OFF QUAY STREET, HALESWORTH,
SUFFOLK

AN ARCHAEOLOGICAL EVALUATION

PHASE I AND II

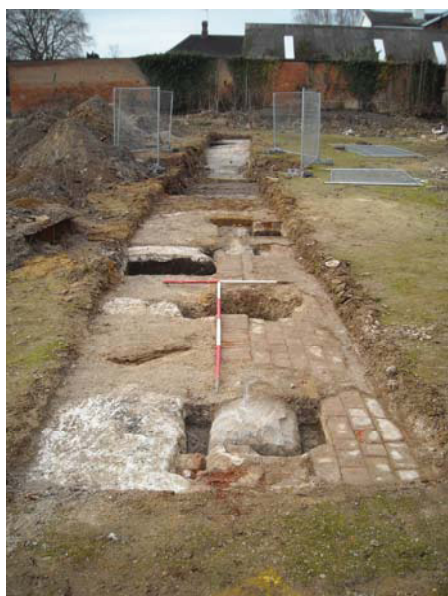
DP1 Trench 1. From south-east

Description: A foundation trench (F1005) was present at the north-western end and it was cut by Posthole F1011. A modern ditch (F1008) was situated next to a spread of material in the north-western end of the trench and modern pits, possibly associated with the builders' merchants, were located in the centre. A modern pit (F1037) was located next to a drain, M1039. A brick floor surface, M1003, contained postholes, F1019, F1026, F1030 and F1034, that contained substantial postpads of granite blocks, M1047, M1048, M104 and M1050. This was aligned with the extant Malthouse Flats building along the north-east border of the site.

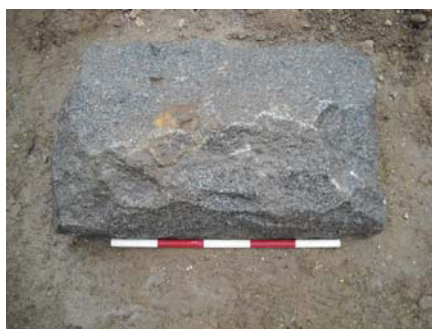
DP2 M1049, F1030. Granite block.

Post Holes	Fill	Dimensions	Description	Fill	Finds	Relationship
F1026	M1050	0.20m+ x 0.70m x 0.31m	Granite block	-	-	-
	L1029	1.0m x 0.70m x 0.31m	Rectangular, steep sides, flat base.	Light orange red compact rubble.	CBM (34g), Fe fragment (36g)	
	L1028			Light white pink firm quartz mortar.	-	
	L1027			Dark brown orange loose silty sand.	CBM (266g)	
F1030	M1049	0.70m x 0.46m x 0.22m	Granite block	-	-	-
	L1036	1.05m x 0.80m x	Rectangular, moderately steep sides, convex base.	Black brown loose sandy silt.	-	
	L1033	0.21m		Light pink white compact rubble.	CBM (112g)	
	L1032			Light white pink firm quartz mortar substance.		
	L1031			Light yellow brown loose silty sand.		
F1019	M1048	0.75m x 0.45m x 0.16m	Granite block	-	-	Contained Post Pipe F1021
	L1020	1.03m x 0.81m x 0.24m	Sub-rectangular, slightly rounded corners, moderately steep sides.	Light green grey clayey chalky sand. Firm.		
F1021	L1022	0.30m+ x 0.40m x 0.24m	Rectangular with rounded corners. Vertical sides. Sloped to north-east.	Firm brown silty sand.	CBM (544g), Fe Fragments (3, 1702g).	Postpipe in Posthole F1019

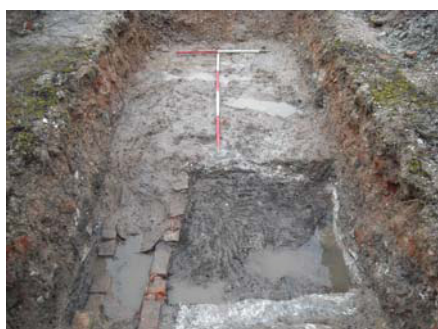
DP3 Trench 2A. From north-east

Pit F1042 extended beyond the north-eastern edge of trench 2A (4.25m+ x 2m+ x 0.70m), and is likely to have been the same feature as that marked as modern disturbance in the centre of Trench 1. F1042 contained two fills. The basal fill, L1044, comprised dark brown grey loose sandy silt. It contained a large amount of CBM, of which a sample was recovered (90g). L1044 also contained large iron fragments, one of which was recovered (1727g). L1043 was the upper fill and comprised light brown grey loose sandy gravel. L1043 contained large quantities of modern CBM, none of which was recovered. Pit F1042 was cut by a modern pit, F1040. Pit F1042 cut through the top of Drain M1069.

Drain M1069 was orientated north-east to south-west and extended beyond the south-eastern edge of the trench (2m+ x 0.80m+ x 0.13m+). The drain was not fully excavated due to the alteration in methodology (See Section 8). The construction cut of the drain (F1068) had moderately sloping sides and a concave base and cut through L1071. It contained one fill, L1070. L1070 comprised a dark black brown loose sandy silt and coal ash. Drain M1069 comprised three courses of unfrogged red bricks laid on bed in a stretcher style, measuring 230mm x 115mm x 65mm. The bricks were bonded by cement mortar. One brick was retained (300g). The drain was capped by a layer of thick slate and sealed by a covering of concrete (L1045). M1069 appeared to be a continuation of Drain M1039 in Trench 1. The concrete cover L1045 of M1069 was cut by Pit F1042.

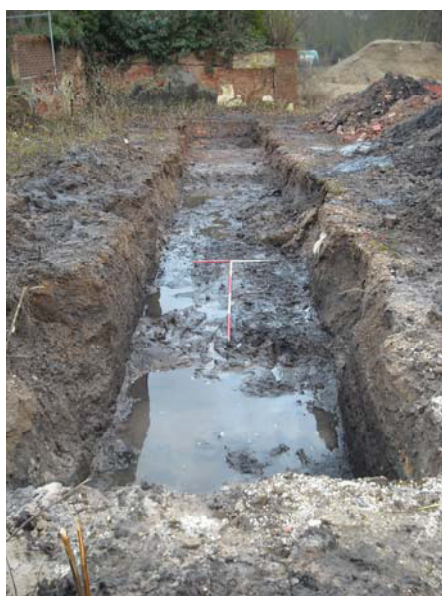
DP4 Trench 2B. From north-east.

conditions of the trench resulted in the preservation of the wooden posts within all 11 postholes. The three groups were aligned north north-east to south south-west. The most northerly group comprised three postholes (F1079, F1081 and F1083). The next group was located 2.6m to the south and comprised four postholes (F1085, F1087, F1089, F1091). The final group was situated 2.8m south of the central group and comprised F1093, F095, F1097 and F1099. The posts in the central group were a much lighter colour than those in the two outer groups, perhaps indicative of different preservation conditions towards the centre of the trench.

Wall M1102 was located towards the south-western end of Trench 2B. It extended beyond the south-eastern edge of the trench and was aligned north-west to south-east (1.70m+ x 0.17m x 0.13m). The wall comprised unfrogged red bricks (280mm x 170mm x 60mm) bonded with cement mortar. Two courses remained and formed a stretcher bond. The foundation, L1116, consisted of a three layers of slate. A layer of wood (L1117), possibly one timber, was laid beneath L1116. It was not possible to identify the type of wood as the feature was not excavated. M1102 may have been related to the walls present along the eastern boundary of the site, as it follows a similar alignment (Fig. 2).

Drain F1103 was located along the south-western edge of Wall M1102 (1.80m+ x 0.37m x 0.34m). Another branch of the drain or a later drain ran north-east to south-west and cut across the line of Wall M1102. The drain cut, F1103, was had steep sides and a flatish base. The basal fill, L1104, was rounded gravel to aid drainage. The upper fill, L1118, comprised a thin accumulation of very dark grey loose sandy silt.

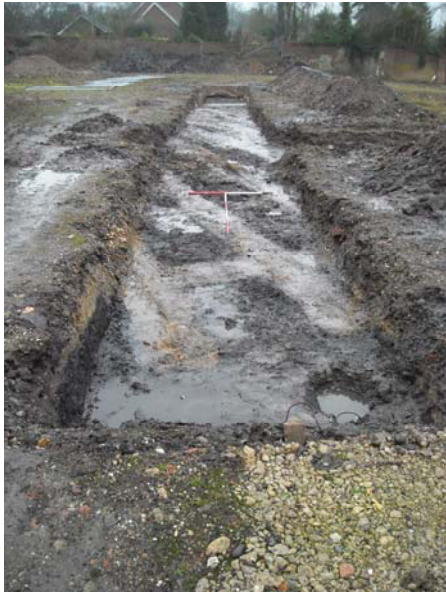
DP5 Trench 3. From north-west

Five concrete footings on a roughly east to west alignment were located in the north-western end of the trench (Table 4). They all extended beyond the north-eastern edge of the trench. L1141 extended into Trench 4. Two of the footings (L1144 and L1145) terminated in the north-western end of the trench, representing the western extent of the foundations. A north to south aligned footing (L1146) crossed L1144 and L1145 1m from their termini. These were probably building foundations, sleeper walls for a raised granary floor or an under floor flue system.

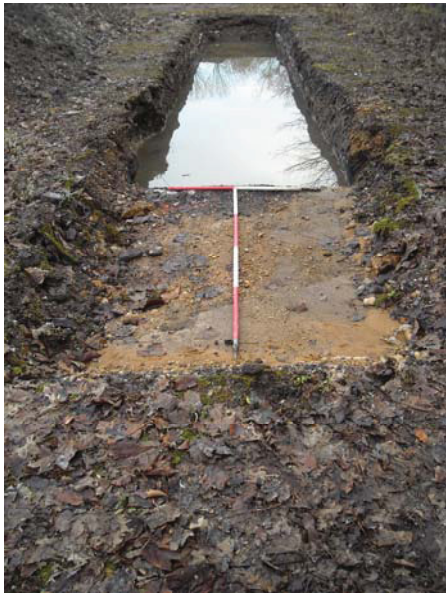
DP7 Trench 5A. From north-west

It was not possible to hand clean or record Trench 5A after the mechanical excavation because of a high level of hydrocarbon contamination. However, two rows of preserved timber posts were noted. The northern row crossed the trench on an east to west alignment and was composed of small and rounded posts. The southern row was aligned more north-east to south-west were two parallel rows of postholes that still contained timber posts. With the mechanical excavator one timber was recovered from each row. The post from the most northerly line (T1187) was rounded and measured 0.28m x 0.12m x 0.03m, while the post from the southern line (T1188) was squared and measured 0.48m x 0.21m x 0.18m.

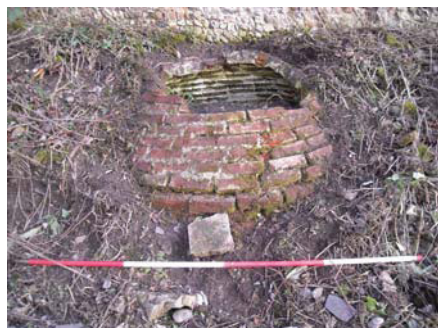
DP10 Kiln/Oven M1196. From north-west.

A domed brick constructed kiln/oven, M1196, was situated in the bank forming the south-eastern border (1.76m x 1.60m+ x 0.48m+ (length x width x height)). It was made of handmade unfrogged red bricks measuring 235mm x 110mm x 65mm (9 1/4" x 4 1/4" x 2 1/2") and bonded with lime mortar (L1197). Its top had been damaged by recent activity. It was covered in vegetation and had been almost completely infilled. The lower bricks had been undermined due to the natural erosion of the bank and were propped up by a concrete slab (not removed). The kiln/oven is situated within an earth bank beneath a brick and flint boundary wall shown on the historic maps from 1840 onward. The feature was not excavated, nor was a sample of the bricks and mortar taken as this would have damaged the structure prior to any future investigation. No flue was identified, although the concrete block may conceal an opening. The observed upper part of the interior was not lined and did not display evidence of high temperatures. It is possible that the kiln/oven predates the industrial remains located within the trenches, as the bricks are possibly 18th century and the 19th century boundary wall had been constructed over it. Equally, it may be associated with the documented malhouses as ovens are needed in the germination process. The location of the kiln just 7.5m south-east of the malhouse flats bordering the site could be significant. No other similar features were found along the bank, or within the site, but some could be buried within the bank beneath the brick and flint boundary wall.

8.1.4 An extant domed kiln or oven located within the bank forming the eastern boundary was cleaned and recorded on advice from Will Fletcher (19/01/09). As much vegetation and surrounding loose bank material was removed as possible ensuring the structural integrity of the kiln and the boundary wall constructed over it. The extent of the feature was planned and photographs were taken.

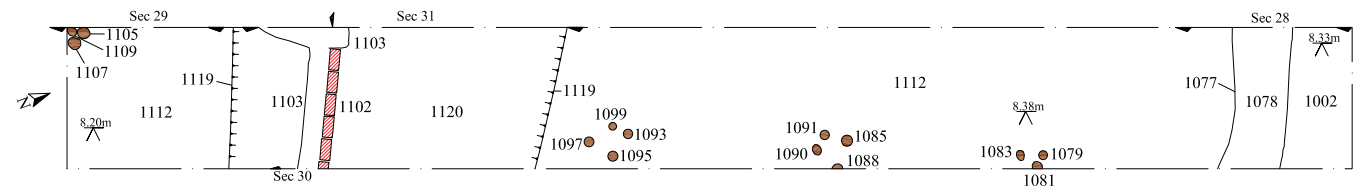
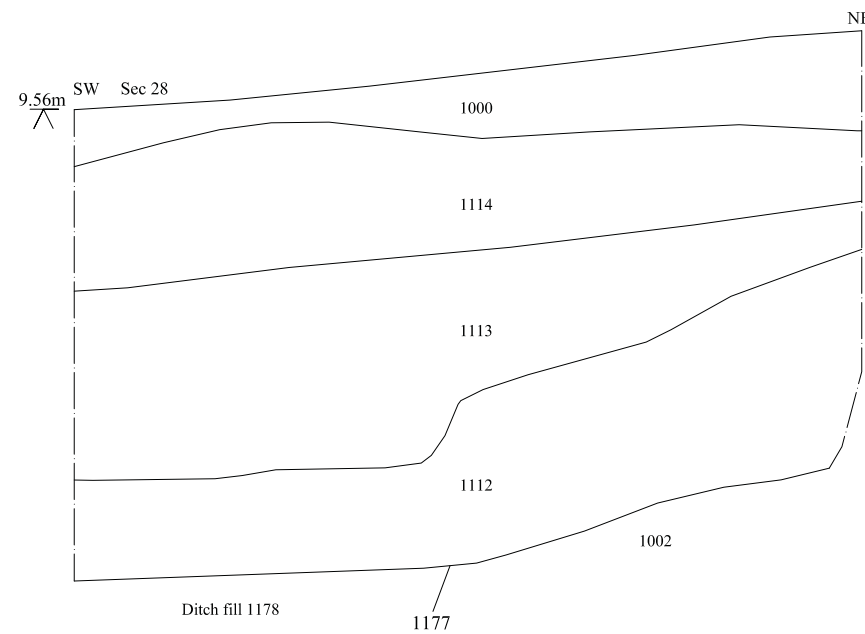
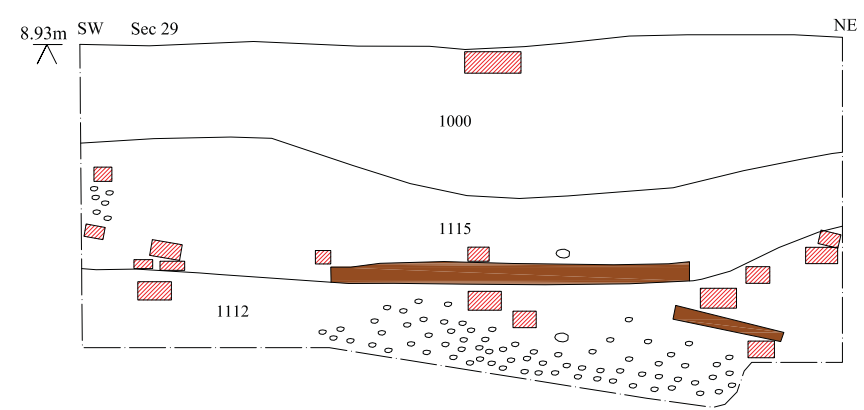
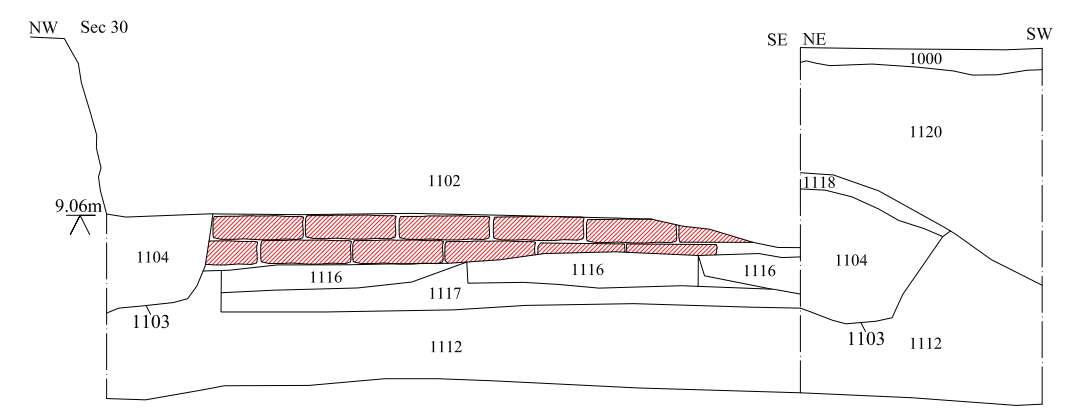
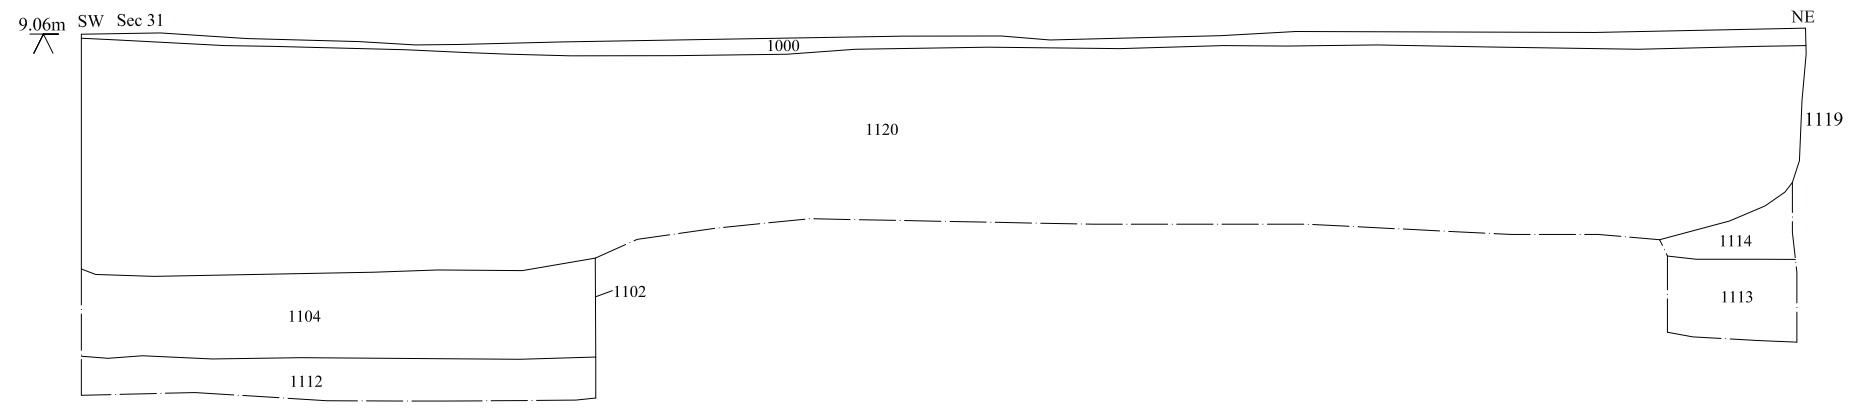
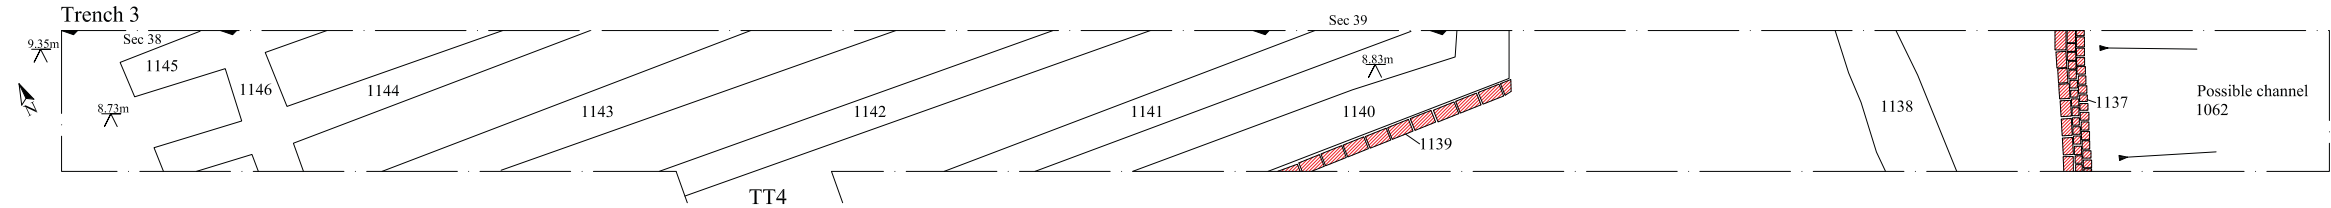
Archaeological Solutions Ltd
Fig. 10 Plans & sections
Scale Plans 1:100, sections 1:20 at A3

Trench 2B

Trench 3

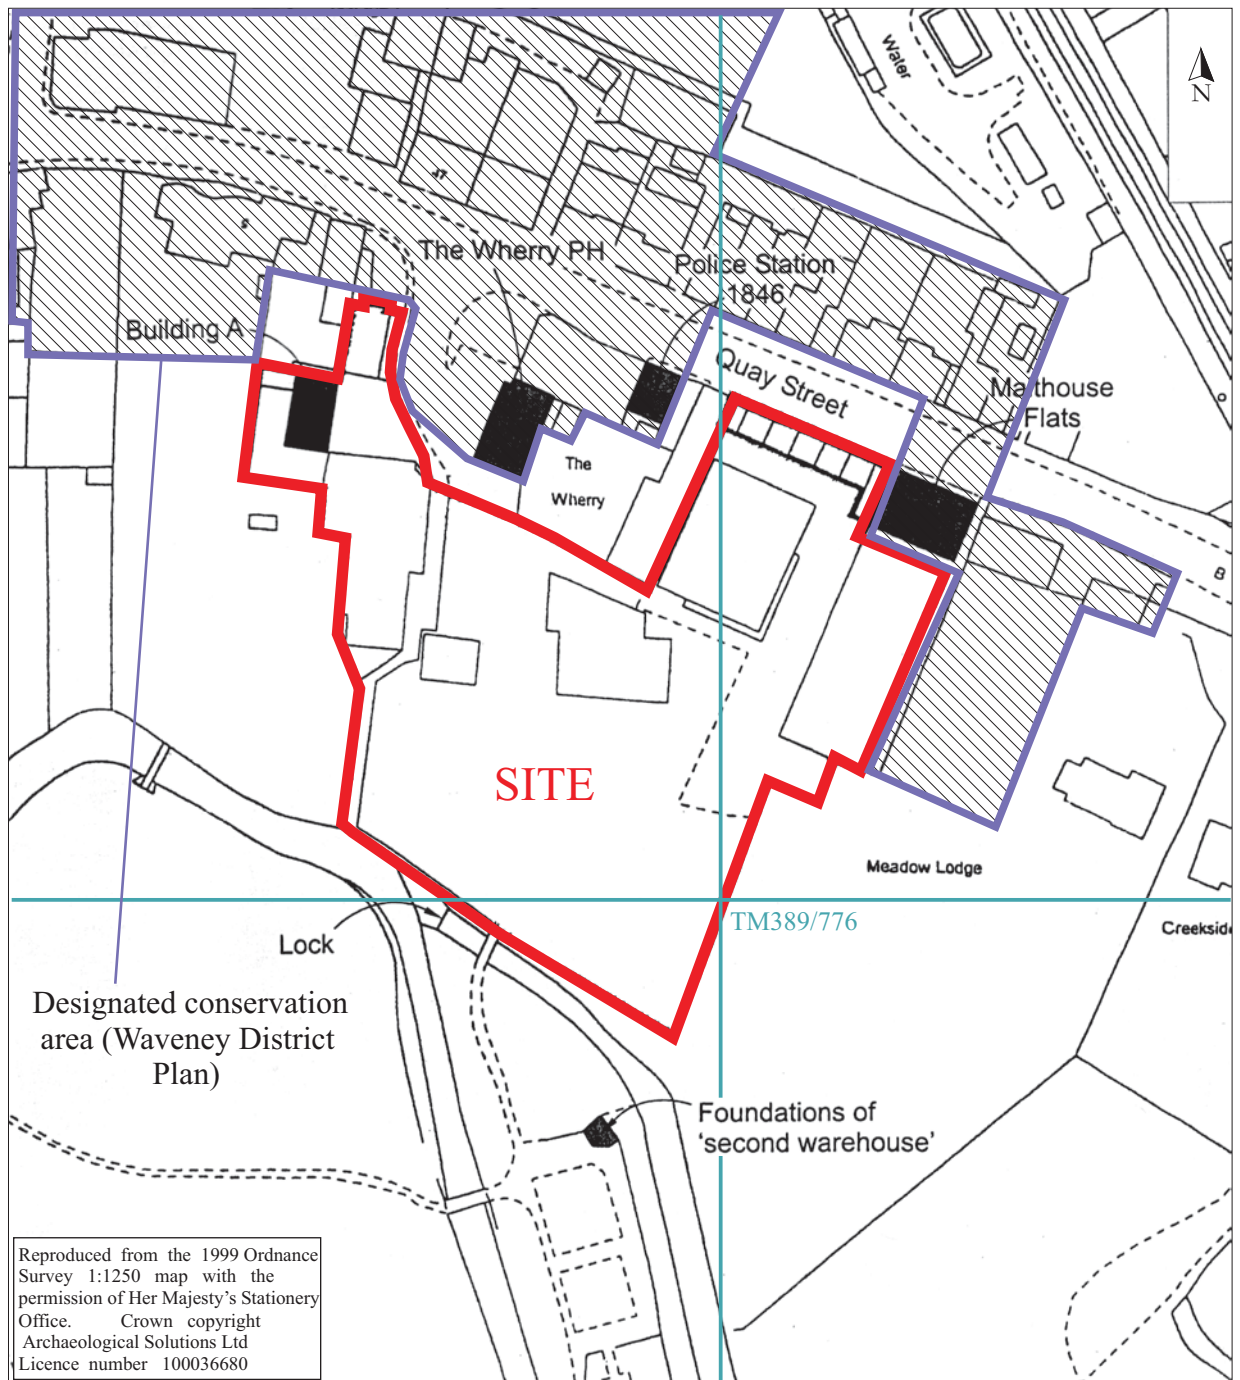
<i>Archaeological Solutions Ltd</i>
Fig. 2 Detailed site location plan
Scale 1:1250 At A4

The cartographic evidence shows that the site has been developed since at least 1840 (Tithe Map). Since closure in 1930s the site has been comprehensively redeveloped, with only one original building surviving (Building A, Fig. 2). Currently it comprises a surface of broken concrete with large spoil heaps of crushed concrete located in the southern corner.

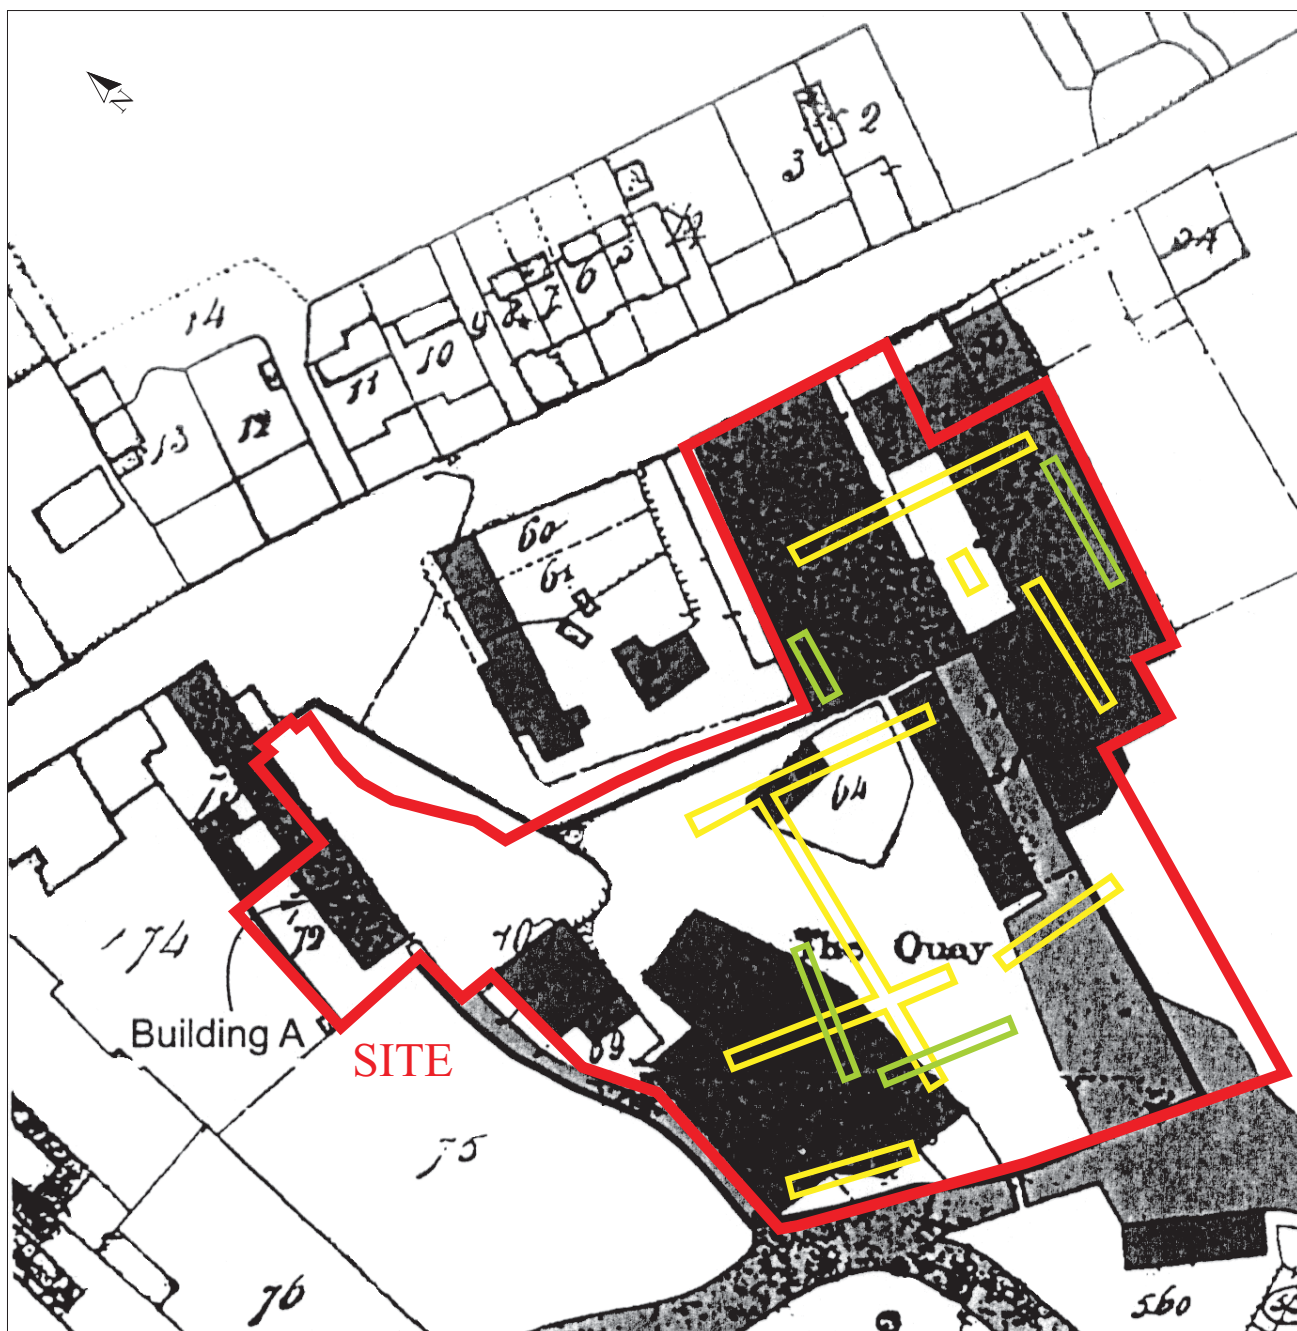
Archaeological Solutions Ltd
Fig. 4 Tithe map, 1840
Scale unknown

5.1.2 The Quay is shown in the Tithe map of 1840 as a cut or small basin off the New Cut, with a building alongside it. Few of the buildings shown in 1840 remain, the only extant 'Quay' building is Building A. The open area across the site provided access across the New Cut to the 'second warehouse' (the foundations of which are still visible). A second minor cut / canal is shown located immediately outside the western edge of the site. This probably provided water access to the buildings in the south-west part of the site..

Foundation Trench F1005 was located in, and extended beyond, the north-western end of the trench, aligned north-east to south-west (1.88m+ x 0.66m+ x 0.33m). It was linear in plan and had a vertical south-eastern side and a flat base. F1005 cut Spread L1001. F1005 contained two fills, L1006 and L1007. First Fill L1006 comprised light pinkish white lime mortar. L1006 contained no finds. Upper Fill L1007 comprised dark brownish orange loose sand, gravel and rubble. L1007 contained no finds. F1005 does not correspond with any walls depicted on the historic maps (Figs. 4-7), and therefore may have been an internal wall.

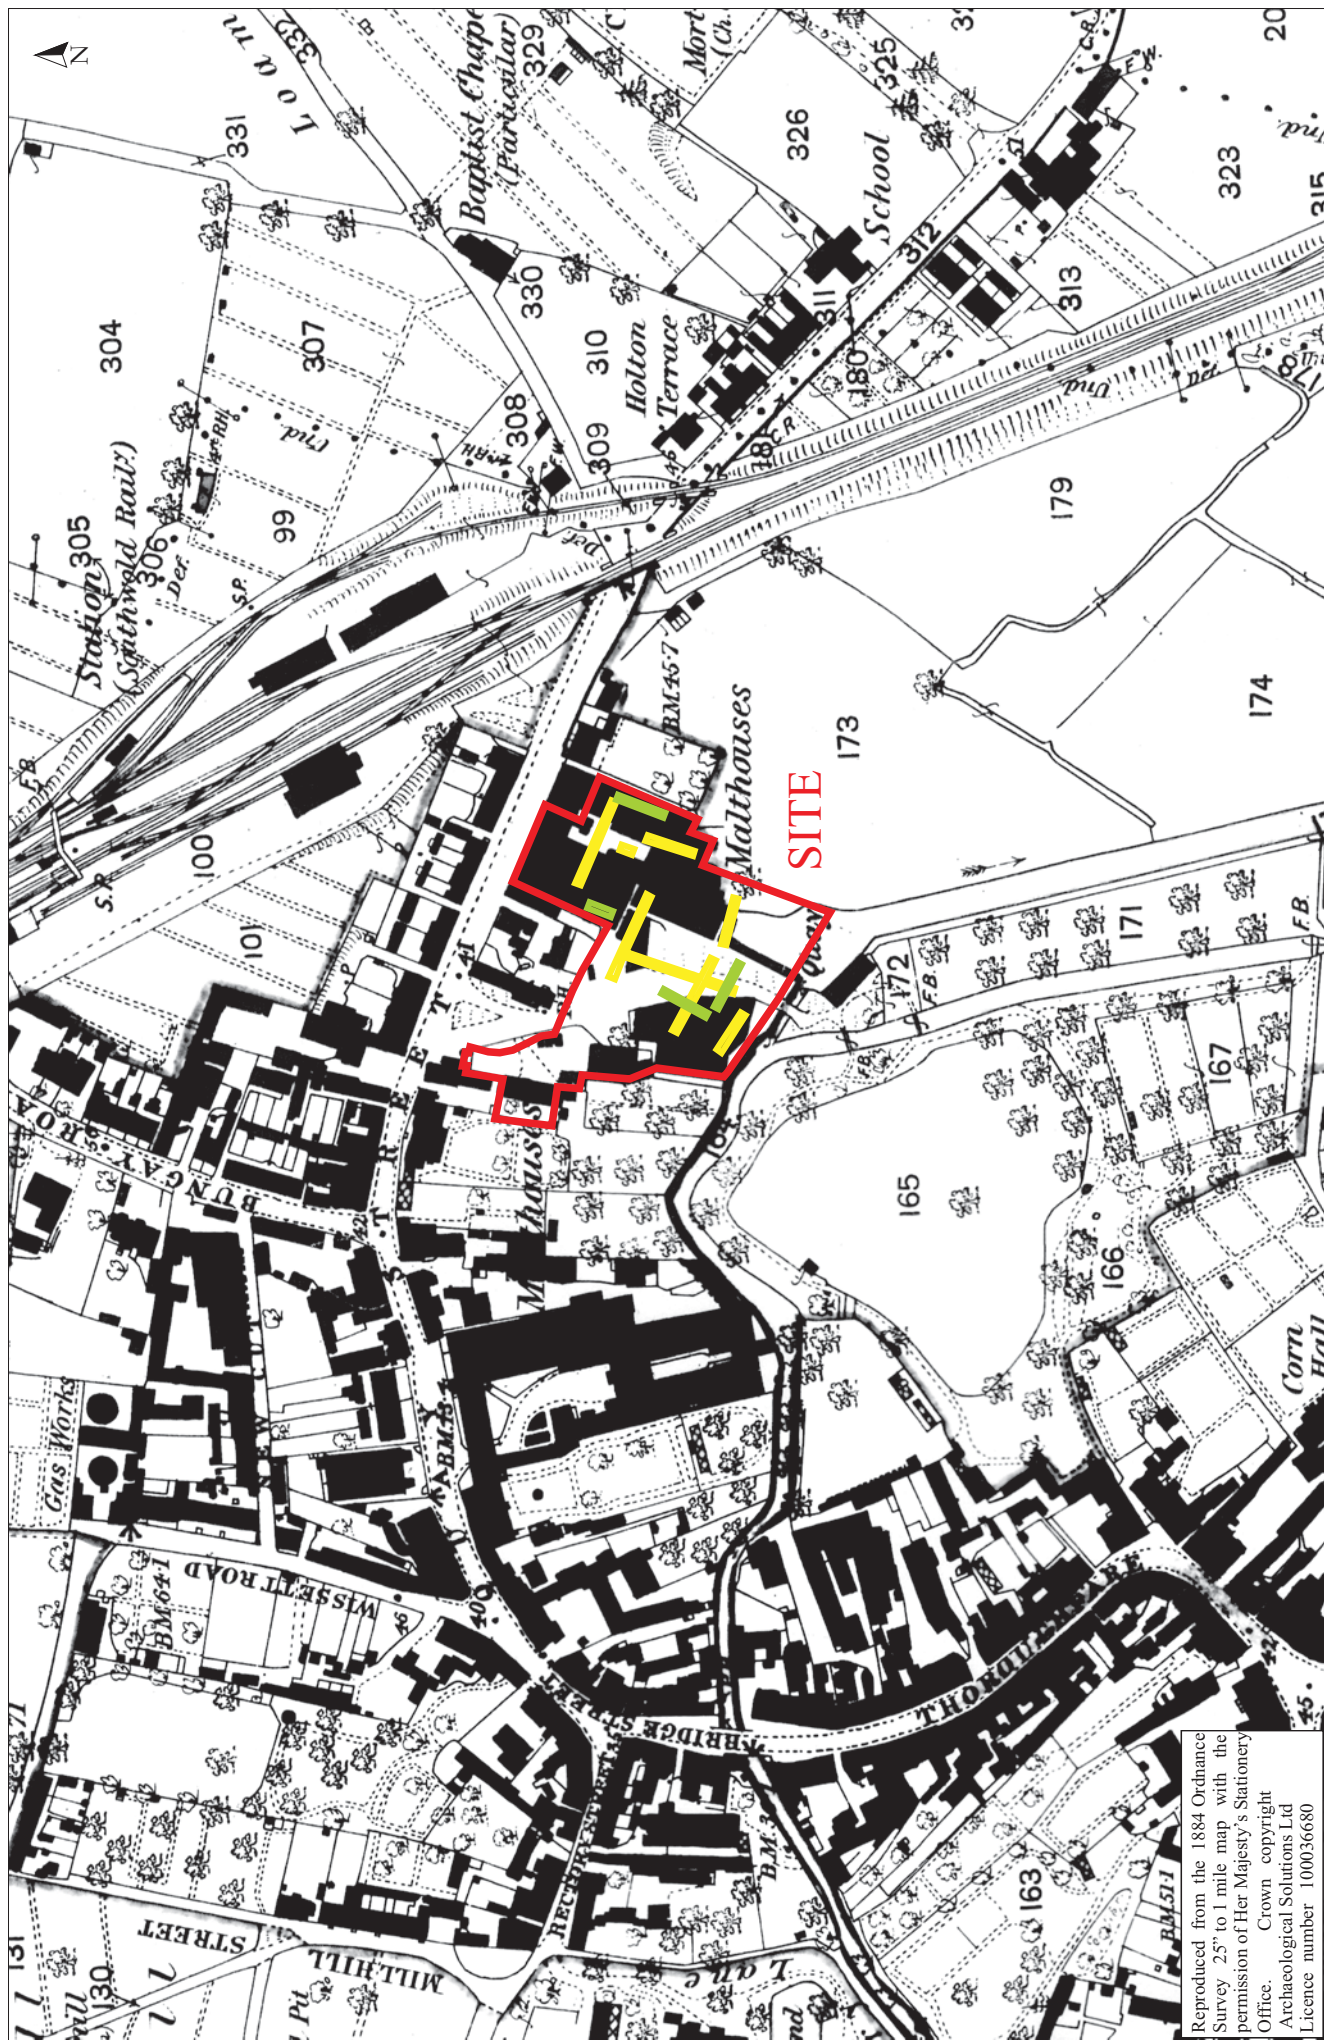
Fig. 5 1st edition OS map, 1884

5.1.4 The OS map of 1884 shows the site at a time when water transport had been superseded by the railway. Comparison of the first edition OS map of 1884 with the earlier Tithe map of 1840 shows little change in the mid- to late-19th century. The adjacent malthouse and police station were built in 1842 and 1846, respectively; and the Wherry public house burnt down and was re-built c. 1900. A lock was located at the point at which the New Cut rejoins the main channel, elements of which survive to the south of the development site. There was very little development within the site during the period covered by these maps.
