# 5-6 HIGH STREET, WINDSOR, BERKSHIRE

# AN ARCHAEOLOGICAL EVALUATION

Authors: Zbigniew Pozorski MA (field work & report) Kate Higgs (desk-based research)		
NGR: SU 9686 7671	Report No. 3645	
District: Royal Borough of Windsor & Maidenhead	Site Code: AS 1353	
Approved: Claire Halpin MIFA	Project No. 3720	
Signed:	Date: September 2010

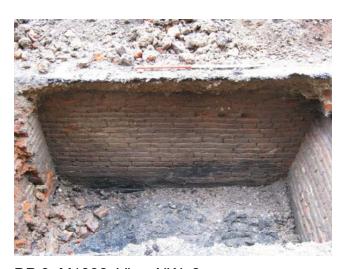
DP 9. M1006. View NW. 6

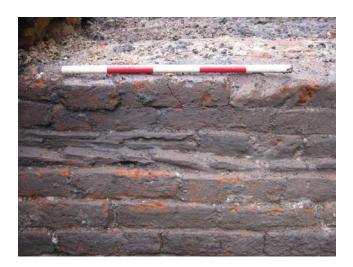
- 6.6 The north-eastern wall (M1004), unlike the other walls of the basement, was slightly inclined by approximately 0.15m with an offset marked by a single course of roof tiles (DP 8-10) which may represent damp proofing or simply a levelling course. Three further brick courses rise above before being sealed by L1001. In some places tiles have been used instead of brick.

DP 9. M1004. View NE.

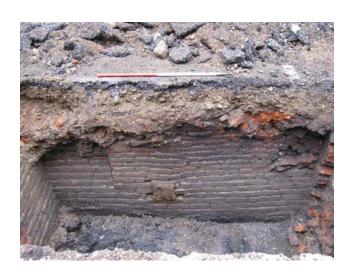
DP 11. M1007. View SE.

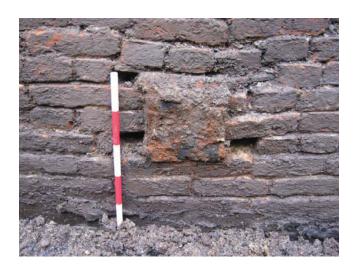
- 6.8 A square timber member (0.245m x 0.22m) has been crudely inserted into Wall M1007 at lower level resulting in some disturbance to the brickwork with some voids present (DP 13). It was located 1m to the south-west from the north-eastern corner of the basement and 1.10m below ground level. The purpose of this timber beam is not known.

DP 13. M1007. View SE.
