**THE BELL HOTEL, TICEHURST, ROTHER,
EAST SUSSEX**

**HISTORIC BUILDING AND
ARCHAEOLOGICAL MONITORING & RECORDING**

Authors:	Matthew Adams BA (Report) Tansy Collins BSc (Fieldwork & report) Adam Dyson BA (Fieldwork) Kath Henry (Graphics)	
NGR: TQ 68796 30314		Report No. 3656
District: Rother		Site Code: AS 1342
Approved: Claire Halpin MIFA		Project No. P3811
Signed:		Date: September 2010

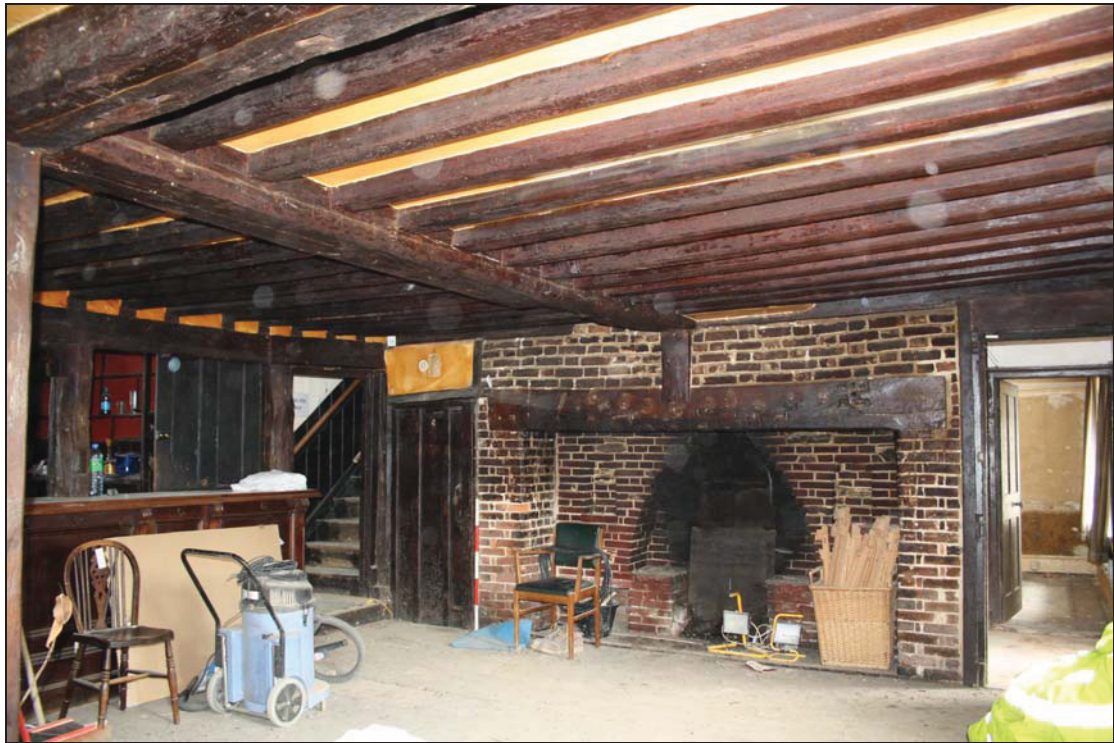
Plate 1 East side of the hall, taken from the west (09)

(Plate 1), although a small area of early fabric has been exposed within the staircase to the cellar adjoining the principal chimney stack. The flank of the later chimney stack is visible, all painted, but a portion of modern dry-lining to the east has been removed. At ground floor level, removal of an approximate 0.8m x 1.4m section of plasterboard reveals the bevelled edge of the earlier chimney stack, surviving as a fragment behind the later brick stack to the west (Plate 2). This is a thin section constructed of limestone covered with a lime mortar with a high straw content, all now covered with the white paint seen elsewhere. In addition the partition to the east dividing this area with the service area (new parlour] is partially visible behind the modern dry lining. Lath and plasterwork is visible but little else of interest. No works have been carried out in the service / new parlour area.

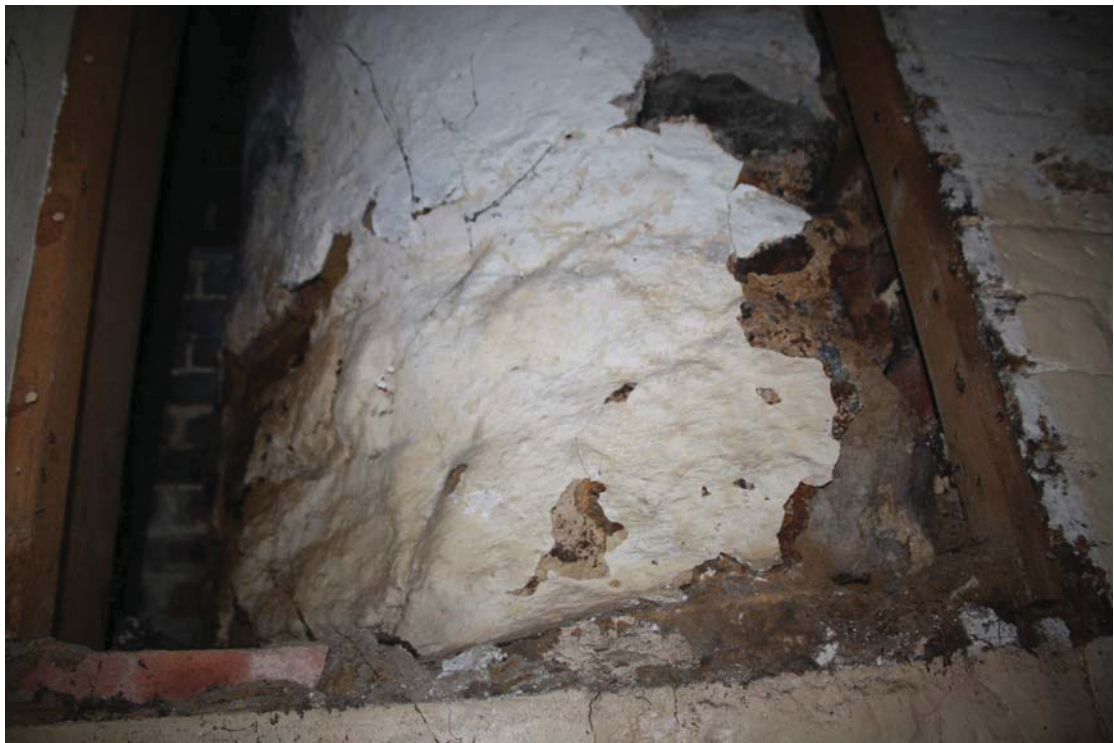
Plate 2 Detail showing the north side of the principal chimney stack, taken from the north (13)

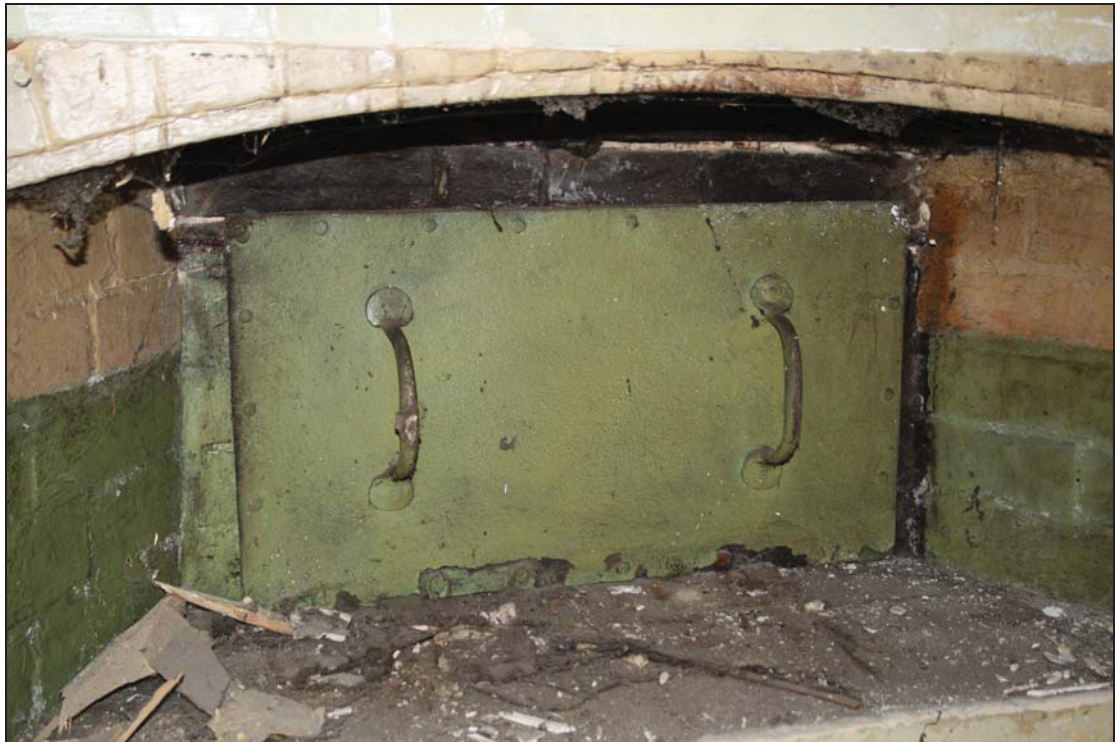
Plate 3 Door of the later inserted oven in the side of the Period B chimney stack of the rear kitchen, taken from the north-west (16)

5.3 Within the rear ranges, much of the wallpaper has been stripped and some dry-lining removed, along with an internal brick partition in the outshut on the west side of the kitchen. Removal of these later element confirms that the north-west chimney stack of the Phase B addition does house an oven, the entrance for which lies on the west flank of the stack. The aperture has a cambered arch, reinforced with a metal strip, and splayed reveals (Plate 3). The aperture contains a removable door that is probably 18th century and contemporary with the insertion of the oven. Little else in this area has been exposed.

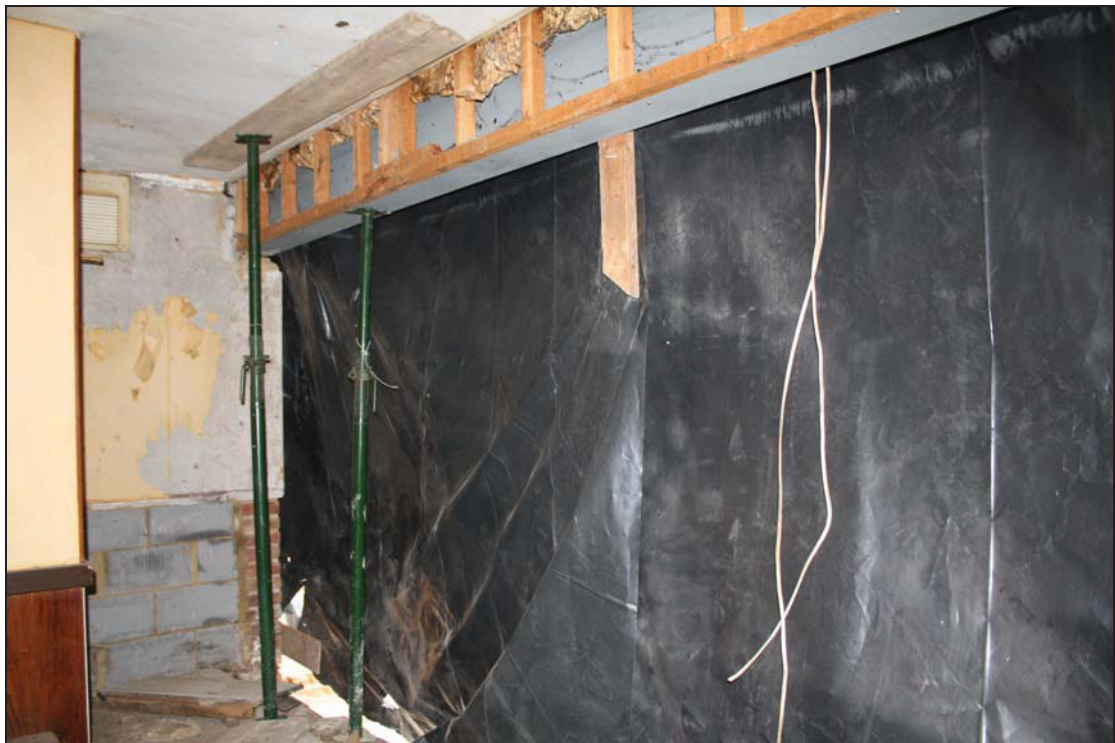
Plate 4 Detail of formerly external brickwork of the main range, taken from the south-west (5)

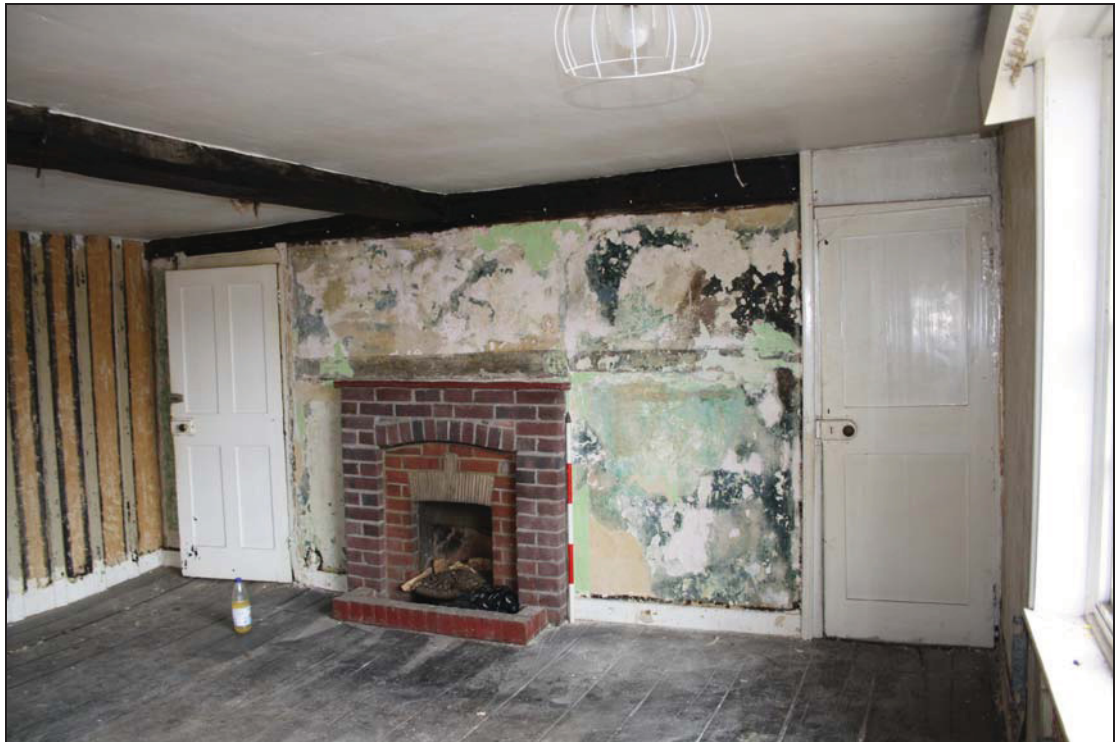
Plate 5 East wall of the hall chamber, taken from the west (17)

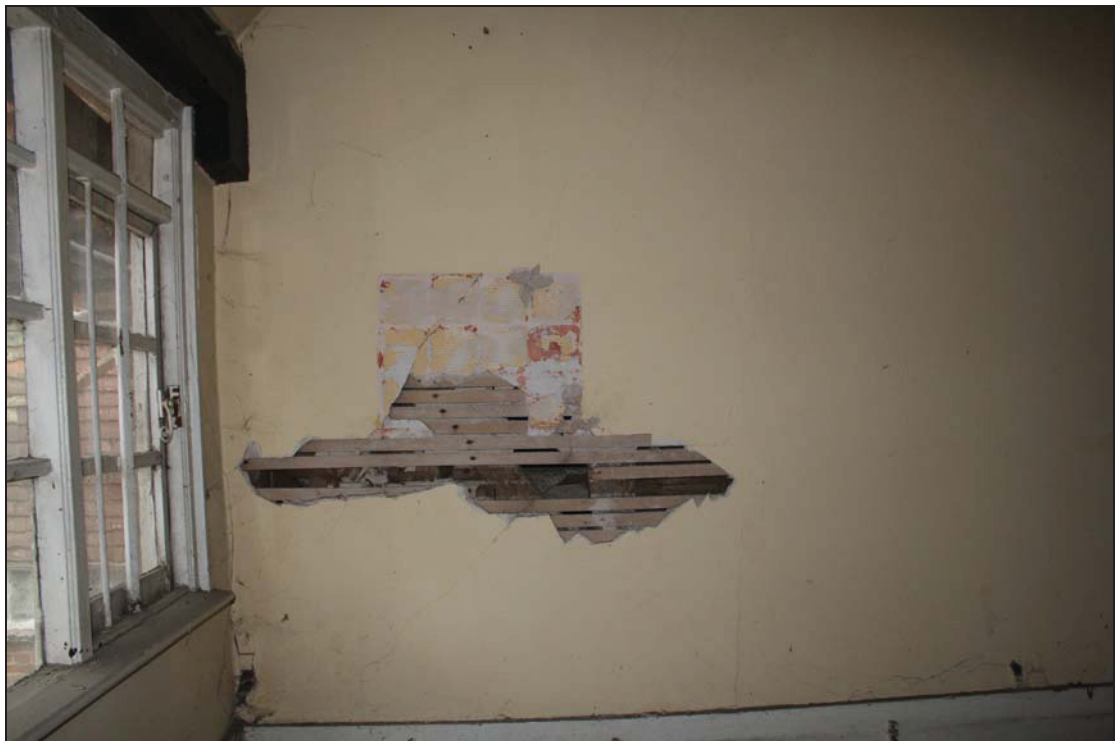
Plate 6 Section of plasterwork removed on the south wall of the second northern service chamber, taken from the north (30)

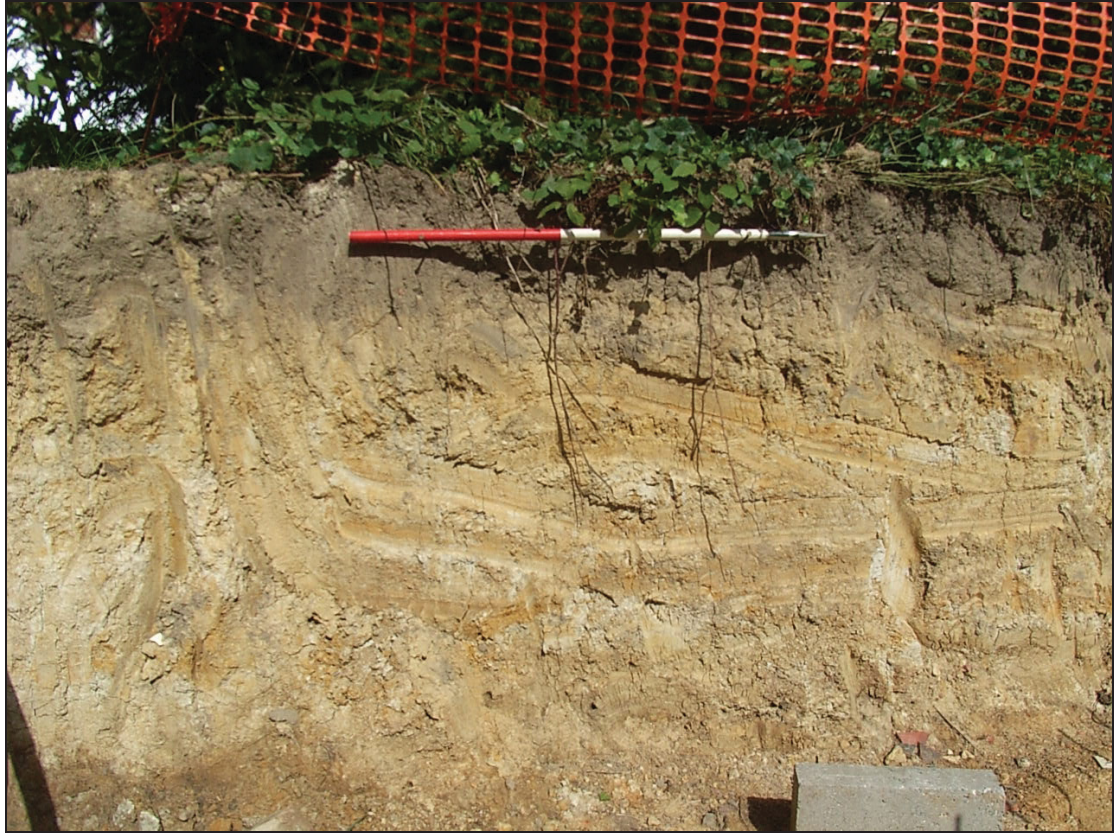
Sample Section 1 (Plate 7)	
SE Facing	
0.00m = 110.15m	
0.00 – 0.30m	L1000. Topsoil. Mid greyish brown, friable sandy silt.
0.30m+	L1001 Natural. Light orange yellow, firm silty clay.

Plate 7 Sample section 1. View north-west

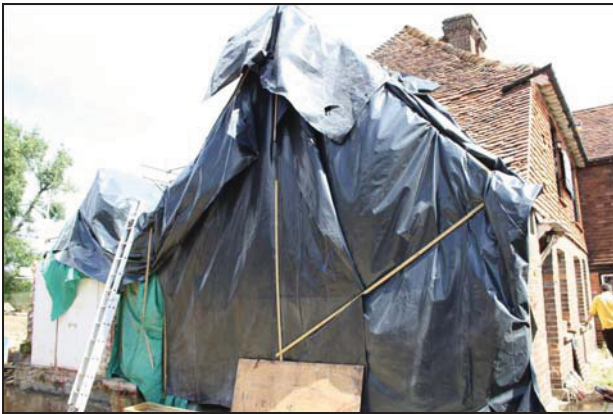
3

West façade of the main range at the point the 1930s wing has been removed, taken from the west

5.4 To the west of the hall and parlour area lies the Period E lean-to / outshut which has been affected by the removal of the 1930s wing. From the exterior little is visible as the juncture has been covered with plastic sheeting, although what is visible from the interior suggests this area was substantially reworked with the addition of the 1930s range. At lower level the wall is supported by a large I-girder in place of a mid-rail (Plate 4) and a post in the north-west corner is a reused timber, which has also been artificially distressed. On the east the formerly external wall of the original range is partially preserved, as seen in the earlier recording. No studwork survives at lower level although the mid-rail preserves mortices and peg-holes for the lost studs. The feet of the upper studs are visible above the mid-rail. On the south side, a section of the wall has been rebuilt in blockwork.

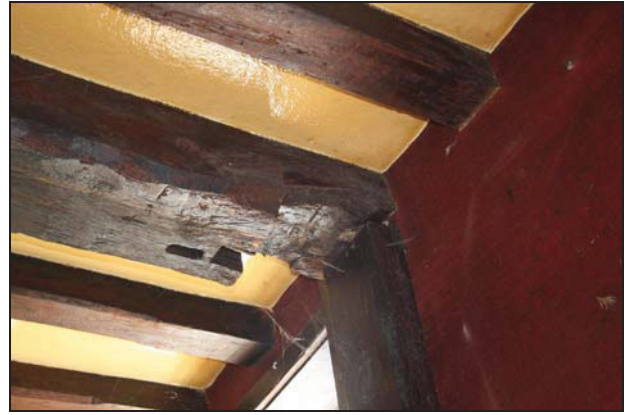
8

Binding joist on the south side of the hall showing evidence for the original jetty, taken from the north-west

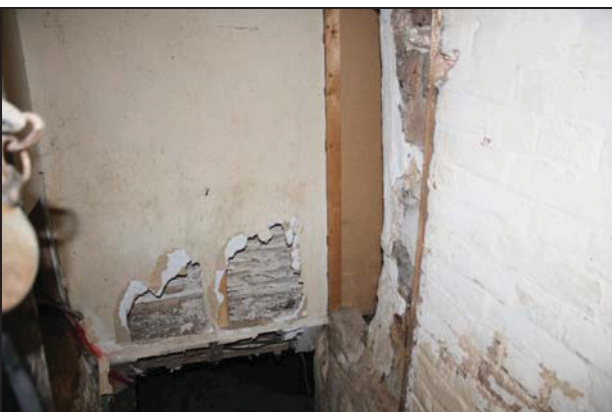
11

Detail on north side of the principal chimney stack showing lath and plasterwork behind modern lining, taken from the west

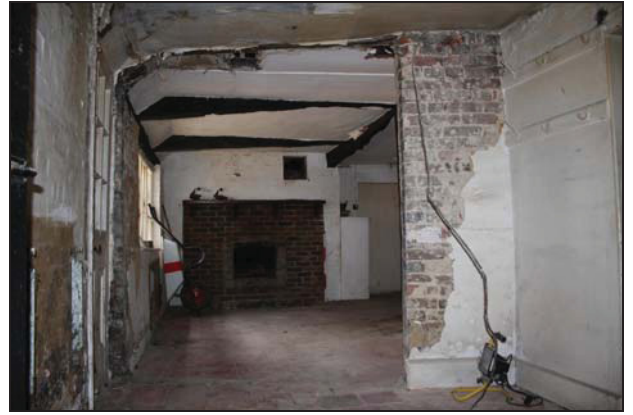
14

View of the rear wing, ground floor, after removal of a dividing partition, taken from the south

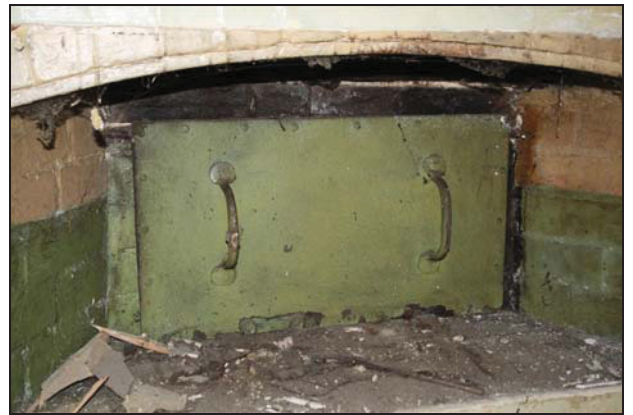
16

Door of the later inserted oven in the side of the Period B chimney stack of the rear kitchen, taken from the north-west

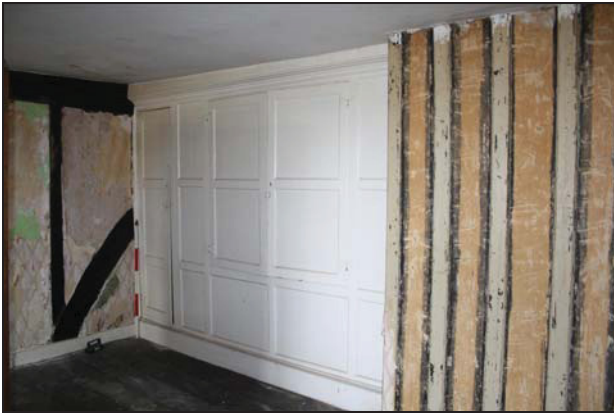
19

Probable mid-18th century panelling on the north side of the hall chamber, taken from the south

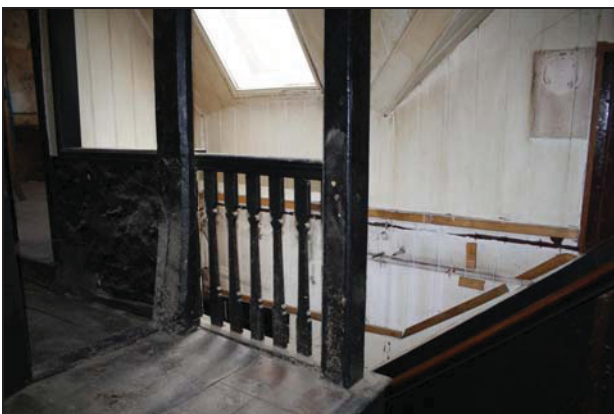
23

Section of mid-18th century balustrade of principal staircase, taken from the south-west

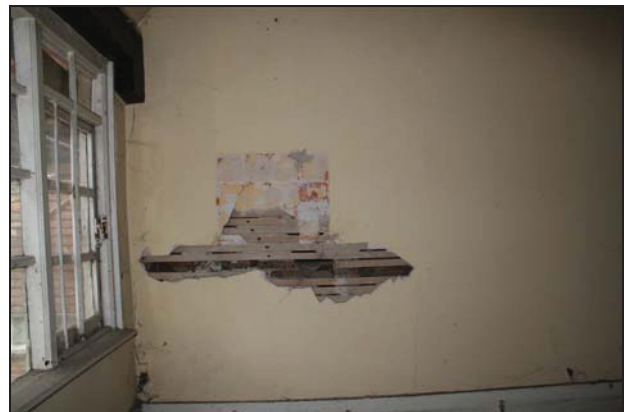
29
The second northern service chamber, taken from the south-east

30
Section of plasterwork removed on the south wall of the second northern service chamber, taken from the north

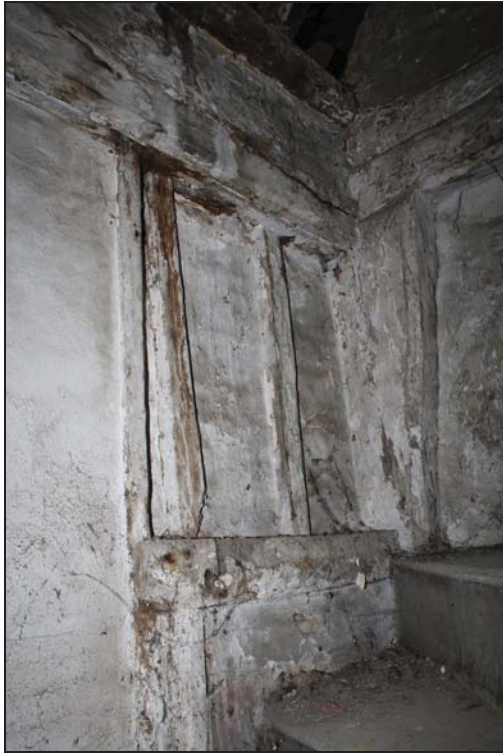
33

Detail of former window on the north wall of the old parlour chamber, now enclosed by the staircase, taken from the south-west

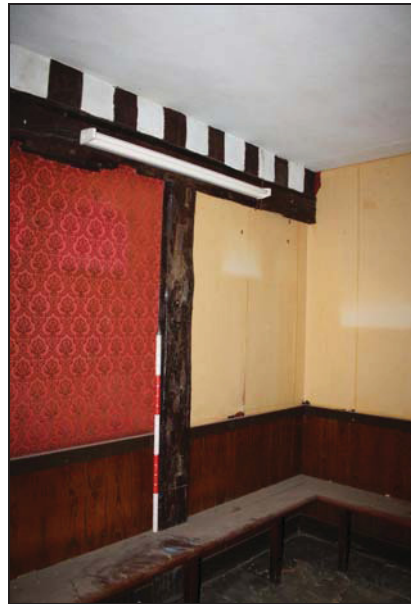
38
Formerly external wall of the main range parlour showing partially surviving timber-frame, taken from the north-west

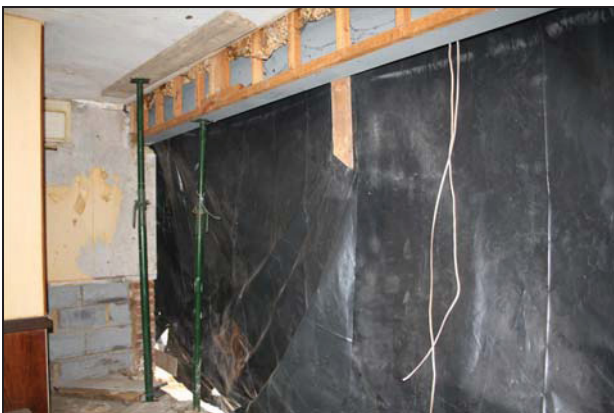
39
West wall of the Period E lean-to/outshut after the removal of the 1930s wing, taken from the north-east

10.2 The removal of the 1930s wing revealed that most of the end wall of the Period E outshut had likely been removed at this time, and the entombed pent-roof of the outshut supported by a large I-girder. There was no access to the roof space although the form of the roof and truncation at this level was observed in the earlier report.

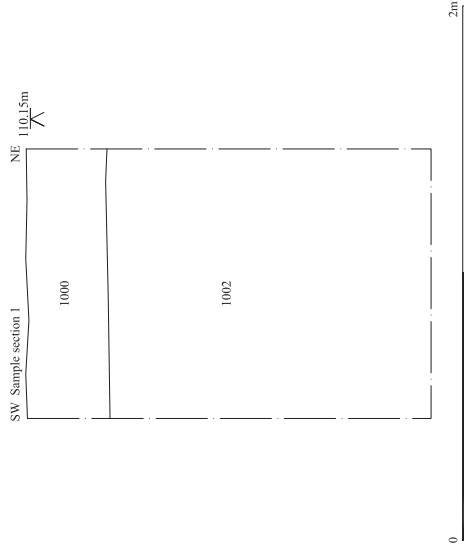
Archaeological Solutions Ltd
Fig. 6 Area of watching brief & sections
 Scale plan at 1:125 & section at 1:20 at A3

Sample Section 1 was located on the western bank of one of the foundation trenches, and is representative of the overall stratigraphy revealed (Fig. 6)
