**CHURCH OF THE HOLY CROSS,  
FELSTED, ESSEX**

**ARCHAEOLOGICAL EVALUATION**

Authors: Peter Thompson MA (Desk-based assessment) Gareth Barlow MSc (Fieldwork & report)	
NGR: TL 6765 2039	Report No: 3660
District: Uttlesford	Site Code: FLHC10
Approved: Claire Halpin	Project No: P4100
Signed:	Date: October 2010

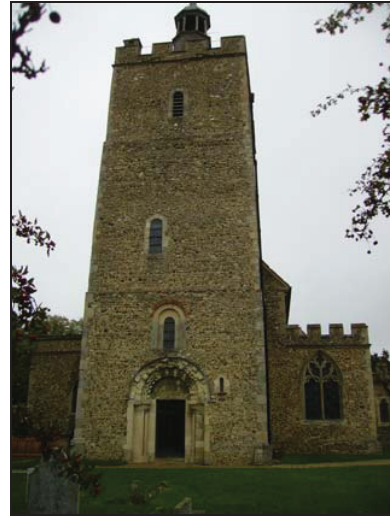
2  
*The 12<sup>th</sup> century tower. Looking east.*

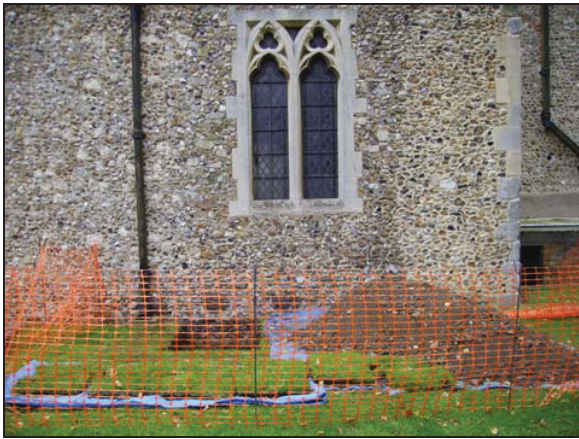
3  
*General view of Trench 1. Looking south.*

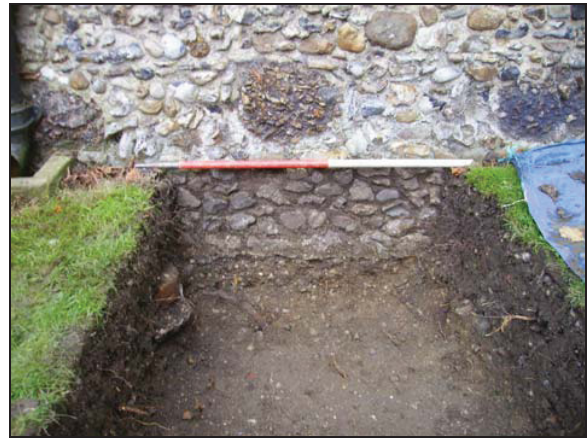
<i>Sample section: South end, east facing</i> <i>0.00 = 73.44m AOD</i>		
0.00 – 0.41m	L1000	Topsoil. Friable, dark grey brown, organic sandy silt with frequent small and medium angular and rounded flints.
0.41 – 0.75m	L1001	Subsoil. Firm, dark mid orange brown, sandy silt with frequent small and medium angular and rounded flints.

4  
*North facing section of Trench 1.*

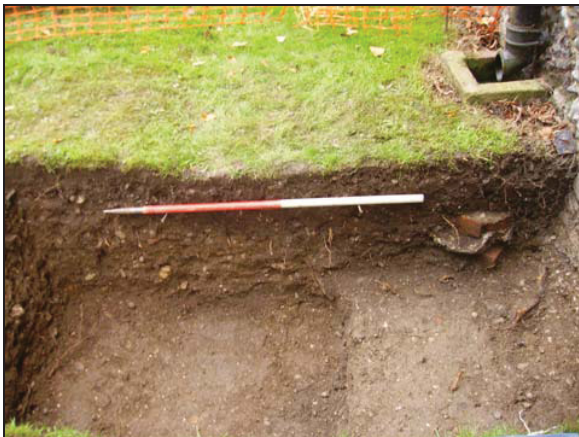
5  
*West facing section of Trench 1.*

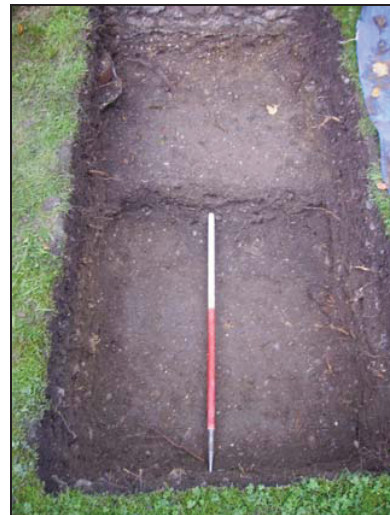
*Description:* Trench 1 contained an undated grave cut (F1005) and the base of the northern aisle exterior wall (M1002).

M1002 was the base of the north wall of the early 14<sup>th</sup> century north aisle of the church. It was present to a depth of 0.40m below ground and was built of undressed flint nodules (0.19 x 0.08m – 0.40 x 0.40m) and occasional rounded sandstone (0.16 x 0.05m) and chalk blocks (0.18 x 0.08m) randomly arranged in a matrix of pale orange brown mortar. There was no construction cut apparent as the two layers of earth against the wall were modern. The wall was built on L1004, a firm, mid orange brown sandy silt with frequent small and medium rounded and angular flints. L1004 was the natural, and it was truncated c.0.22m out from the wall.

6  
*Trench 1 post excavation. Looking south.*

9.2 The base of Wall M1002 of the church northern aisle was revealed. It was built directly onto the natural (L1004) at a depth of only 0.40m. There was no evidence of the use of larger building materials or increased wall thickness to help support the weight of the wall, neither was there any evidence of subsidence.

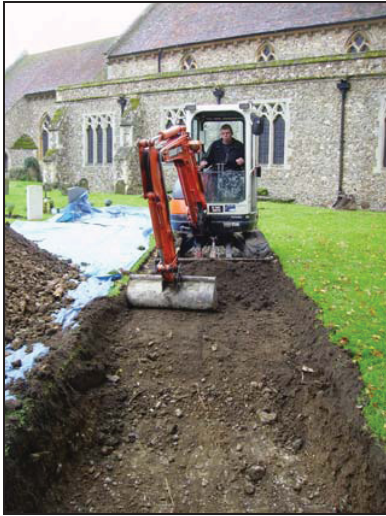
7  
Excavating Trench 2. Looking southeast.

*Description:* Trench 2 contained nine grave cuts (F1008, F1010, F1012, F1014, F1016, F1018, F1020, F1022, and F1024) and an *in situ* modern headstone (M1007) that had been broken off below ground surface level.

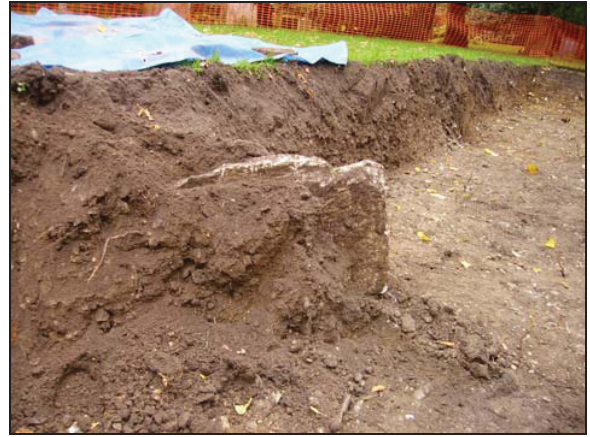
M1007 was a modern grave headstone located upright and, therefore, probably *in situ*, at the western end of Grave F1022. It had been placed just outside the western end of the cut and was directly above the far eastern end of Grave F1024. It was made from a very pale creamy brown limestone slab (0.6 x 0.47 x 0.10m). It had been broken off at a level below the current ground surface, and some of the fragments were lying adjacent to its top edge. The west facing side had a flat smooth finish whilst the east facing side was left rough with the chisel marks still apparent on the lower 0.40m. Above this, just below the line of the break, the thickness had been reduced, on the east facing side only, from 0.10m to 0.06m and the finish on this reduced side was also smooth. The fragments found were also smooth finished on both sides. No inscriptions were present.

8  
Headstone M1007 pre excavation. Trench 2. Looking west.

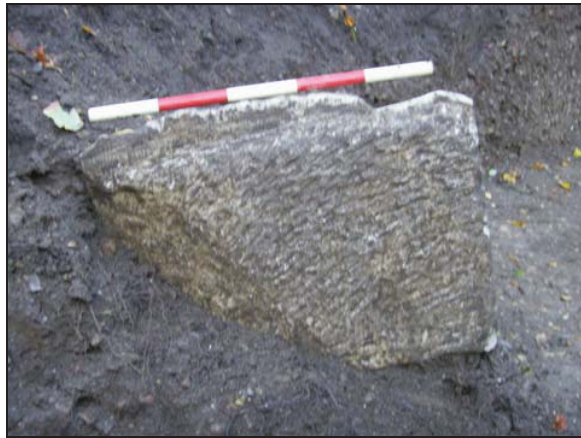
9  
Headstone M1007 post excavation. Trench 2. Looking west.

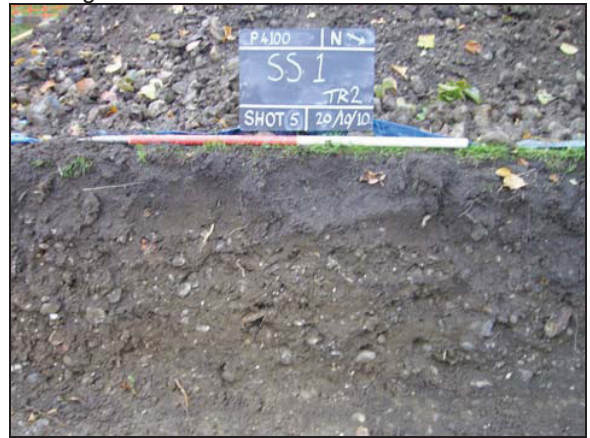
<i>Sample section: Southeast end, northeast facing.</i> <i>0.00 = 73.54m AOD</i>		
0.00 – 0.22m	L1000	Topsoil. As Trench 1
0.22 – 0.66m	L1001	Subsoil. As Trench 1
0.66 – 0.72m+	L1027	Disturbed ground. Friable, dark mid grey brown sandy silt with frequent small and medium angular and rounded flints.

10  
Sample section 1. Trench 2. Southeast end, northeast facing.

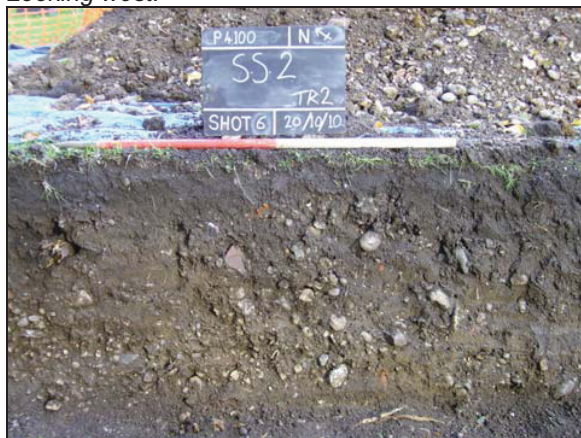
<i>Sample section: Northwest end, southwest facing.</i> <i>0.00 = 73.23m AOD</i>		
0.00 – 0.17m	L1000	Topsoil. As Trench 1
0.17 – 0.48m	L1001	Subsoil. As Trench 1
0.48 – 0.70m+	L1027	Disturbed ground. As above.

11  
Sample section 2. Trench 2. Northwest end, southwest facing

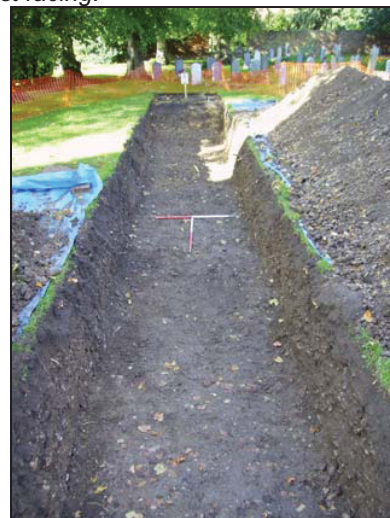
Nine grave cuts were revealed within the trench (tabulated below). As they were visible within Layer L1027 that contained post-medieval/modern CBM they are of relatively modern date. Grave F1022 with its *in situ* headstone is modern. As Grave F1014 cuts Graves F1012 and F1016 it post dates them, but more than this cannot be determined.

12  
Trench 2 post excavation. Looking northwest.
