**203-209 MERTON ROAD,
WANDSWORTH, SW18**

HISTORICAL BUILDING RECORDING

Authors: Hannah Tweedie MPhil (Report) Lisa Smith BA (Fieldwork and Report) Kathren Henry (Fieldwork)	
NGR: TQ 25216 73830	Report No: 3695
District: London	Site Code: MEJ10
Approved: Claire Halpin	Project No:4144
Signed:	Date: November 2010

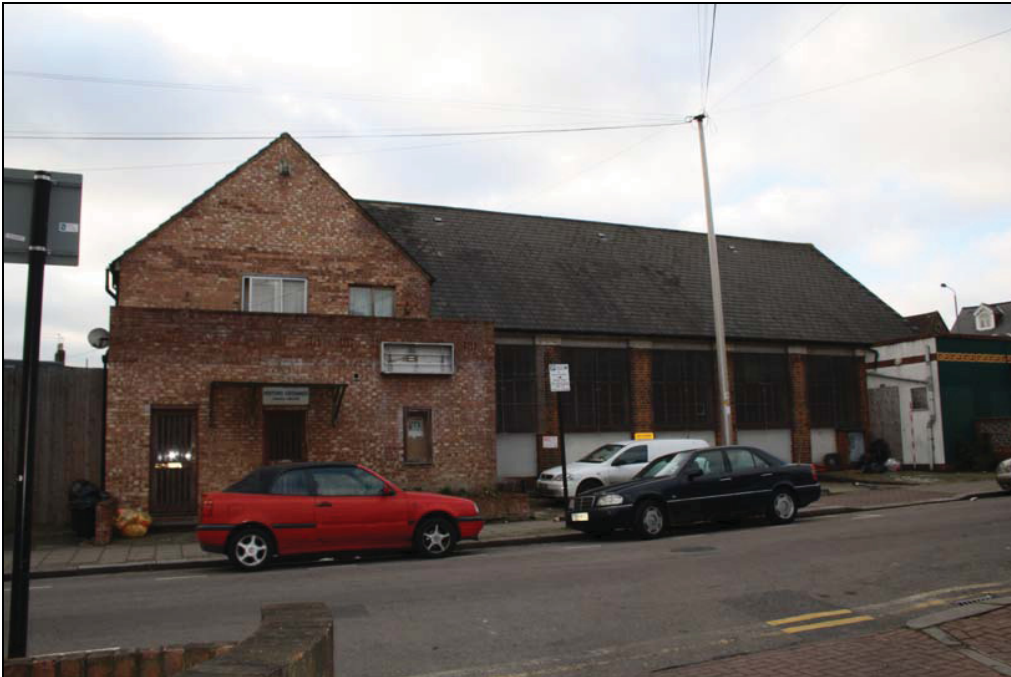
Plate 1 Yawara centre, taken from the north (DP 3)

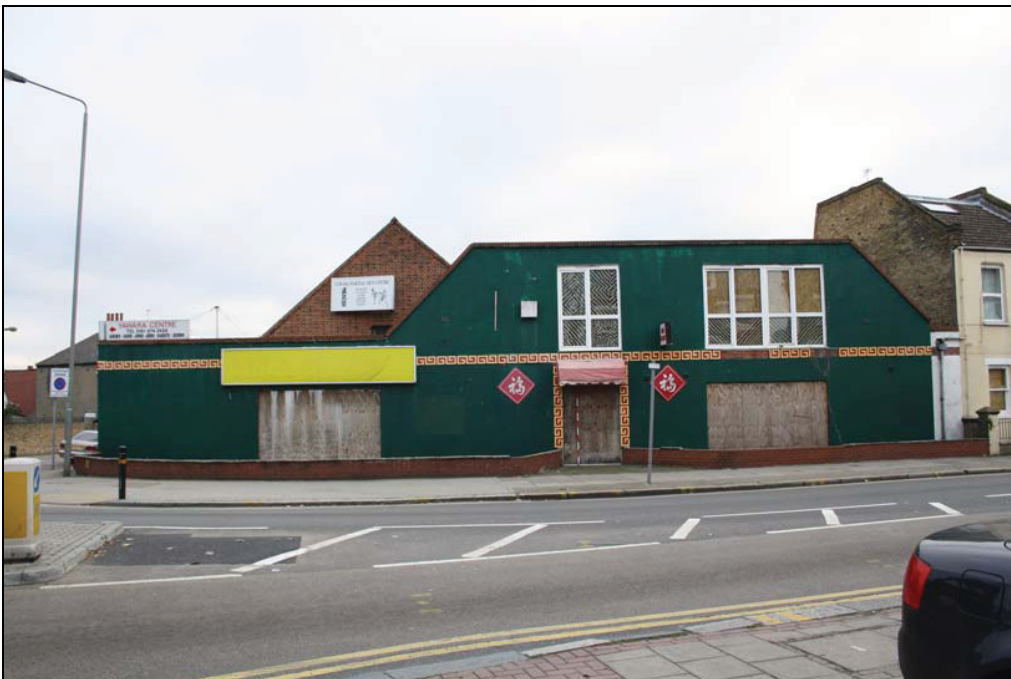
Plate 2 Yawara centre, taken from the west (DP 4)

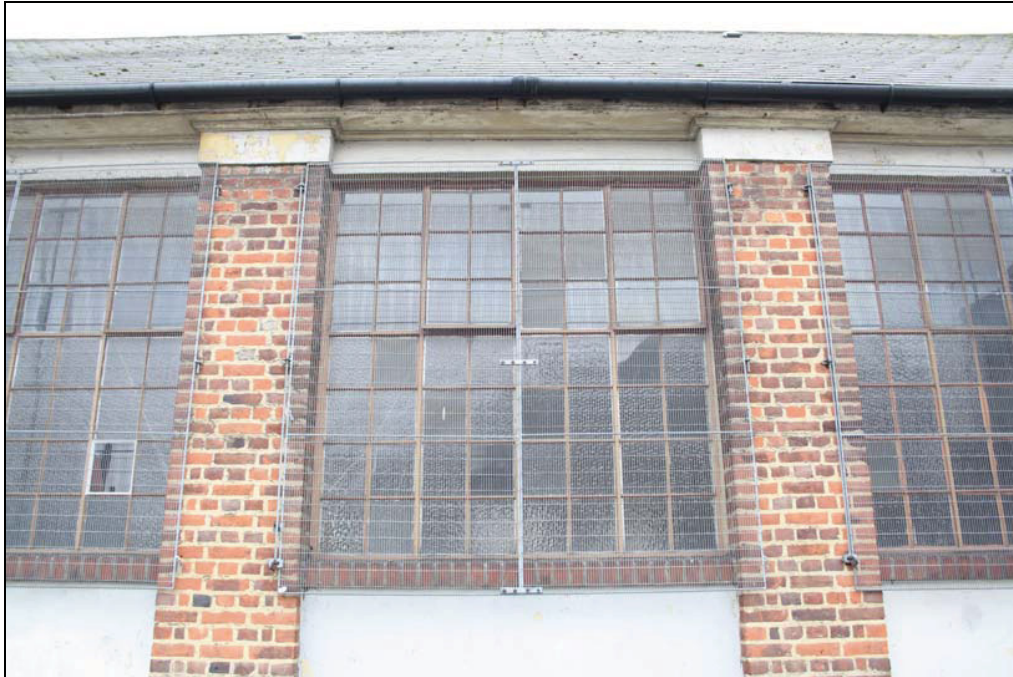
6.4 The northern elevation and western gable end of the main hall are still visible beneath a pitched roof covered in slate tiles. The walls are brick built (8" x 4" x 2³/₄") laid in English bond formed of a reddish purple fabric with frequent ceramic inclusions and bonded by ³/₄" mortar joints. The northern elevation is divided by evenly spaced brick piers with large metal Crittall style casement windows in between at upper level and rendered panels below (Plate 3). Concrete lintels frame the windows above, and a row of bricks set in soldier course and of a finer fabric form a sill below. A brick plinth of six courses slightly offset from the main façade extends along the base of the elevation. Modern metal grilles have been applied to the windows.

Plate 3 Original windows, northern elevation, taken from the north (DP 29)

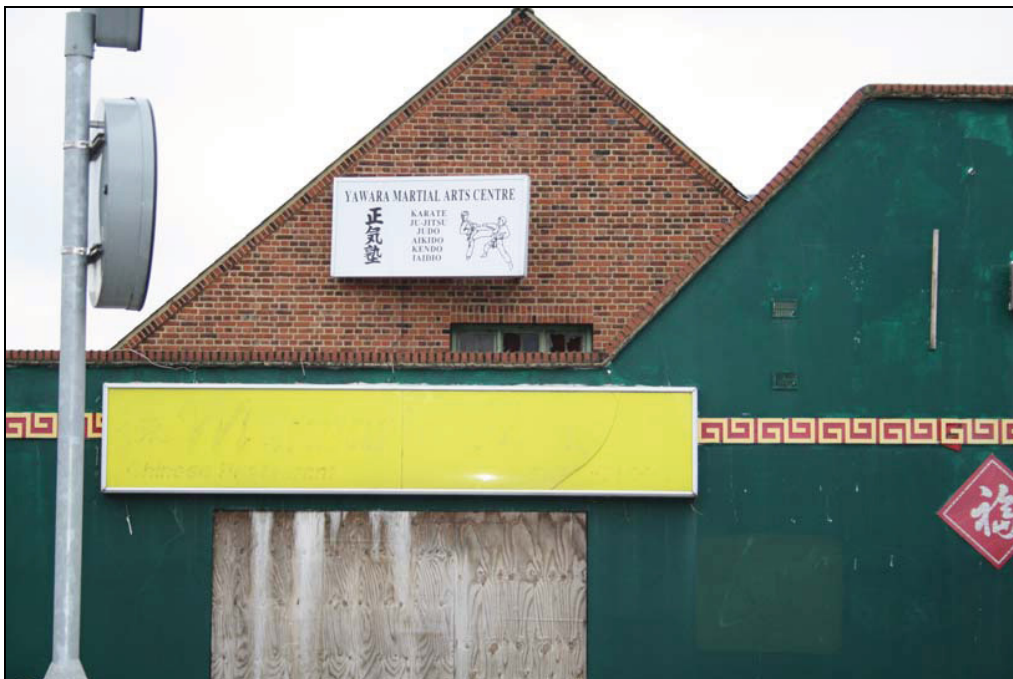
6.5 The western elevation is mostly hidden by the restaurant extension however a three light window piercing the brickwork at upper level and framed above by two courses of brickwork in soldier course is visible (Plate 4). It is in poor condition and now blocked from the inside.

Plate 4 Blocked window at upper level, west elevation, yawara centre, taken from the west (DP 28)

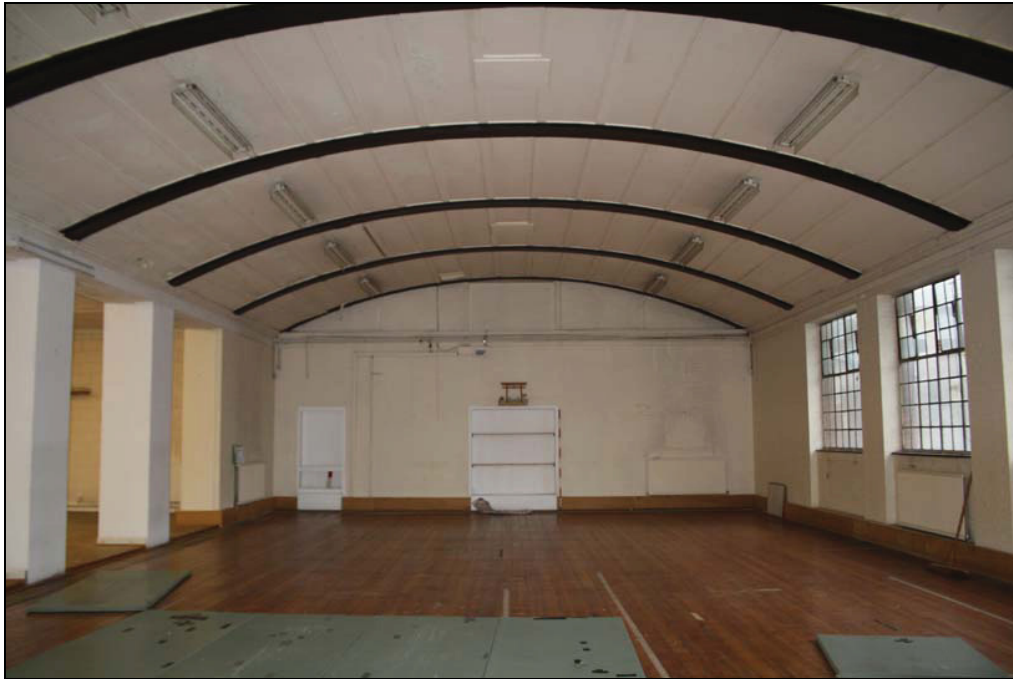
6.6 Internally the main hall retains some of its original character although the impact of the later extensions has taken its toll. The main historical core of the building comprises a plain single open space spanned by a barrel vaulted ceiling. The hall is divided into six bays represented by a series of brick piers slightly offset from the northern elevation (Plate 5). The walls are simple painted brickwork and the floor boarded, probably original, showing some signs of repair.

Plate 5 Main hall, yawara centre, taken from the east (DP 26)

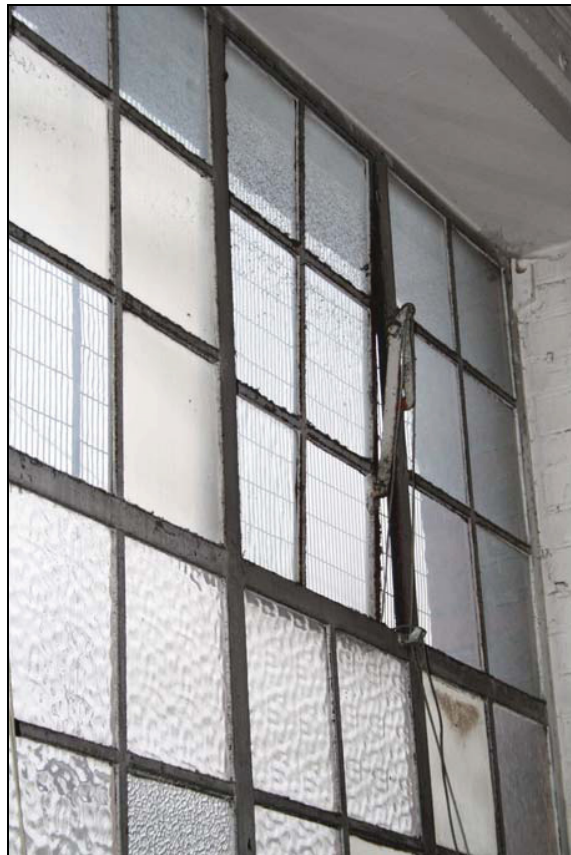
6.8 The northern elevation is pierced by five large metal casement windows as noted above. Each is comprised of eight lights divided by metal mullions and transoms, those at lower level have eight frosted panes while above each light has six panes two of the upper lights in each window are pivoting operated by

draw cords (Plate 6). Modern radiators and boxed pipework have been applied to the blank brickwork below. Where the wall meets the ceiling moulded coving extends around continuing across the western elevation.

Plate 6 Pivoting upper casement, northern elevation, taken from the south-west (DP 24)

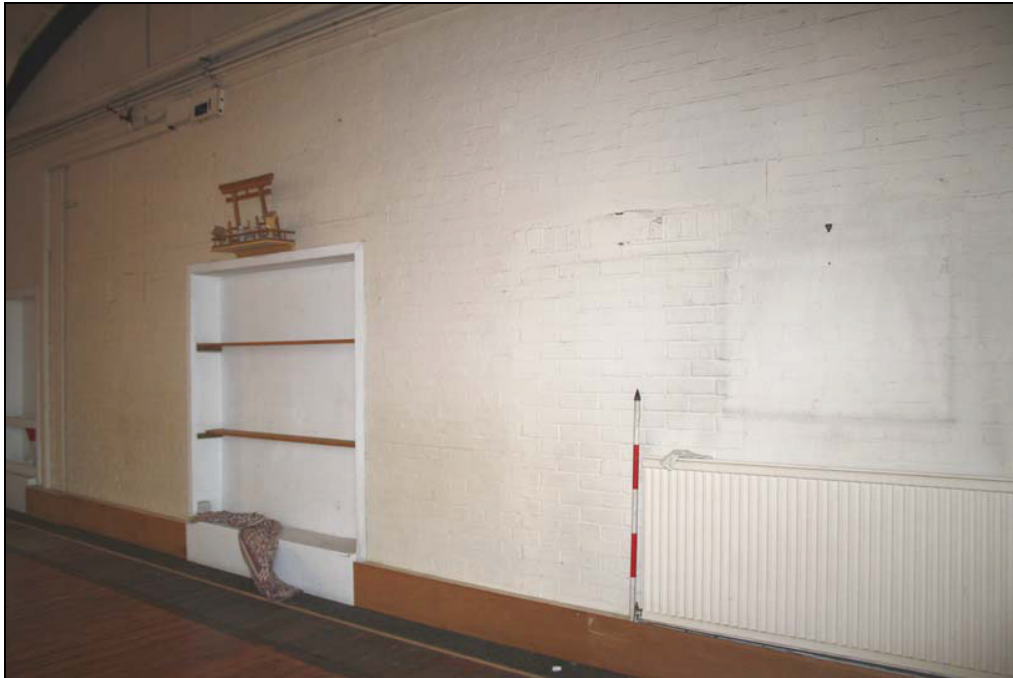
6.9 The western elevation is comprised of plain painted brickwork retaining concrete lintels for three doorways. A wide central aperture flanked by two domestic doorways would have been the main entrance to the mission church from Merton Street. The two smaller doorways are now blocked with brickwork laid in stretcher bond; the central entrance is also blocked now occupied by wooden shelving (Plate 7). Directly above, a window at ceiling level has been blocked with modern plaster board. The blocking may have occurred when the western restaurant extension was added. A tall recessed cupboard to the south may be original.

Plate 7 Blocked doorway and recessed cupboard, western elevation, taken from the north-east (DP 22)

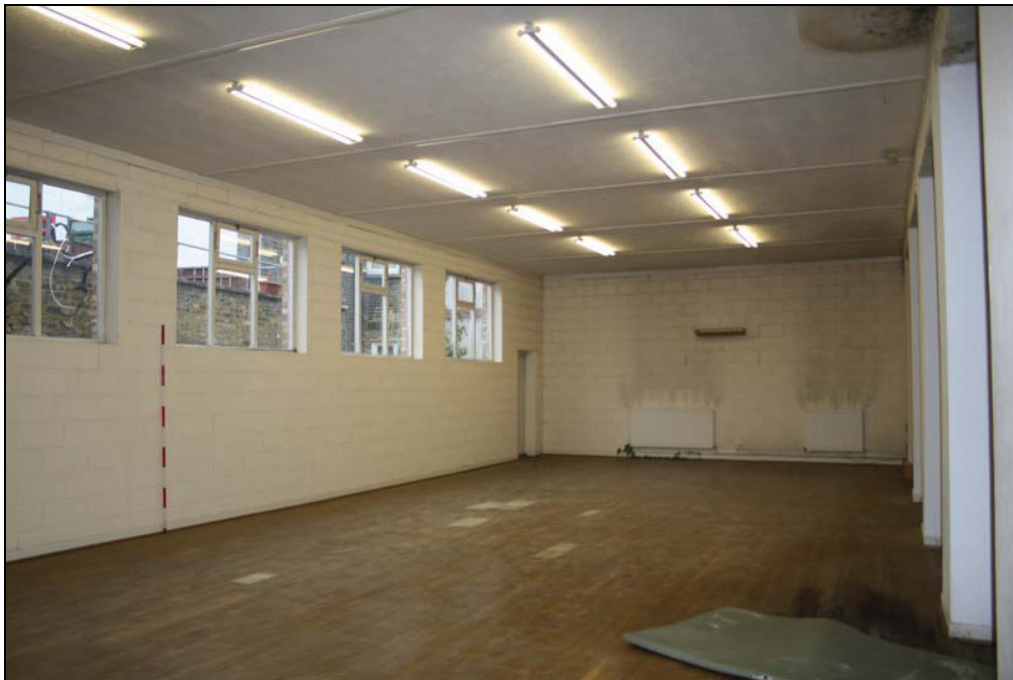
6.11 The modern hall extension to the south has a sprung boarded floor, painted block work walls with windows piercing the southern elevation at upper level (Plate 8). It is of no historic interest.

Plate 8 Modern addition to the main hall, yawara centre, taken from the north-east (DP 13)

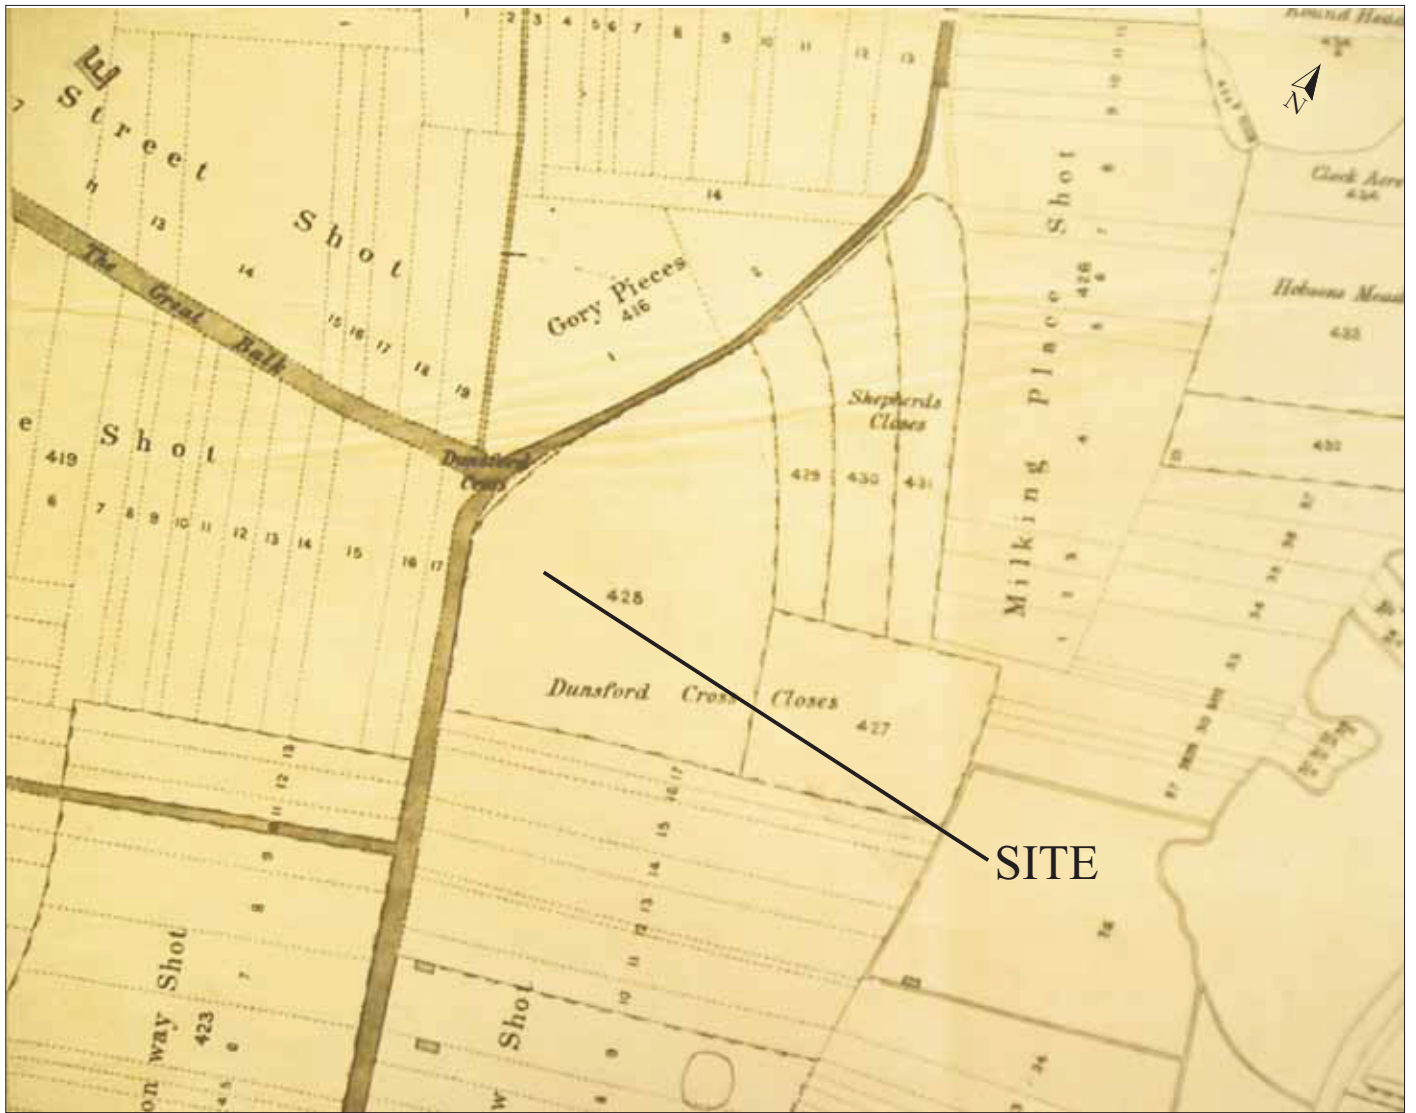
<i>Archaeological Solutions Ltd</i>
Fig. 4 Tithe map, 1847
Not to scale

The Wandsworth Tithe Map is the first map to depict the area of the site in any detail. This source shows that the modern roads of Merton road and Granville Road were already in place by this date, although the area remains undeveloped. The site lies within Dunsford Cross Closes, and the Tithe apportionment indicates that the area was owned and occupied by W Newton.

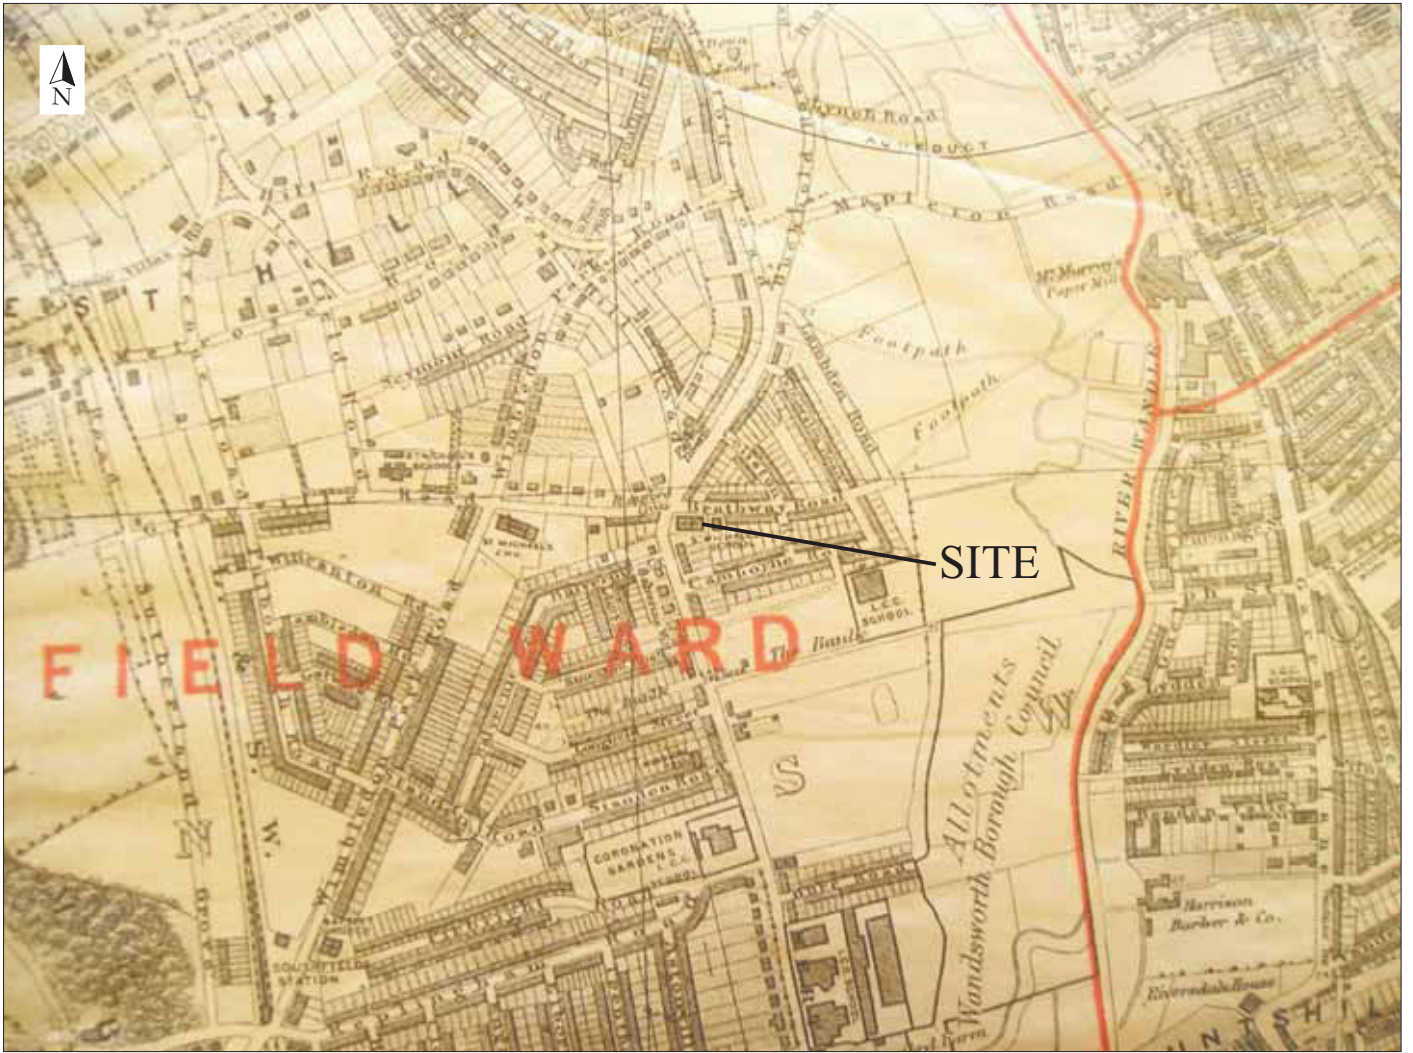
Fig. 7 Map of Wandsworth borough, 1912

The next available cartographic source dates to 1912, but as it is at a much smaller scale it is difficult to determine much further useful detail. The buildings at the site are marked as a church and as St Michael's School.

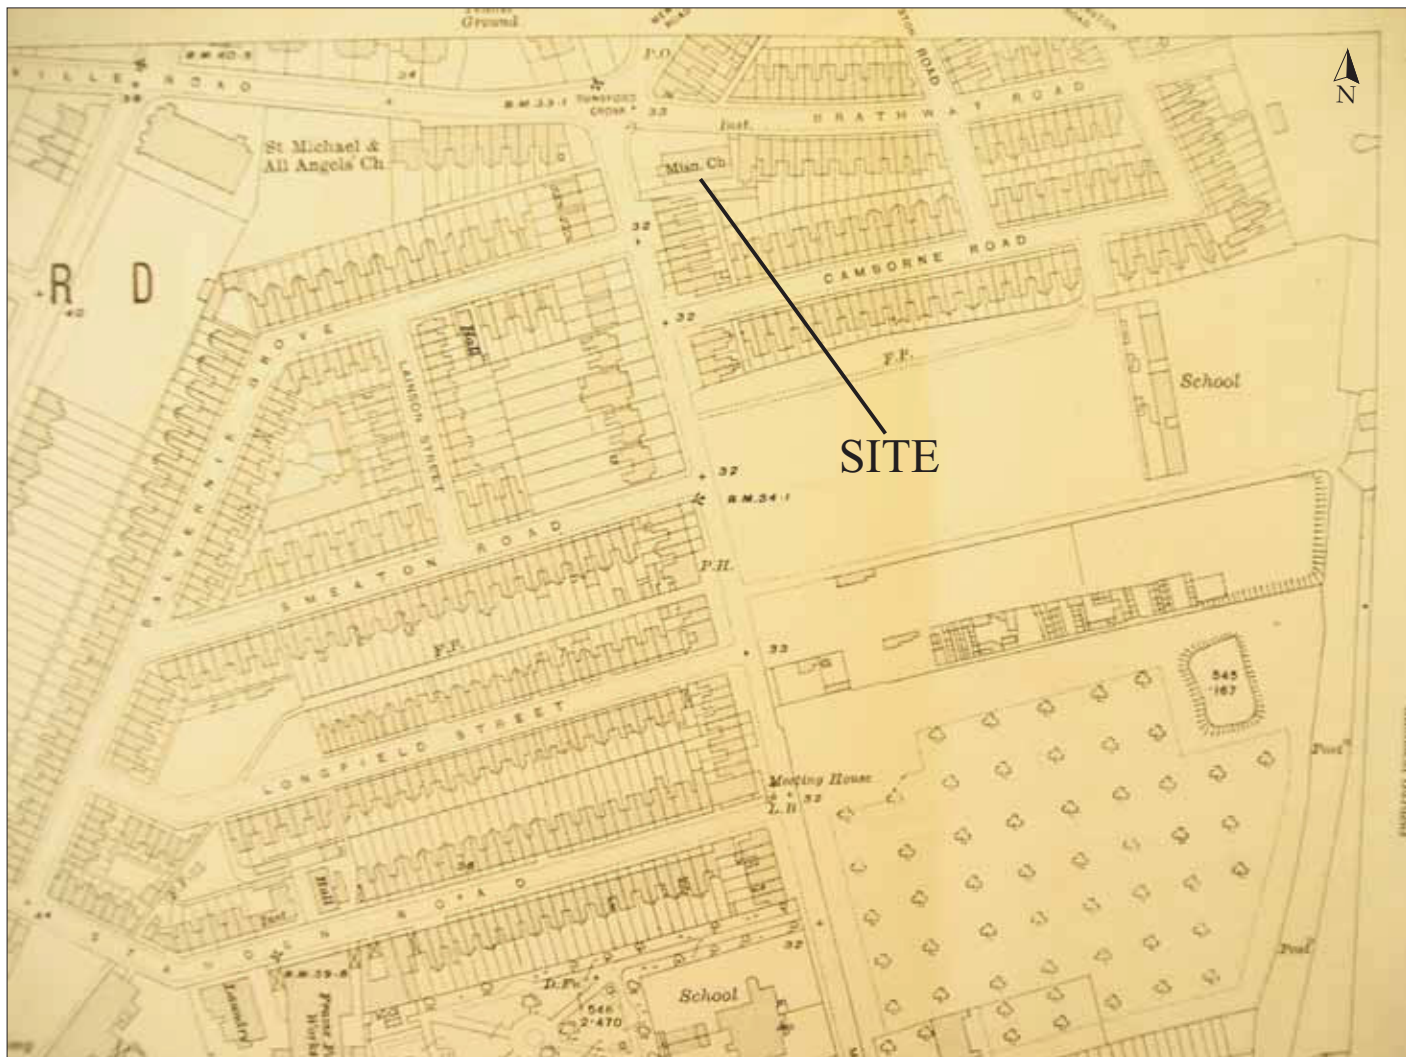
Archaeological Solutions Ltd
Fig. 8 OS map, 1916
Not to scale

The 1916 Ordnance Survey Map shows the increasing urbanisation of the area. The site itself remains unchanged with the building fronting onto Merton Road marked as a Mission Chapel and the building to the east, fronting onto Brathway Road, marked as an Institute. It is known that these buildings were later replaced by the buildings now extant at the site and currently in use as a Yawara Centre.
