**BARN AT THE HALL, HALL ROAD, LAVENHAM,
SUFFOLK**

HISTORIC BUILDING APPRAISAL

Level 2

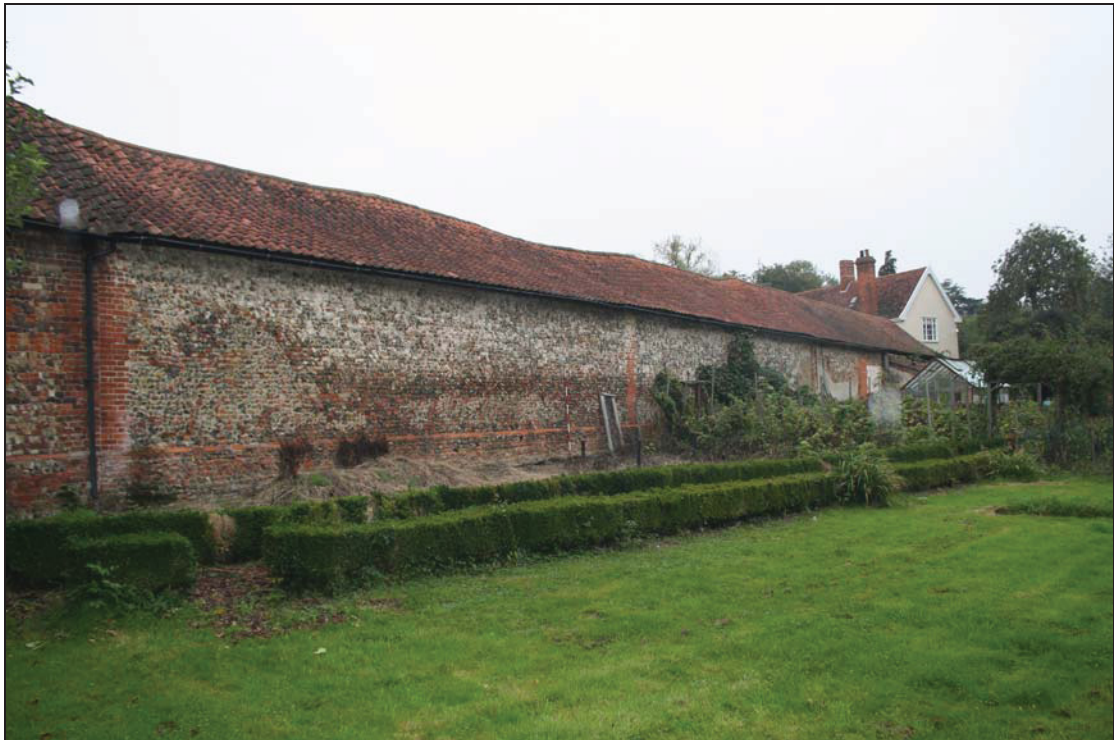
1 South-east elevation, taken from the south (14)

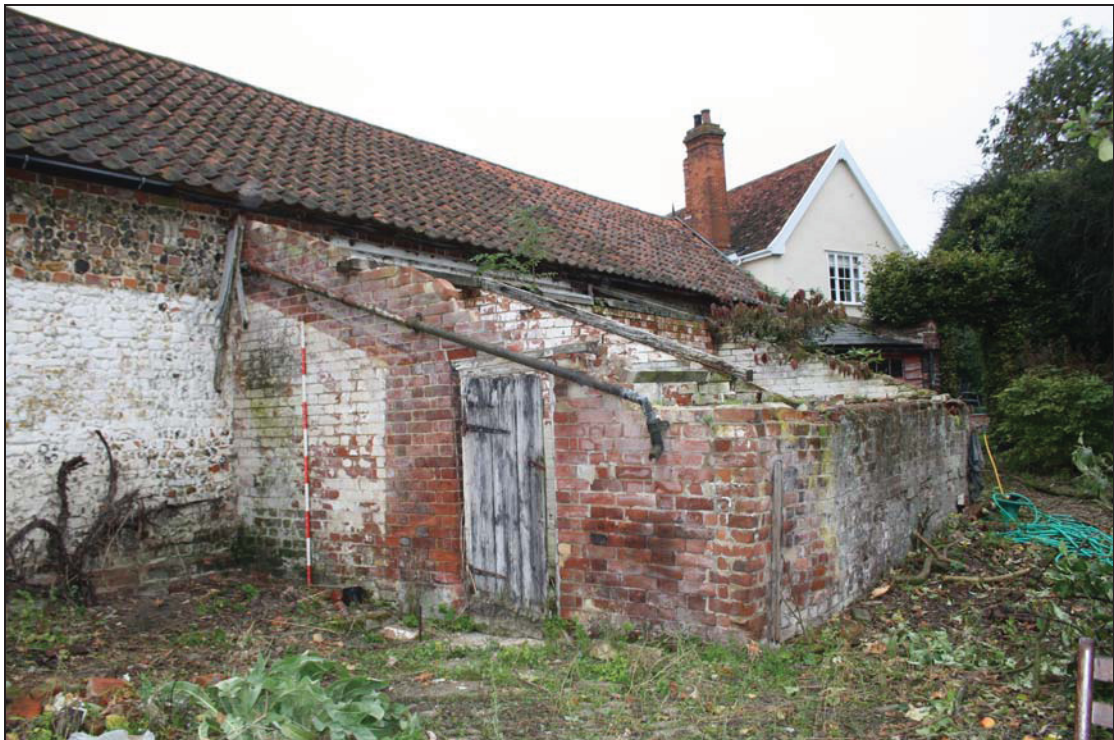
5.3 As noted, to the east the partial remains of a brick-built potting shed survive. It has no roof, and although is shown with a glass roof on early OS maps it appears to have been ruinous for some time.

2 The remains of the potting shed to the rear of the range (east end), taken from the south (12)

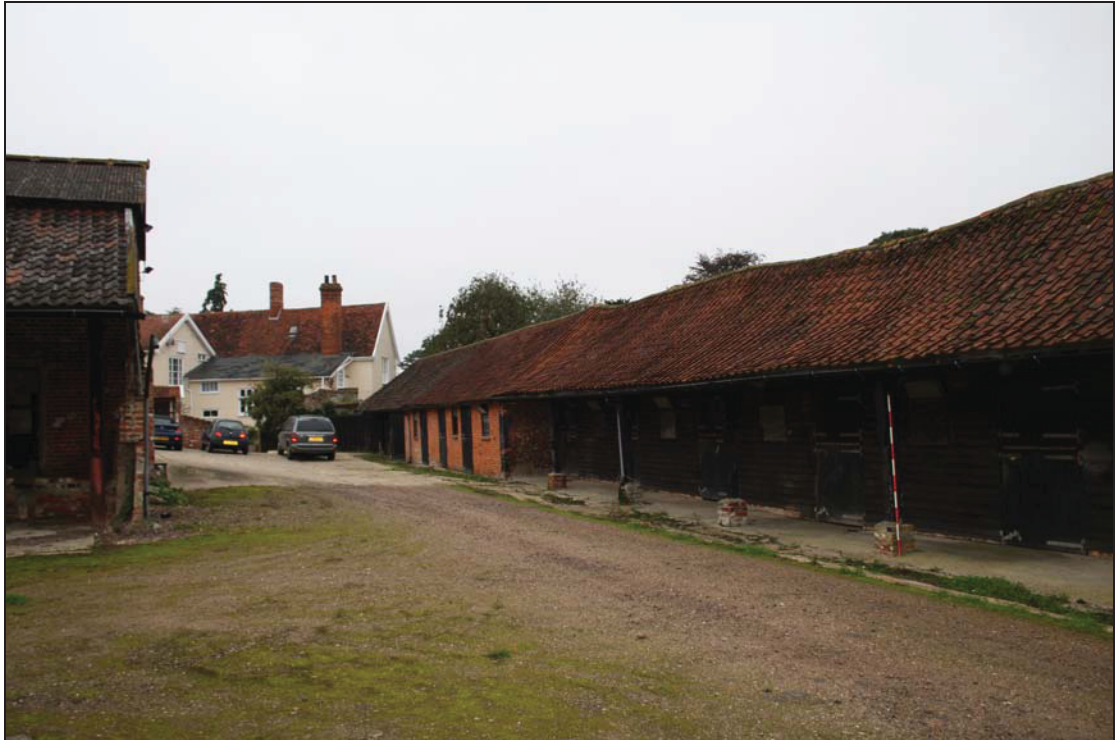
5.5 The principal elevation faces into the farm yard, with a continuous range divided into 14 bays (Plate 3). Notional enumeration begins at the western end, though bays 1 – 6 were not part of the appraisal, nor inspected internally.

3 North elevation of the assessment range showing open-fronted area, taken from the west (03)

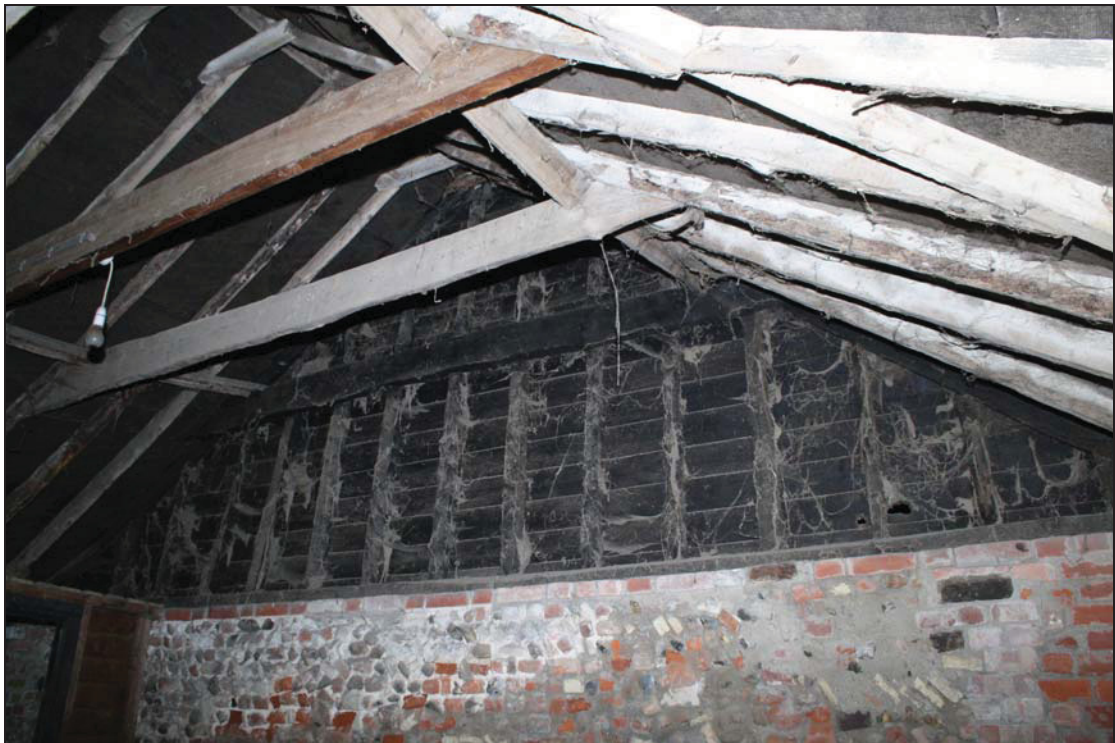
5.10 A closed partition divides the area from the adjoining bays to the east (Plate 4). Here, regular studs are nailed over the collar to the apex.

4 East wall of Bay 8 (partition between eastern and western elements), taken from the south (30)

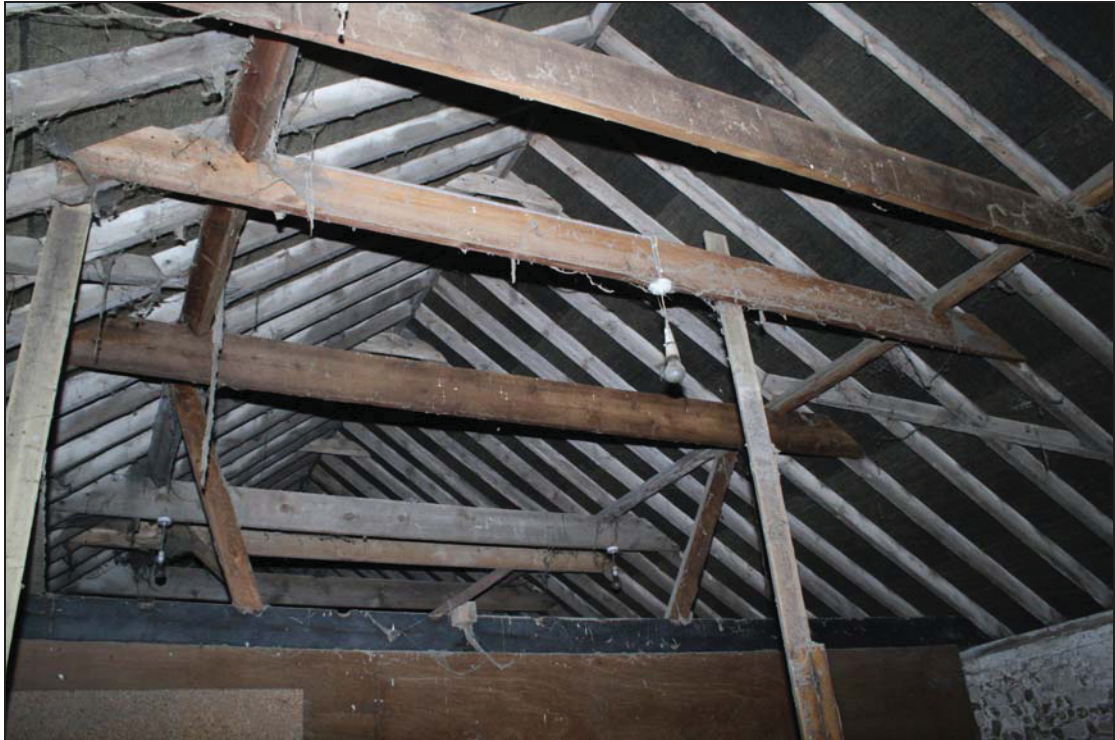
5.13 The roof has no particular structural coherence. The three western bays are similar to the adjoining area though constructed of more evenly-sawn softwood, while the yoke pieces only occur at the bay divisions (Plate 5). The east bay differs in having a proper framed truss comprising a waney hand-sawn tie-beam with raking struts pegged to principal rafters and cleats supporting a side purlin in each pitch. This is congruous with its companions to the east. An iron king-rod with an extra planked piece at the apex which engaging the ridge board also provides extra support.

5 Roof structure above Bays 10 and 9, taken from the south-west (26)

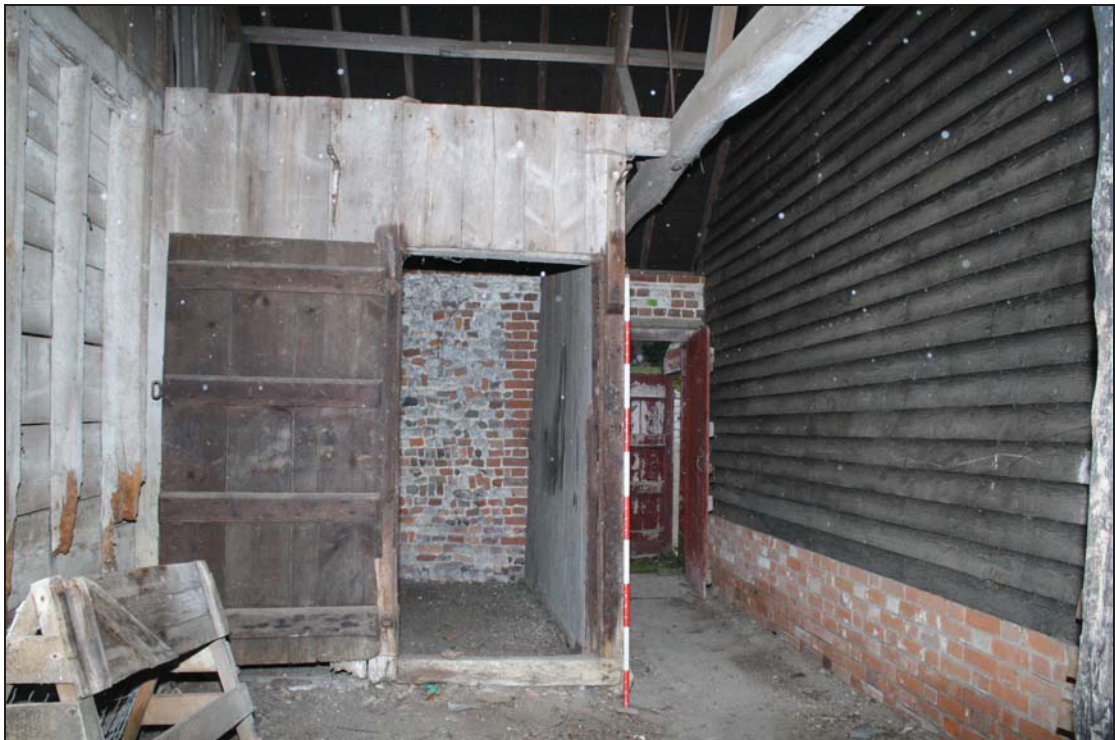
5.15 Bay 13 remains open-fronted, but a section of brickwork from the adjoining external north wall extends for a short distance and remains toothed, and so was clearly meant to continue. This side is now framed by two chunky posts; essentially roughly dressed tree-trunks, one standing on a conical stone stylobate. The partition to the final east bay is constructed of nailed studwork on a low brick wall, with horizontal oak or elm boarding below the tie-beam. To the rear the kitchen garden is given access through a bead-moulded and boarded door, ledged to the rear with hand-made catch and strap-hinges hung on pintles. The south-east corner is occupied by a framed partition which may have formed a pen for calves or a bull (Plate 6). It rises to tie-beam level and is simply constructed. A corner post is probably reused, as it has a jowled base, while wide vertical boards have been applied to the exterior of the framework, with access given through a 19th century bead-moulded boarded door, which is ledged to the rear and hung on hand made strap hinges. A smaller, second hatch pierces the east wall at higher level. Of some note is a 19th century lamp holder attached to the boarding of the east wall (Plate 7).

6 Bay 13, internal pen, taken from the north-west (22)

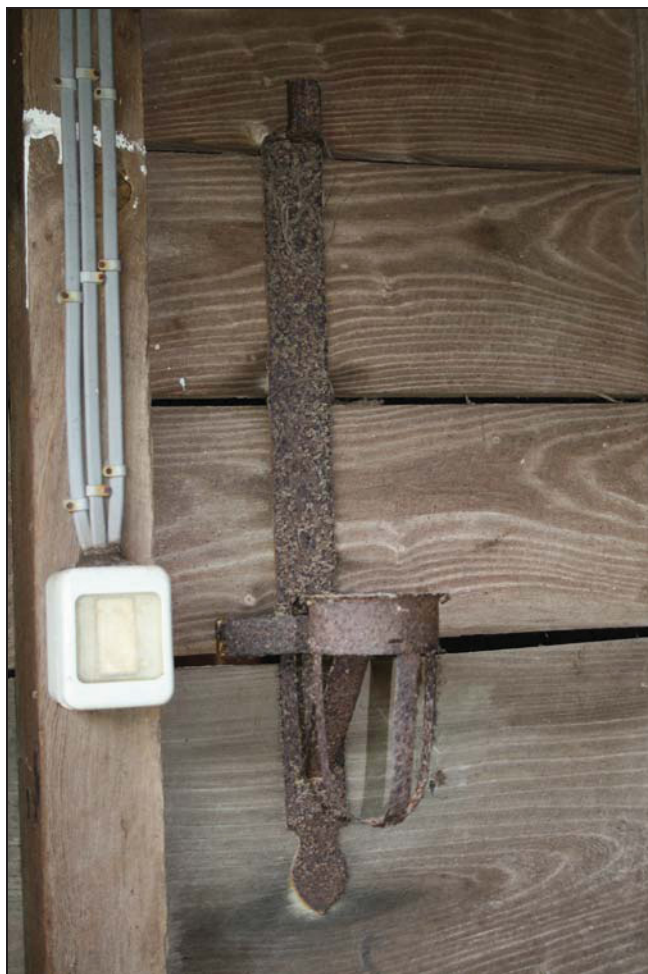
Plate 7 19th century lamp holder on the western wall of Bay 13, taken from the southwest (42)

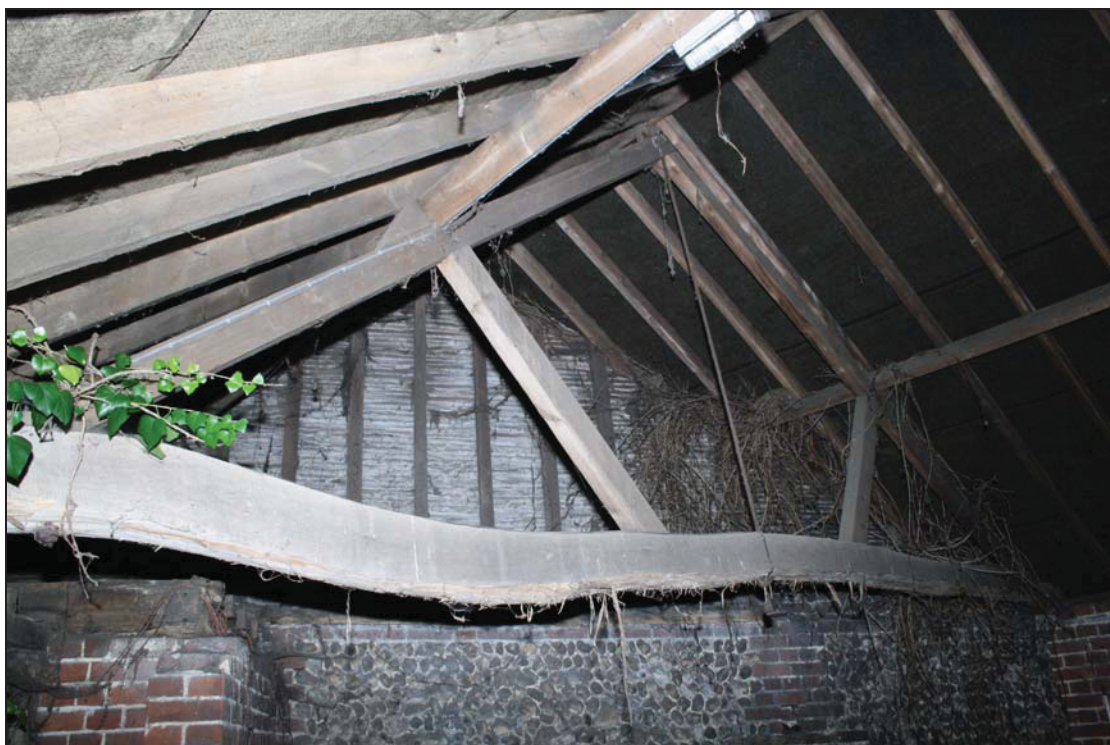
5.18 The internal partition from Bay 13 is boarded with oak or elm, and partially closed above the partition to the apex by the outer off-cuts from the timber-sawing process. The only other feature of note is a small internal wall, framing an enclosure may originally have been a wood store or similar. The roof is supported by a single truss as in neighbouring areas (Plate 8).

Plate 8 Bay 14, roof truss, taken from the west (20)

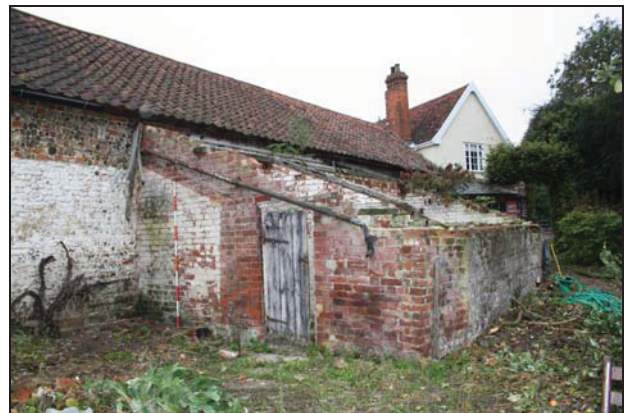
12

The remains of the potting shed to the rear of the range (east end), taken from the south

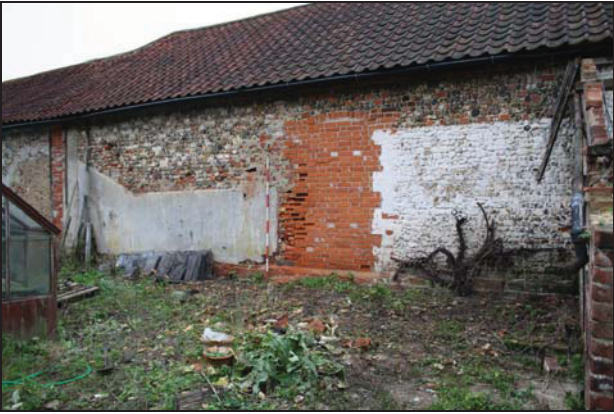
13

Blocked doorway and area of rendering (south-east elevation), taken from the south-east

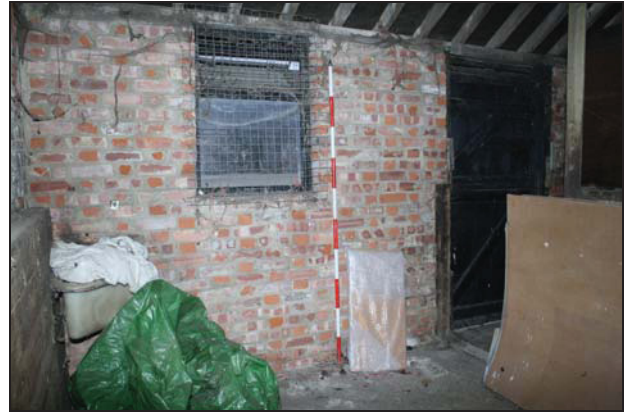
28

5.12 Some modern modification is visible with the inner face of the outer wall lined with Fletton bricks. The internal stall partitions are modern and of no interest.

Stable door and window showing Fletton brick inner face of Bay 9, taken from the south-east

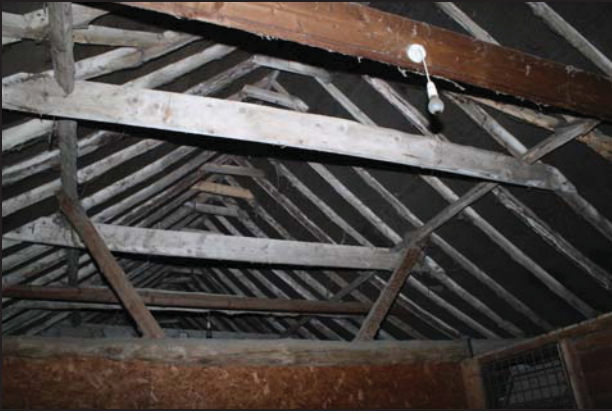
31
Roof structure above Bays 7 & 8, taken from the east

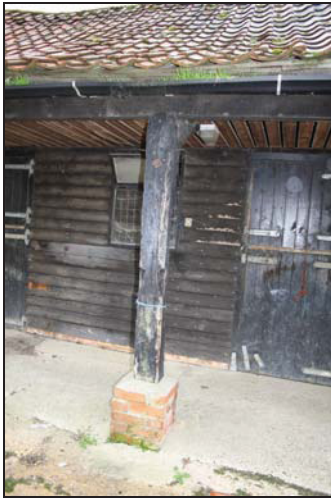
33
Supporting post on brick stylobate between Bays 7 & 8, taken from the north

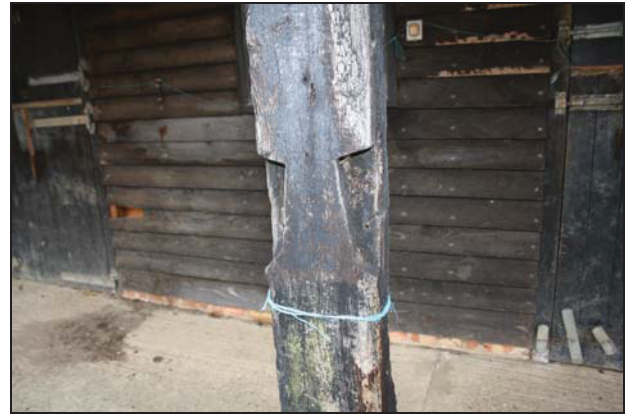
stylobates, with solid shaped braces to the tie-beam. The posts vary slightly; most appear to be re-used with redundant mortices for half-notched jointing which does not appear to relate to their present position. The wall plate has been replaced and in modern times the existing recessed frontage added on a base of Fletton bricks with modern stable doors.

34
Supporting post between Bays 7 and 8, retaining redundant mortices, taken from the north-west

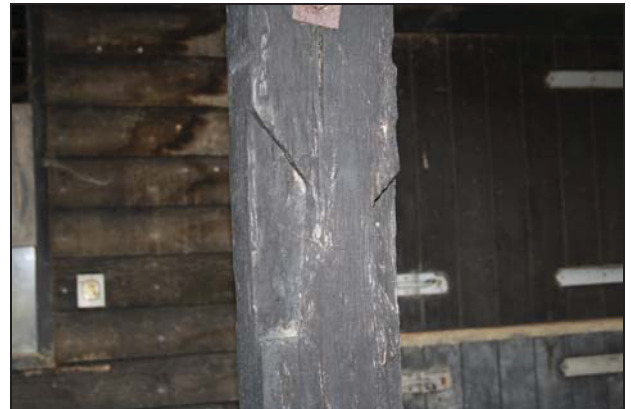
36
Supporting post between Bays 6 and 7 retaining redundant mortices, taken from the north
