Archaeological Observation  
Investigation and Recording  
at the  
Gate Helmsley – Kexby  
11kw Overhead Line Rebuild

Site Code: WB2013.001

Northern Powergrid Project No: D107507

Watching Brief Report Number: 1336  
February 2013

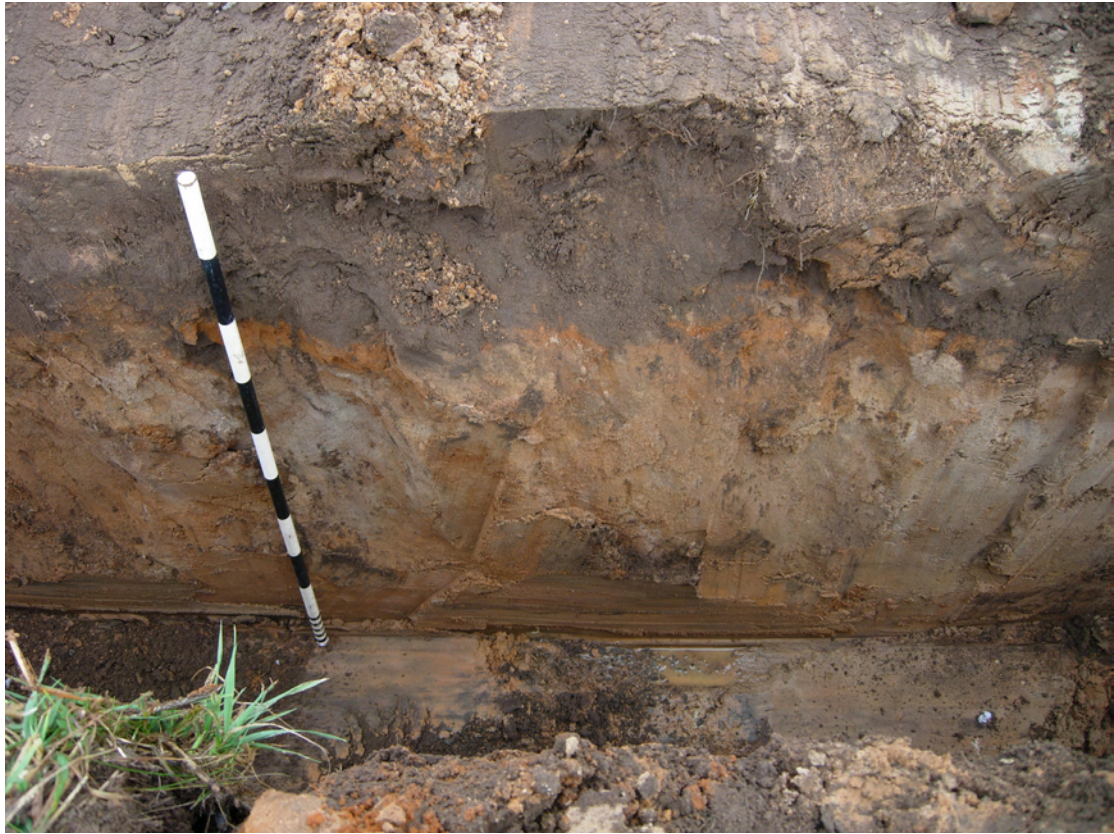
In the easternmost 100m of trench (Figure 2) there was a layer of pale grey and yellow/orange sand at least 0.80m thick (1002) above which there was a 0.20m thick layer of dark grey/brown sandy topsoil (1001) (Figure 3). The westernmost 50m of the trench were in both field 9 and the paddock noted above (Figure 4). With the exception of the final 10m at the east end throughout the next 40m there was within the base of the trench a layer at least 0.50m thick of yellow/brown sandy silt clay (1004) (Figure 5). Above this there was a 0.30m thick layer of dark reddish grey/brown silt clay sand (1003) and 0.20m of (1001). Finally within the final 10m of trench throughout its base there was a layer at least 0.50m thick of dark reddish brown sandy silt clay containing frequent gravel (1006) (Figure 6). Above this there was a 0.30m thick layer of grey/brown pinkish silt clay sand containing frequent gravel (1005) and 0.20m of (1001).
