Archaeological Observation
Investigation and Recording

Spurn Peninsula Roadway
East Riding of Yorkshire

Site Code: WB2013.012

Watching Brief Report Number: 1350
May 2013

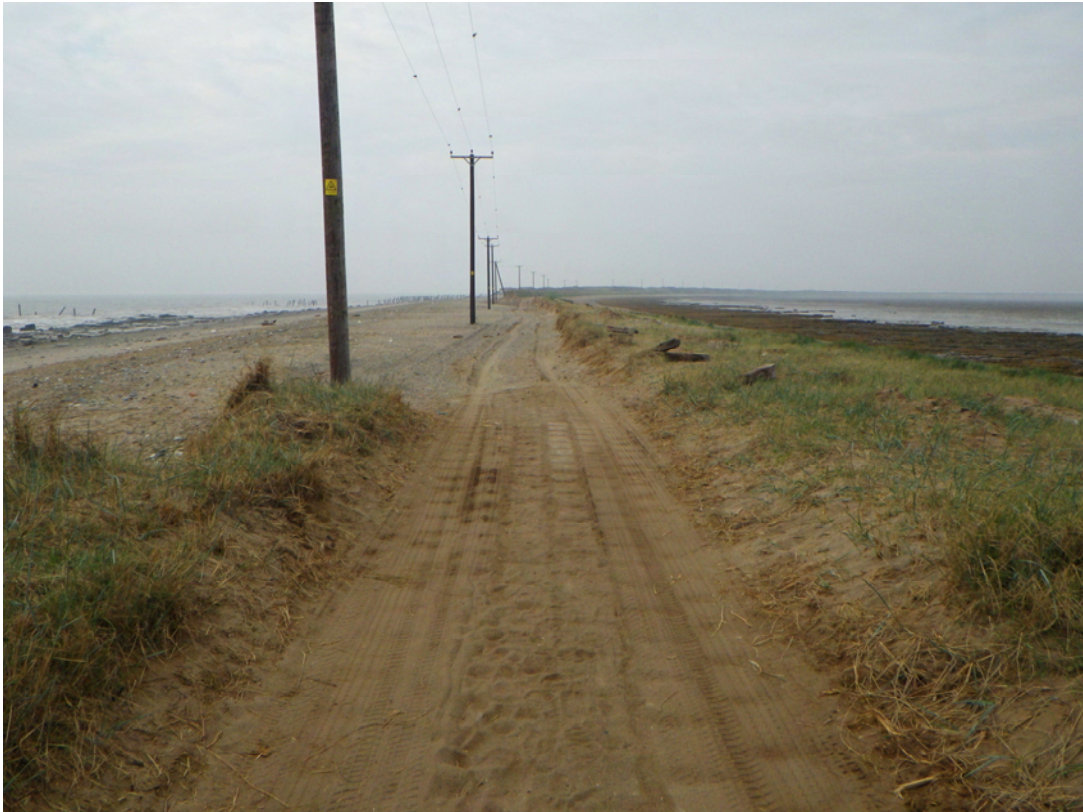
Plate 1 The site of the development, showing the collapsed and washed-out road; the proposed road is to the west (right). Viewed from the north.

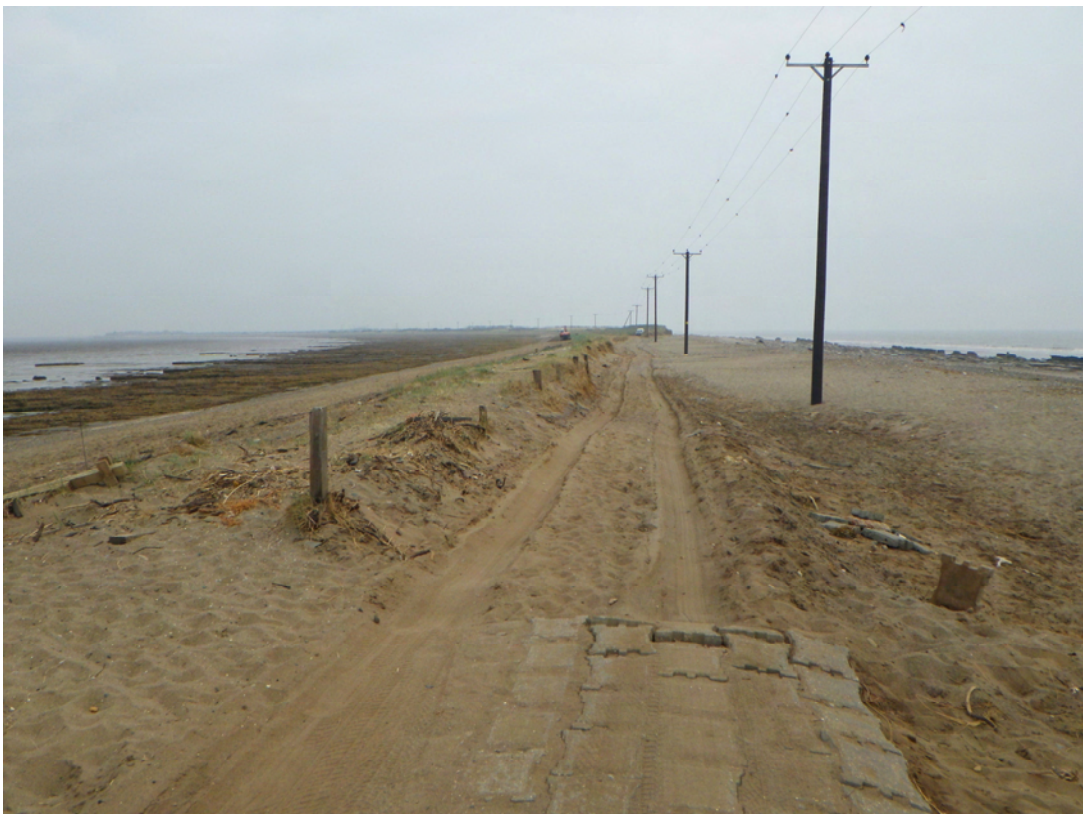
Plate 2 View of the site from the south showing the former position of the road.

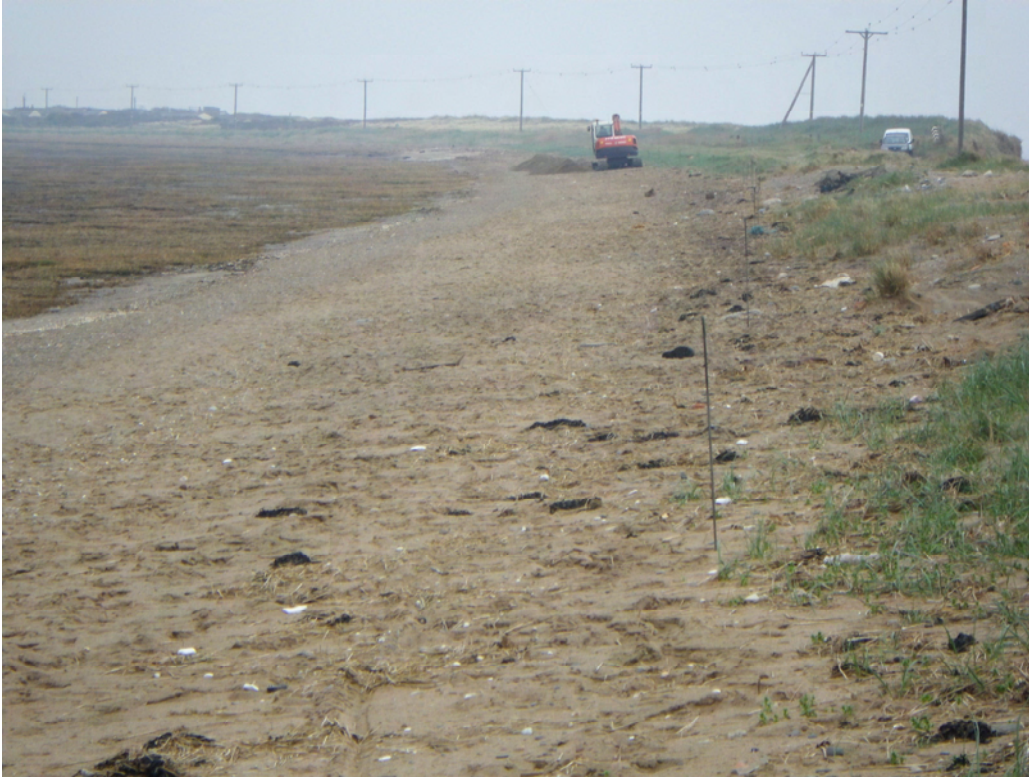
Plate 3 The site of the repositioned roadway along the western bank of Spurn peninsula. The metal road pins on the right demarcate the eastern side of the new road. Viewed from the south.

The location of the new road is set to the west of the recent breach along the existing access to Spurn Point. The distance between the two ranges between 7.00m and 10.00m except at the north and south where there are returns to the extant road.

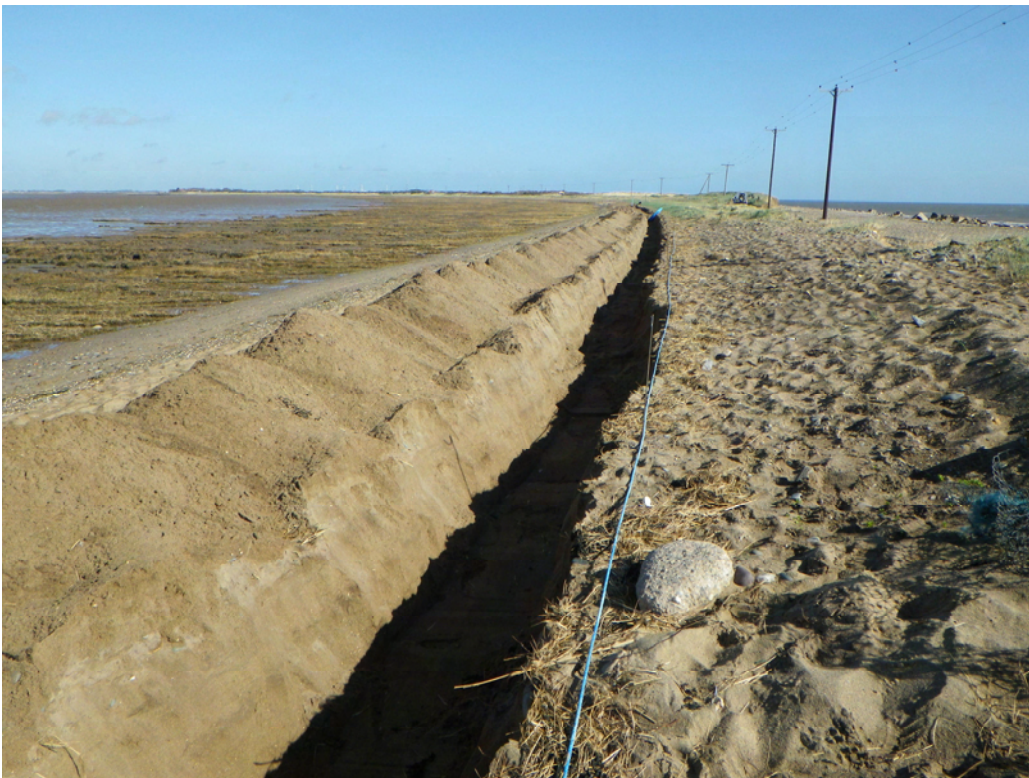
Plate 4 Showing the partially excavated water service pipe trench in the northern half of the proposed works. Viewed from the south.

The water service pipe trench was oriented north to south over a distance of 307.50m starting at TA 42098 14355 and finishing at TA 42122 14049. It was located centrally along the mid point of the proposed new access road, offset 1.20 from the eastern edge of the road boundary. The width of the trench was nominally 0.80m wide, but generally increased in width at the top of the trench to around 1.00m where collapse occurred frequently. The depth of the trench averaged 0.90m occasionally increasing to 1.00m below the current ground level. The height at ground level ranged between 3.52m O.D at the north to 3.65m O.D. at the south. The deepest part of the excavation was at 2.62m O.D which varied only slightly along the trench base.

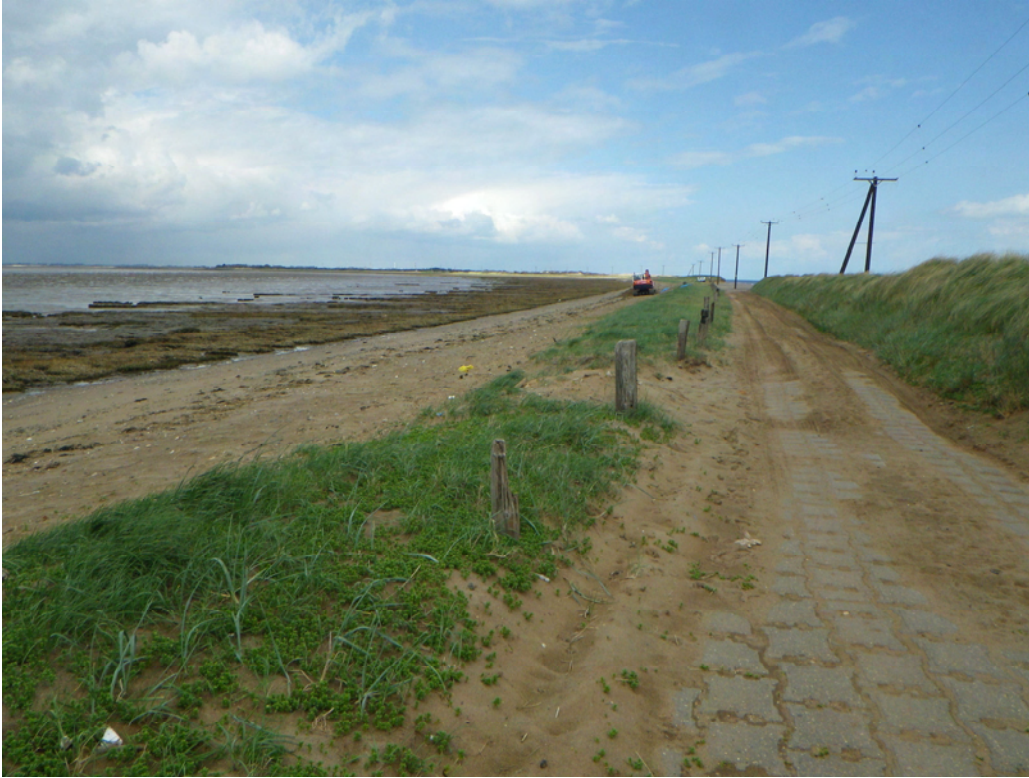
Plate 5 Showing the remainder of the water service pipe trench from the southerly extent of the works, looking north.

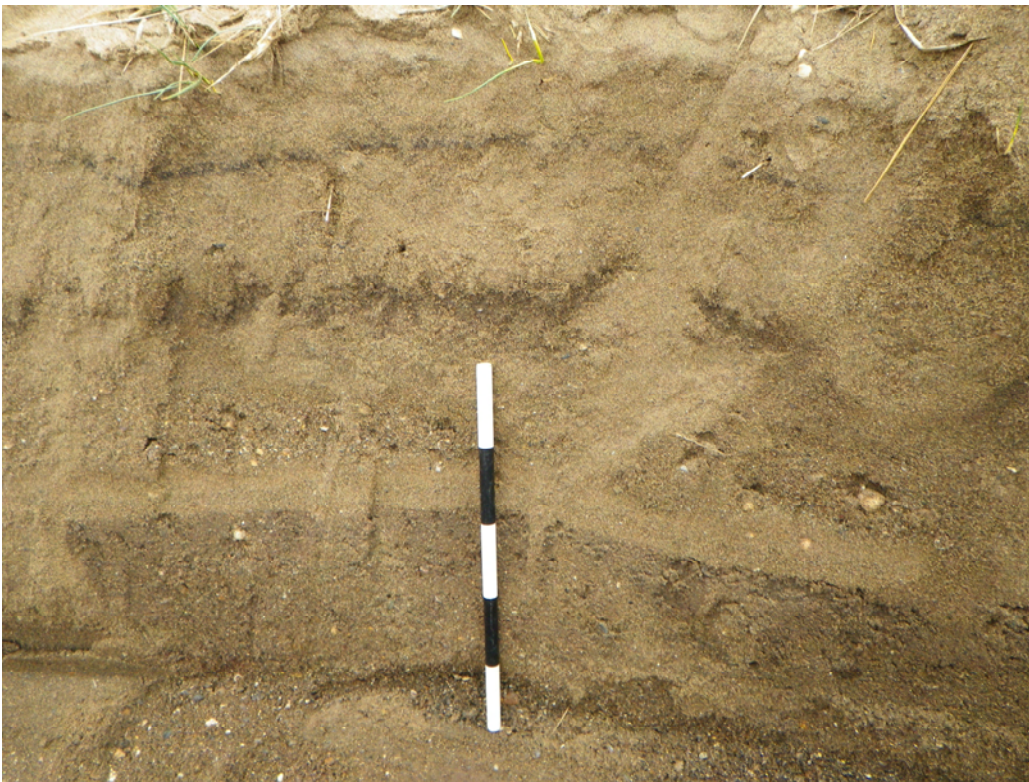
Plate 6 A typical profile view of sand deposit (101) within the trench system. A minor amount of the underlying mud flat layer (102) can be partially seen at the bottom of the scale bar. Looking east, 0.5m scale.

Only two deposits were encountered throughout the entirety of the excavation. In one instance in the base of the trench, located at TA 42100 14340, was deposit (102) a mid brown silt clay mud with very occasional small gravel inclusions exposed for only 0.50m in plan. The depth at which it was revealed suggested it to be the same mud flat deposit which lies less than 7.00m to the west in the lee of the Spurn Peninsula. The uppermost deposit recorded, and which constituted the majority of the material exposed was (101) mid golden brown windblown and waterlain sands with varying amounts of small gravel content.

- (101) – Modern accumulation of windblown and waterlain sands with some small gravel content inclusions
- (102) – Continuation of the extant mud flats which appear to the immediate west of the current construction works
