Archaeological observation, investigation and  
recording

York Field Development Project, Easington  
Terminal, East Riding of Yorkshire

Site Code: EYF 2011

Watching Brief Report Number: 1351

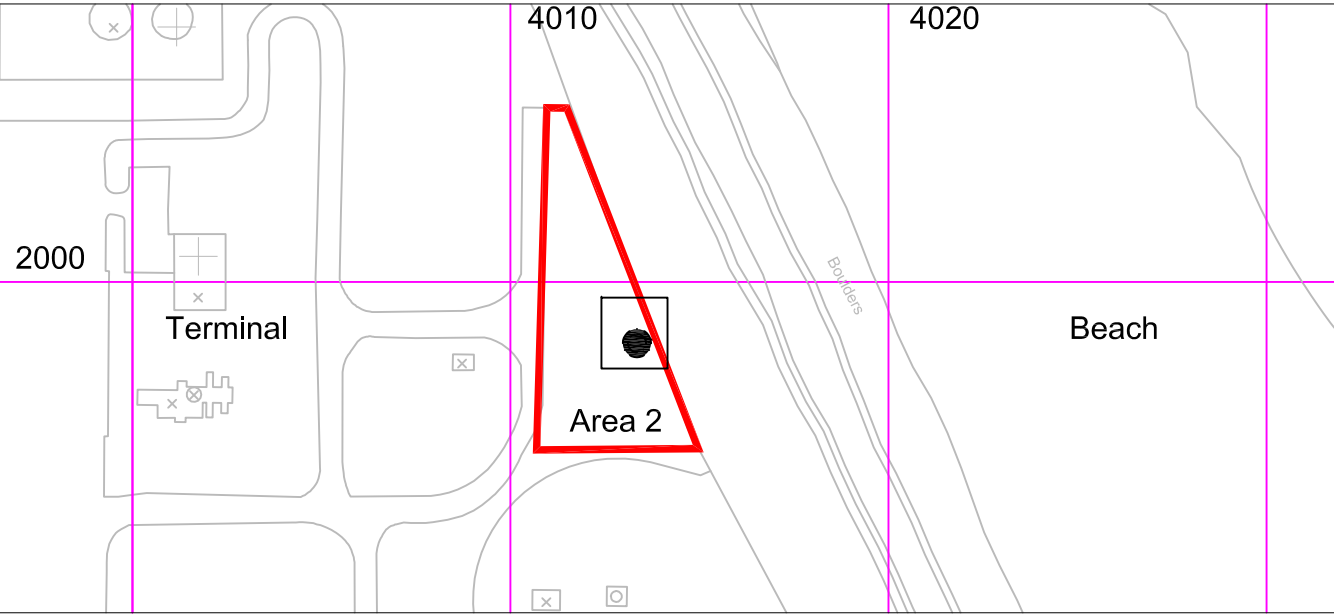
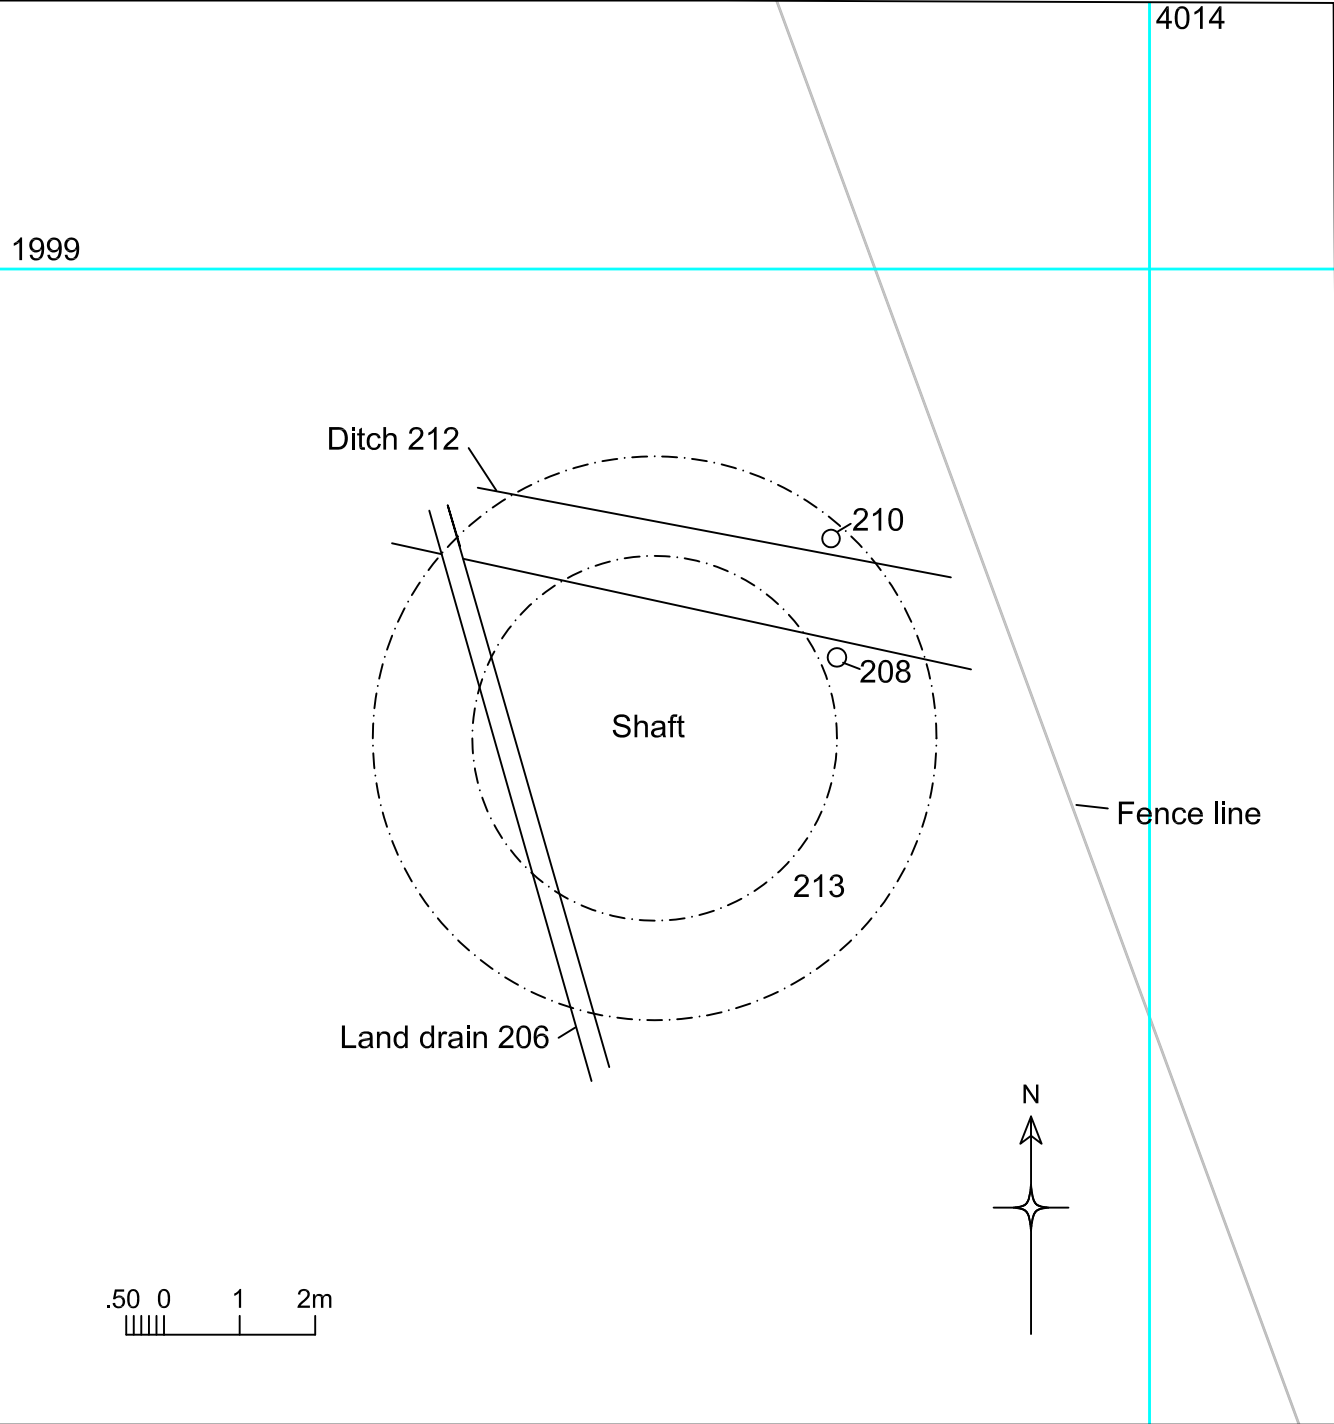
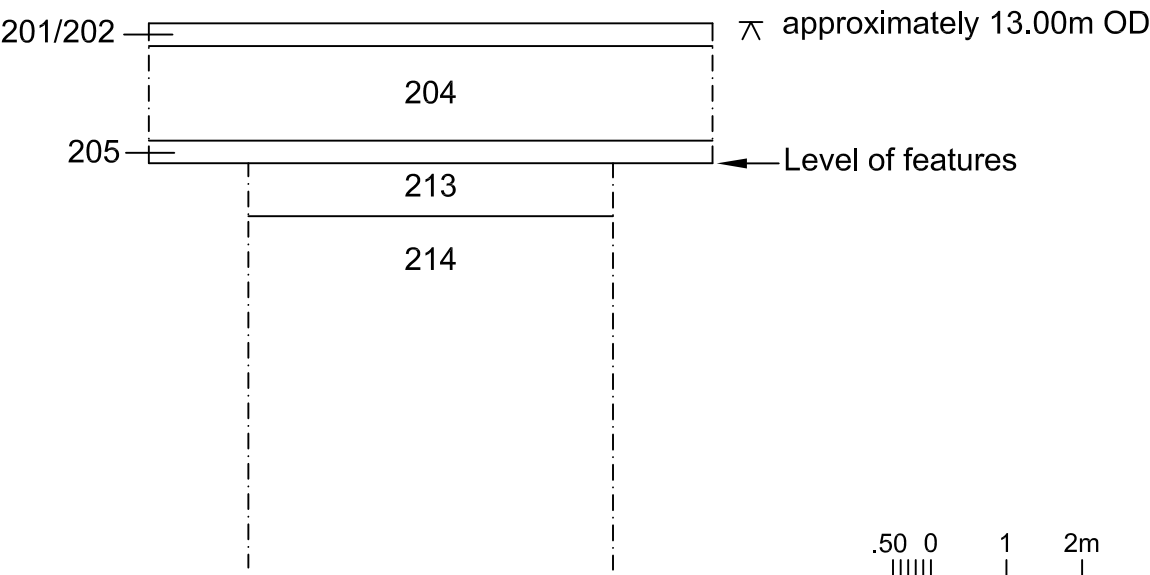
Figure 2 Easington York Field  
Features recorded in Area 2

In the sides of the shaft it was possible to see the full depth of deposits above the natural orange brown boulder clay (214). Immediately above was a mid orange-grey silty clay (213), around 0.7m deep, interpreted as a buried subsoil. Cutting into layer 213 was a ditch (212), extending east to west across the northern part of the shaft (Fig. 2; Plate 21), represented by a band of mid blue-grey silty clay (211). The feature, which was approximately 0.60m wide and 0.45m deep, was principally seen in plan, and only partially in section (Plate 22), it not being possible to enter the trench due to health and safety constraints. At the eastern end of the ditch were observed two similarly-sized circles of darker soil, around 0.10m in diameter, considered to represent postholes: posthole 208 lay to the south of the ditch and posthole 210 to the north; both fills (207 and 209, respectively) were dark grey silty clay. It was not possible to investigate the feature, so no dating evidence was able to be recovered. Although it remains undated, the alignment of the ditch was seen to differ from that of the field boundaries marked on early Ordnance Survey maps in this area, suggesting that it at least pre-dates the late 18th-century enclosure of this area. The relatively pale colour of its fill, furthermore, may suggest that it is of a considerably earlier date.

Cutting through the western part of the ditch, extending north to south across the shaft trench, was a post-medieval ceramic land-drain (206) of horse-shoe profile, set in a cut of 0.30m width. Sealing this and the earlier features was a buried topsoil, 0.30m deep, of mid-dark grey silty clay (205), above which was a 1.25m thick ground raising deposit of red-brown, sandy clay (204), possibly re-deposited natural clay. The uppermost 0.30m of the section comprised a mixture of hardcore deposit (202) and the gravel surface (201).

Schematic section of deposits in shaft

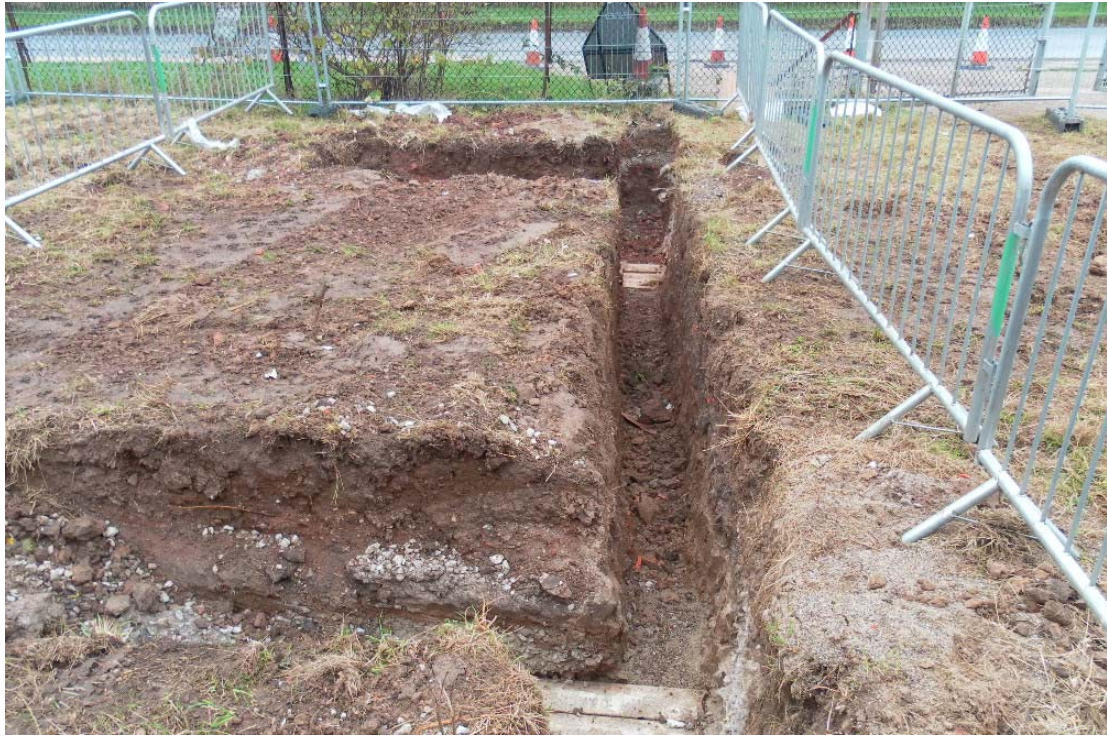
The initial works comprised the excavation and exposure of known cable trenches across the site; these were located in the north-west and south-west corners, exploratory trenches being machine- and hand-dug down to approximately 0.80m-1.0m, until the known electricity cables were uncovered, checked and backfilled (Plates 1 and 2).

*Plate 1: Cable trenches in Area 1, looking west.*

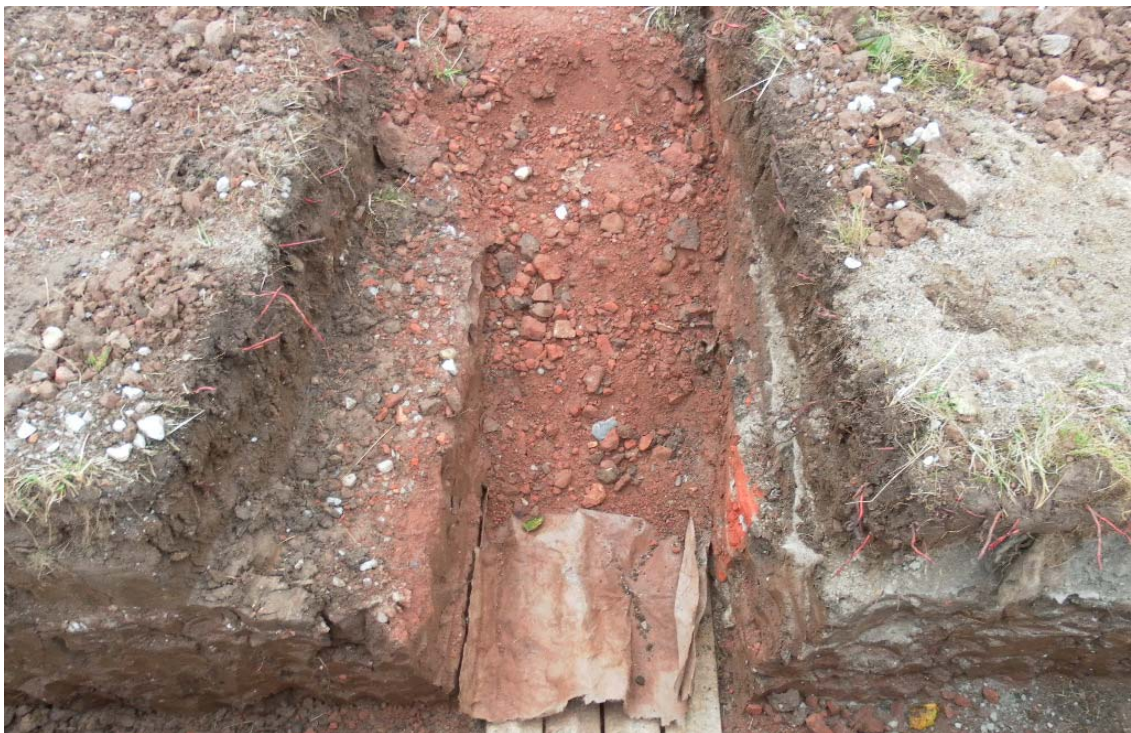
*Plate 2: Cable trenches in Area 1, looking south.*

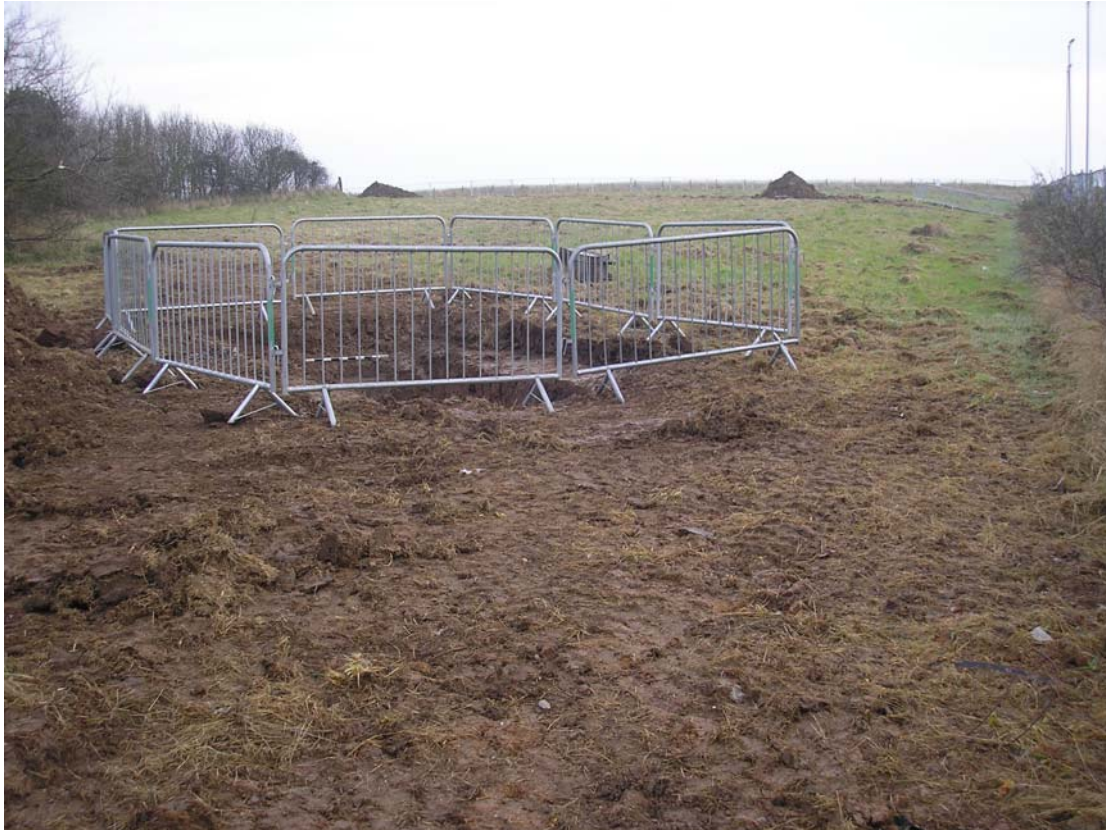
Two 1.3m-deep test trenches were machine-excavated in the south-western and south-eastern corners of the area to locate large drainage pipes which crossed the southern edge (Plates 3 and 4). The basal deposit within both trenches was natural boulder clay, an orange-brown silt-clay (103) with rounded stones and chalk flecks, above which was a ground-raising deposit of red-brown silt-clay (105), at least 0.50m thick, containing modern ceramic building material (CBM) fragments, stone, modern metal and plastic. Cutting through layer 105 were the pipe trenches (e.g 107), backfilled with mid orange brown fine sandy clay (106), containing modern CBM, stone and modern hardcore, over the round plastic pipe. Sealing the deposits was 0.30m of modern topsoil, being dark brown fine coarse sandy clay (101).

*Plate 3: Drainage trench in Area 1, looking east.*

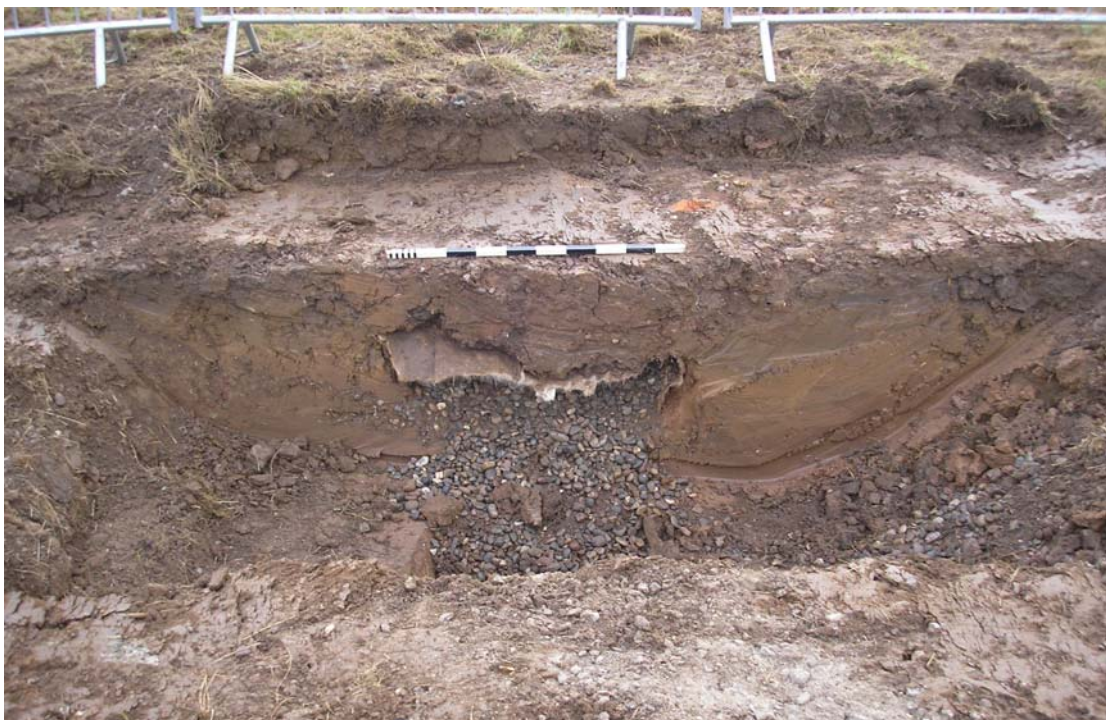
*Plate 4: West-facing section in drainage trench, Area 1 (1m scale).*

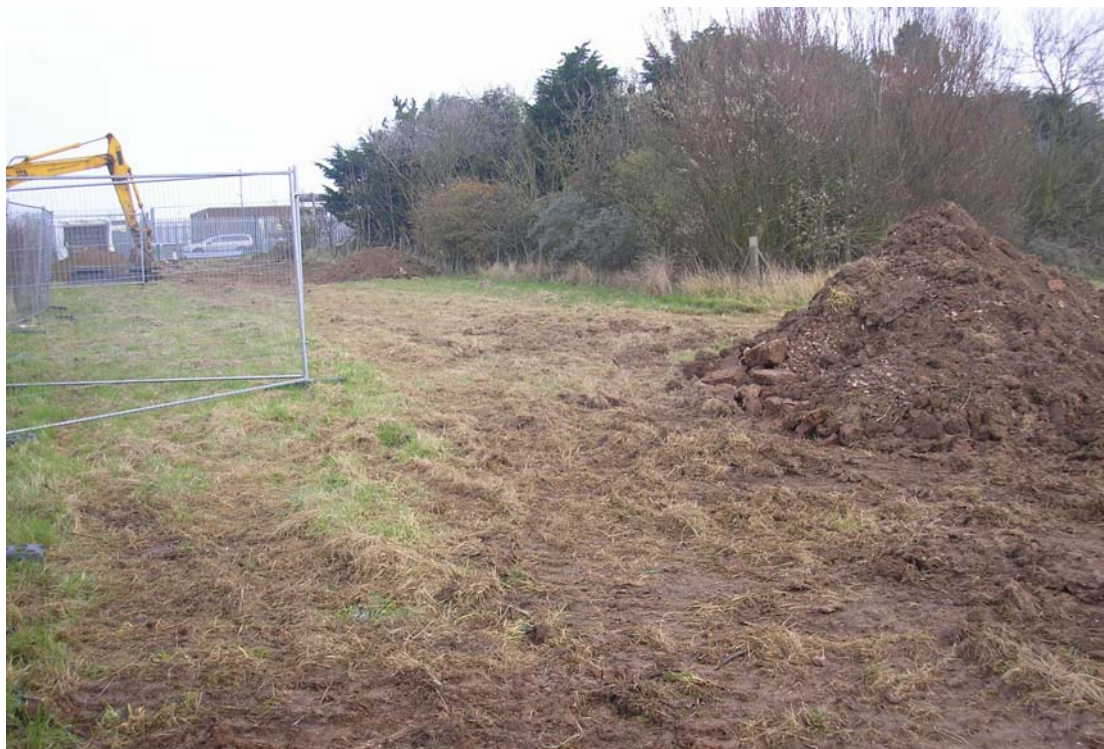
The topsoil strip of Area 1 occurred over several days, beginning at the access gates on the western edge (Plate 5), then proceeding south towards the CSL car park. A small excavator removed the western arm of the woodland plantation (Plate 6). Stripping of 0.30m depth of the topsoil (101) exposed deposit 105 over much of that part of the area (Plates 7-10). Ground reduction around the access gates involved taking off a further 0.30-0.60m of deposit (105), which exposed a light grey stone hardcore in concentration, indicating the backfill of cable trenches, and a brick rubble hardcore (108). In the very north-western corner, a higher concentration of brick rubble hardcore (108) was exposed, representing a previous access route into the area (Plate 14).

*Plate 5: Area 1, stripping in the north-western corner, looking north towards the sub-station.*

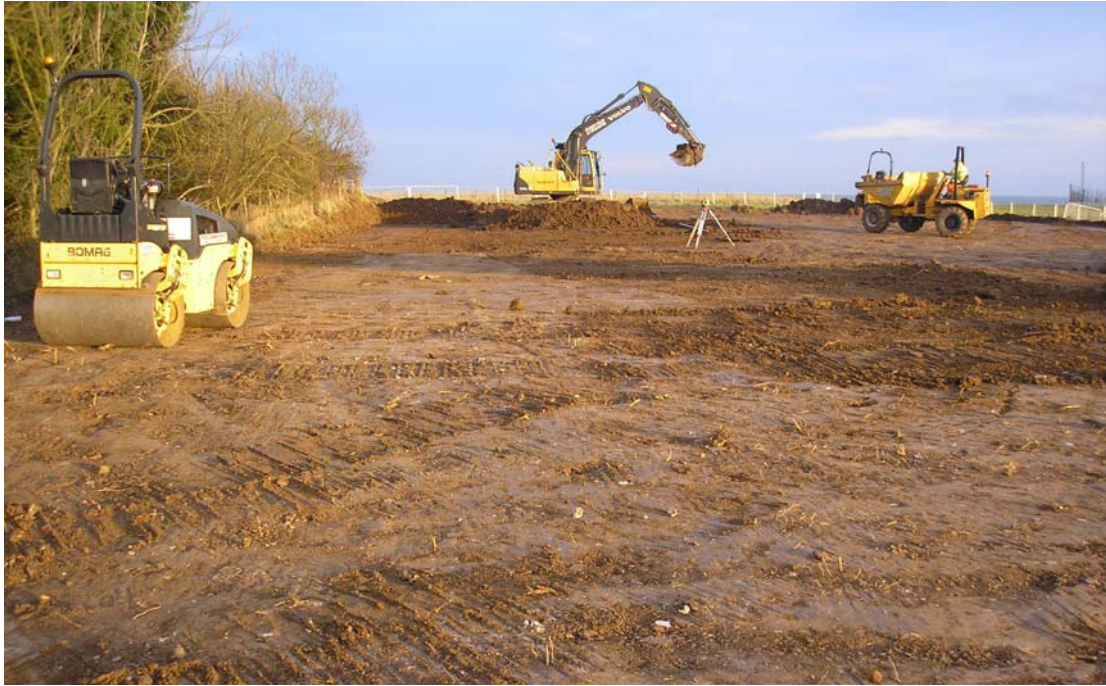
Continuation of topsoil stripping along the northern and eastern edge the area, between the remainder of the woodland plantation and the fenced-off area along the cliff, exposed more of deposit 105, and following this phase of stripping (Plate 13), reduction of the ground level took place along the southern edge (Plates 11 and 12)

*Plate 11: Ground reduction, southern edge of Area 1.*

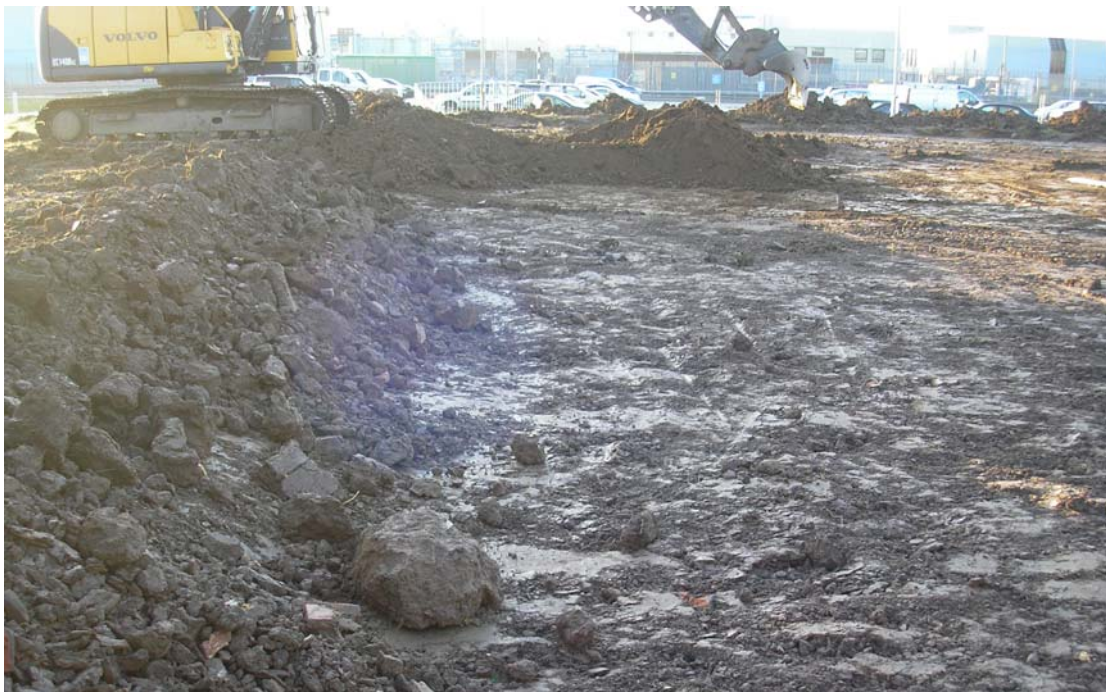
*Plate 12: Ground reduction in centre of Area 1, looking south.*

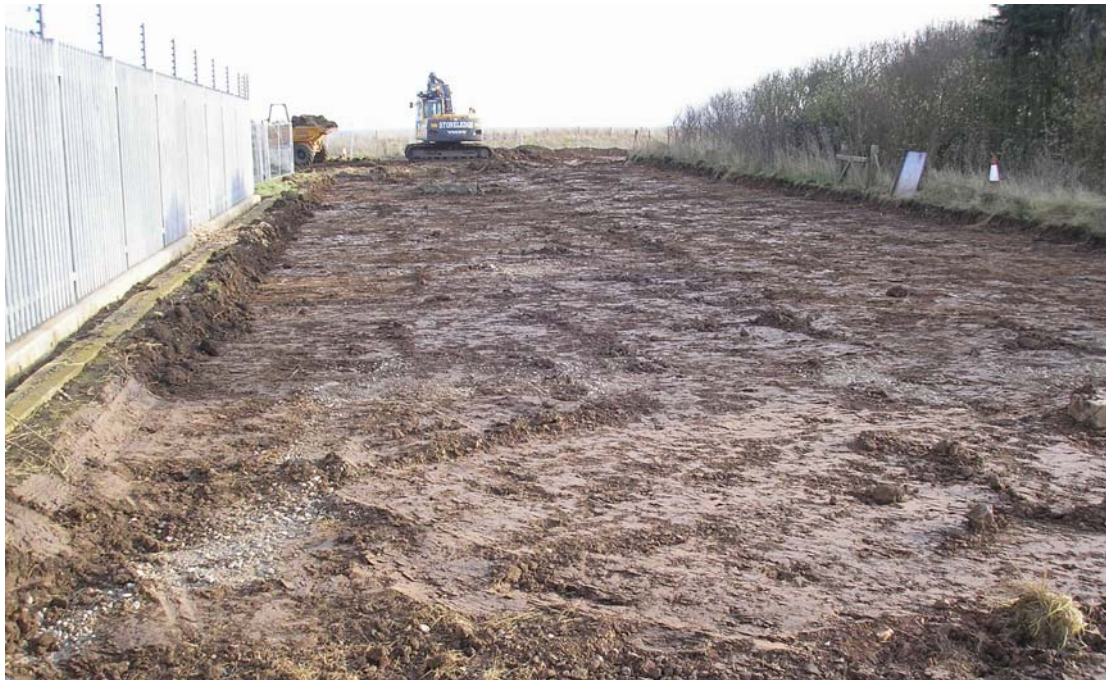
*Plate 13: Topsoil strip along the northern edge of Area 1, looking east.*

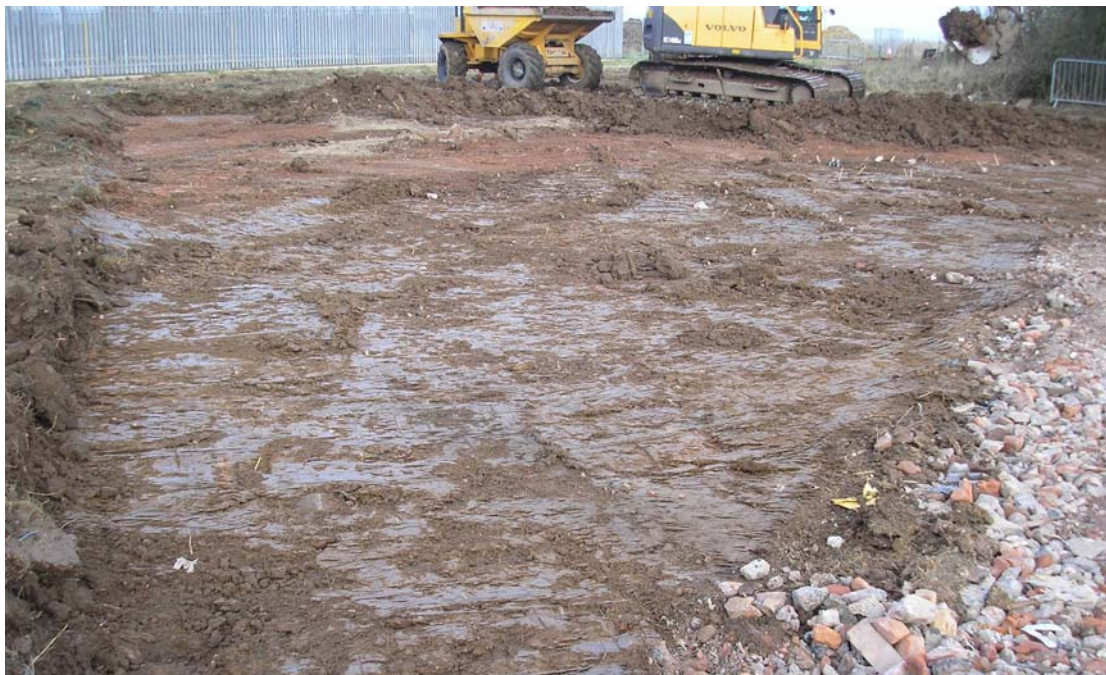
*Plate 14: Topsoil strip, north-west corner Area 1, looking east.*

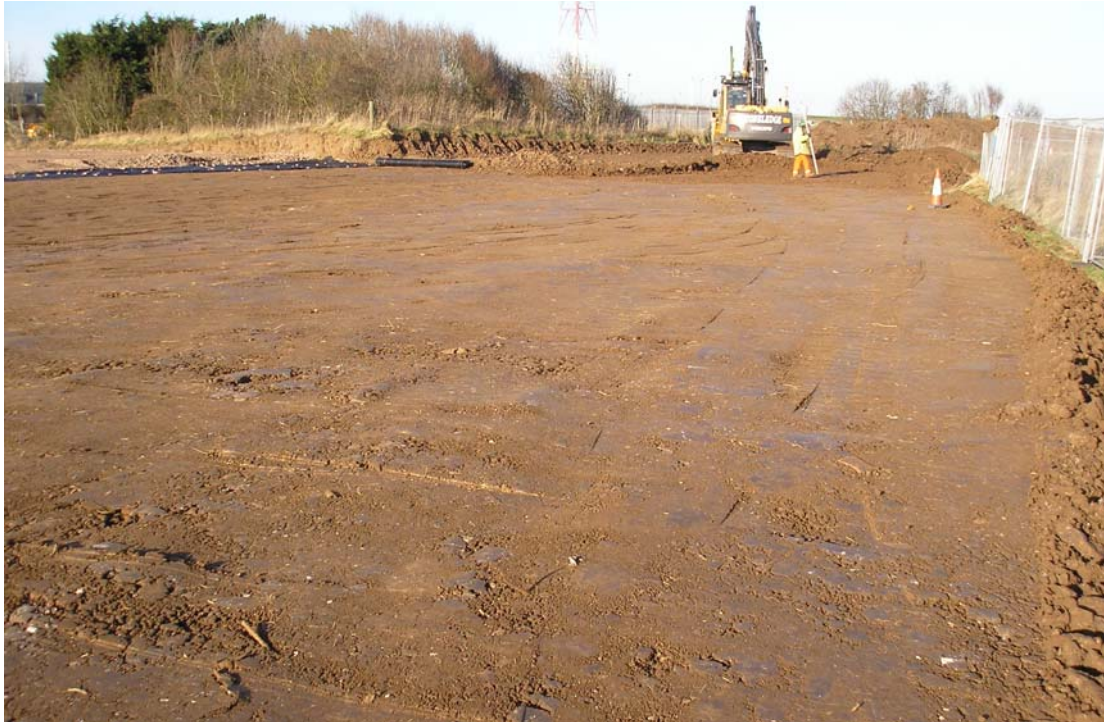
and along the eastern edge, with subsequent dumping of hardcore onto these reduced areas and elsewhere (Plates 15 and 16).

*Plate 15: Final ground level eastern edge of Area 1, looking north.*

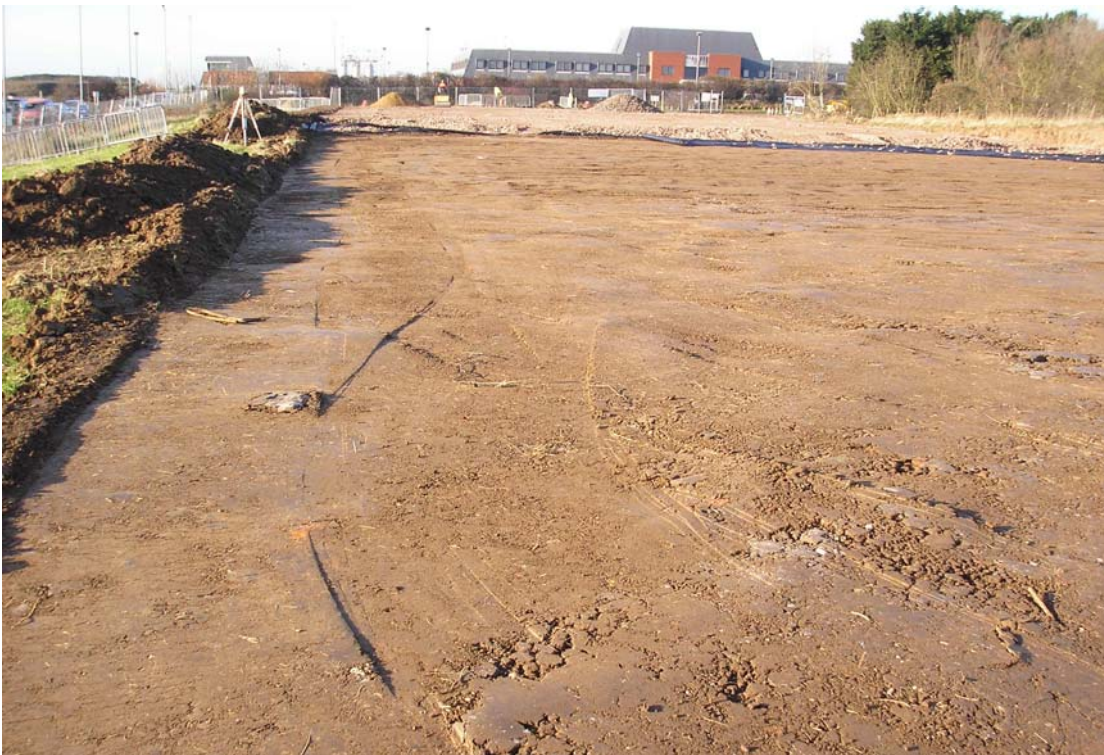
*Plate 16: Final ground level, southern edge of Area 1, looking west.*

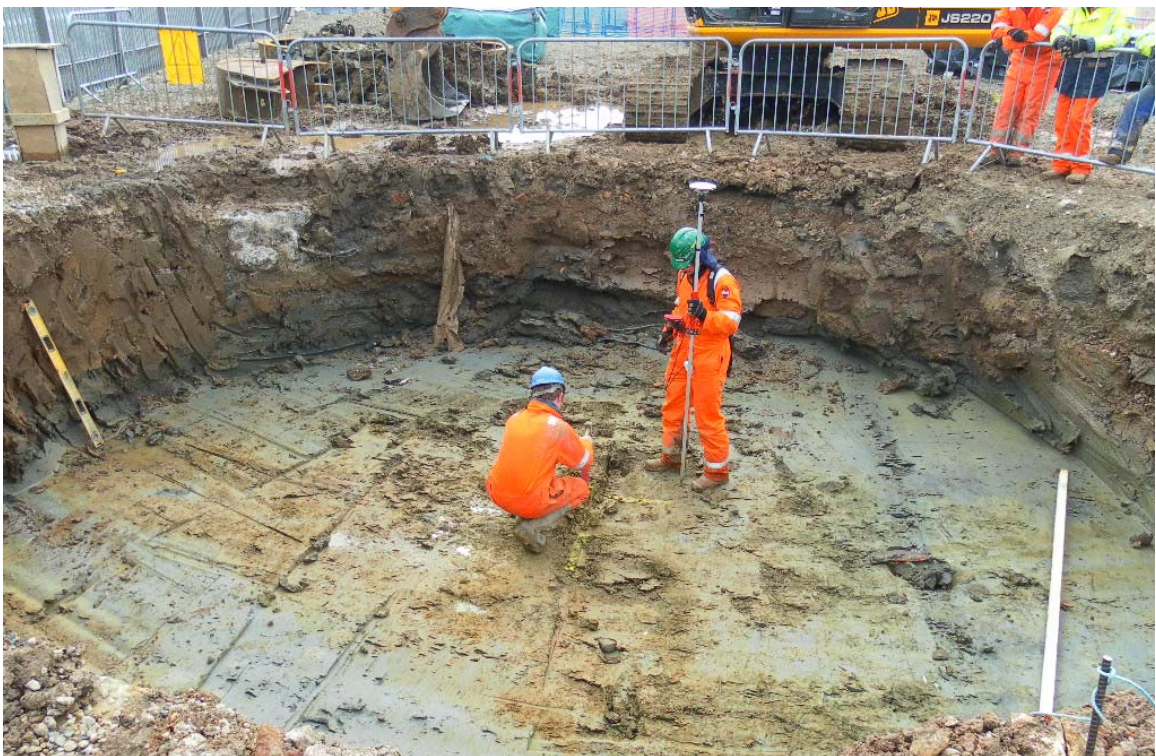
On completion of the ground reduction, work commenced further south on the excavation of the shaft. The initial excavation of the shaft was of a circular trench measuring approximately 7m in diameter to a depth of 1.75m below the ground surface (Plate 20), excavated from a level of approximately 13m OD. The shaft was then stepped in by approximately 1.35m, and a second circular trench approximately 4.5m in diameter was excavated centrally (Plate 22). The total depth reached during archaeological monitoring was 2.55m, at which point excavation reached the natural boulder clay; excavation below this point would involve concrete collars being driven into the deposits, the full excavation depth of the shaft being expected to be around 18m.

*Plate 20: Area 2 shaft, looking south.*

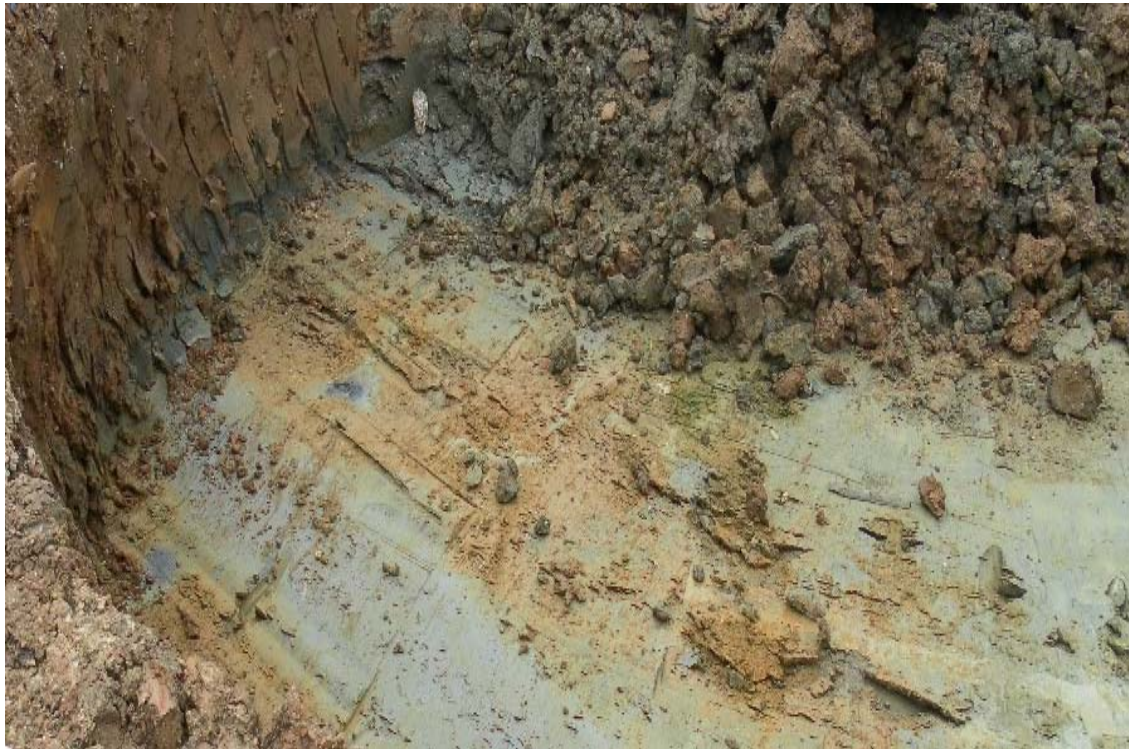
The earliest features were recorded in Area 2, in a trench for a vertical shaft cut close to the current cliff edge. A ditch and two flanking postholes were recorded cutting into a shallow subsoil layer overlying the natural boulder clay, at a depth of over 2m below current ground level. The ditch and postholes remain undated – it was not possible to investigate them due to health and safety constraints – though their contrary alignment to boundaries shown on 19th-century Ordnance Survey maps, and the relative paleness of their fill, may suggest that they significantly pre-date late 18th-century enclosure of the area, being of medieval or earlier date. Indeed, it is not inconceivable that they may represent activity of Iron Age/Roman date, numerous settlement remains of these periods having been recorded in the vicinity of the terminal.

*Plate 21: Area 2, shaft; close up of east-west ditch 212 (grey diagonal band on left) and flanking post-holes (208 and 210).*

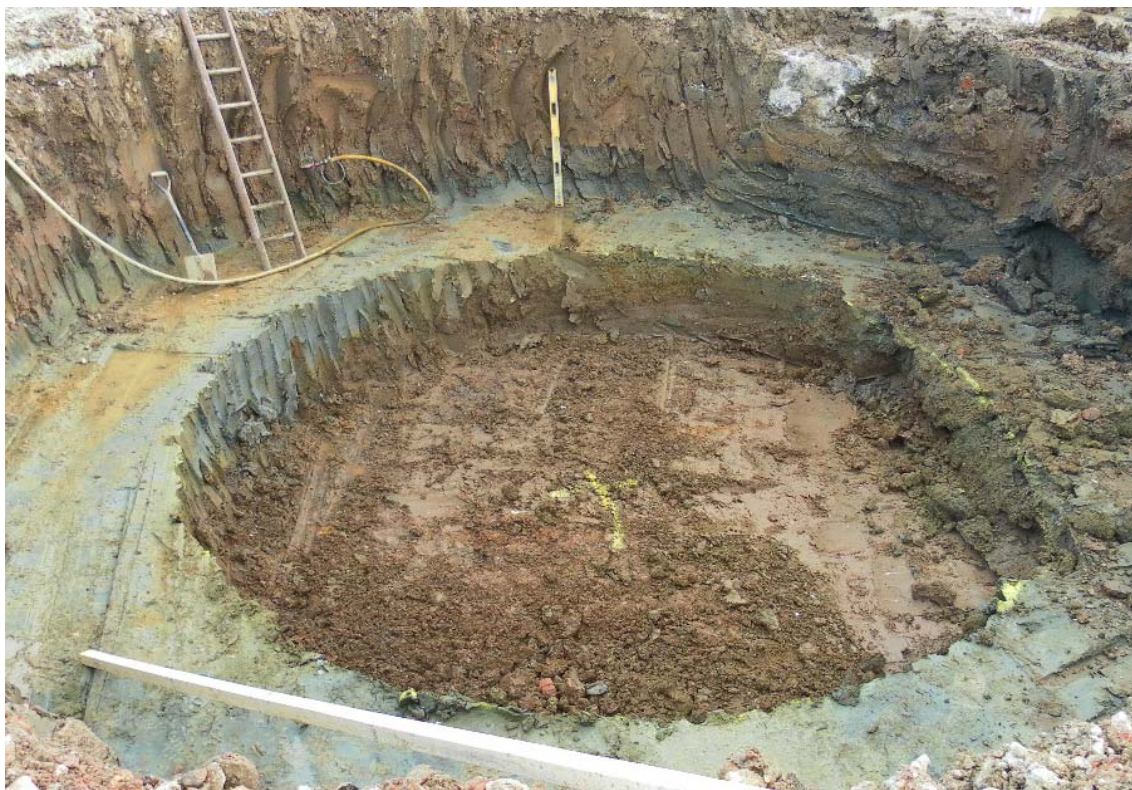
*Plate 22: Area 2, excavation of inner shaft trench, looking east, with surface of natural boulder clay exposed; pale grey fill of ditch 212 seen partially in section on left side of inner trench, cutting into clay 213.*

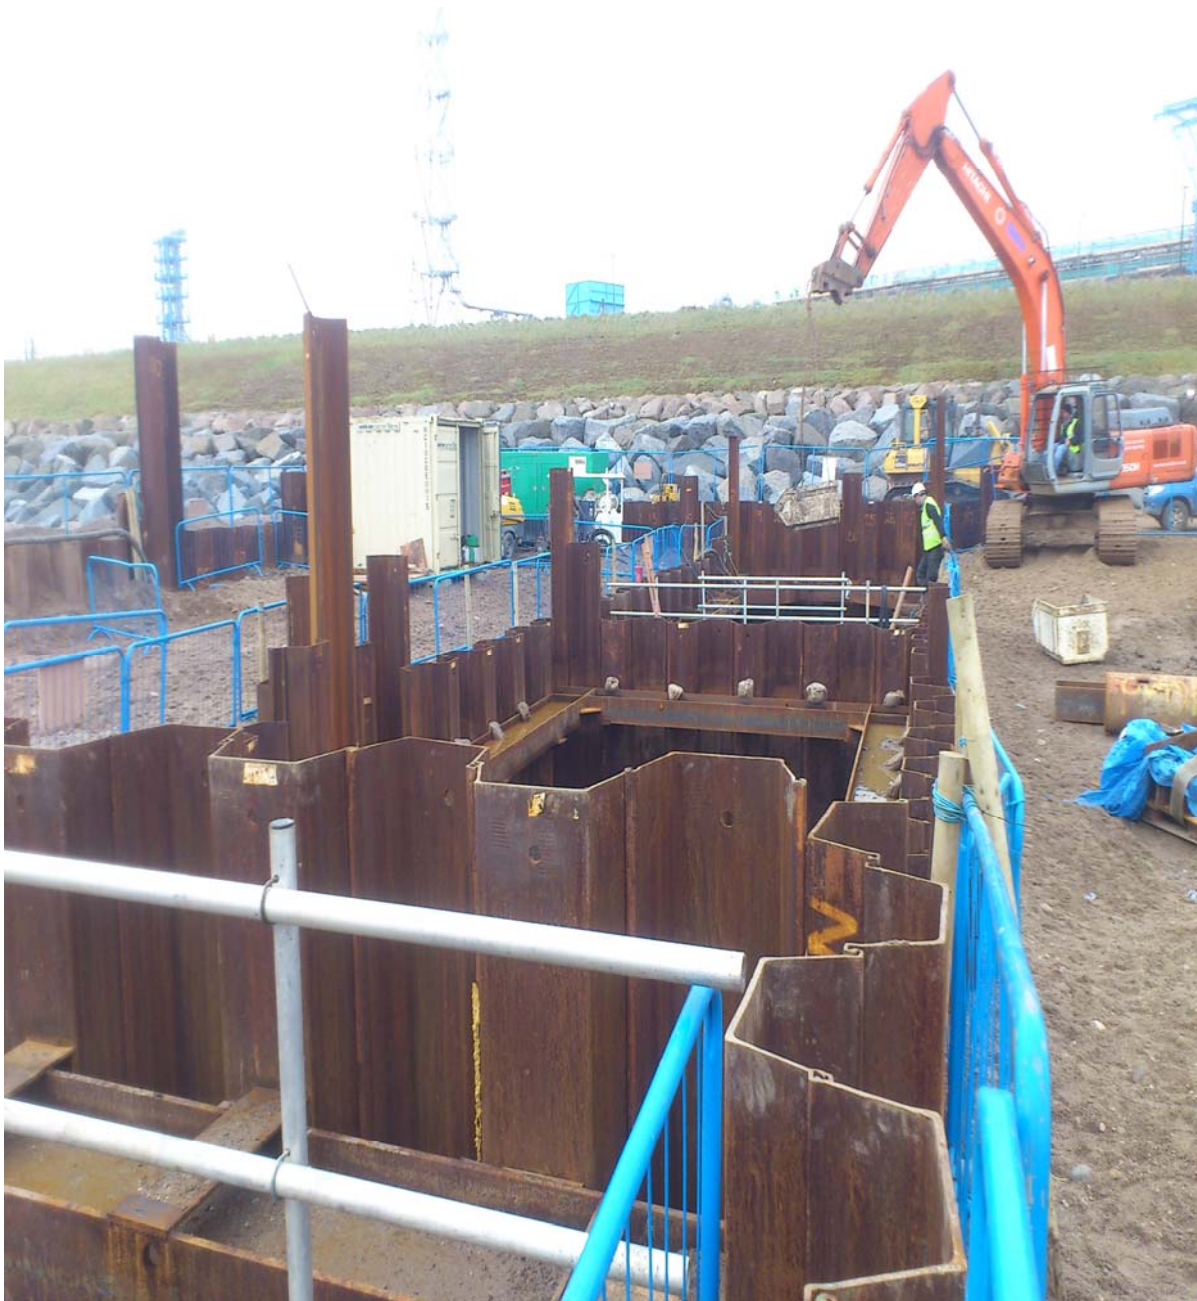
The three pits were excavated down to around 6-8m below the beach level (Plates 23 and 24). All three had sheet metal siding, were low-tide dependent and all exposed the natural boulder clay in their bases. Pit 1 was located at the base of the cliff on the beach to the east of the shaft within Area 2; it is within this pit that the excavations took place through the cliff and connecting with the shaft. Pits 2 and 3 lay east of Pit 1, with the coffer dam trench extending a further 250m plus, out to sea. The construction of the winch platform involved no excavation.

*Plate 23: Area 3, looking west over pits 1 and 2.*

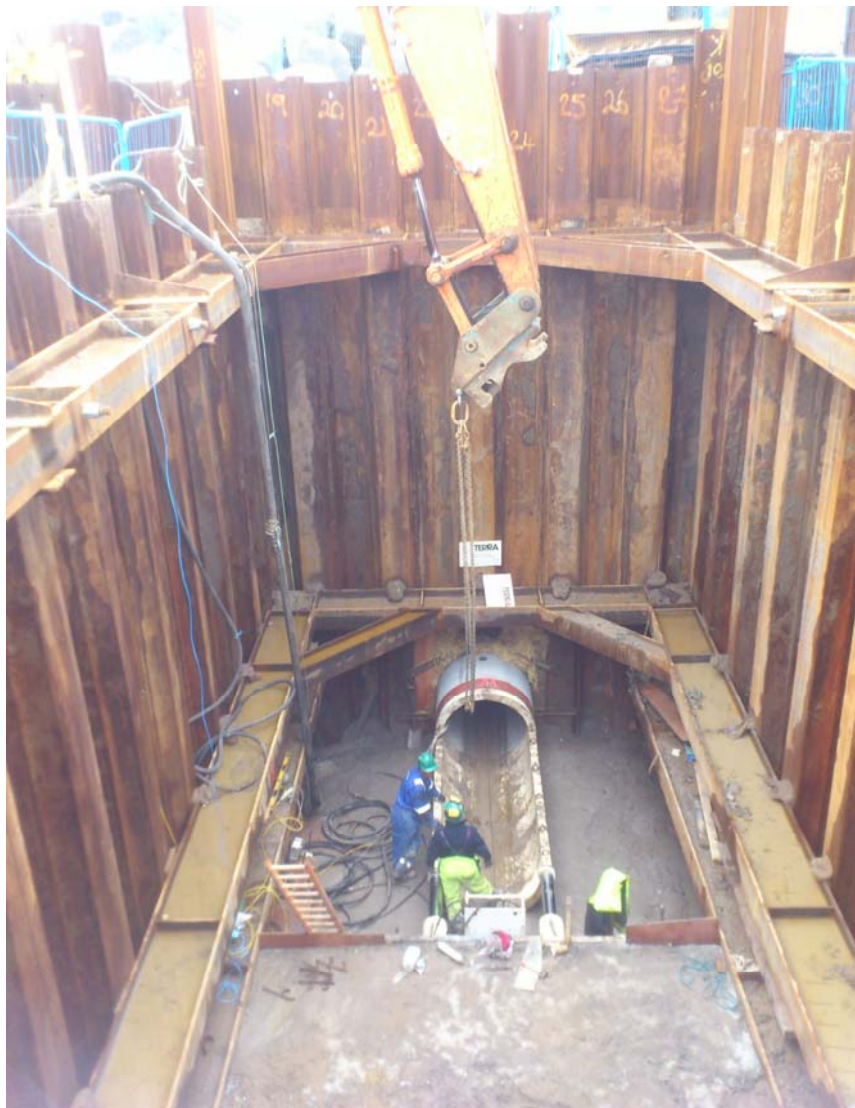
*Plate 24: Area 3, pit 1; excavation through cliff to well shaft, looking west.*

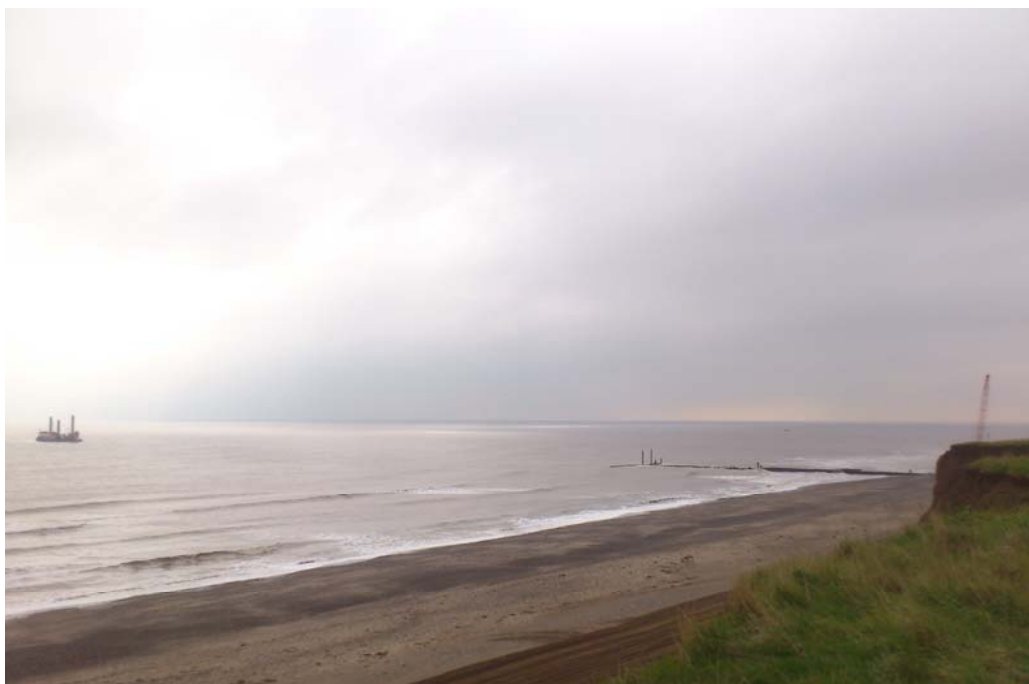
The excavation of the coffer dam trench out to sea (Plate 25) involved the sheet piling being set out using a dredger which was side-casting spoil, with a muck skip coming ashore, the spoil then being compacted at the cliff base on the beach.

*Plate 25: Area 3, coffer dam trench and dredger, looking south-east.*

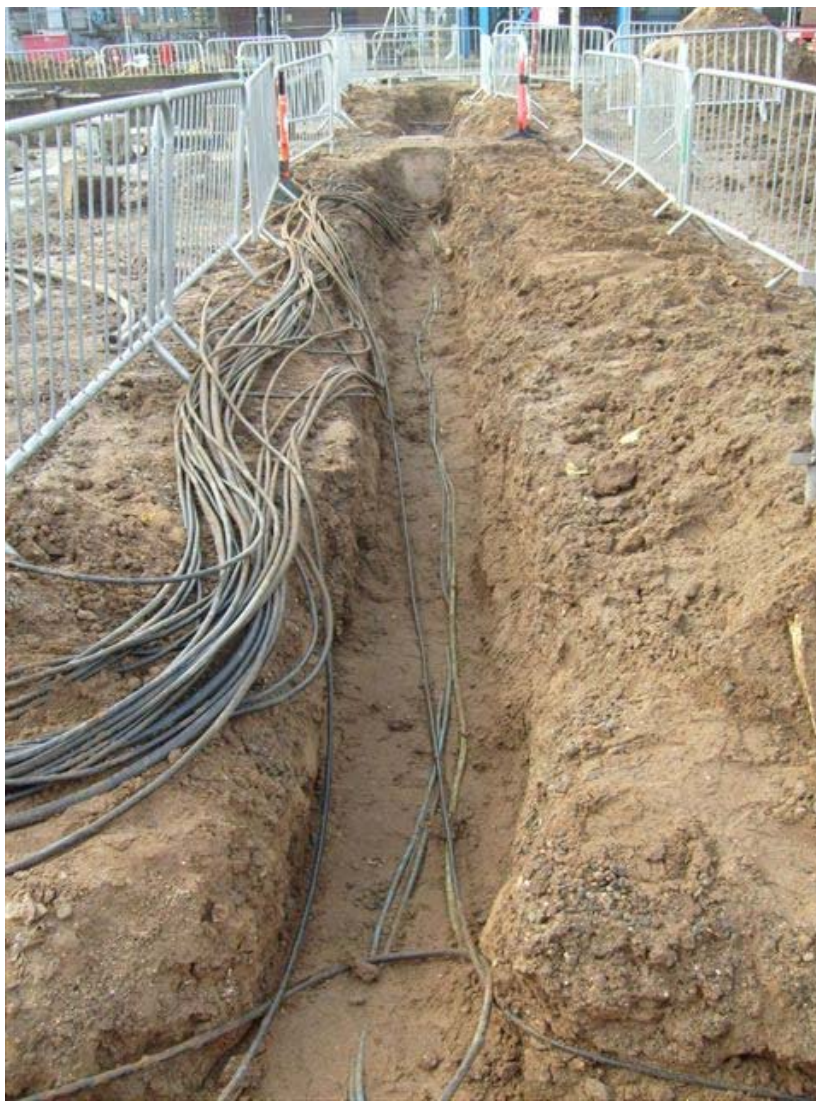
The first phase of work involved the exposure of inactive electricity cables (Plates 26 and 27). The trenches were opened using a small 360 degree machine, with the exposure of the cables being completed by hand-digging to a depth of about 0.40m from the existing ground surface, which was primarily made up of a multi-coloured, variably-sized stone gravel (401). The cable trenches extended both north to south and east to west, around the existing infrastructure foundations. The exposed sections of the trenches showed a modern ground-raising deposit, over 0.40m deep, consisting of a mix of orange-brown coarse sandy clay and coarse orange sand (402). In some places, secondary, deeper laid sets of cables were also exposed and removed.

*Plate 26: Cable trenches, Area 4, looking west.*

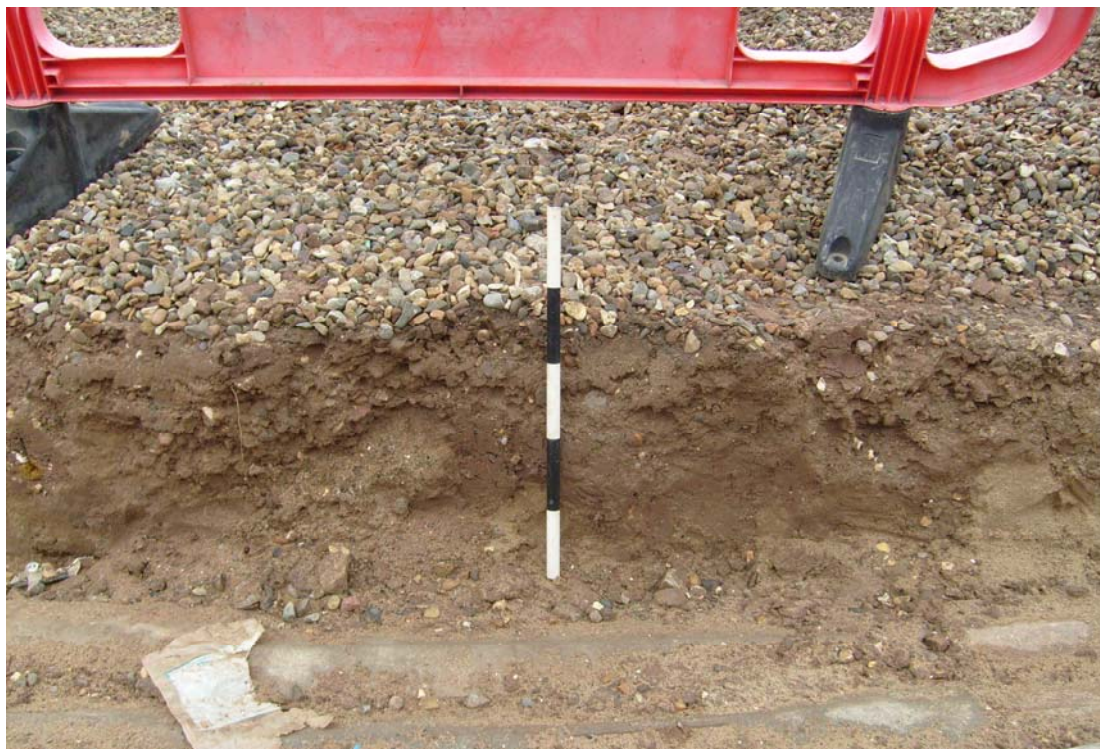
*Plate 27: Area 4, west-facing section, cable trenches (0.50m scale).*
