Archaeological observation, investigation and  
recording

York Field Development Project, Easington  
Terminal, East Riding of Yorkshire

Site Code: EYF 2011

Watching Brief Report Number: 1351

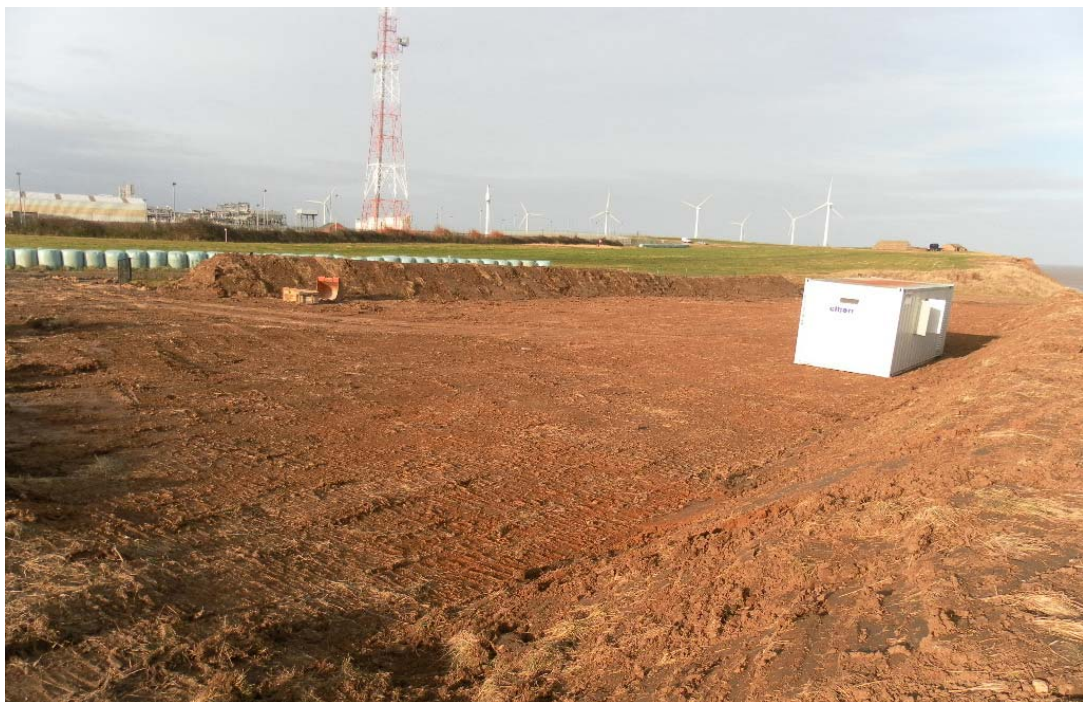
The groundworks involved a 250mm deep topsoil strip (Plate 33), no ground reduction or levelling, with terram and hardcore being laid as a surface for the accommodation units. As was the case in Area 1, the material exposed through stripping was material brought in to raise and level the ground.

*Plate 33: Area 5, stripped compound for Land and Marine, looking north.*
