Archaeological Observation
Investigation and Recording

Church House
2 Church Lane
Bottesford

Site Code: WB2013.006

Watching Brief Report Number: 1385
December 2013

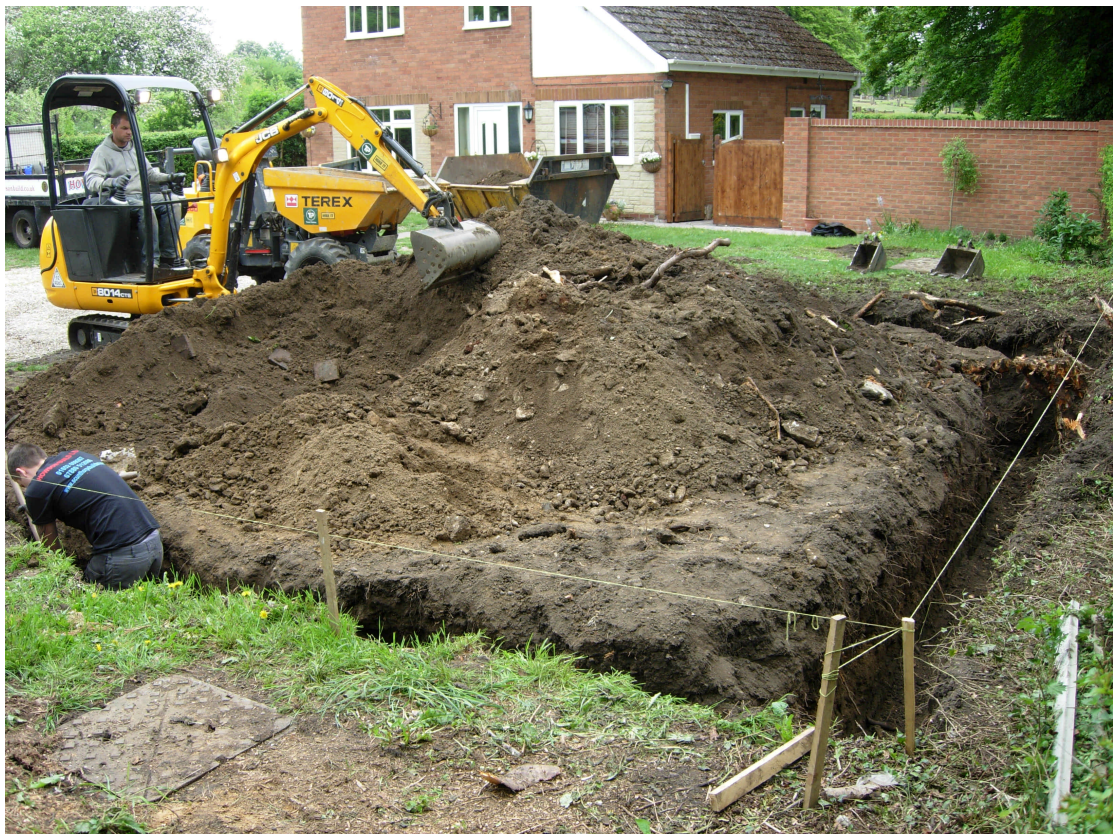
Plate 2 The garage foundation trenches viewed from the south-east

The trenches covered an area measuring 7.70m from north to south and 6.20m from east to west (47.70m²) (Figure 2, Plate 2). The trenches were 0.60m wide and 1.20m deep. No archaeological features were observed although a single potsherd was recovered from an unstratified context (1000) (see **5. Finds**). The stratigraphy observed in the trenches is described below.

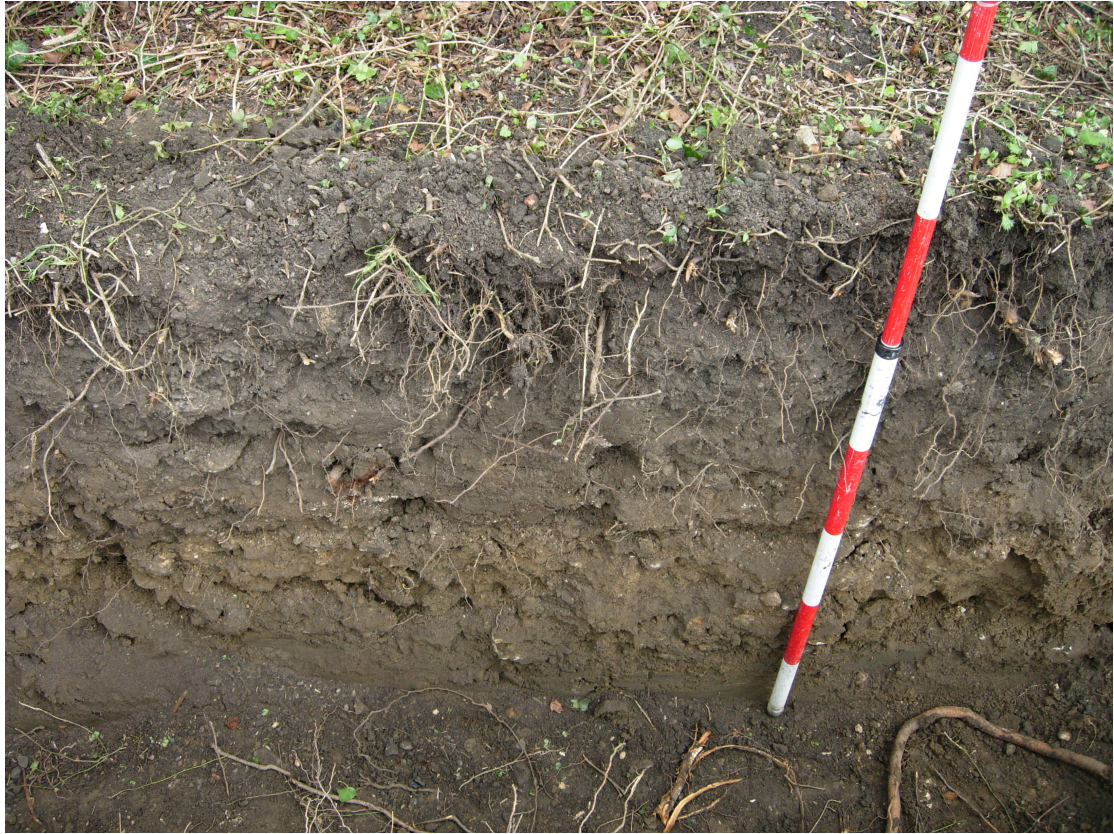
Throughout the base of the trenches there was a deposit at least 0.60m thick of a yellow-brown silt with greater clay content lower down (1003). The deposit contained occasional pieces of limestone rubble of average size 0.15m x 0.10m x 0.10m and frequent small stones (Plate 3). Above this there was a 0.40m thick layer of a dark yellowish grey-brown mix of topsoil (1001) and the 1003 already described,

containing occasional fragments of ceramic building material and small stones (1002). The topsoil above was very dark grey-brown and 0.20m thick (1001).

Plate 3 Contexts (1001)-(1003) in the garage foundation trenches

The pieces of limestone rubble noted in 1003 were similar to the rubble stone used in much of the construction of St Peter Ad Vincula. It seems likely that the ground level has been raised in the vicinity of Church House, though the buried topsoil 2003 most likely originated during the building of Church House in the 1960s or early 1970s.

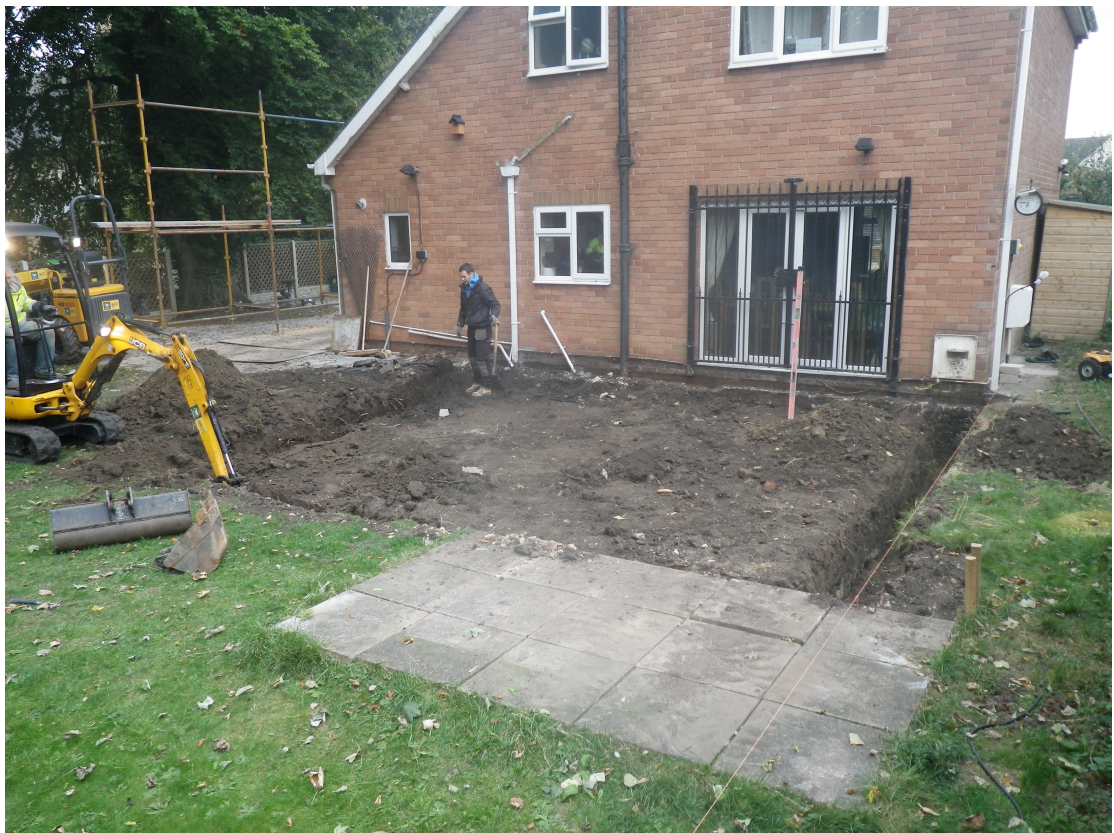
Plate 4 The extension foundation trenches viewed from the north-west

The trenches covered an area measuring 6.20m from north to south and 6.80m from east to west (42.10m²) (Figure 2, Plate 4). The trenches were 0.60m wide and 1.20m deep.

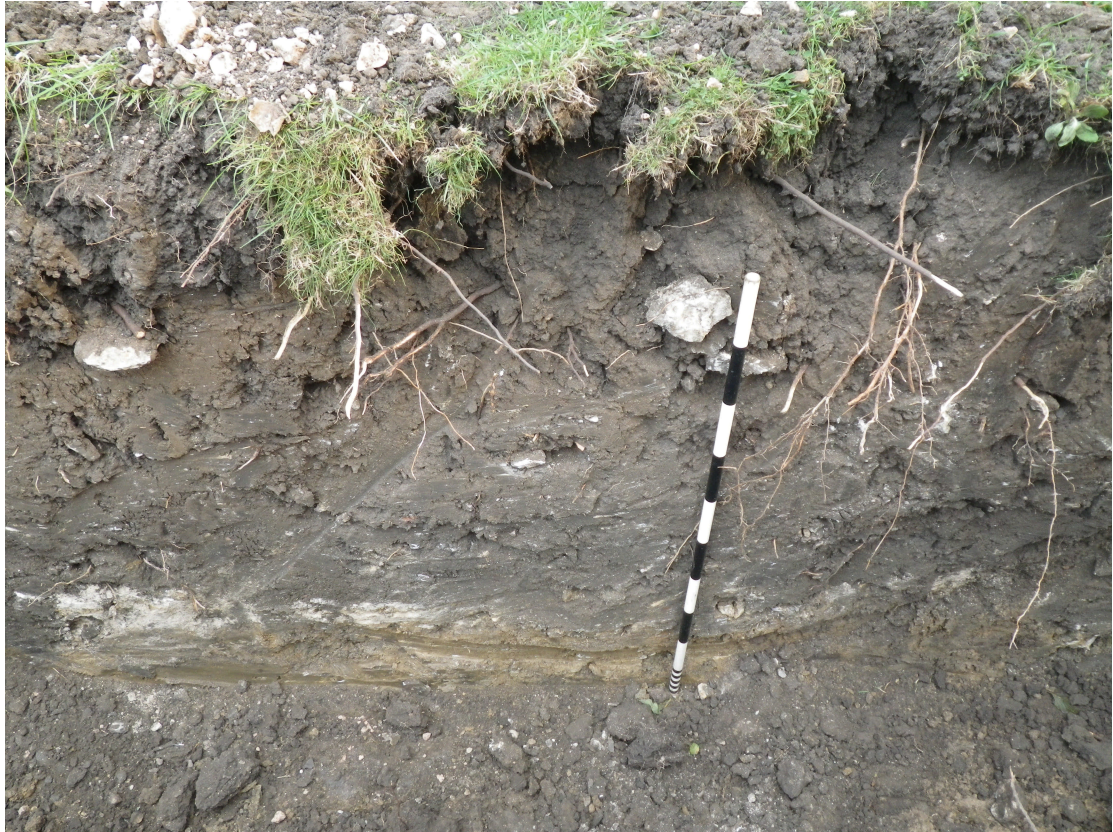
Throughout the base of the trenches there was deposit at least 0.25m thick of yellow-brown sandy silt clay with occasional patches of yellow-grey sand (2004) (Plate 5). This sand was particularly prominent in the upper part of the context, with small stones being rather more frequent in the lower part. Above this there was 0.35m thick layer of a very dark grey-brown possible buried topsoil that contained small inclusions of yellow-grey sand (2003). Above this in turn there was a 0.35m thick layer of dark red-brown sandy clay silt containing occasional small stones (2002) and a 0.25m thick layer of very dark grey-brown topsoil (2001).

Plate 5 Contexts (2001)-(2004) in the extension foundation trenches
