Archaeological Observation  
Investigation and Recording  
at  
St Helen's Lane  
Barnburgh

Site Code: WB2013.043  
National Grid Reference: SE 49600 03254  
Northern Powergrid Reference: YP15196

Watching Brief Report Number: 1388  
January 2014

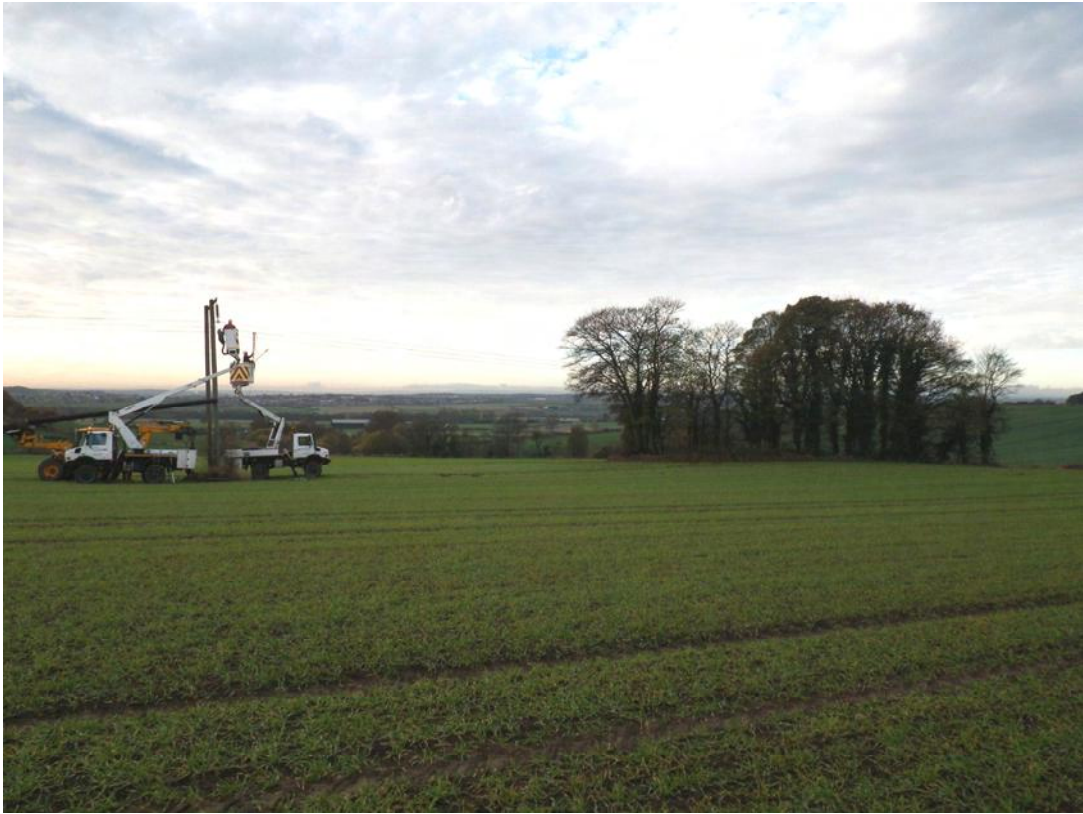
Plate 1 The site of the pole replacement (Pole 22), with the site of St. Helen's chapel to the right, looking south-west

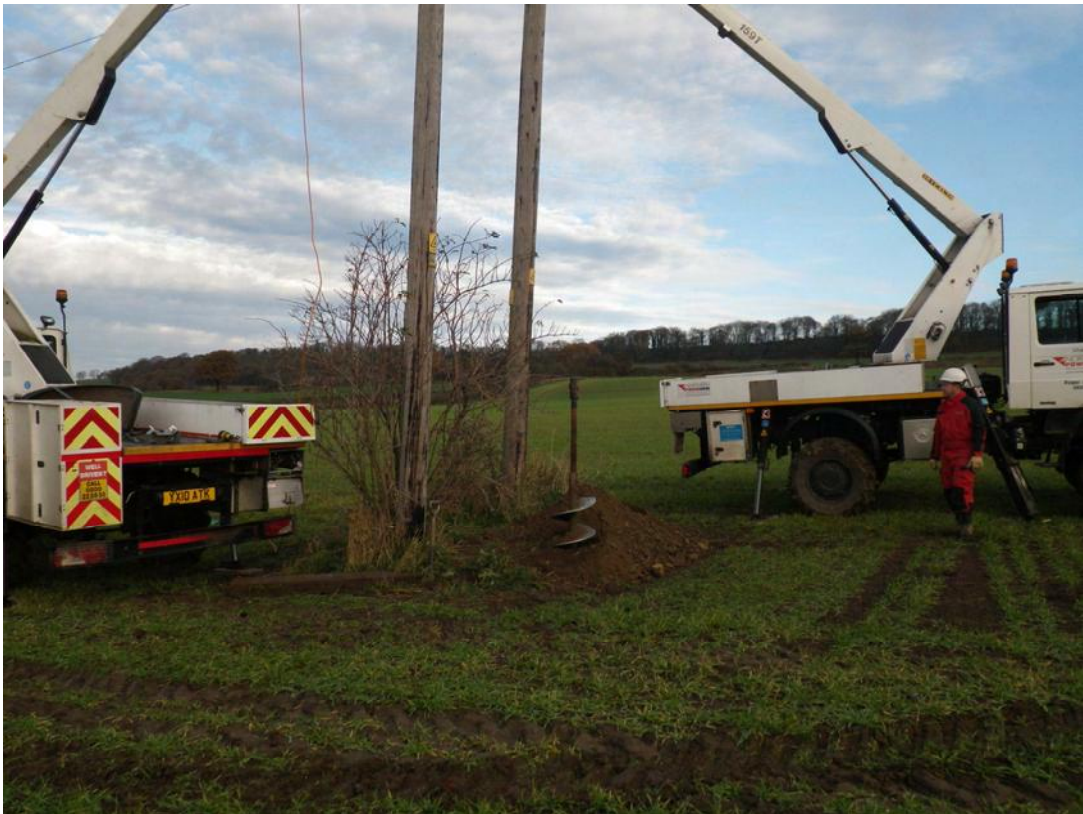
The two pole replacement holes were offset to the east of the current poles by 1.5m. Both holes were drilled using a 0.5m diameter borer to a depth of 1.6m.

In each hole, the stratigraphy consisted of 0.30m of mid to light grey brown clay silt ploughsoil (1001) over natural drift geology (1002) mid to light yellow brown very sandy silt with sub-angular to sub-rounded small to large gravels, sandstone and soapstone.

Plate 2 Drilling the replacement pole locations, looking north

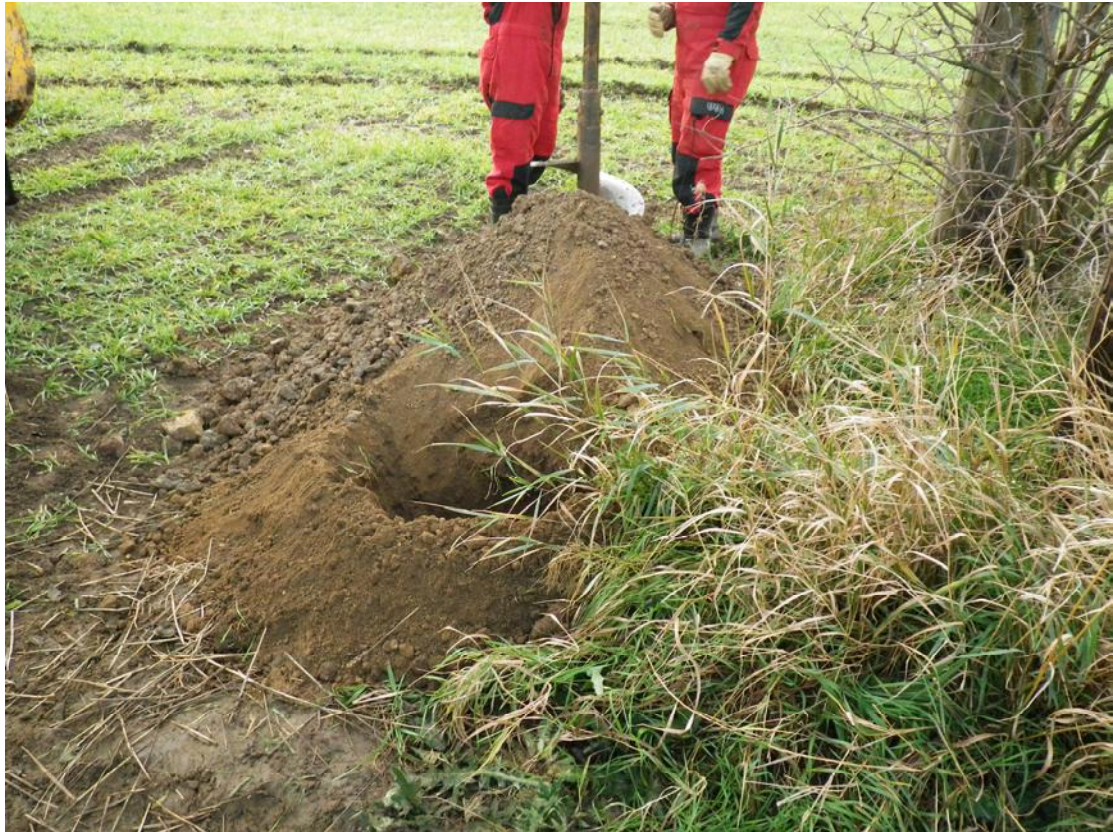
No other deposits were seen or identified within the excavations.

Plate 3 Examined spoil heaps surrounding the pole replacement area, looking south

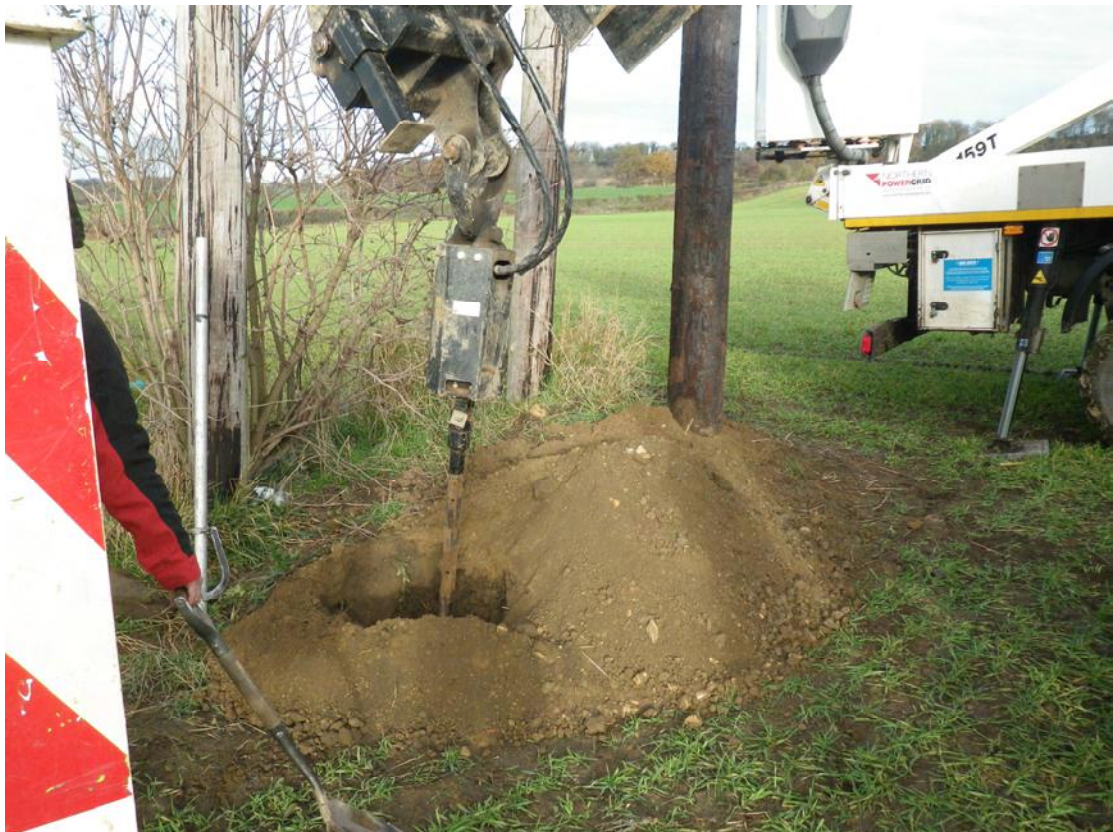
Plate 4 Drilling the second pole replacement position, looking north

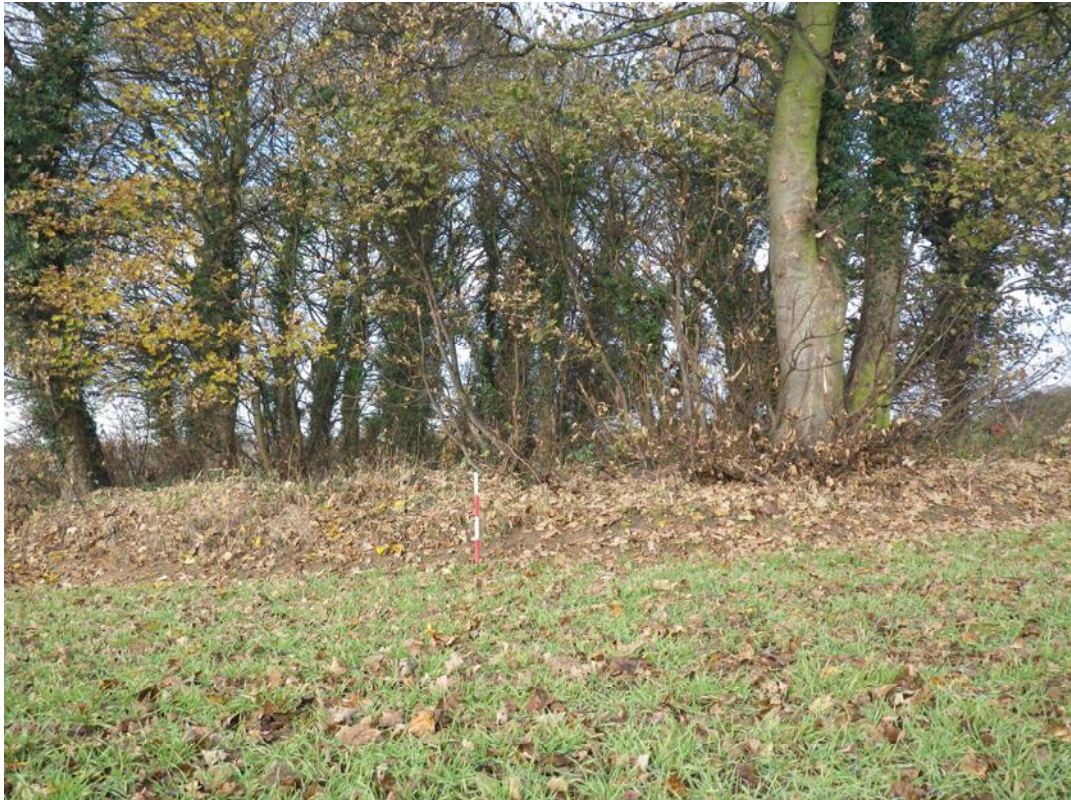
Currently, the site can be seen as a stand of trees within the same agricultural field as the current programme of work. The site stands proud of the surrounding landscape by an average of 0.5m (Plate 5). Within the site of the former chapel there are also the remains of worked masonry (Plates 6 to 8) in addition to standing remains (Plate 9).

The cursory examination of the Scheduled Monument of the site of St. Helen’s Chapel yielded some interesting results: the site is slightly mounded, being 0.5m higher than the surrounding agricultural field. There is still evidence of the outline of the church with at least one stone wall existing above ground level; the one observed was 2 courses high. Further, there are also elements of worked masonry scattered throughout the interior. There may also be further upstanding remains present, but are currently obscured by vegetation.

Plate 5 The rise in ground level around the site of St. Helen's chapel, 0.5m scale, looking north

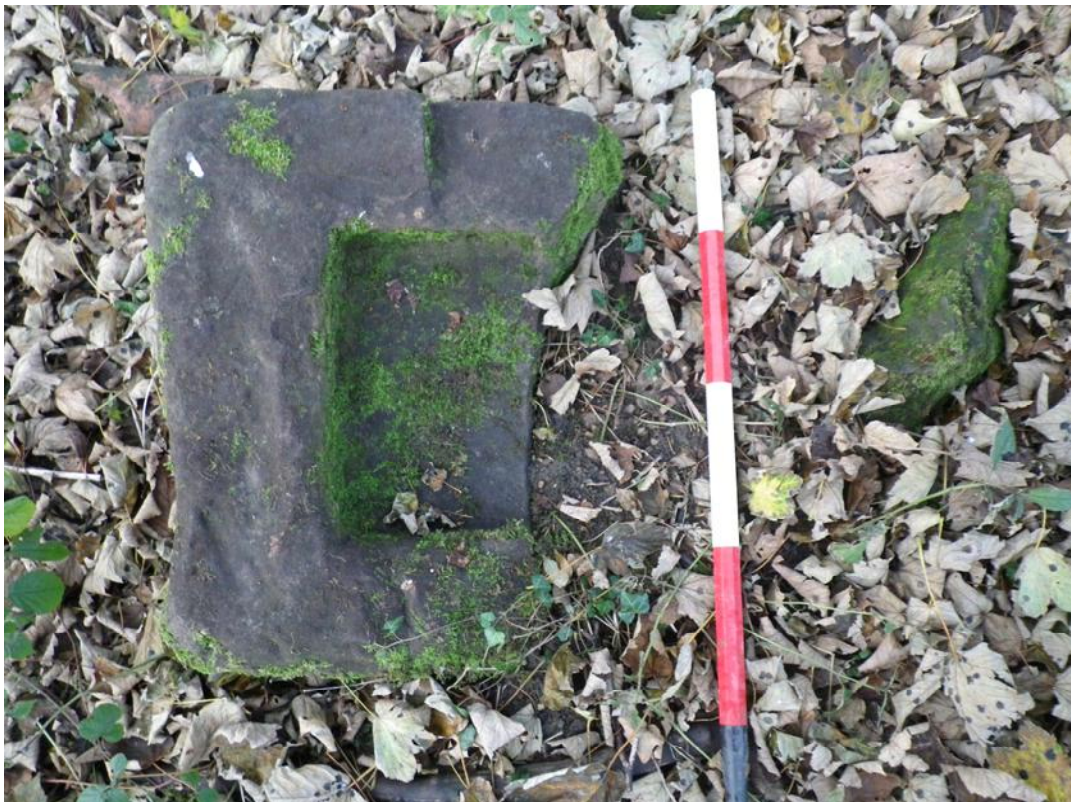
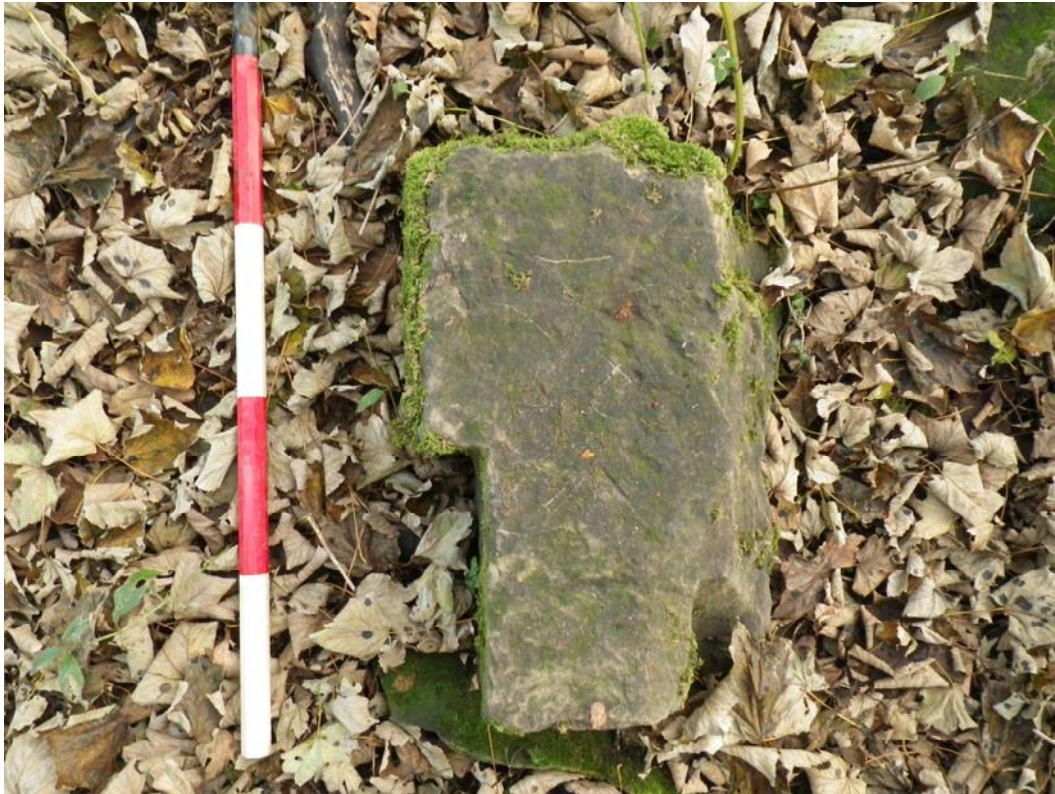
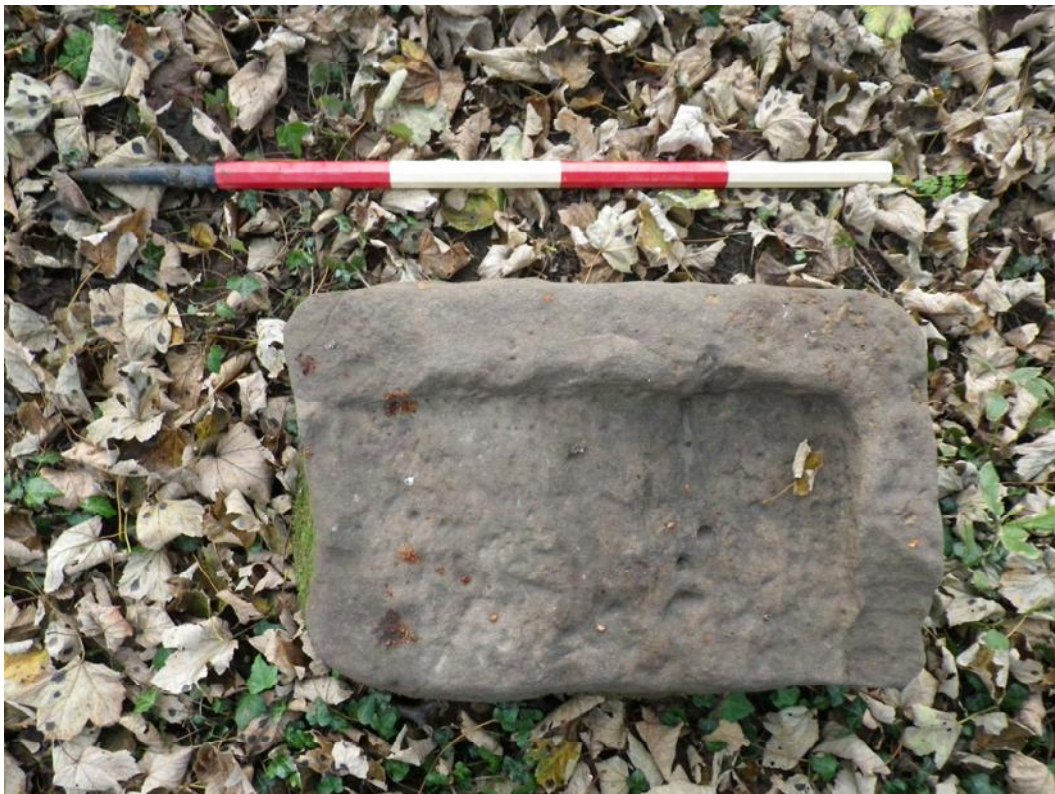
Plate 6 Masonry block within the confines of the site of St. Helen's chapel, 0.5m scale

Plate 7 Masonry block within the confines of the site of St. Helen's chapel, 0.5m scale

Plate 8 Masonry block within the confines of the site of St. Helen's chapel, 0.5m scale

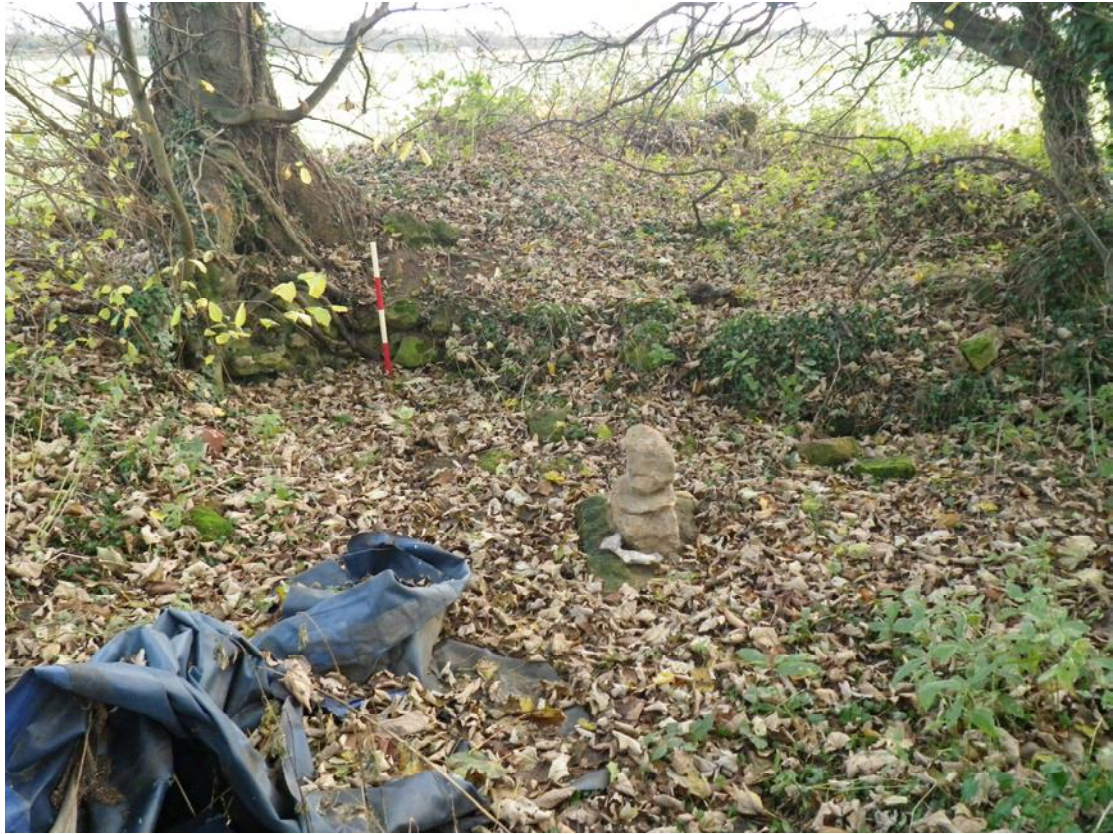
Plate 9 Evidence of stone wall foundations, prominent in the upper left near the scale bar. Looking east, 0.5m scale
