Archaeological Observation
Investigation and Recording
on
Land south of Norton Mill Lane
Norton
Doncaster

Site Code: WB2014.032
National Grid Reference: SE 5425 1579

Northern Powergrid (Yorkshire) PLC

Watching Brief Report Number: 1427
December 2014

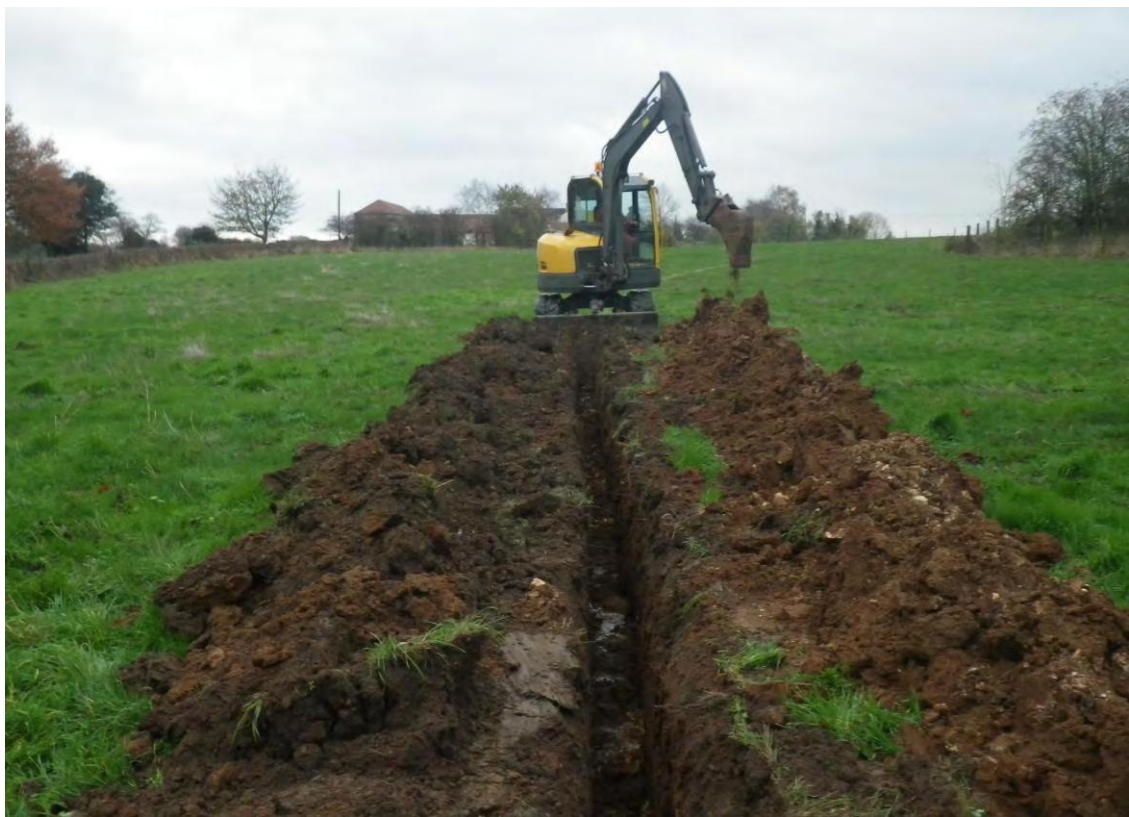
Plate 2 The most westerly part of the trench viewed from the west

In the westernmost part of the trench (Plate 2) the trench base contained chalk brash in a dark red brown silt clay matrix (1003) (Plate 3). At this stage the brash was of unknown thickness. Above this there was a 0.70m thick layer of dark red brown sandy silt clay that contained very occasional inclusions of chalk fragments in its lower part (1002). This layer also grew progressively sandier towards the very western end of the trench. The (1002) was in turn topped by a 0.20m thick layer of dark grey brown topsoil (1001).

The westernmost part of the trench was only around 150m from the River Went and so the greater presence of sand in the (1002) at this end of the trench probably indicated a fluvial origin for much of this material. The presence of large blocks of chalk in the (1003) at the southern end of the trench indicated what would have spurred the excavation of the quarry in the second half of the 19th century.

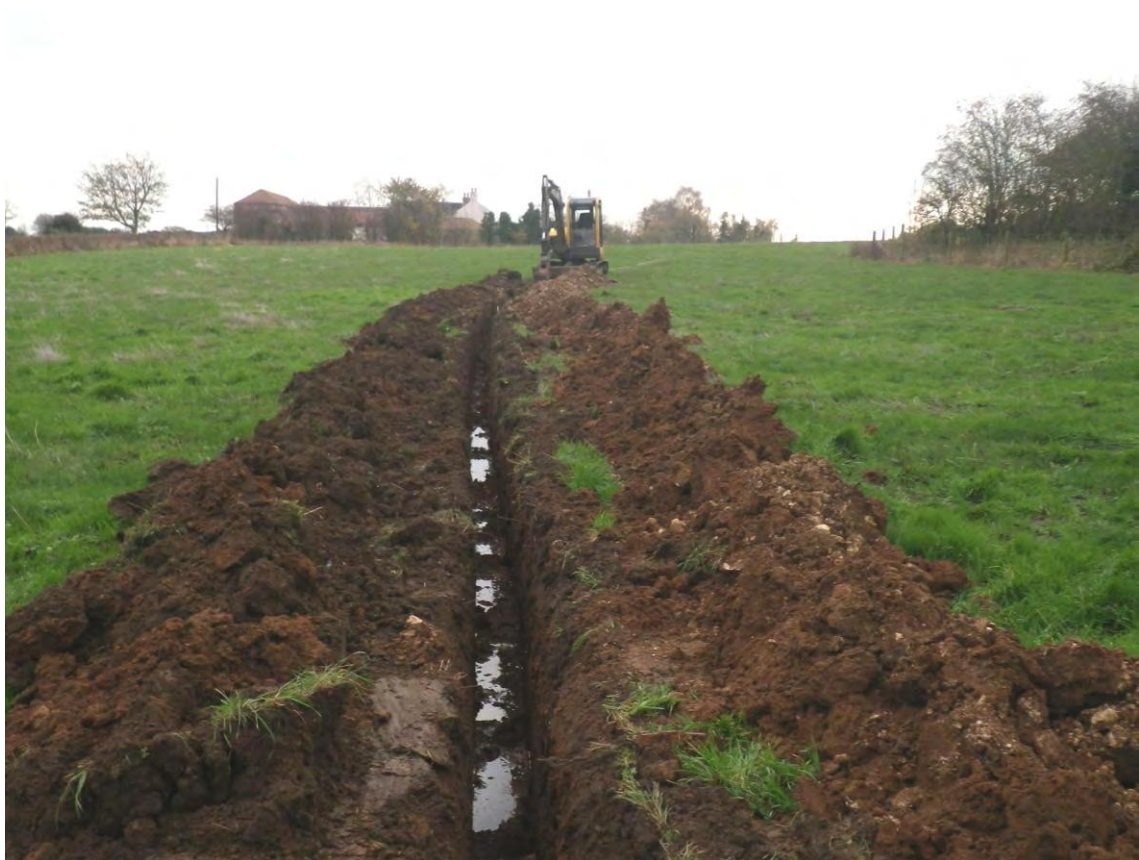
Plate 4 The central part of the trench viewed from the west

Towards the central portion of the trench (Plate 4) the base of the trench contained a layer at least 0.40m thick of (1003), with an 0.20m thick layer of (1002) and a 0.30m thick layer of (1001) above (Plate 5).

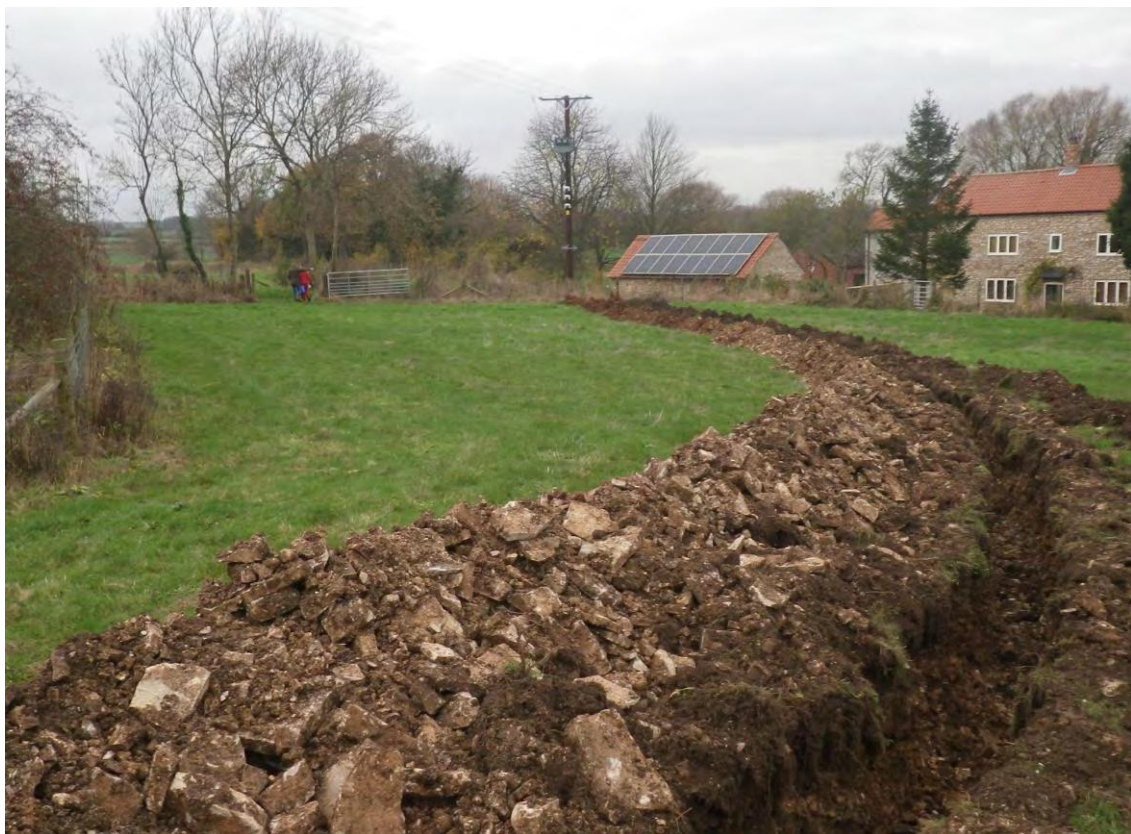
Plate 6 The bulk of the trench viewed from the south-east

Finally, in the southernmost part of the trench (Plate 6) the base contained a layer at least 0.70m thick of (1003), the blocks of chalk here being significant larger than those encountered to the north and west (Plates 6 and 7). Above the (1003) the layer (1002) was absent or negligible, there being a 0.20m thick layer of (1001).
