Archaeological Observation
Investigation and Recording

St. Martin's Church
Womersley

Site Code: WB2015.006

Watching Brief Report Number: 1444

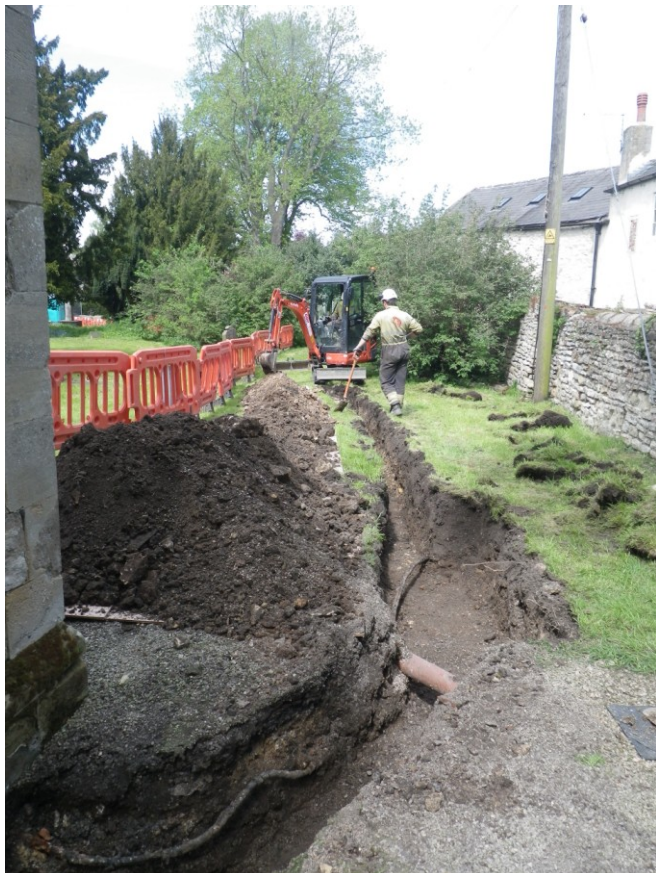
Plate 2 Section A under
excavation, looking north

The first 14.50m stretch of the trench saw a layer, 0.25m thick, consisting of frequent pieces of limestone rubble and occasional fragments of non-diagnostic ceramic building material 103 lying between deposits 101 and 102. On average, the limestone pieces were 170mm x 100mm x 80mm and did not present any evidence of being worked, whole pieces.

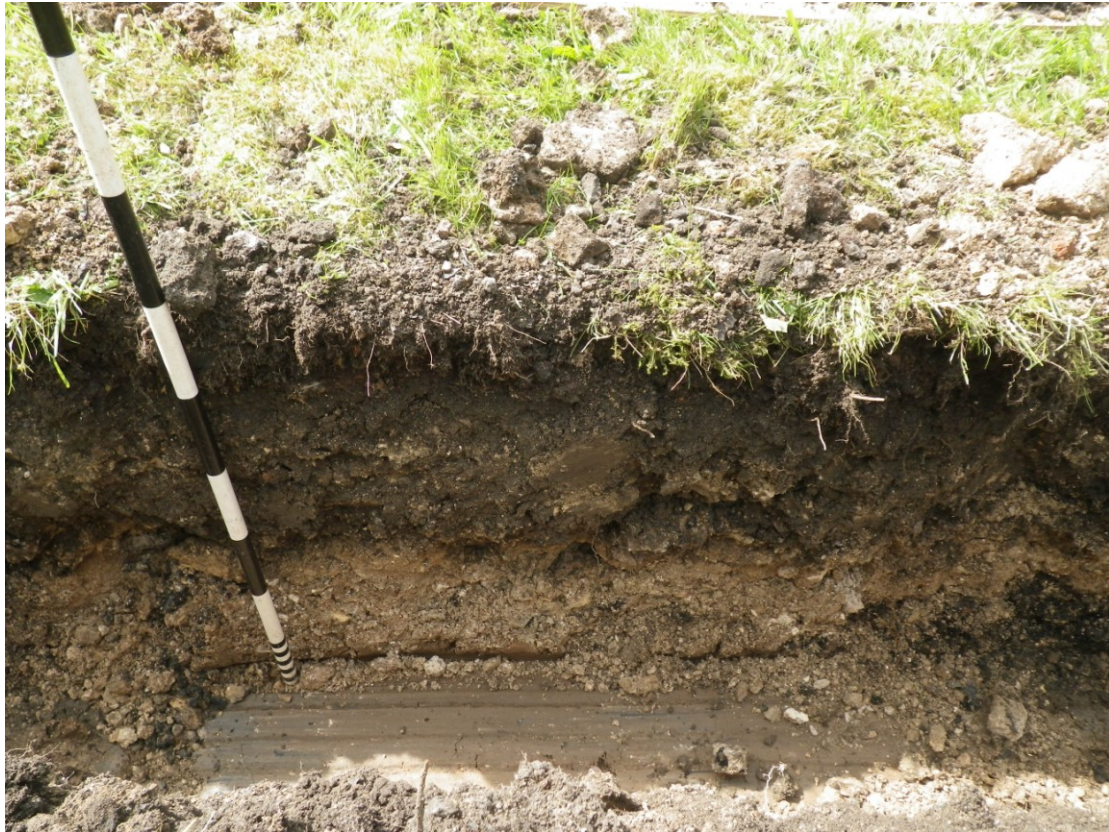
Plate 3 View of the rubble layer 103 set between topsoil 101 and clays 103 within section A, looking west (1m scale)

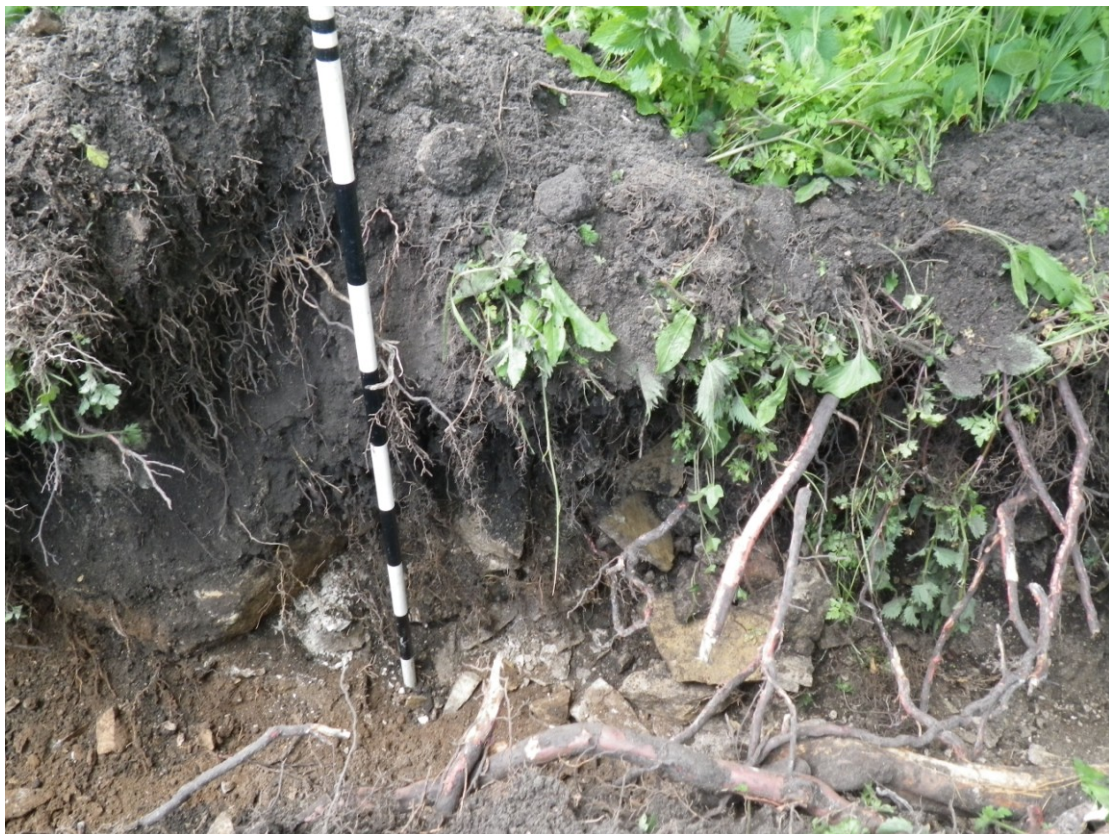
Plate 4 View of the rubble 104 in section B, looking east (1m scale)

Following a gap of 17.60 where only deposits 101 and 102 were seen, there was a section of the trench, 9.80m long, which presented a further layer of limestone rubble, albeit consisting of larger pieces (640mm x 220mm x 180mm, 230mm x 230mm x 200mm, 400mm x 230mm x 120mm for example) together with occasional fragments of non-diagnostic ceramic building material fragments (104). This layer was up to 0.40m thick and lay between deposits 101 and 102.

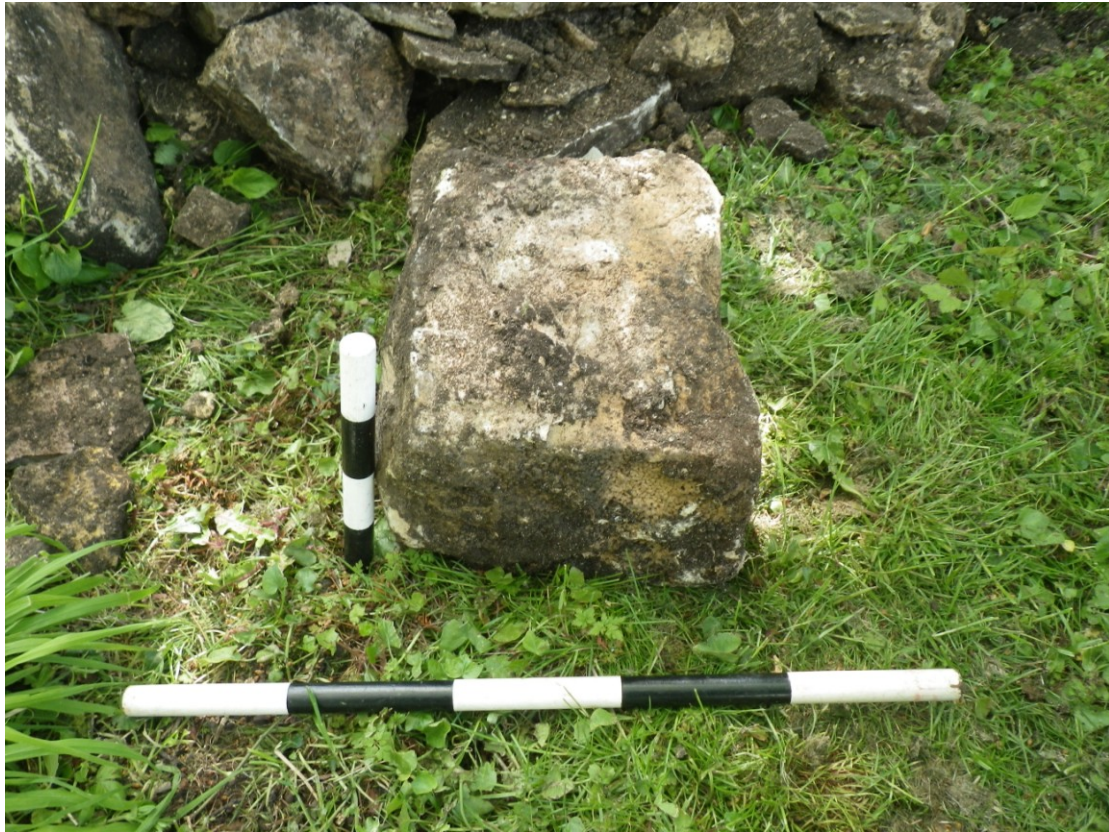
Plate 5 An example of the limestone blocks arising from deposit 104 (0.2m and 0.5m scales)

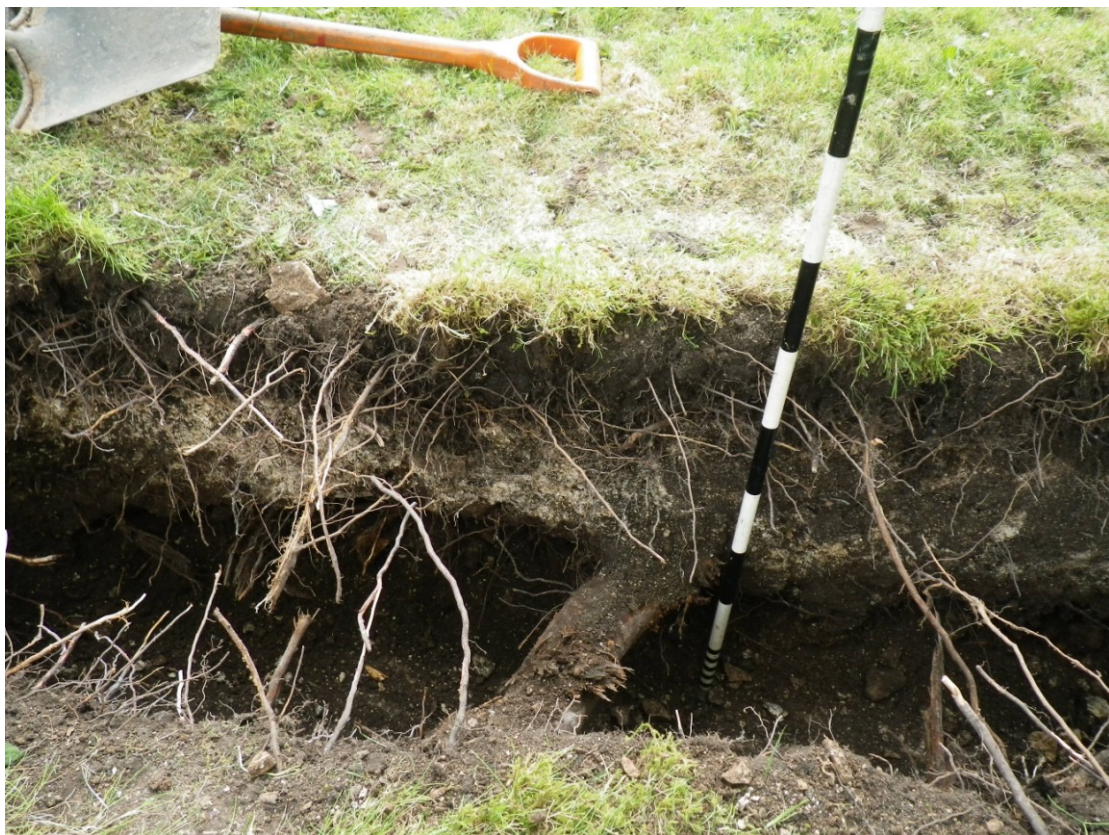
Plate 6 Mortar spread 105 in section C, looking east (1m scale)

After a shorter gap of 2.65m, there was a 5.71m wide spread of cream/white lime mortar 105, up to 0.20m thick lying between deposits 101 and 102. 105 appears to represent a dump rather than a consolidated surface horizon.

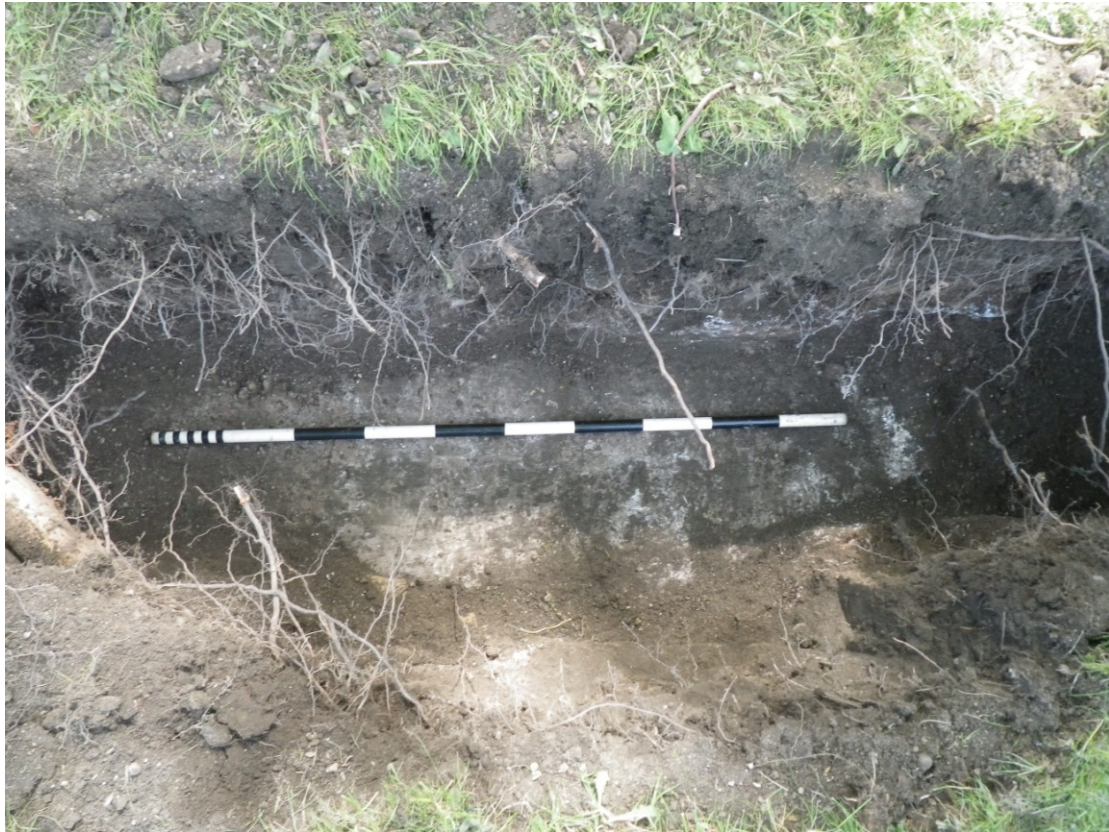
Plate 7 Hardened surface horizon 106 (section D), looking east (1m scale)

6.75m further north, there was evidence of a surface horizon 106, up to 1.69m wide and 0.10m thick which consisted of consolidated pale cream/white lime mortar

combined with non-diagnostic brick fragments lying below the topsoil 101. This may represent a path or similar surface.

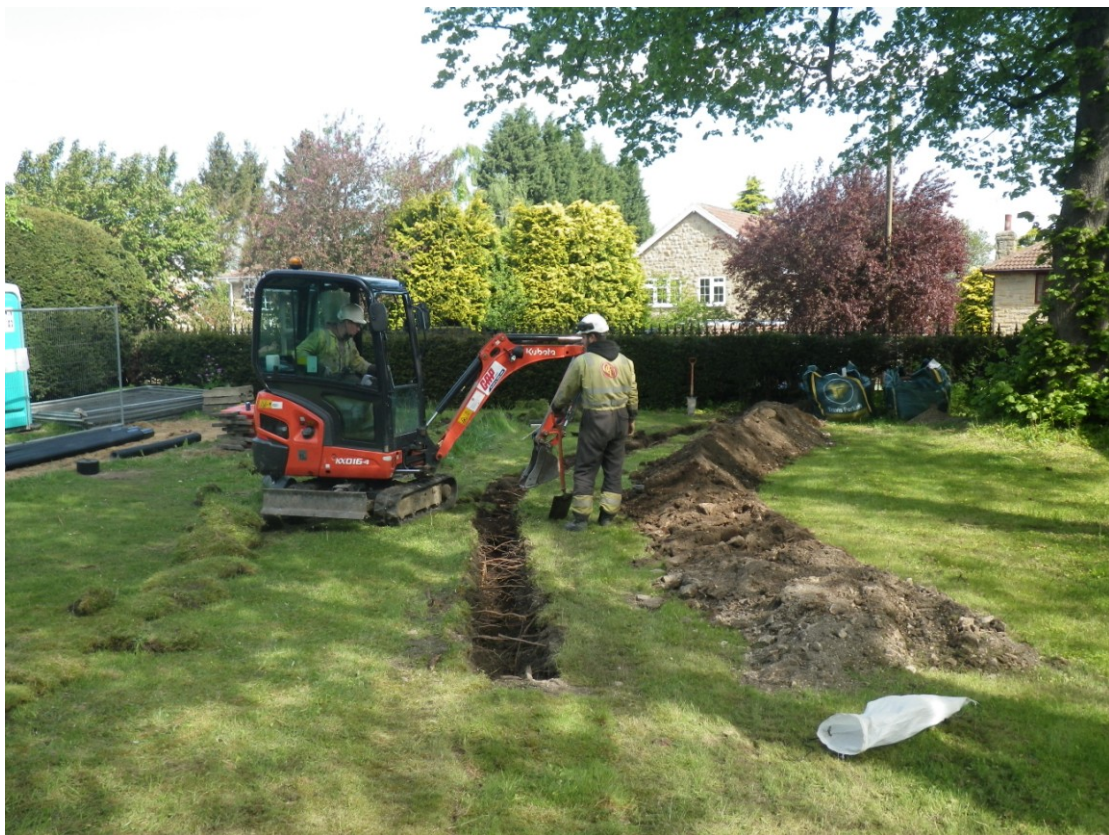
Plate 8 Showing excavation work at the northern end of the trench route (sections D and E), looking north

Immediately to the north of surface 106, and butting it, was a localised deposit of limestone rubble 107 (average size 200mm x 150mm x 80mm) up to 1.72m wide and 0.25m thick lying below deposit 101. The proximity of 106 and 107 may indicate an element of contemporaneity.

There were no further deposits or stratigraphic change seen between the presence of 107 and the northern churchyard boundary.
