Archaeological  
Metal Detecting Survey  
and  
Watching Brief  
at  
Hill Top Farm  
Hodgson Lane  
Birkenshaw

Site Code: WB2016.003

Northern Powergrid  
and  
John Hall

Watching Brief Report Number: 1468  
May 2016

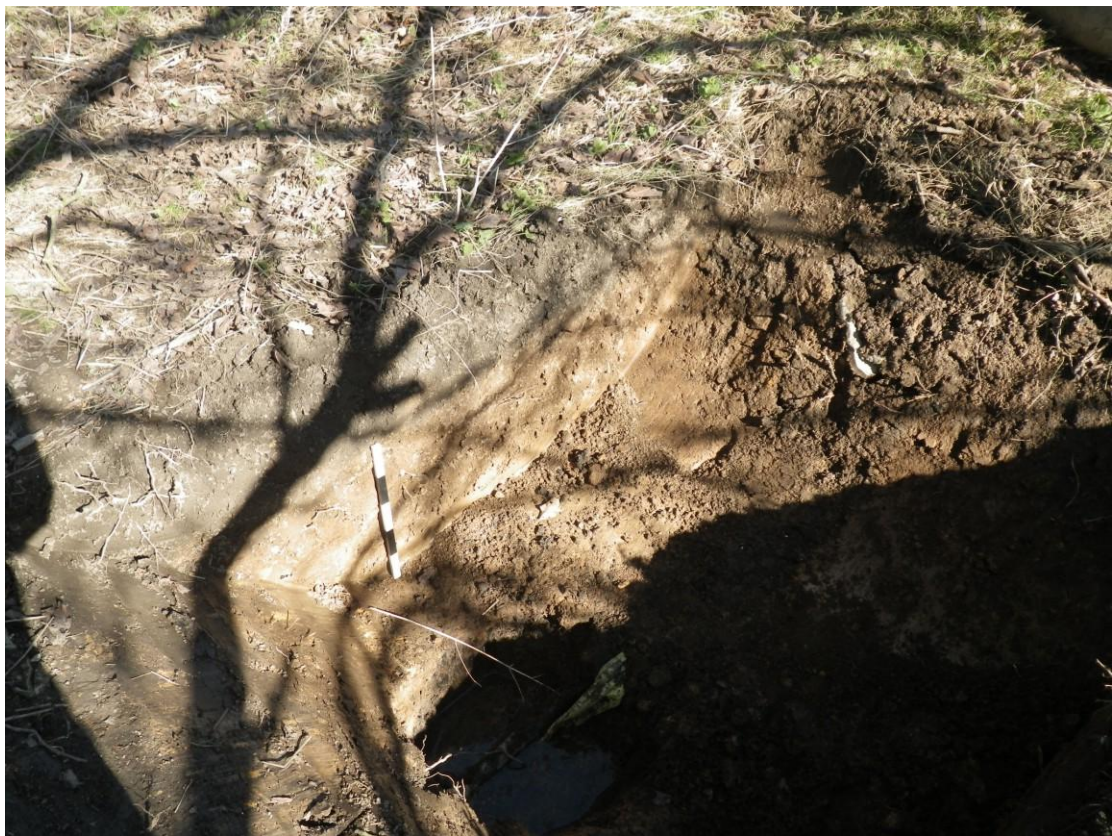
Plate 2 Portion of excavation to the east of the southern access road to Hill Top Farm, as viewed from the south-west and showing contexts 1001 and 1002 (0.5m scale)

This marked the very eastern end of the cable trench excavation (Figure 2). The area excavated measured up to 2m from east to west by up to 1.70m from north to south (Plate 2). The easternmost point of the excavated area was at SE 2120 2861, 190.260m AOD. It was up to 0.80m deep and throughout its base there was a layer at least 0.50m thick of dark orange brown natural clay containing very few inclusions (1002) above which there was a 0.30m thick layer of very dark grey brown topsoil (1001). No archaeological features were observed in the excavated area.

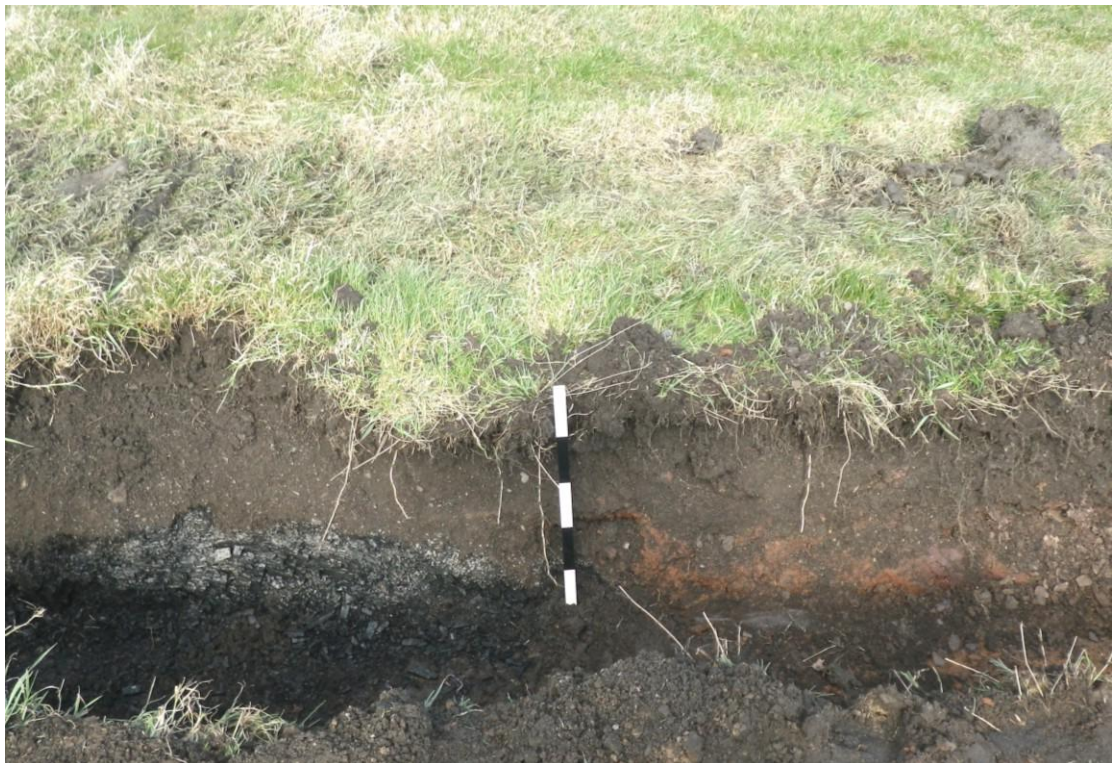
Plate 6 Layer of charcoal and burnt clay 1003 beneath the 1001 in the central portion of the cable trench (0.5m scale)

In the central portion of the trench an area of ash and burnt clay (1003) at least 0.20m thick was observed in its base covering an area measuring around 5.50m by at least 0.70m (Figure 2, Plate 6). The (1003) extended from SE 2112 2864 (189.150m AOD) to SE 2113 2864 (188.390m AOD). Above it the (1001) was 0.30m thick.

The layer of burnt material (1003) was very likely modern in origin. Metal detecting for any pre-modern finds was hampered by the proximity of the excavations to the modern complex of farm buildings and the spread of ferrous waste usually associated with such sites.

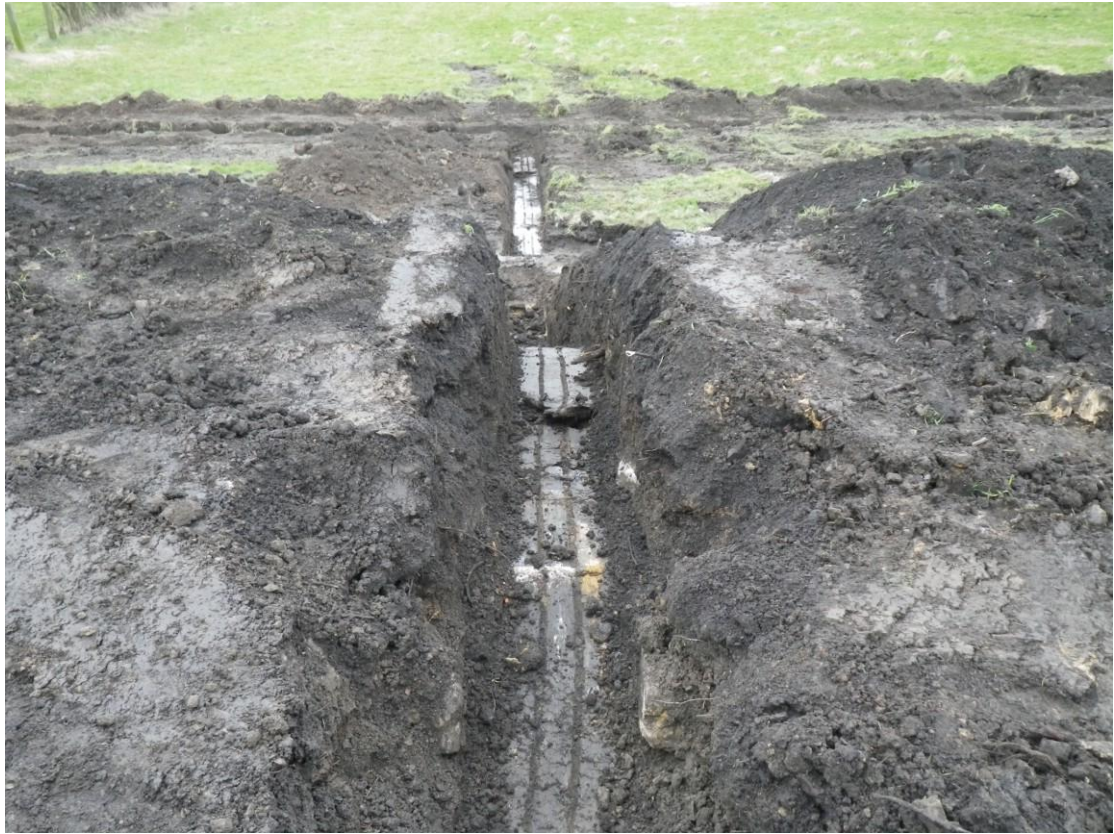
Plate 9 The cable trench spur viewed from the north

This ran north from the main trench (SE 2115 2827, 188.100m AOD) for around 17m and terminated close to the farm buildings (SE 2115 2864, 192.020m AOD). The topsoil (1001) here was far thicker than observed elsewhere on site, being at least 0.50m thick (Plate 9). No archaeological features were observed in the trench.
