Archaeological Observation
Investigation and Recording
at

Manor House
Thorpe Lane
Thorpe in Balne
South Yorkshire

Northern Powergrid (Yorkshire) PLC

Watching Brief Report Number: 1476
July 2016

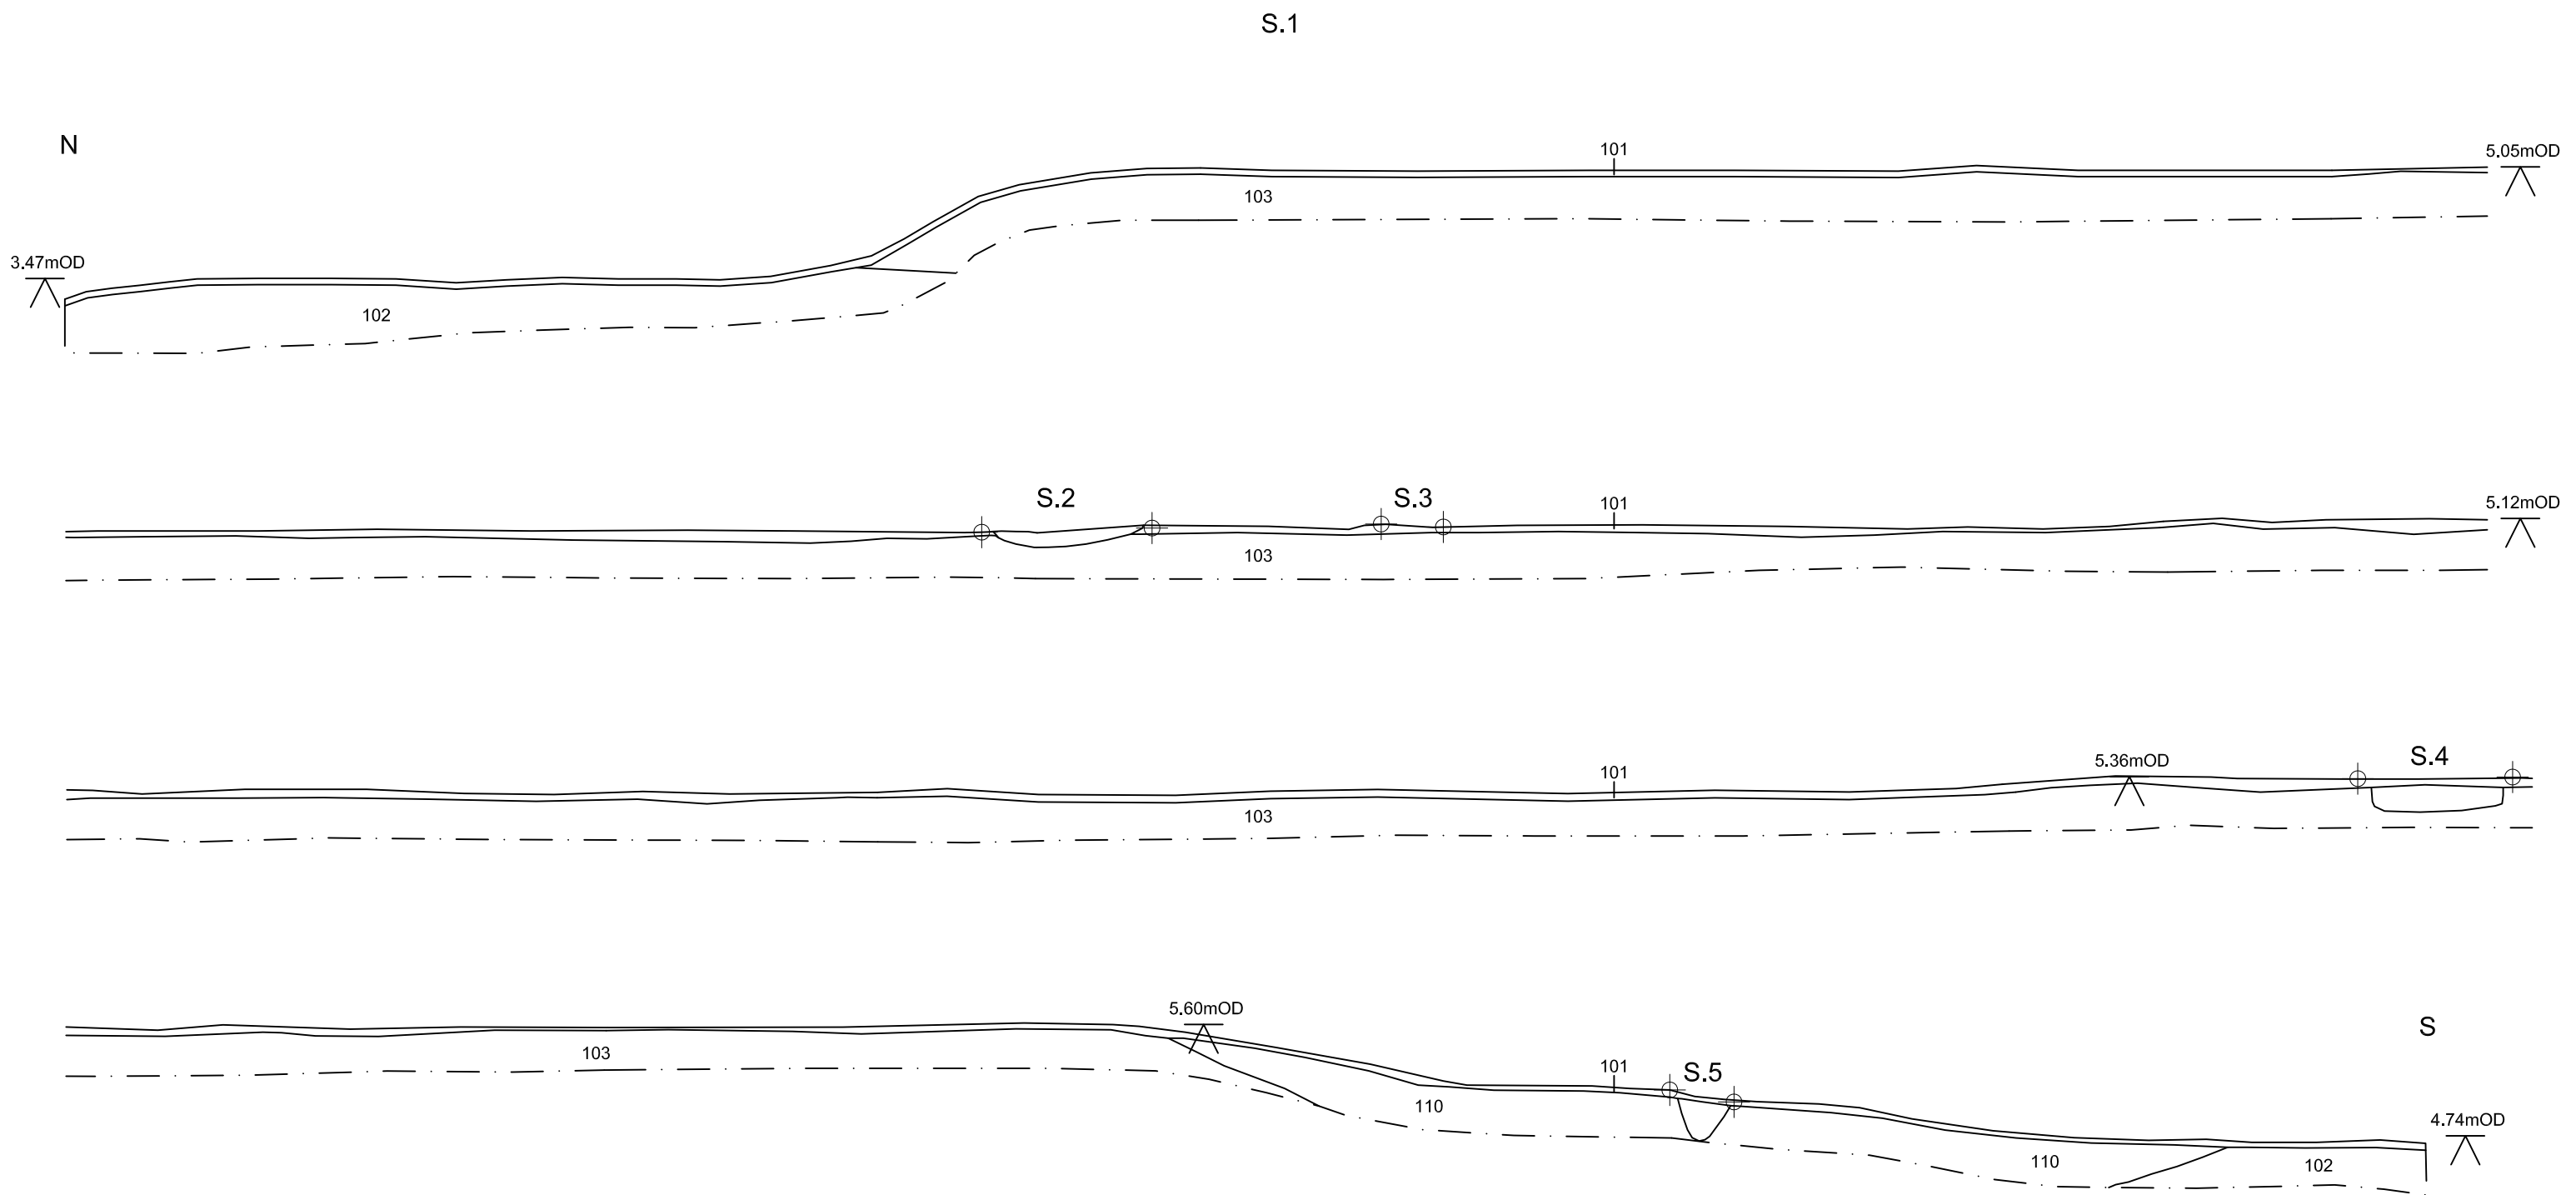
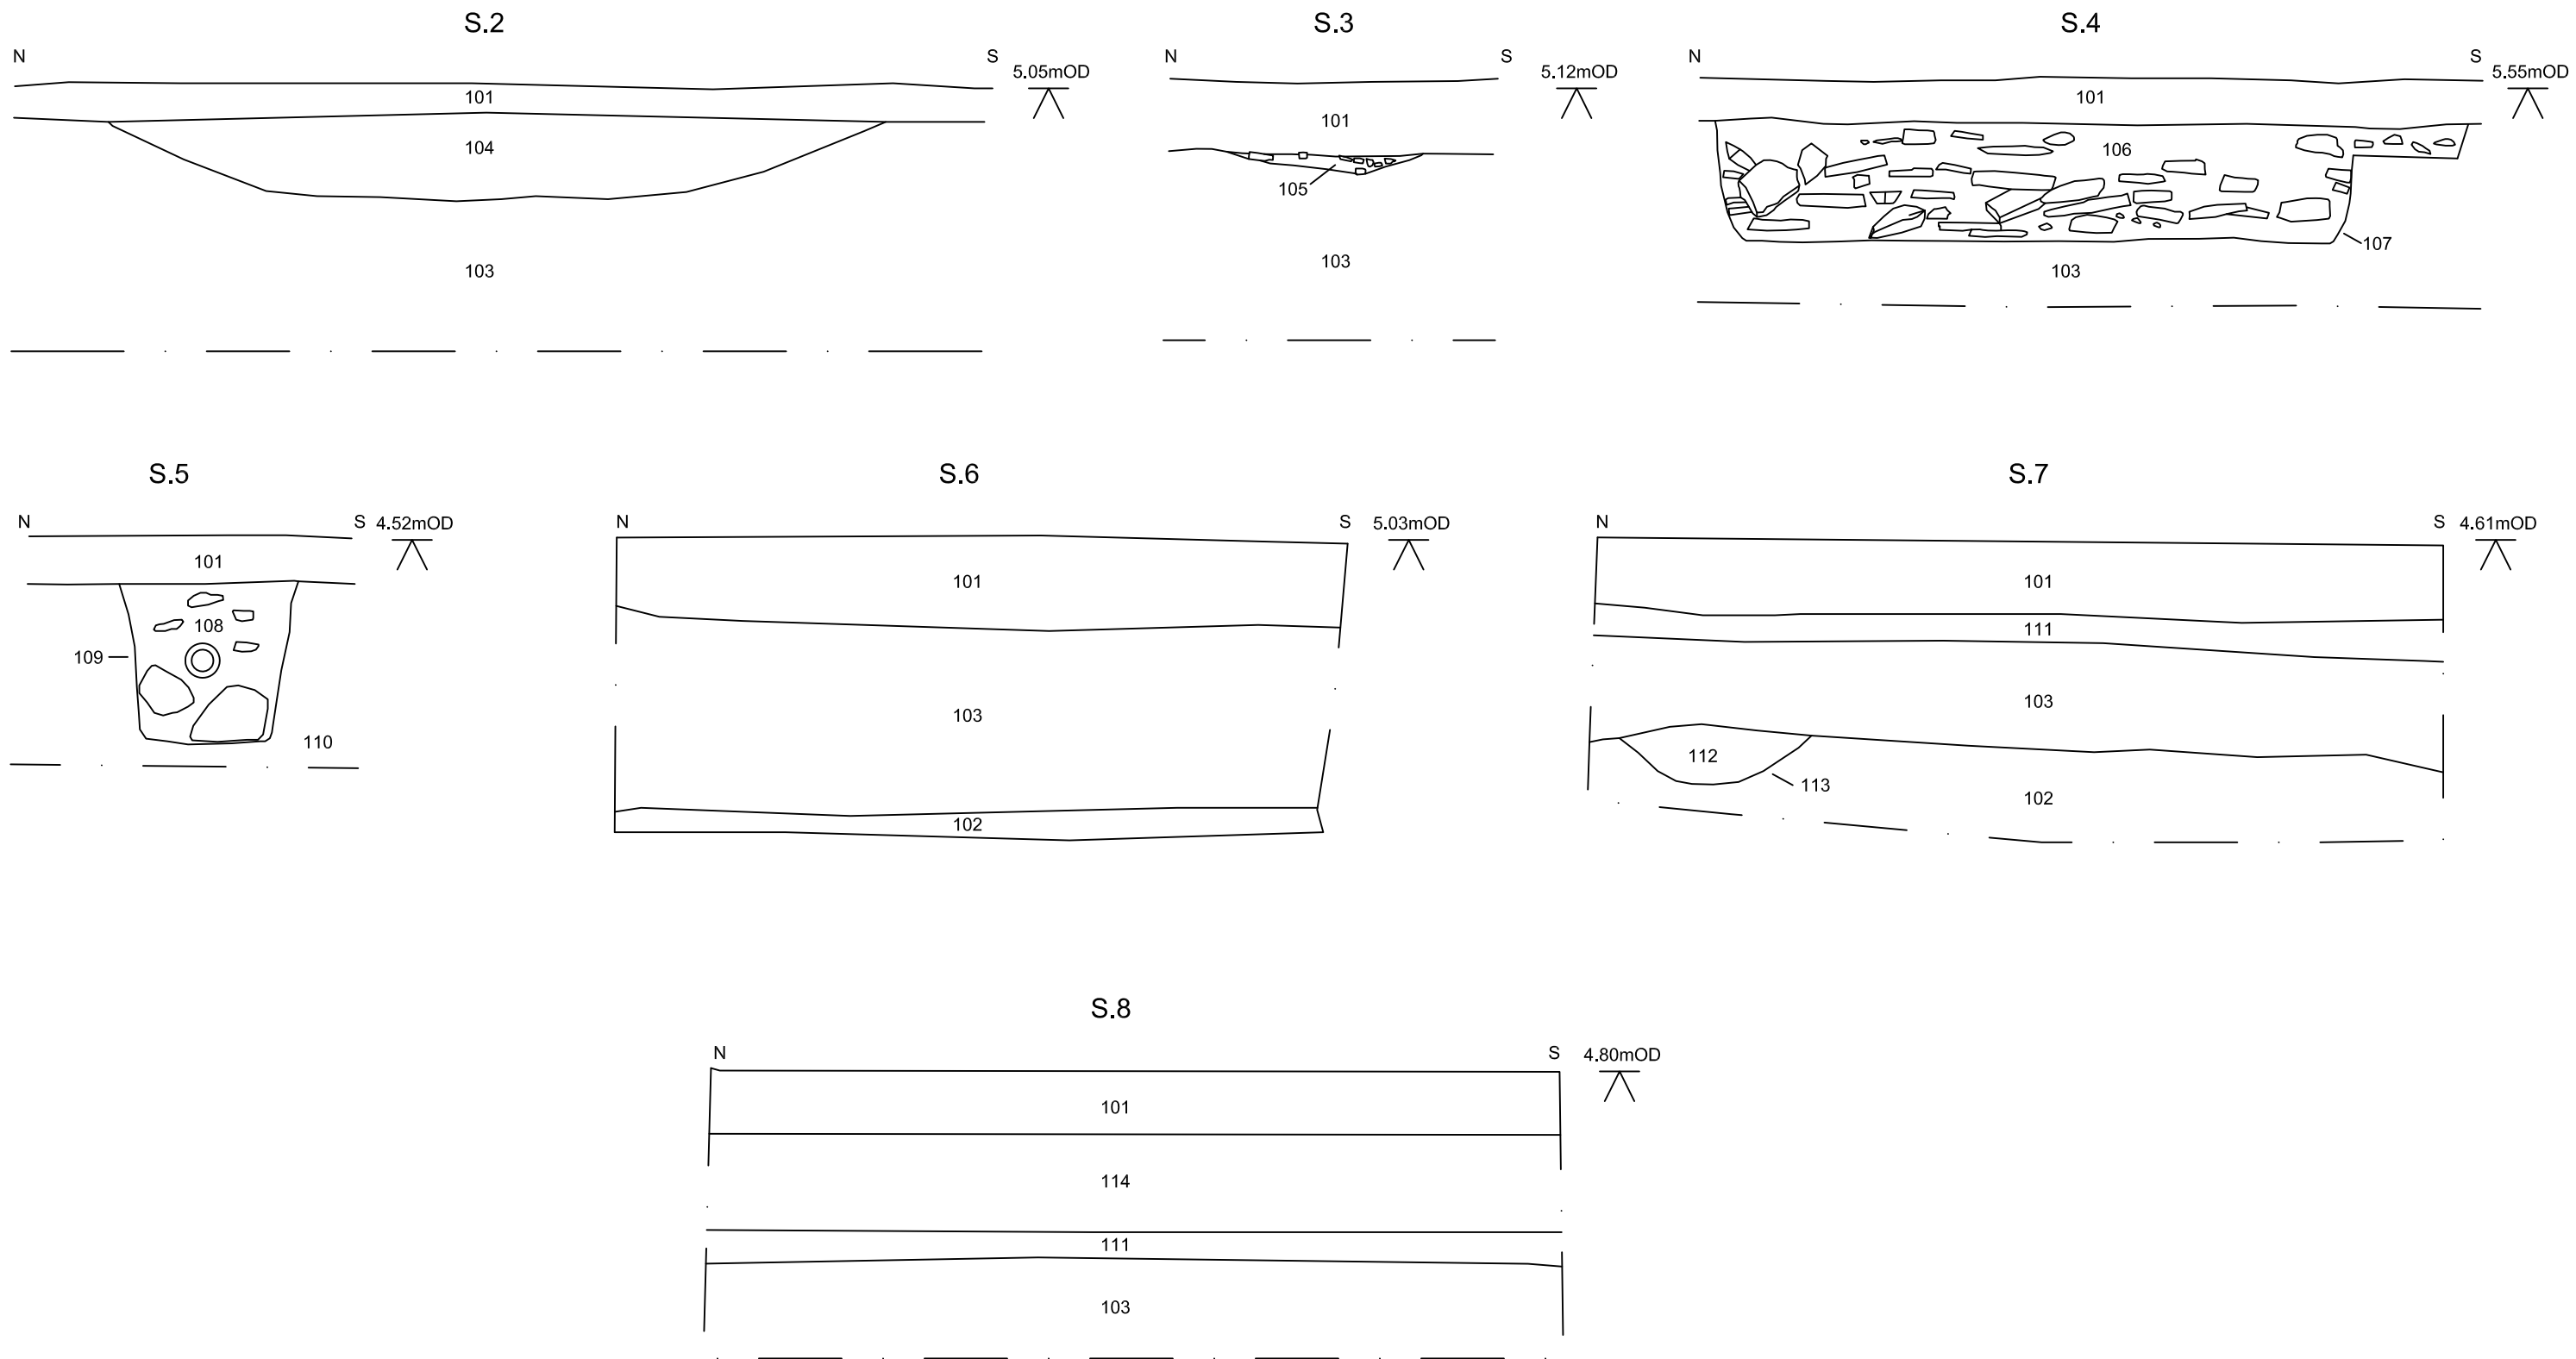
- Figure 1 Site location plan (in red)
- Figure 2 Plan showing the route of the cable trench, mole pit locations and section positions
- Figure 3 Section along the full length of the cable trench showing position of further, detailed sections
- Figure 4 Recorded features and deposits in section

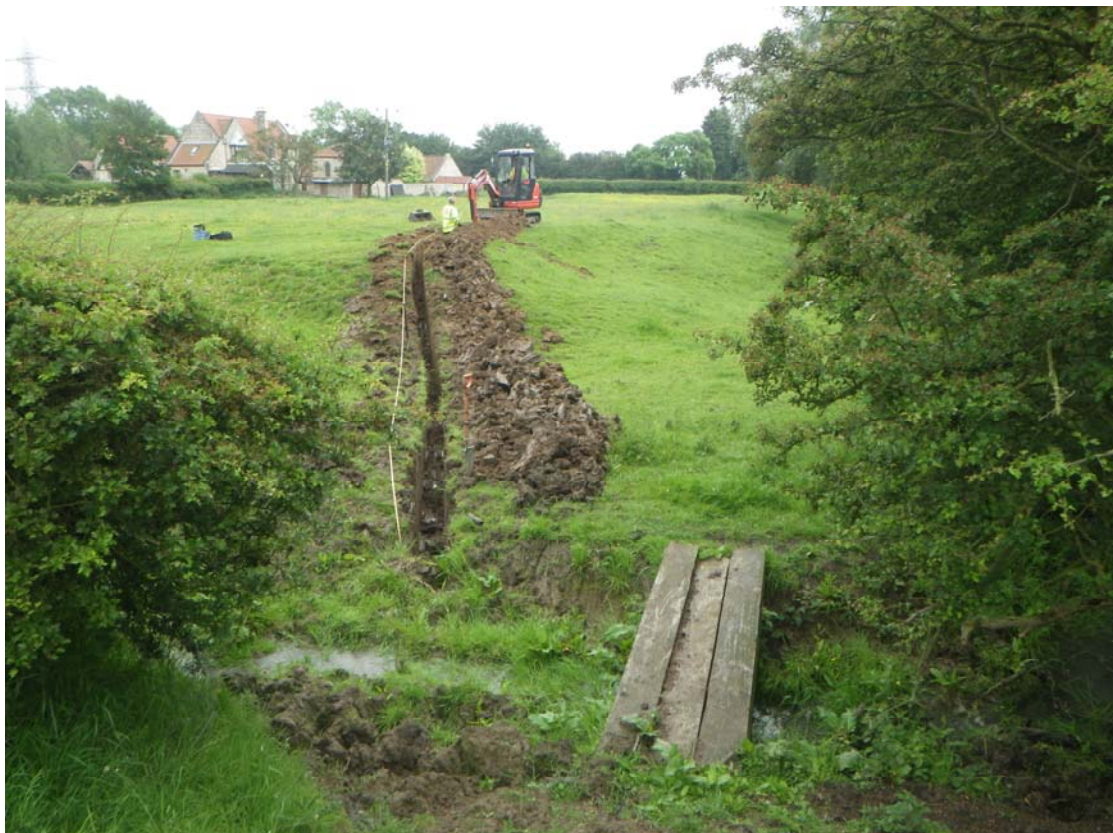
Plate 2 Initial cutting of the cable trench at the NW corner, starting in the moat working up onto the platform, looking SE

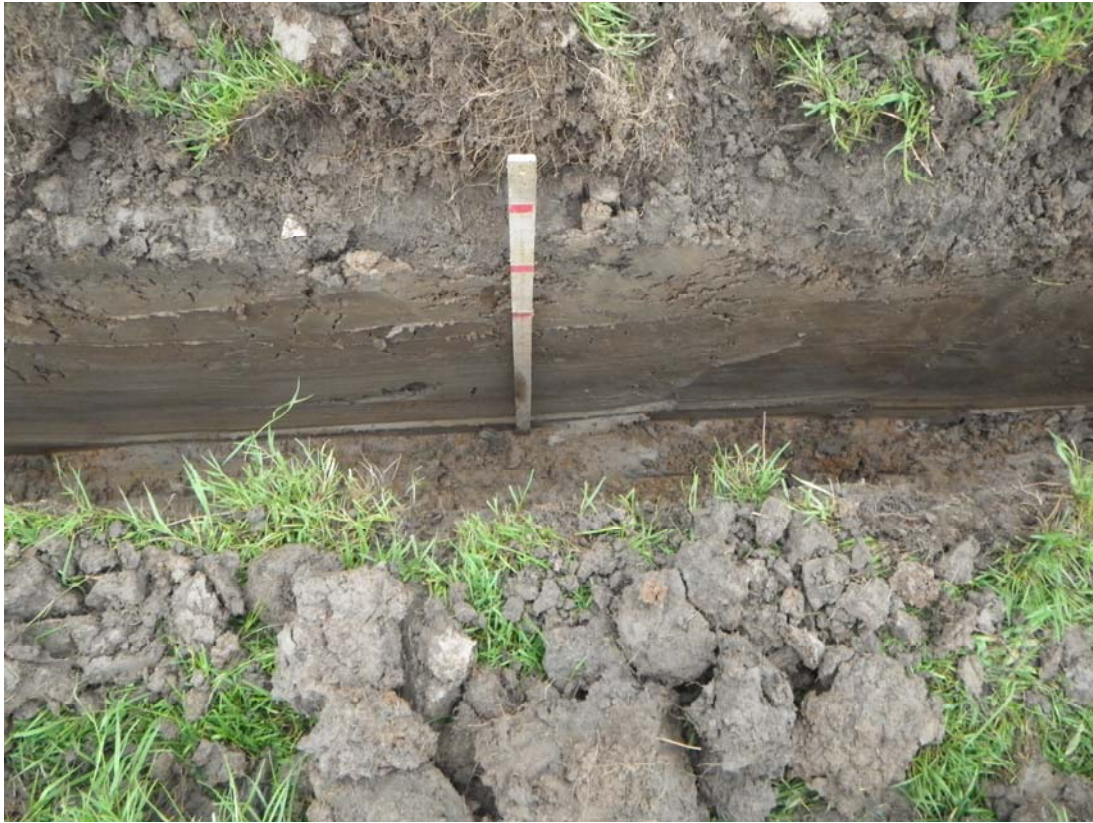
Plate 3 Sample profile of the moat in the NW corner, showing natural clays 102 underlying a thin band of topsoil 101, looking SW (1m scale)

The trench was at its deepest in the NW moat area. Ground level here was at 3.307mOD, the depth of the trench reaching up to 1.20m below that (2.11mOD). The deposit lying below the 0.10m thick topsoil 101, was natural clays 102 (weathered 25-Foot Drift material). It was clear that this part of the moat may have had regular cleaning, or certainly was fully cleaned by the 19th century. Other than the topsoil and natural clays, no other deposits were seen in this part of the moat section.

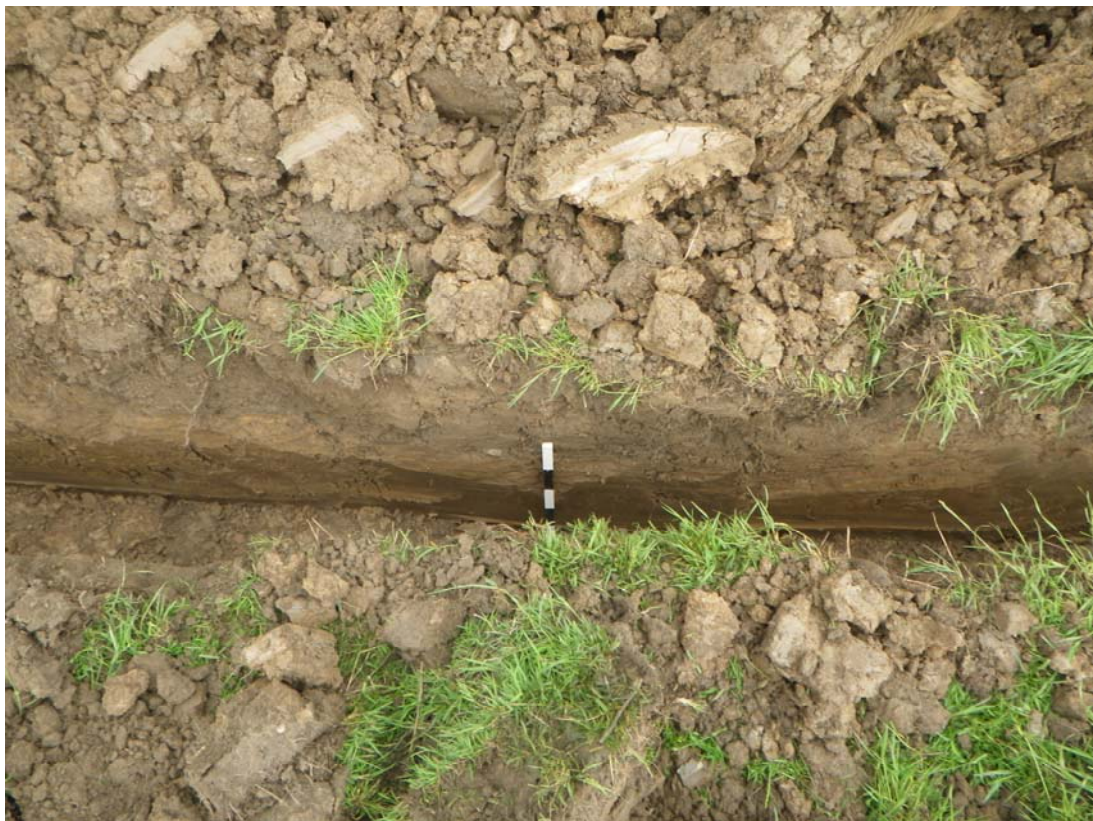
Plate 4 Path-type depression 104, running W-E across the site at its approximate mid-point, down into the moat. Looking W (0.5m scale)

The ground level along the western edge of the moat platform was remarkably similar throughout. It changed in very few instances: at a point 55m from the N boundary, there existed, as an earthwork, the remains of a path or shallow holloway, the alignment of which is depicted on Figure 2. At this point, the ground level lessened slightly to 4.95mOD. The cable trench profile clearly showed a thickening of the topsoil, here re-contexted as deposit 104, being up to 0.22m thick (or 0.34m thick if including the topsoil proper, 4.73mOD) and up to 2.40m wide with a shallow, concave profile. There were not any particularly distinguishing characteristics

between 101 and 104; however, it was clear that a distinction was needed to separate the topsoil from the 'path' deposit. At ground level, the holloway/path exited the W edge of the moat platform to continue down the embankment at the W.

The path/holloway 104 is actually extant as an earthwork running E-W from the centre of the moat platform out the upper boundary and down into the moat itself. This suggests longevity of use of the path and/or a major route within the complex itself.

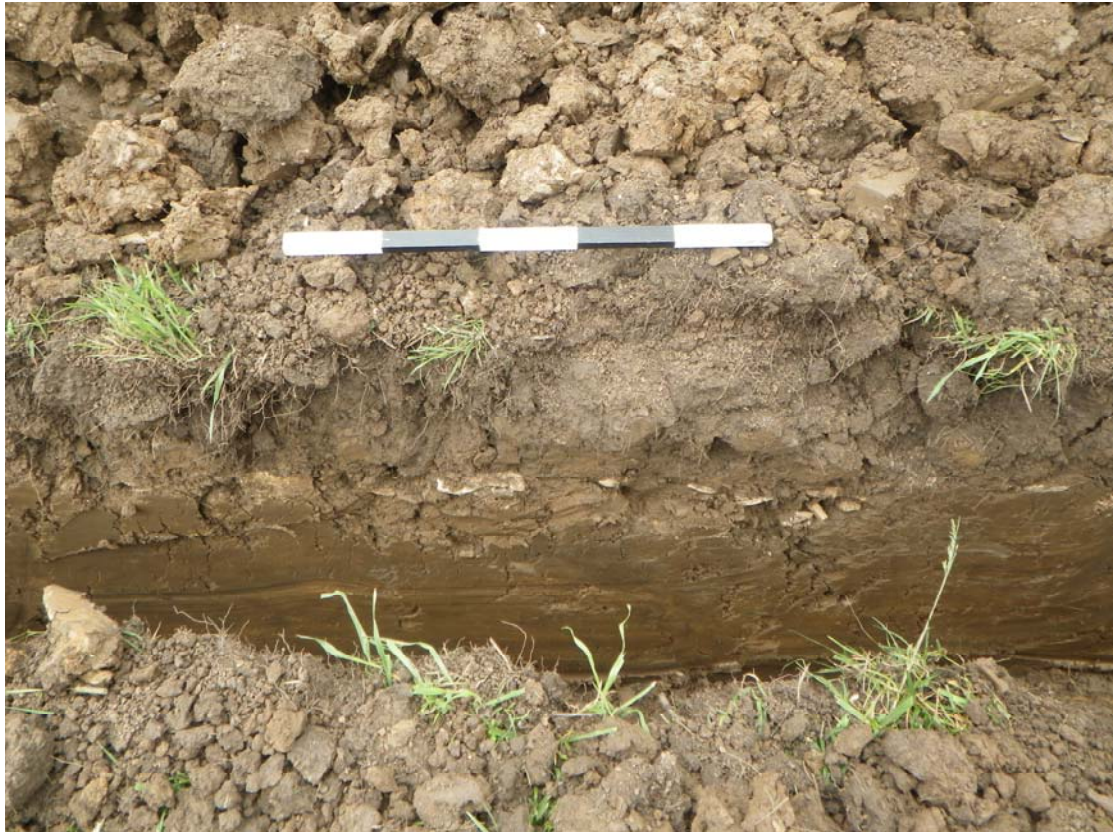
Plate 5 Path-type depression 105, looking W (0.5m scale)

After only a short distance of 6.42m to the south, a further path remnant, 105, was recorded. Here, the topsoil 101 was thicker at 0.22m (ground level 5.12mOD). The path remnant consisted of darker soils and frequent small, angular stone fragments and chips, well-sorted, within the soil matrix, up to 0.65m wide and 0.05m thick (4.82mOD).

A buried path, 105, lies a short distance to the S of 104. No trace of this can be found as an earthwork at ground level currently.

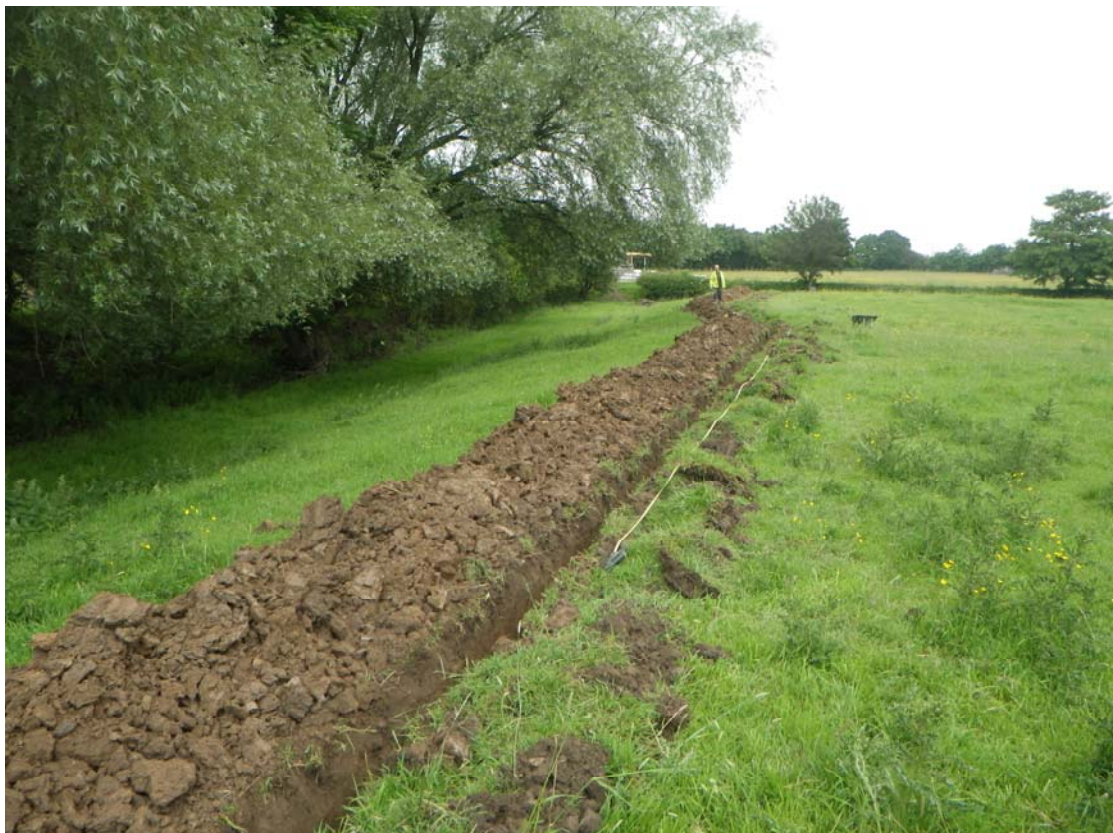
Plate 6 General view of the cable trench as it cuts along the upper western edge of the moat platform, looking NNW

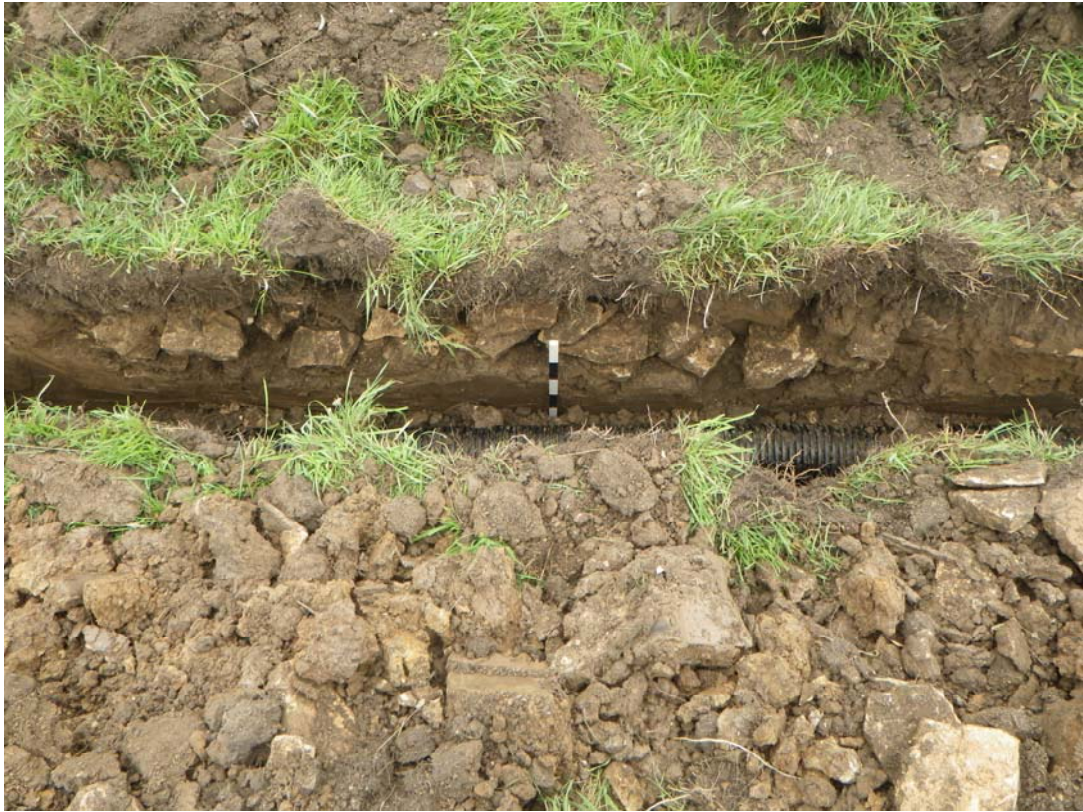
Plate 7 Stone structural element (wall foundation) 106 within cut 107. The cable trench appears to cut obliquely along it. Looking E (0.5m scale)

At a point 36m N from the S corner boundary of the site were the substantial, and well-preserved, remains of a stone wall foundation 106. Ground level had increased here to around 5.50mOD. The topsoil averaged 0.15m thick (5.35mOD). The foundation cut, 107, was up to 0.35m deep (5.00mOD). The width of the cut, in profile, was 1.95m, however, it was clear that the cable trench had cut along the foundation at an oblique angle: the cable trench had turned slightly NNW-SSE and it appears that the wall may have run NS, so the profile was running almost along the centre-line of the foundation. The foundation consisted of what appears to be yellowish sandstone, split into roughly squared or rectangular slabs (not blocks). Of the full size slabs available, their dimensions ranged from 120mm x 120mm x 30mm to 250mm x 200mm x 40mm. The foundation was clearly disturbed at its upper level, with an influx of mid-light brown sandy loam present at the top of the deposit matrix.

Substantial stone wall foundation 106 is perhaps the most important archaeological discovery during the current programme of work. As the trench cut obliquely along the wall, it is suggested that the wall orientation is N-S, running parallel to the upper W embankment. The wall was offset from the top of the embankment by around 1m to 1.5m. It may be possible that the structural material recorded here may correlate with some of the data observed during the geophysical survey undertaken at the site during the 1980s (JMM 1987 in Rowe 2009). The wall certainly confirms that there are substantial structural elements present lying below ground level within the manorial platform. Certainly, other significant structural elements were recorded during an evaluation to the north of the modern Manor House building 2008 (Rowe 2009); the current work implies that buildings and other structures were present in different areas of the platform during the medieval period, even if they were not all contemporaneous.

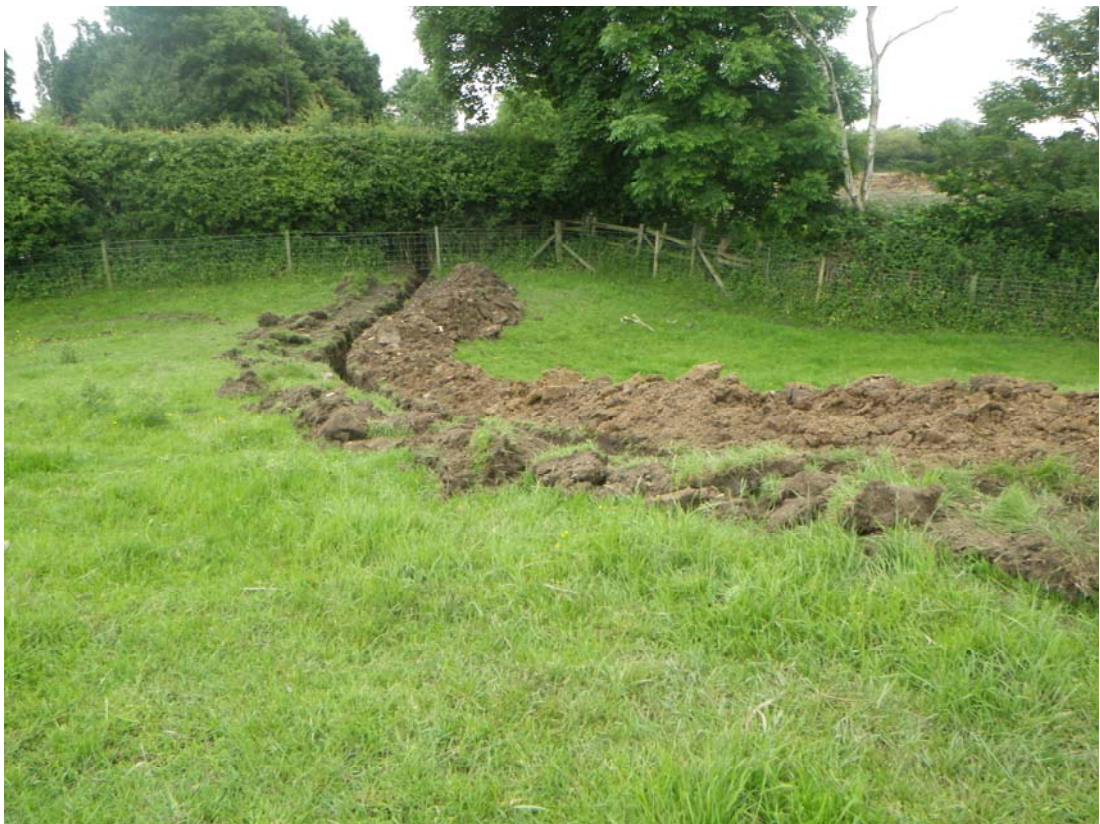
Plate 8 The cable trench as it passes down into the moat in the SW corner of the site to meet the site boundary, looking SW

As the cable trench reached the S part of the W embankment, the ground level was at 5.60mOD. As it dropped down to the moat base in the SW corner, the ground level was lowered to 4.522mOD before rising up to 4.745MOD at the boundary; on the surface, there appears to be a possible raised track heading in a SW direction, accounting for the slight rise in ground level.

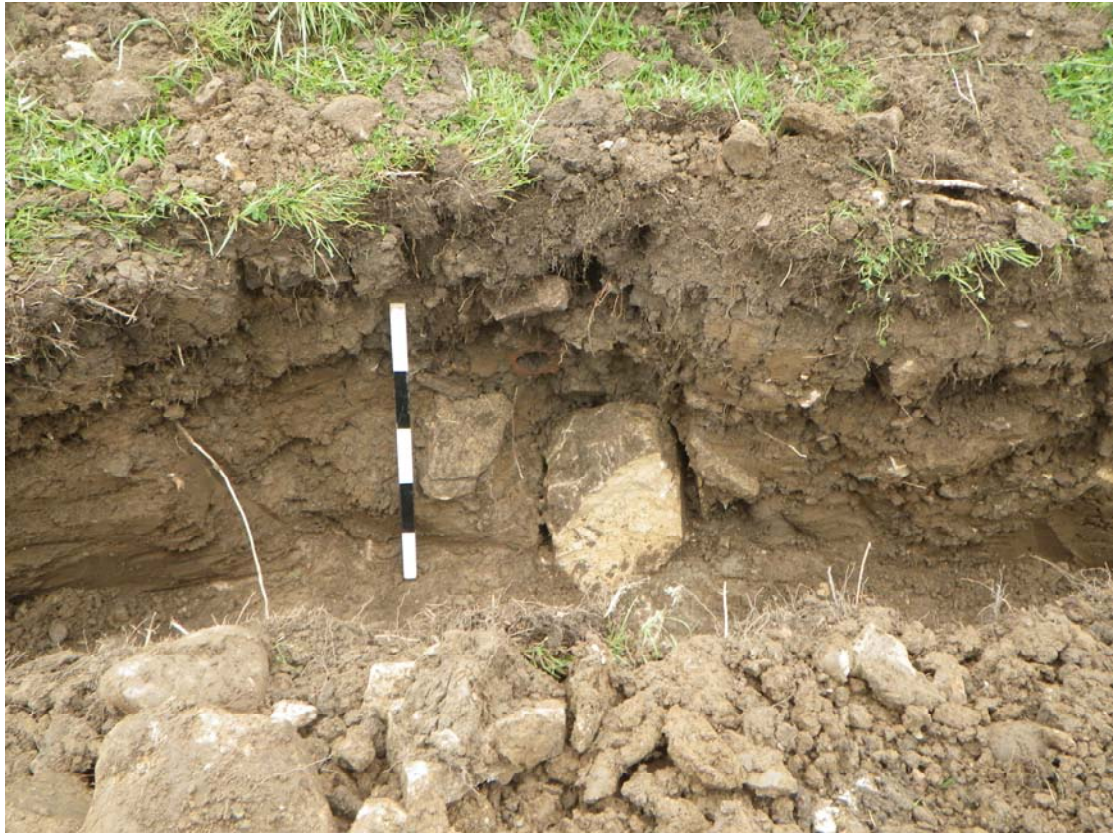
Plate 9 C19 drainage cut 109, utilising robbed stone to aid drainage in the bottom of the moat at the SW corner. Looking SE (0.5m scale)

At a point 9.5m NE from the SW corner, there was evidence for a silted up drain cut 109 with integral machine-extruded circular drain set within a re-used stone base and brown silt fill 108. The cut was up to 0.52m wide at the top, 0.40m wide at the bottom, with straight sides and a flat base at 3.87mOD (0.50m deep). The cut for the drain truncated upper moat fill 110 which was of a mid to light grey brown sandy loam. Deposit 110 overlay redeposited clay 103 at the north of the S embankment and natural clays 102 at the S. There was no discernible cut for 110; it appears to represent a gradual accumulation of material within the moat base and was viewed up to 0.70m thick, although the base of the deposit continued below the lowest level of excavation within this area.

The drainage works encountered within the SW section of the moat are clearly of a much later period, likely the 19th century, as the drainage pipe included within the cut was of a circular, machine-extruded type. It is clear that it was not thought that the pipe would be enough, as additional re-used stone was used to line the base of the cut to facilitate drainage at the site.

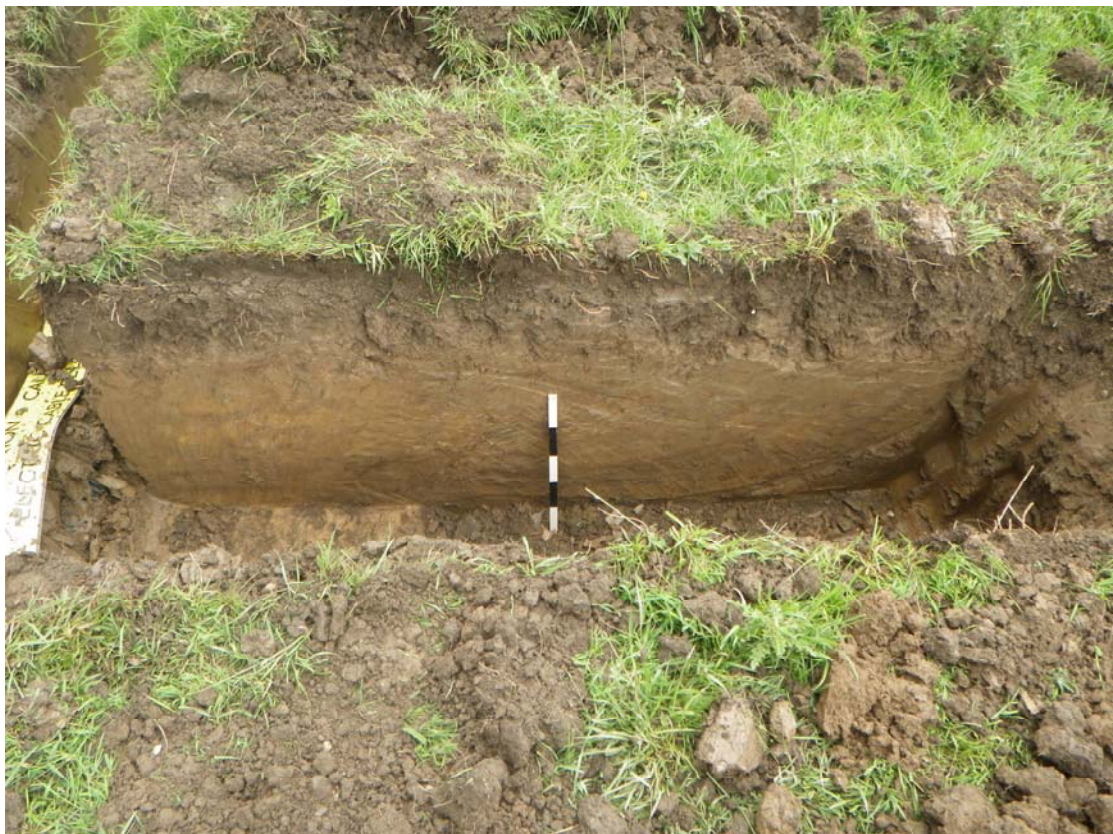
Plate 10 Mole Pit 1, looking N (0.5m scale)

Mole Pit 1 (ground level 5.12mOD) was 2.24m long, 0.76m wide and 0.90m deep (4.22mOD). The basal layer recorded was natural clays 102, greater than 0.04m thick, overlain by redeposited clays 103 up to 0.56m thick, sealed by the topsoil 101, up to 0.26m thick.

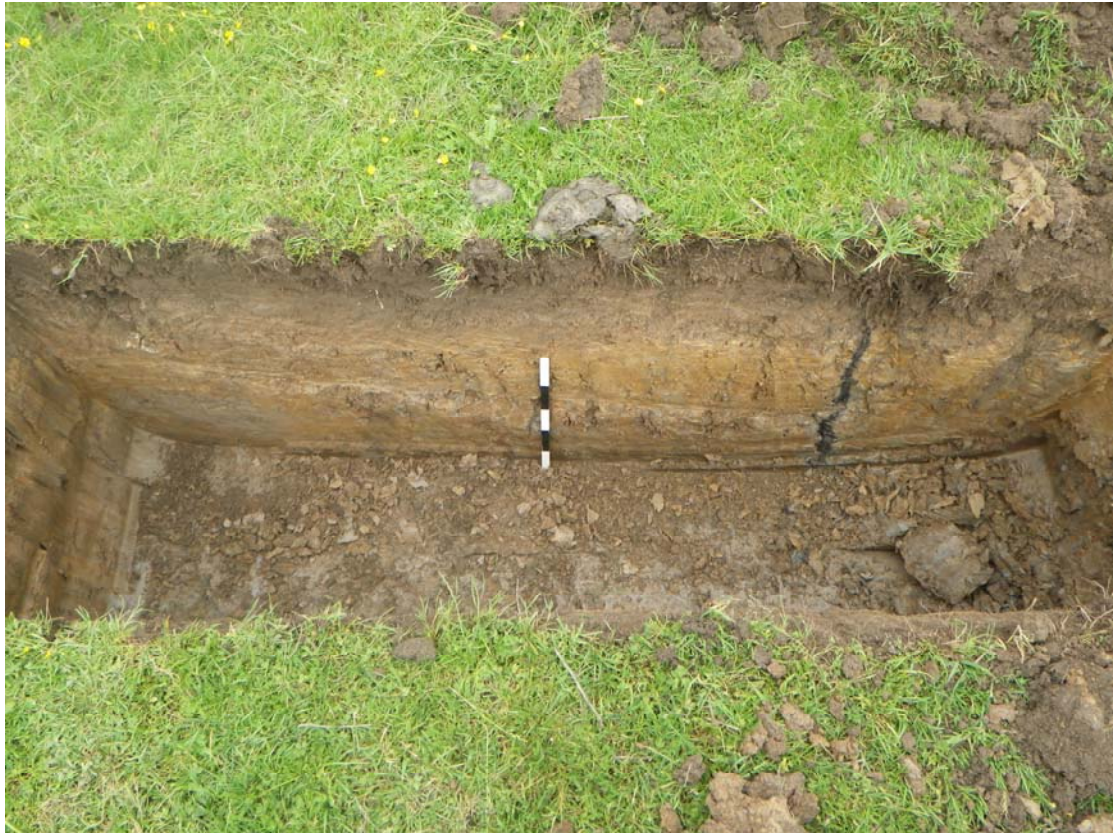
Plate 11 Mole Pit 2, looking N (0.5m scale)

Mole Pit 2 (ground level 4.60mOD) was 2.58m long, 0.74m wide and up to 0.94m deep (3.66mOD). The basal layer was natural clays 102. Cutting into this in the NW corner, was what appeared to be a small pit 113, appearing in profile as being 0.55m wide and 0.16m deep (cut from 4.00mOD) with a generally concave profile. Its fill, 112, was a mid to light grey sandy silt. Sealing this was the moat platform deposit 103, up to 0.32m thick. Overlying this was 111, a light grey silt up to 0.10m thick, lying directly below the topsoil 101, up to 0.22m thick.

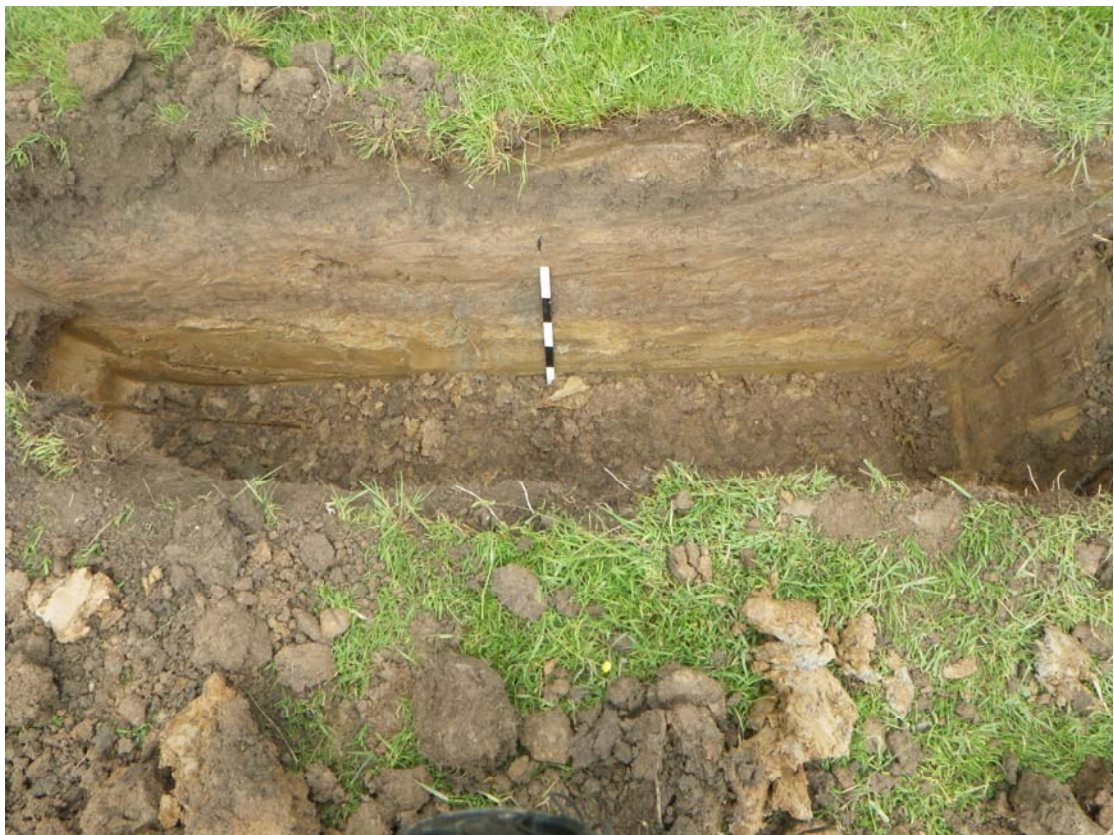
Plate 12 Mole Pit 3, looking N (0.5m scale)

Mole Pit 3 (ground level 4.80mOD) was 2.65m long, 0.90m wide and 0.90m deep (3.90mOD). The basal layer consisted of redeposited platform clays 103, greater than 0.30m thick, sealed by layer 111, up to 0.10m thick, in turn overlain by 114, a 0.30m thick deposit of mid orange brown mottled clays. This deposit was sealed by the topsoil 101, up to 0.21m thick.
