Humber Field Archaeology

Historic Building Recording
at
Parkside Farm
Northorpe
West Lindsey

Watching Brief Report Number: 1477
July 2016

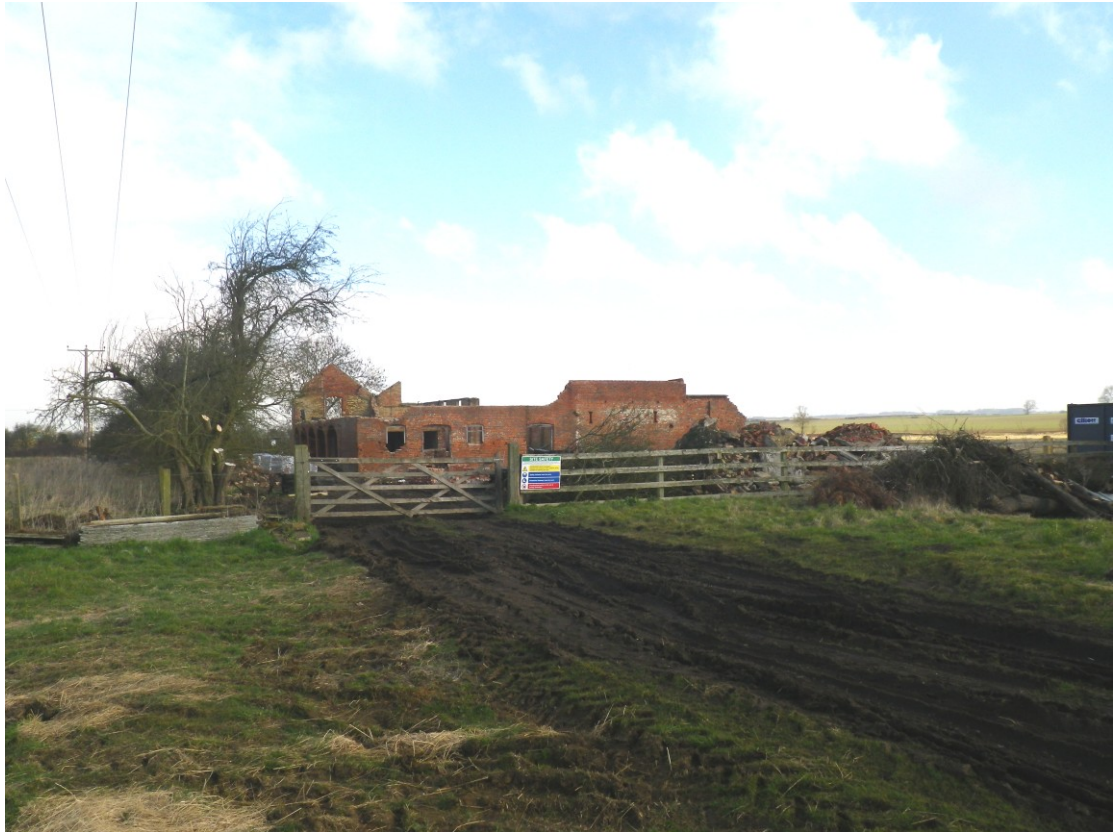
Plate 1 General view of the site from the south

This building was built of brick and limestone rubble and was orientated north-south. It had clearly been formerly of two storeys but only the north gable end of the building survived by the time of the survey (Plate 1, 2 and 6-8).

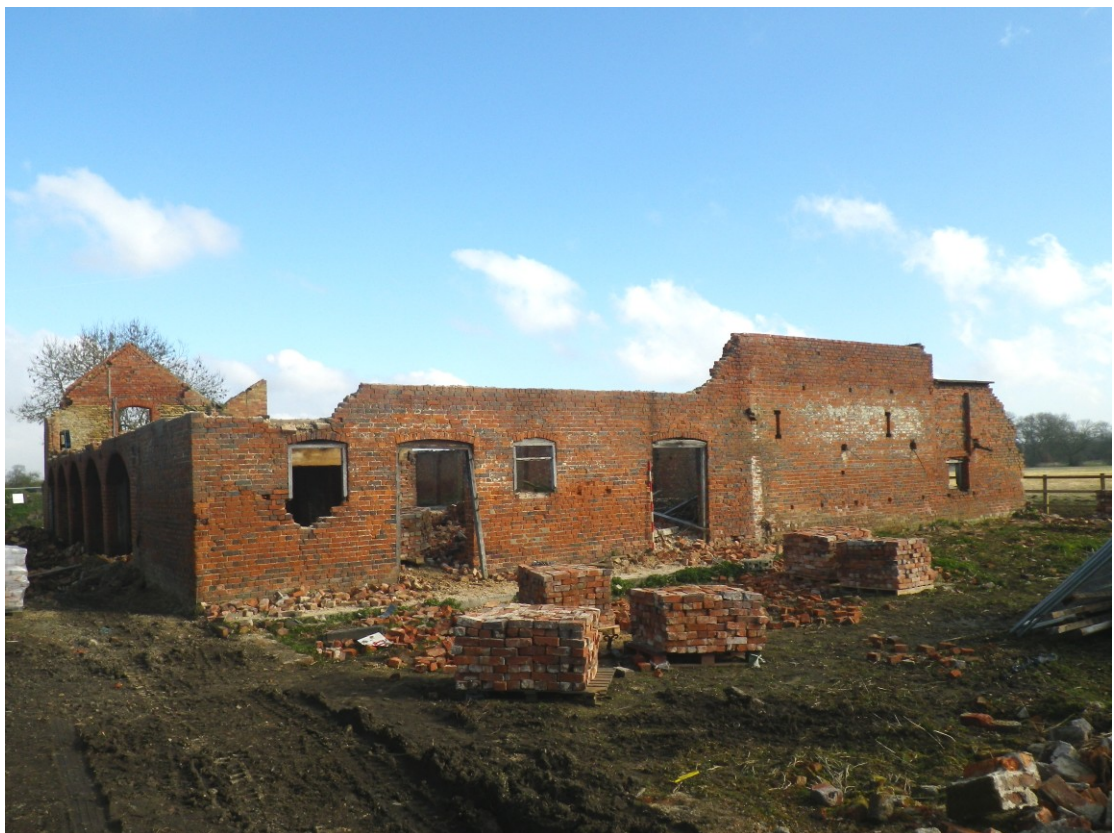
This elevation (Plate 2) consisted of slightly different western (Plate 3) and eastern (Plate 4) parts. In the western part the brickwork (with bricks of size 220mm x 100mm x 60-65mm) had been laid in English garden wall bond and survived to a height of over 3m. There were two doorways and two window openings, all having segmental arches consisting of brick on edge. The brick in the eastern part had also been laid in English garden wall bond but here survived to a height of over 4.5m. The only openings in this area of the wall comprised two ventilation slots, though there were two rows of what appeared to be putlog holes.

Plate 2 Buildings 2 and 3 viewed from the south-west across the site of the demolished building 1 (2m scale)

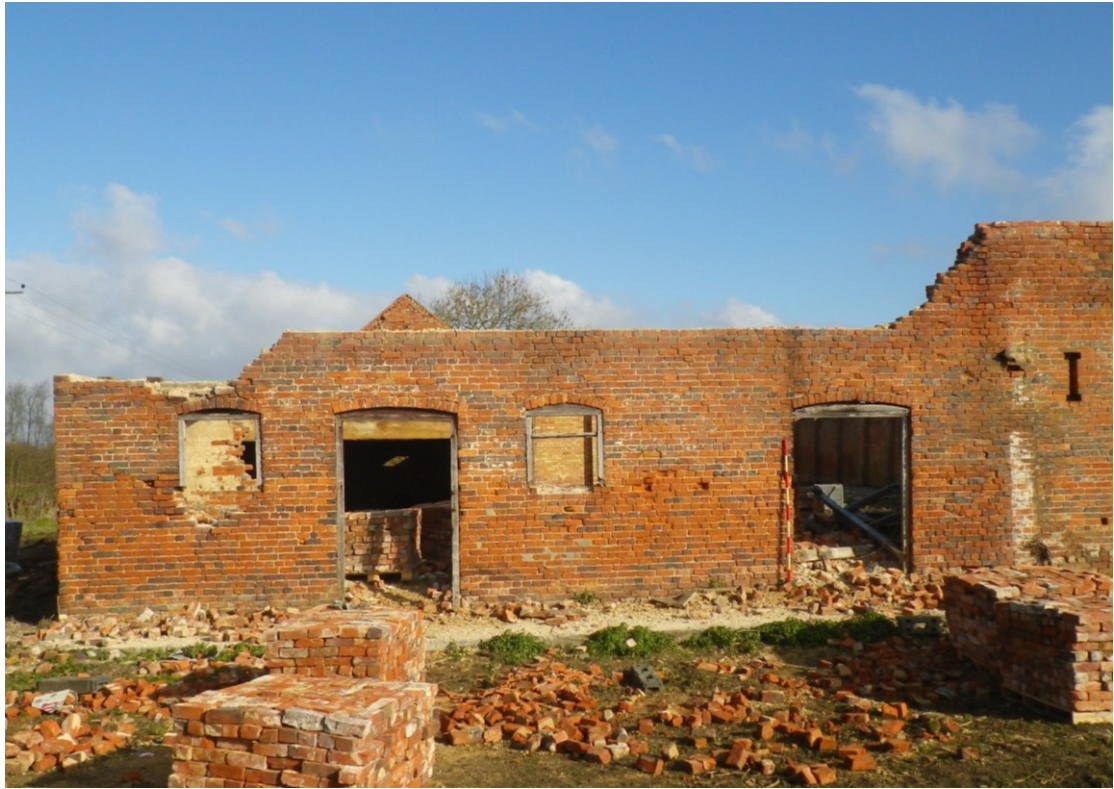
Plate 3 The western part of the south elevation of building 2 (2m scale)

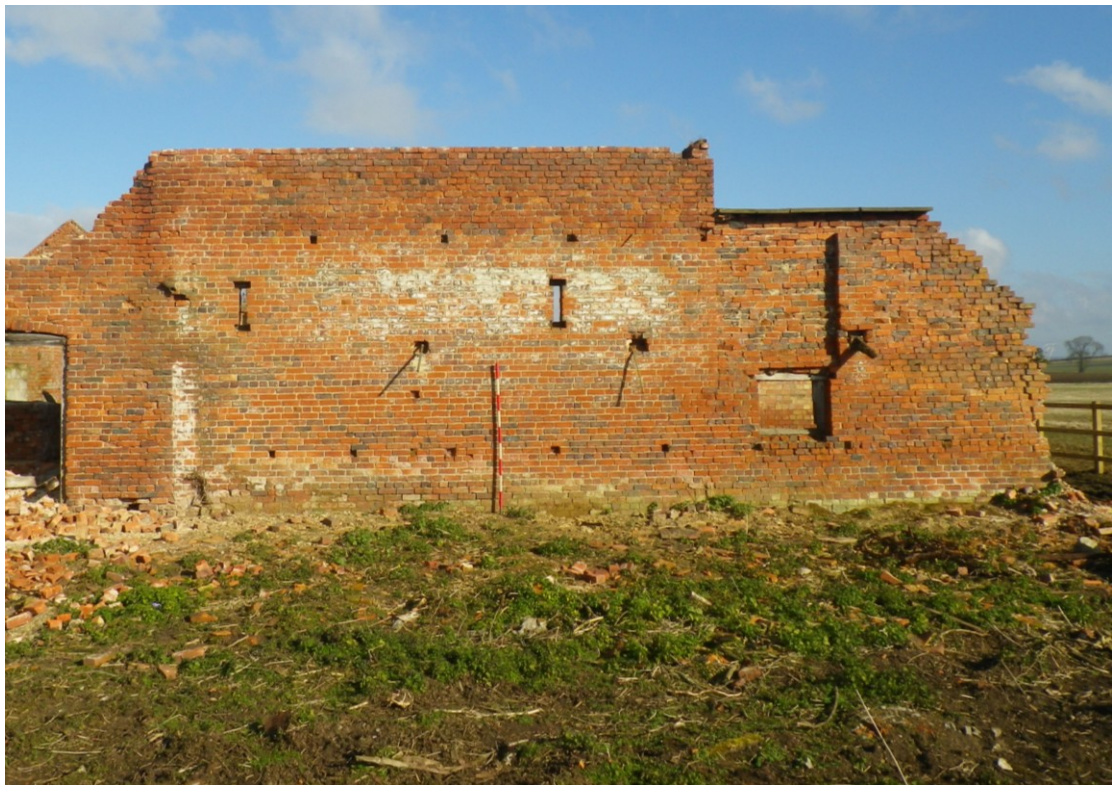
Plate 4 The eastern part of the south elevation of building 2, with the only extant part of building 1 to the right (2m scale)

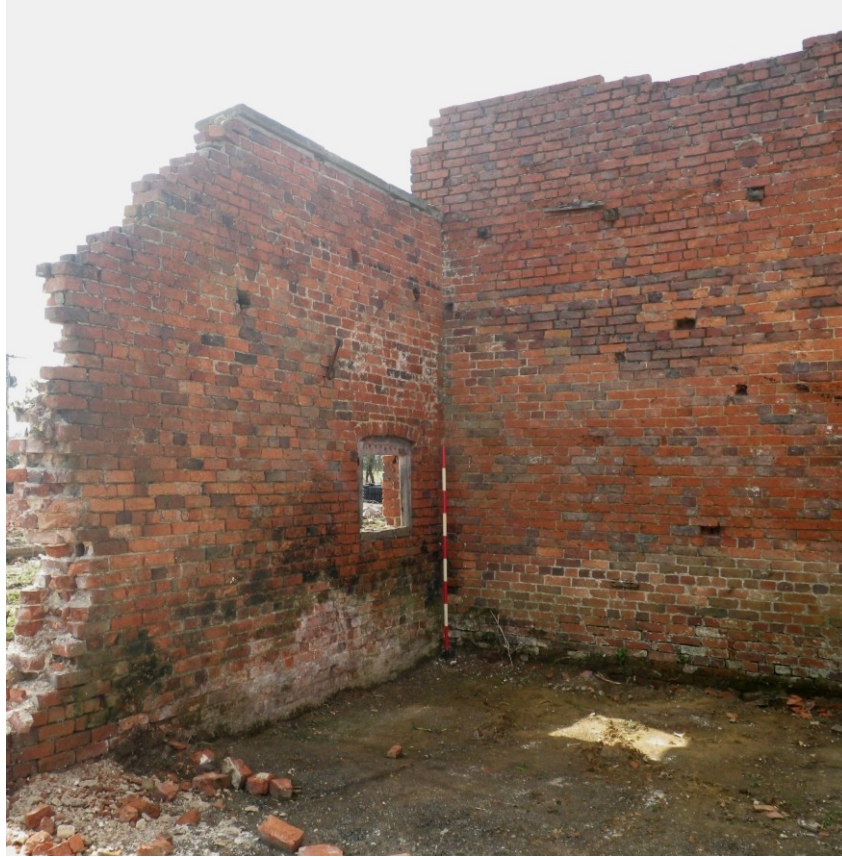
This had been almost entirely demolished prior to survey with the exception of a short stretch of wall in the former buildings north-east corner (Figure 2, Plate 5). The wall was of an orange red and occasionally russet coloured brick that had been largely laid in English garden wall bond (three courses of stretchers to each of headers). There was a single window opening with a segmental arch consisting of brick on edge and the wall had been topped with stone copings.

A mirror image of the west elevation, though here the brickwork survived to a height of over 4.5m (Plate 5).

Plate 5 The east wall of building 2 and the only remaining portion of building 1 viewed from the north-east (2m scale)

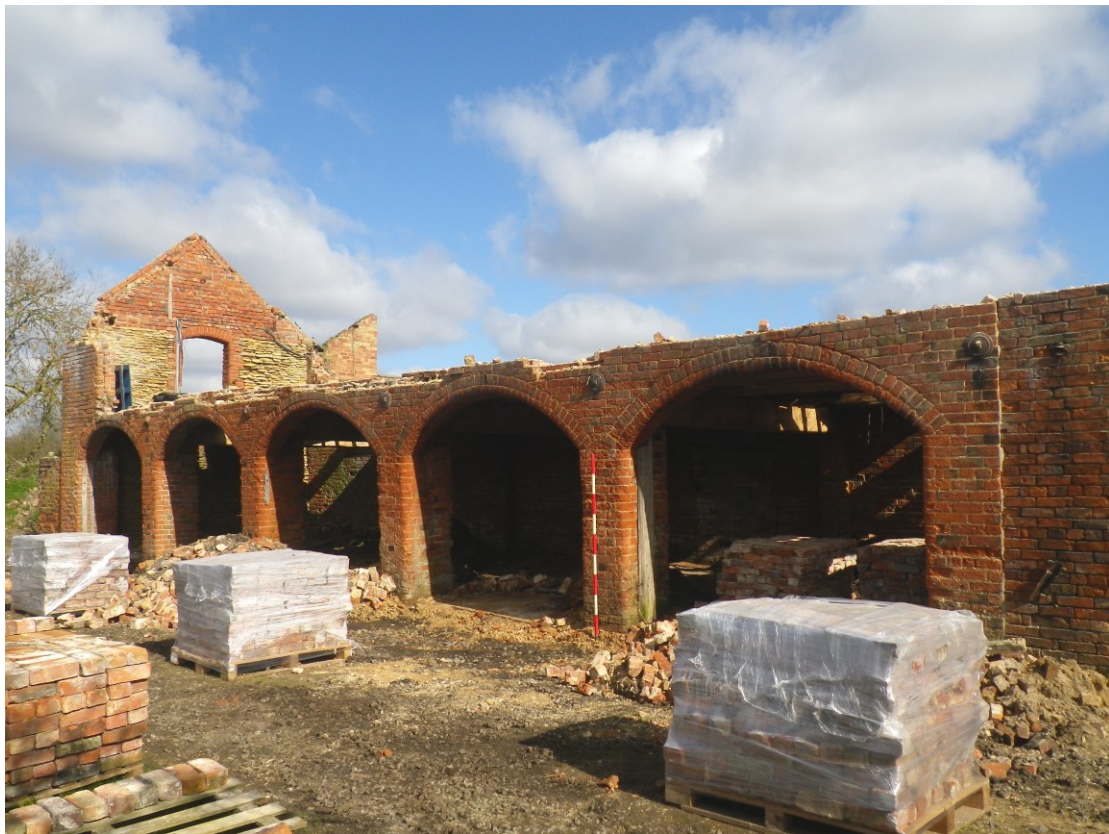
The elevation comprised a row of five segmental brick arches supported by brick piers, the whole surviving to a height of a little less than 3m (Plate 6). The bricks were of a slightly more orange colour than those described earlier and of size 225mm x 105mm x 65-70mm. Bullnose bricks were used at the corners of the piers and also in the lower courses of the arches, which comprised two courses of brick on edge. Cast iron tie-plates were present at the ends of the elevation and between the arches.

Plate 6 The west elevation of building 3 viewed from the south-west (2m scale)

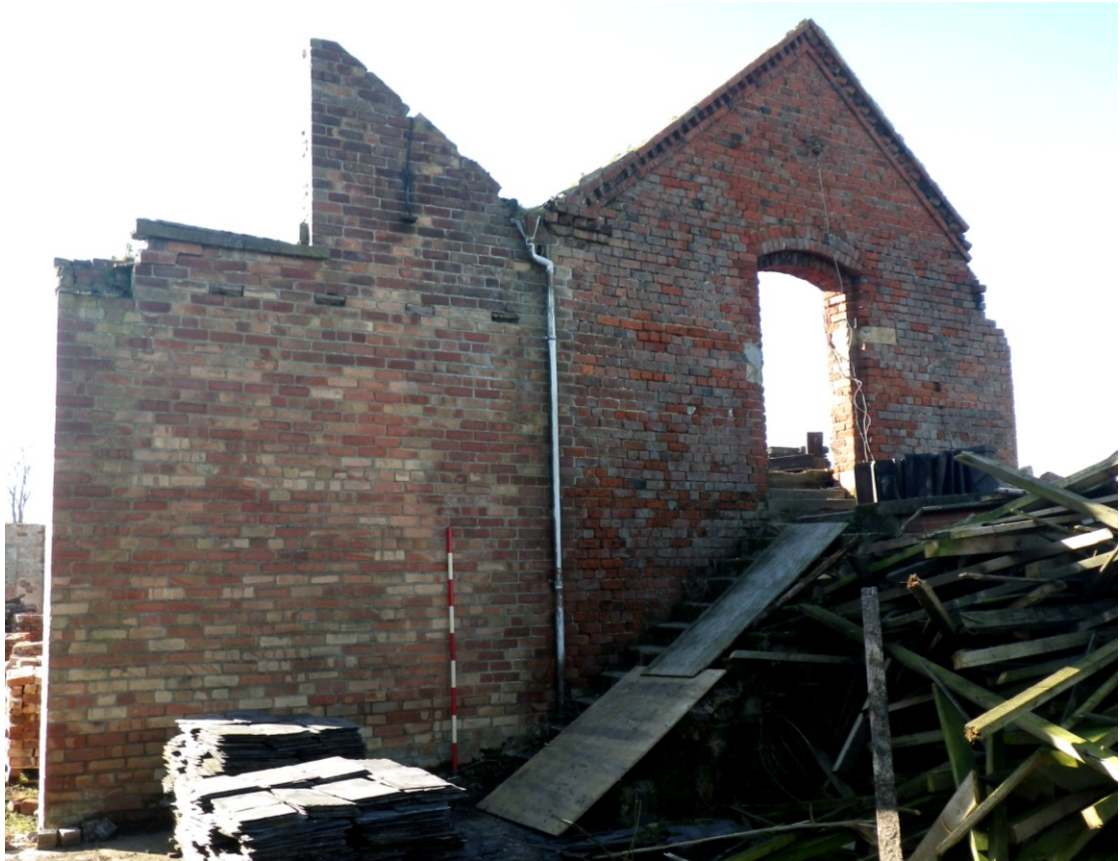
This comprised the surviving gable end of the building (Plate 7). The overall height of the gable end was around 5m. The brick in the elevation had been laid in English garden wall bond and the first-floor entrance was reached via a flight of precast concrete steps (Figure 2). The arch over the entrance was segmental and comprised two courses of brick on edge. The gable was surmounted by decorative detailing consisted of three courses of brick standing slightly proud of the main brickwork of the elevation. The upper and lower courses of this detailing consisted simply of stretchers whilst the middle course was of cogged brickwork.

The flight of concrete steps was supported by a structure (*ibid*) consisting very largely of brickwork that appeared to have been of quite modern machine made bricks of size 220mm x 105mm x 65mm. However, at the north-west corner of this structure there were bullnose bricks there were very similar to those used in the west elevation.

Plate 7 The north elevation of building 3 and part of building 4 viewed from the north (2m scale)

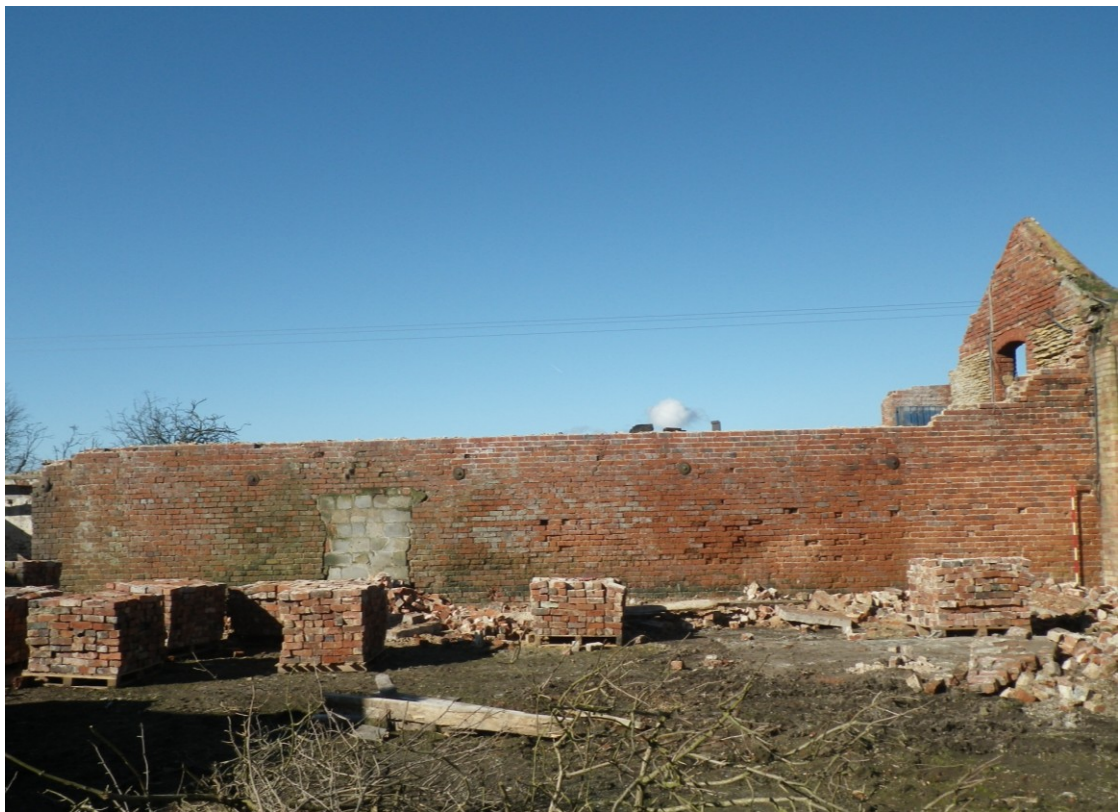
The brickwork was very similar to that described elsewhere in the building though here it had been laid in a mixture of English garden wall bond and Scottish bond (five courses of stretchers to each of headers). There were cast iron tie-plates in positions corresponding to those noted in the west elevation (Plate 8). The only other feature of the elevation was a former doorway blocked with breeze blocks.

Plate 8 The east elevation of building 3 viewed from within building 4 (2m scale)

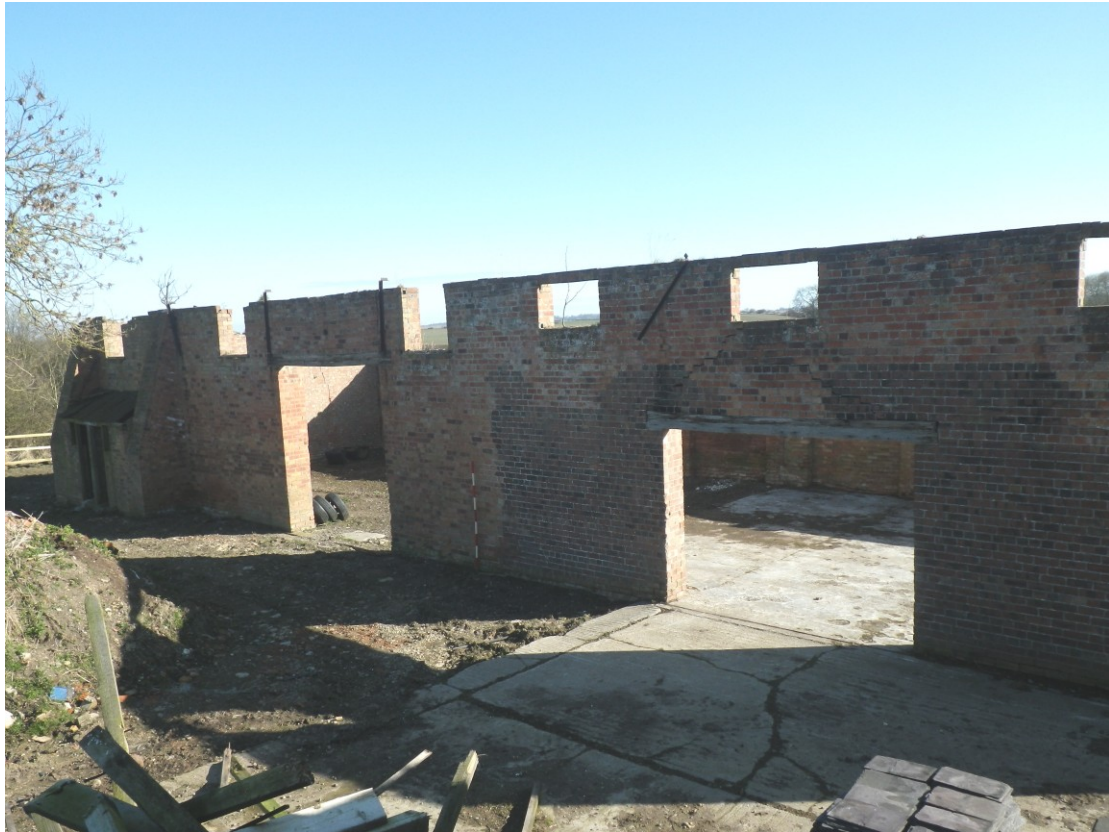
There were two large entrances in the elevation (Figure 2, Plate 9). Both had substantial timber lintels. At the northernmost end of the elevation there were two brick buttresses that ran to the full height of the elevation and positioned between them a small toilet block. At the top of the elevation at regular intervals were a series of window openings.

Plate 9 The west elevation of building 4 viewed from the top of the steps at the north end of building 3 (2m scale)

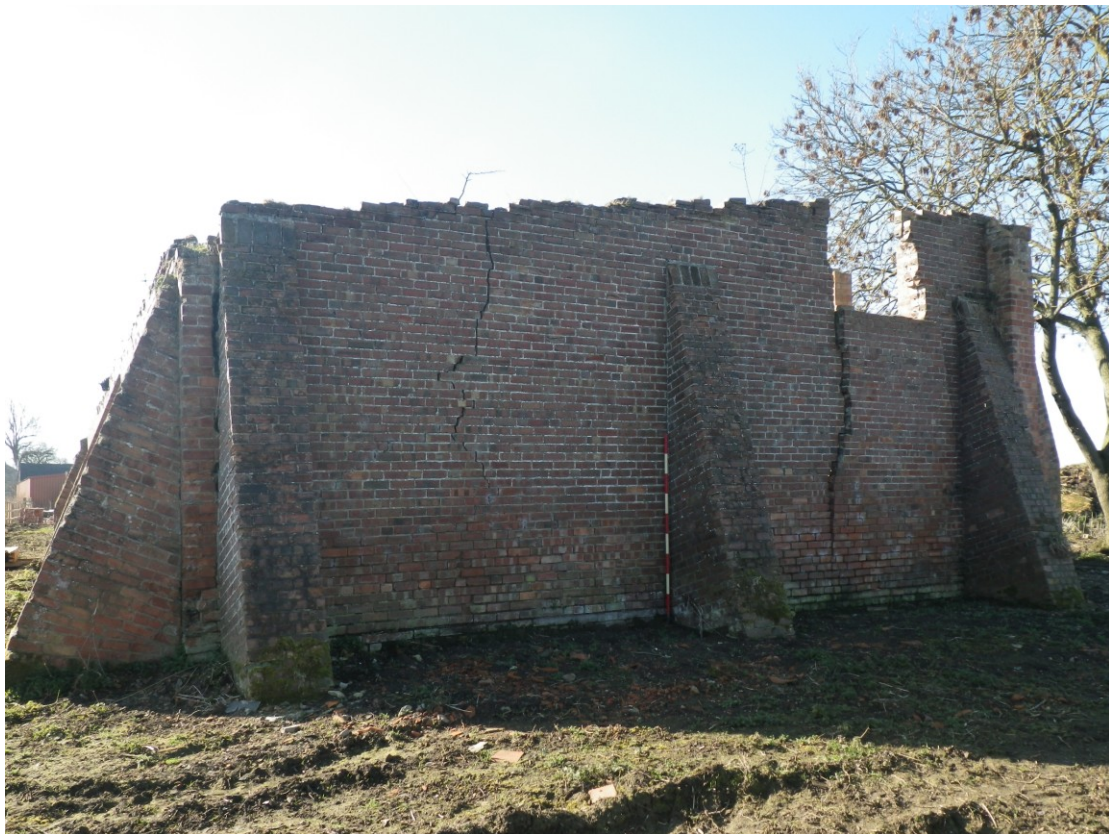
The main north elevation was rather different in character. Here there was only one opening high up in the elevation and the bricks were almost entirely of a russet colour (Plate 10). The brickwork had been laid in manner containing a minimum of cross-bonding – in this case for every five courses of stretchers there was one comprising alternate headers and stretchers. Significantly this short elevation contained three substantial buttresses rising to only a little short of the surviving height of the elevation, which was a maximum of around 5m. Each buttress was topped by a single course of brick on end.

Plate 10 The north elevation of building 4

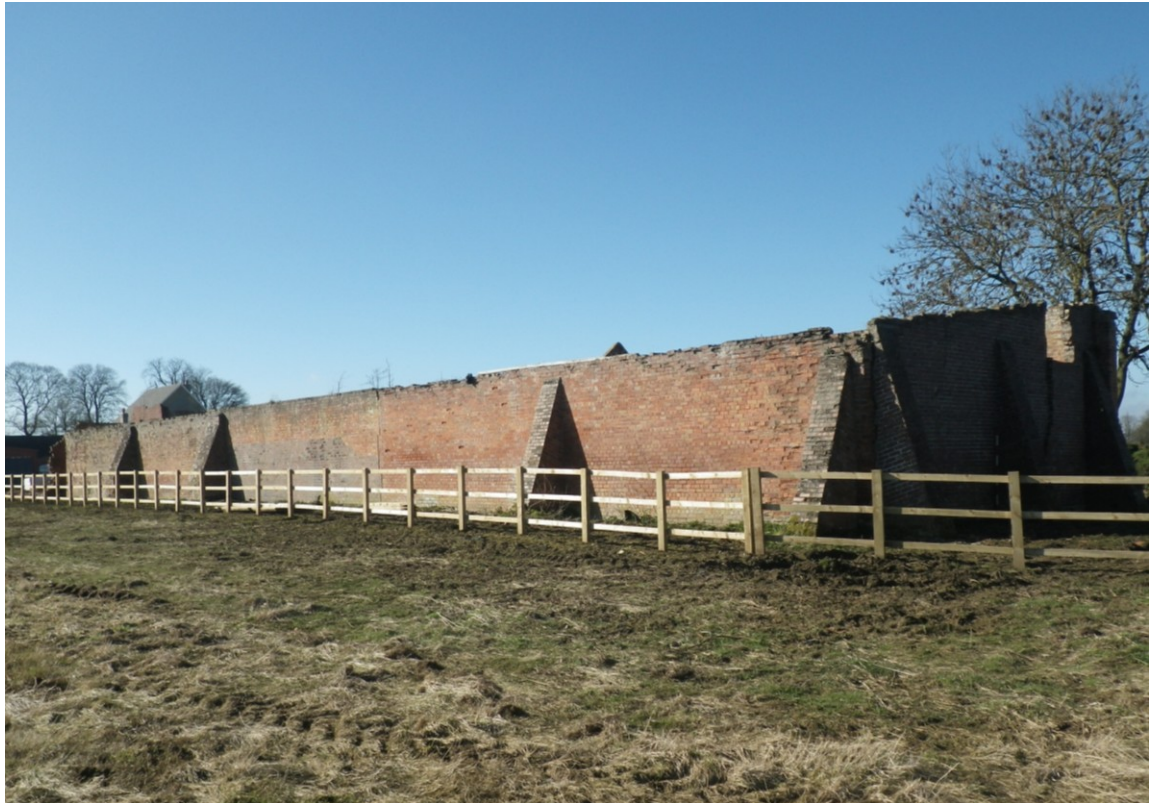
This elevation contained no openings in its surviving height of around 4m (Plate 11). Most of the brickwork was of the pale orange to pink colour noted earlier with regard to the west elevation and this again had been laid in English garden wall bond. Close to the midpoint of the elevation and area of brickwork had been laid in the russet

coloured bricks in the Scottish bond noted earlier. The substantial buttresses were also of the darker brick (Figure 2, *ibid*).

Plate 11 The east elevation of building 4 viewed from the north-east

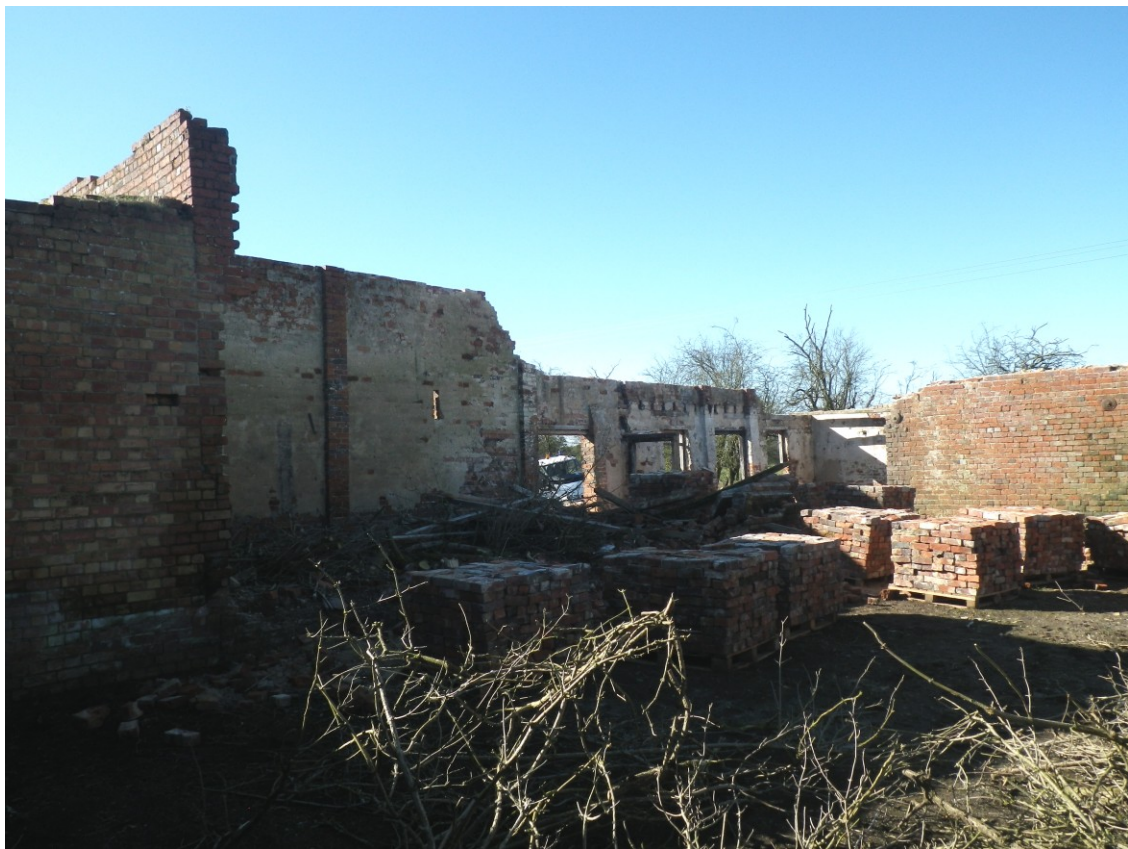
This elevation had been almost entirely demolished (Figure 2, Plate 12).

Plate 12 The interior of building 2 viewed from the north-east and from within building 4

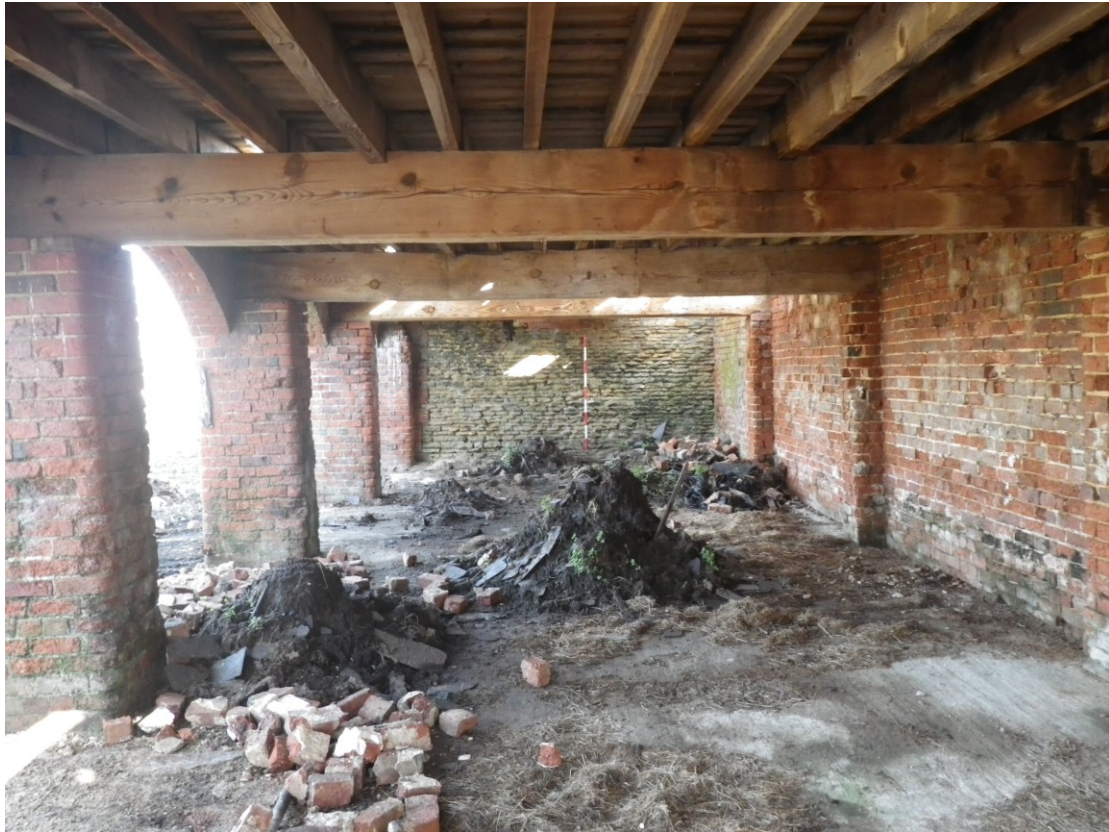
A series of chamfered timber beams of section 0.38m x 0.24m supported the joists for the first floor and ran east to west across the building (Figure 2, Plate 13). Internally, the north wall consisted almost entirely of coursed limestone rubble. The blocked doorway in the east wall noted earlier was blocked internally with bricks, the timber lintel above having deformed considerably (Plate 14).

Plate 13 Interior of the ground floor of building 3, viewed from the south (2m scale)

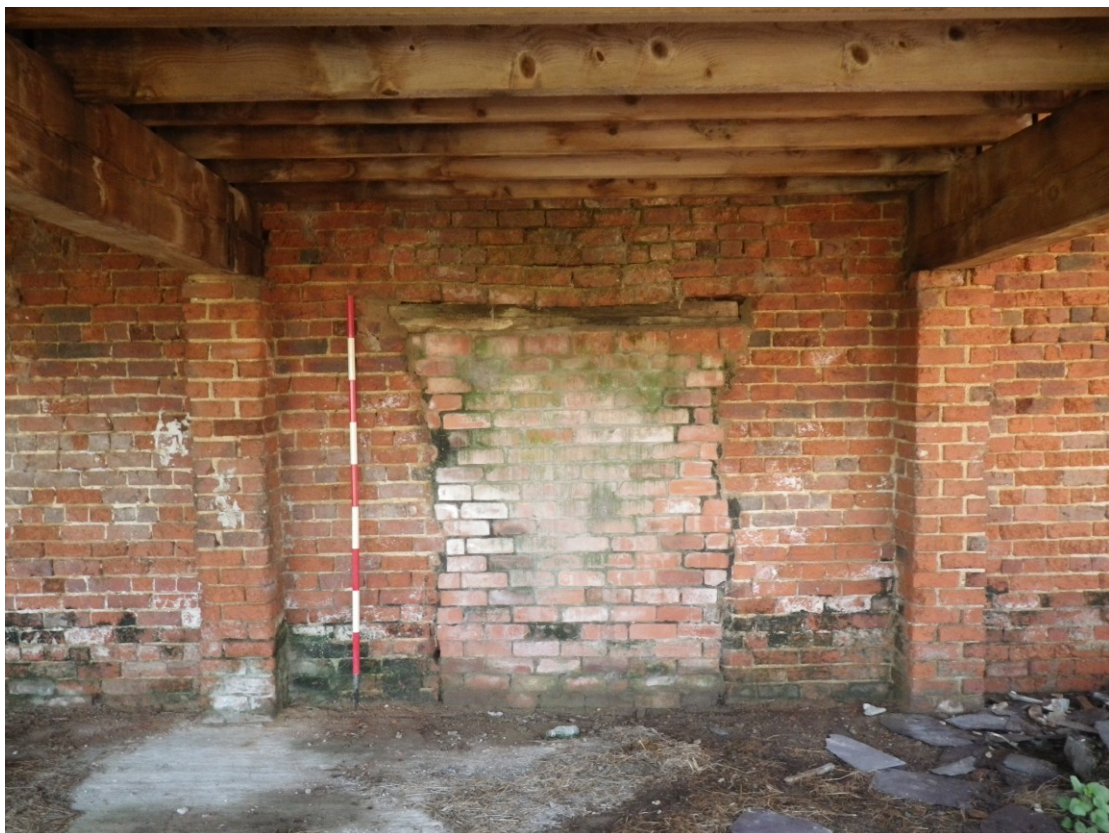
Plate 14 The blocked doorway in the east wall of the ground floor of building 3 viewed from the west (2m scale)

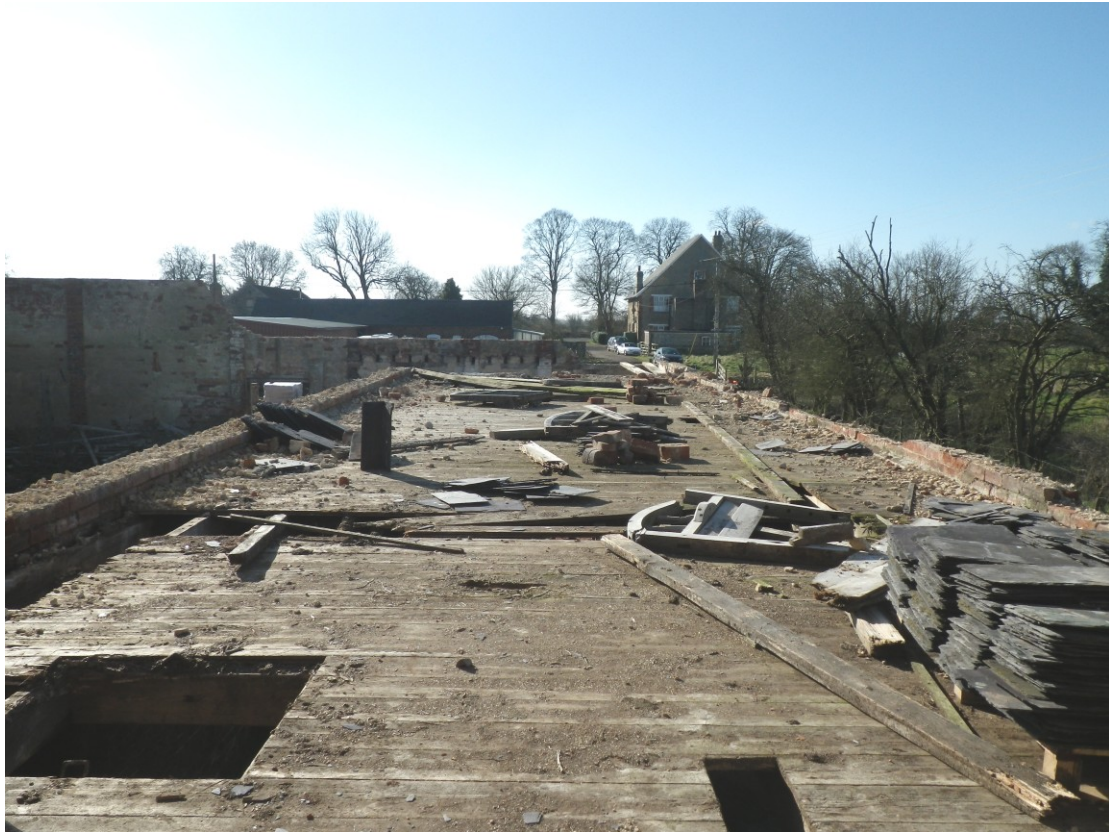
This had been almost entirely reduced to floor level (Plate 15), though the north gable end was almost entirely intact at the time of survey (Plate 16). Like the internal face of the ground-floor north wall the wall at first-floor level was of coursed limestone, though only to the height of the doorway. The door surround was of brick like the internal wall at gable level.

Plate 15 Building 3 at first-floor level as viewed from the north

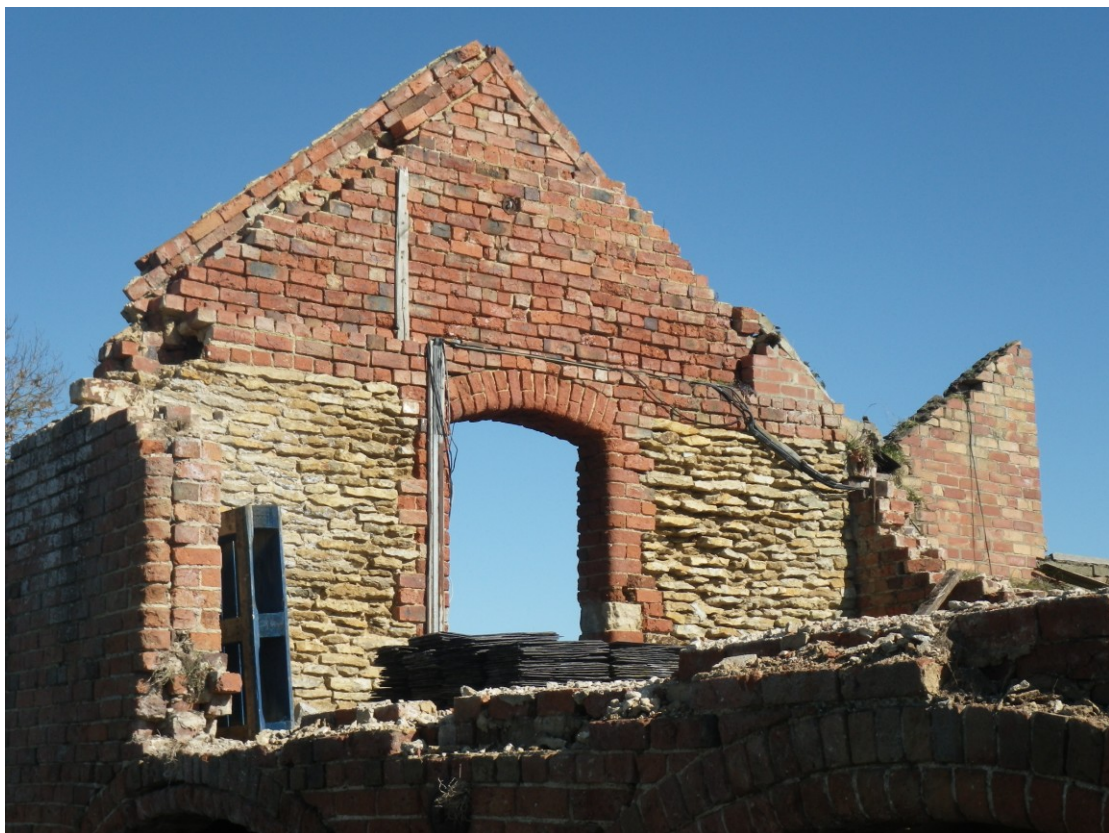
Plate 16 The inner face of the first-floor north gable end of building 3 viewed from the south-west

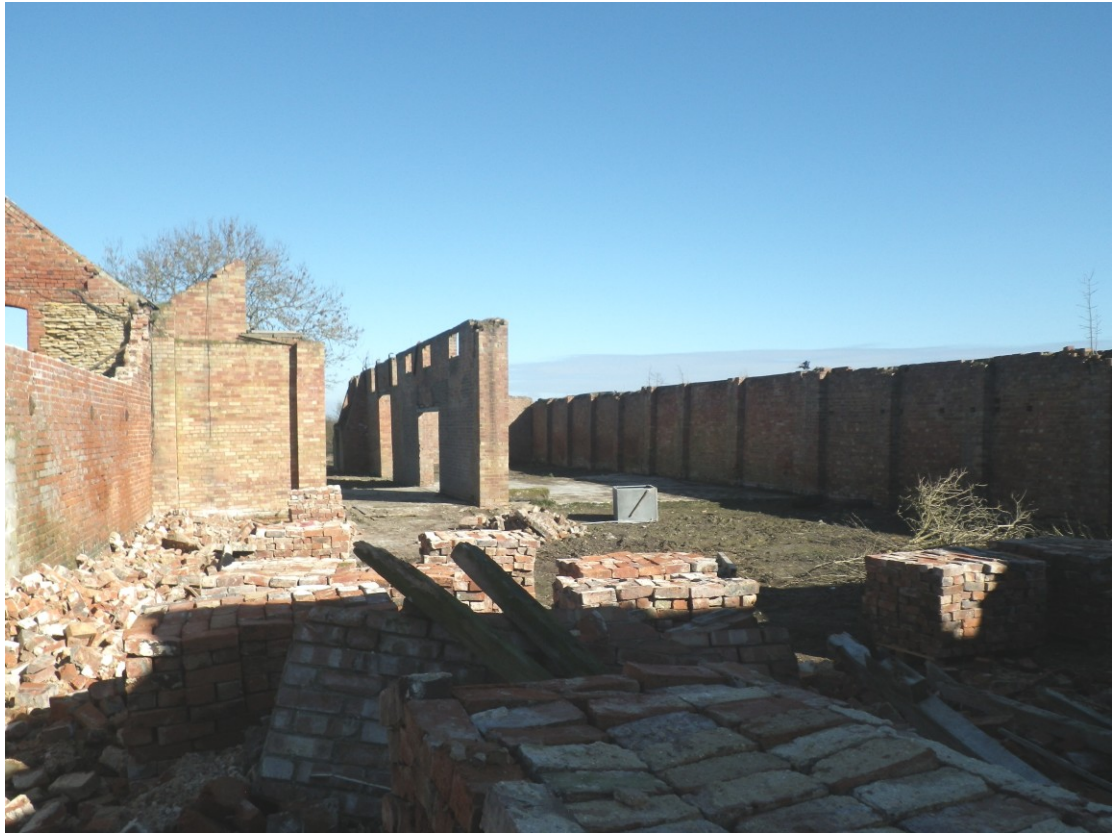
A series of buttresses ran along both the east and west walls (Figure 2, Plate 17). Although a very large building its floor appeared, save for a small central section comprising *in-situ* cast concrete, to have been of earth (Figure 2).

Plate 17 The interior of building 4 viewed from the south
