Archaeological Observation
Investigation and Recording

Church Lane
Marshchapel
Lincolnshire

Watching Brief Report Number: 1500
March 2017

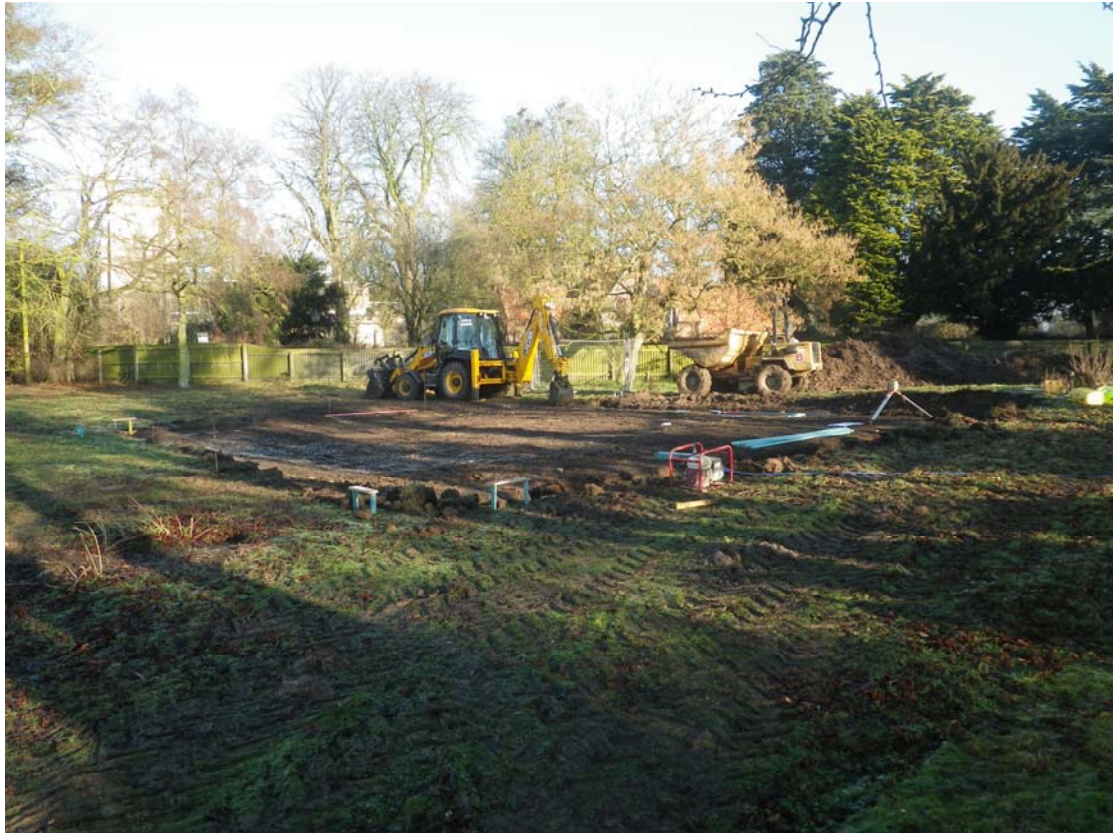
Plate 1 The site of the development, looking from the S

Following stripping of the overlying topsoil overburden and levelling of the site, the foundation trenches for the building footprint were excavated using a mechanical back-hoe excavator fitted with a toothed bucket 0.60m wide (Plates 1 and 2). The footprint covered an area measuring 13.2m SW-NE and 13.3m SE-NW (181.7m²) (Figure 2, Figure 3 – S.1)

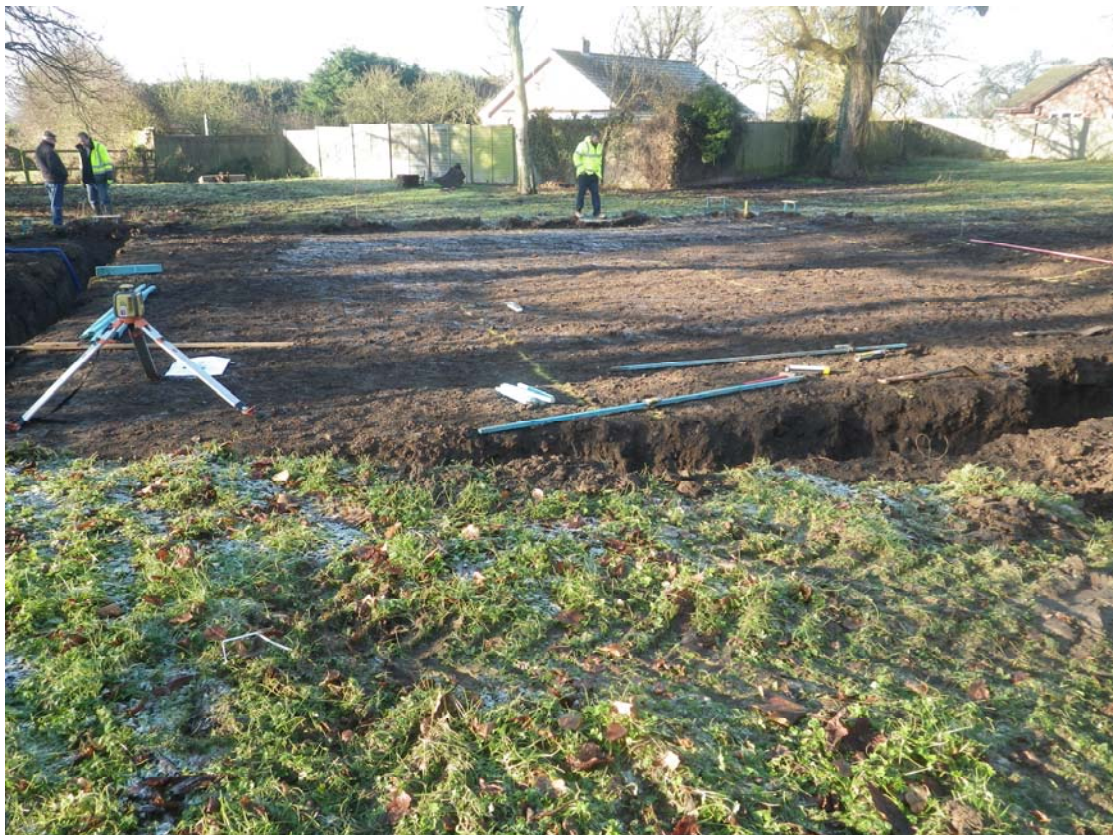
Plate 2 The outer edges of the plot during excavation, looking W

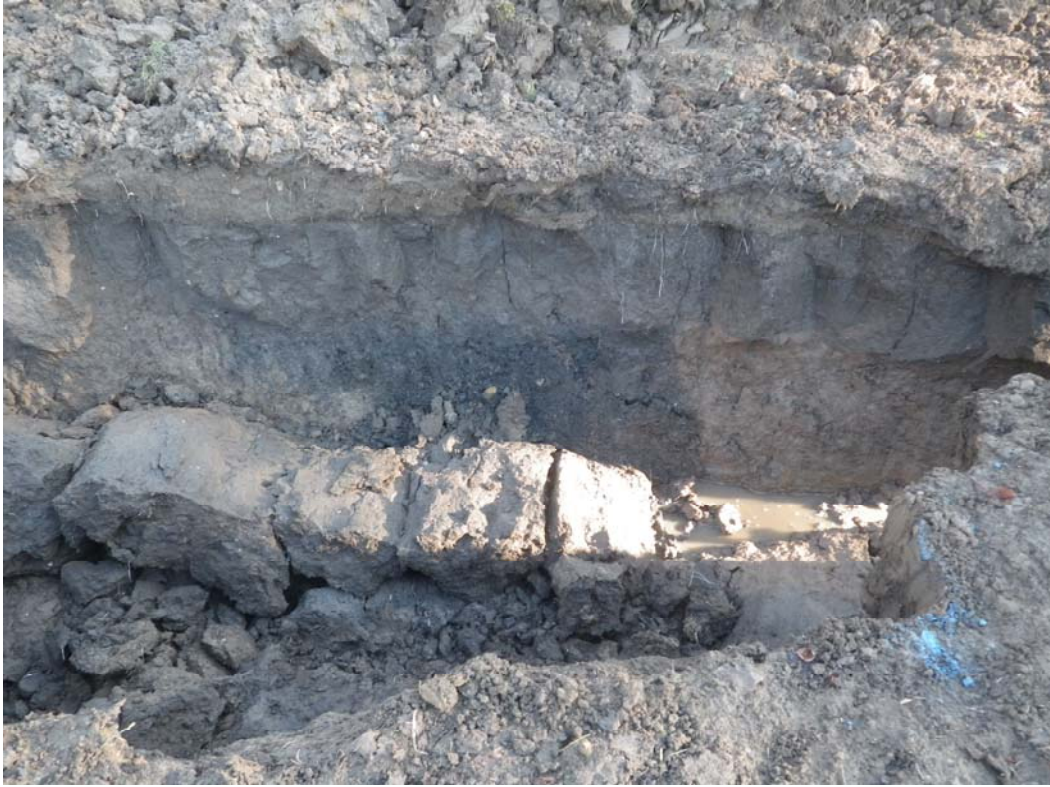
Within the exposed trench sections at the south-west of the site was what appeared to be a pit or ditch; it was not possible to investigate fully, owing to the problems caused by collapsing trench sides; this was largely due to issues with the ground water ingress.

The potential feature (5) (Plate 3) appeared to be around 2m or so wide at the top, and at least 1m deep, and sealed below the subsoil (2). The potential feature was defined more by the dark material within than by appearing to be a definite cut feature; collapsing trench sides prevented full recording of this feature, however, its position is marked on Figure 2. The suggested interpretation is that it may be a pit (illustrated), but could have also been a linear feature, not readily defined during the onsite investigation.

Plate 3 Showing the collapse area in the E corner of the trenches, looking NE

Barring the potential pit-like feature (LOCAL significance only) in the SW corner of the footings, and currently, it is not possible to confirm that it *is* an archaeological feature, no other deposits were recorded other than naturally occurring strata at the site.

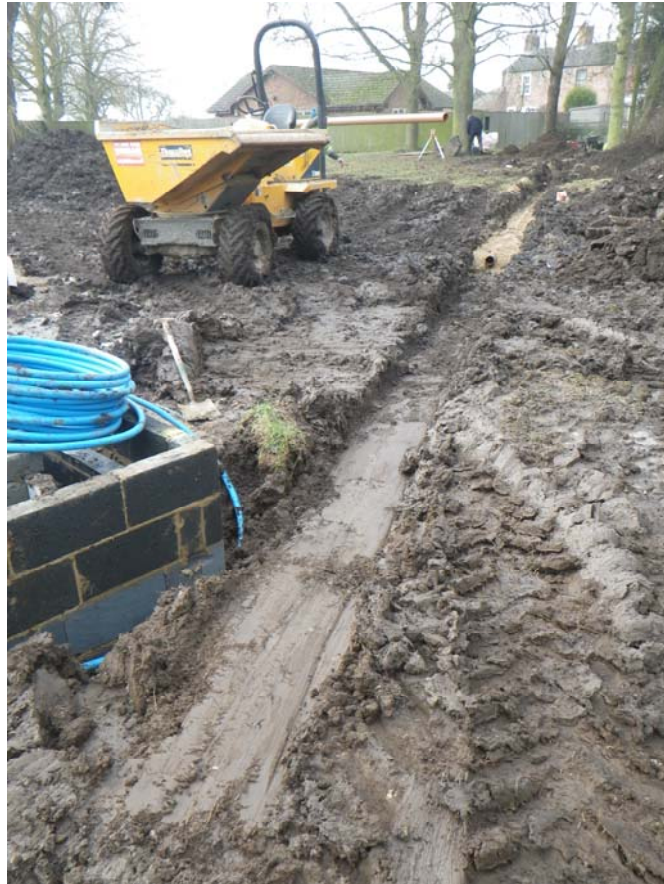
A service trench, 29.50m long and 0.6m wide ran from the N corner of the plot in a north-westerly direction to an extant manhole (Figure 2, Figure 3 – S.2, Plate 4). The service trench ranged in depth from 0.05m at the west to 1m deep at the east. The deposits exposed consisted of the topsoil (1) which overlay subsoil (2) (in places) which in turn overlay deposit (3). No archaeological features were seen during this phase of the work.

Plate 4 The main service/waste trench, looking NW
