## **HISTORIC BUILDING RECORDING**

**HOME FARM  
MAIN STREET  
SOMERBY  
LINCOLNSHIRE**

**Humber Field Archaeology Report no. 2014**

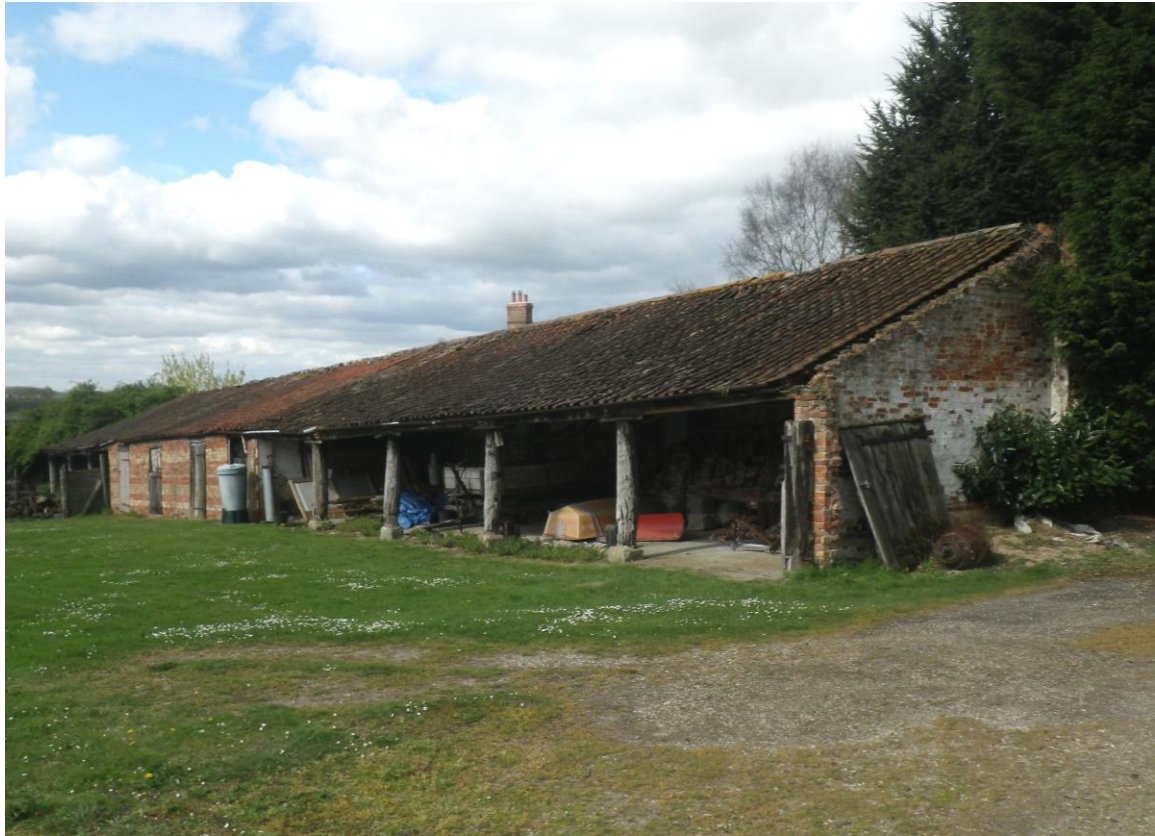
The building was single-storey, of brick with a pantile covered mono-pitched roof (Plates 1 and 2). It had been constructed on a significant north-east – south-west slope. Its eastern portion comprised an open-sided cart shed as did its western portion (Figures 2 and 3). Between the two were three smaller rooms and a passageway (*ibid*). The building had originally extended further to the east but had been cut through to leave an isolated ruinous easternmost portion (*ibid*, Plate 12).

Plate 1 General view of the building from the east (2m scale)

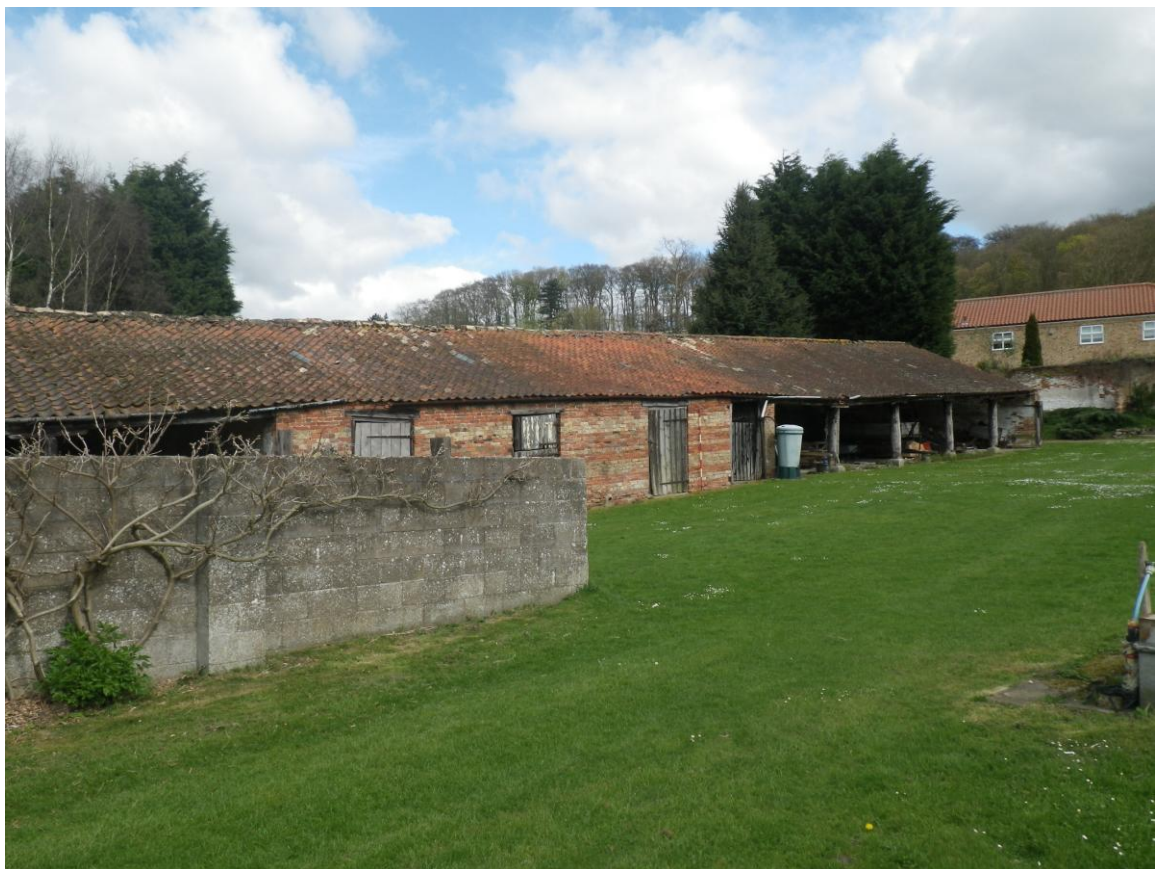
Plate 2 General view of the building from the south (2m scale)

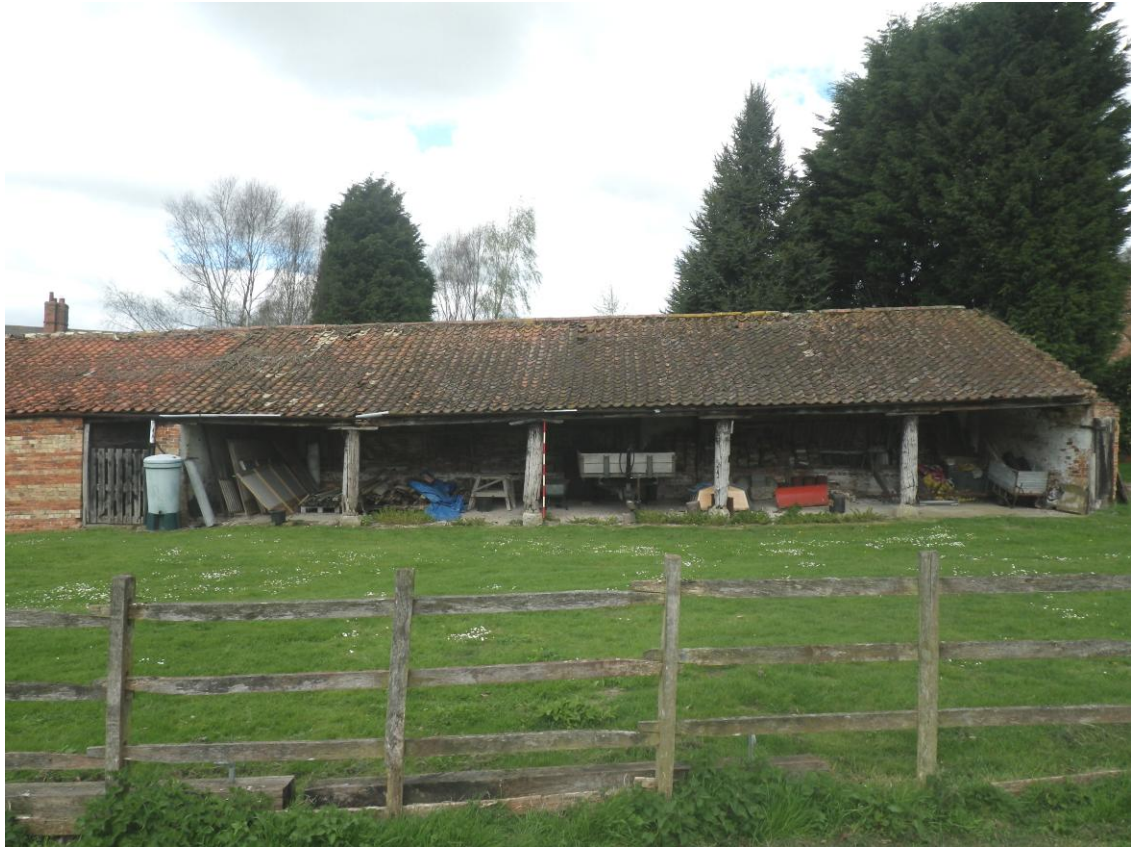
Plate 3 The eastern cart shed viewed from the south-east (2m scale)

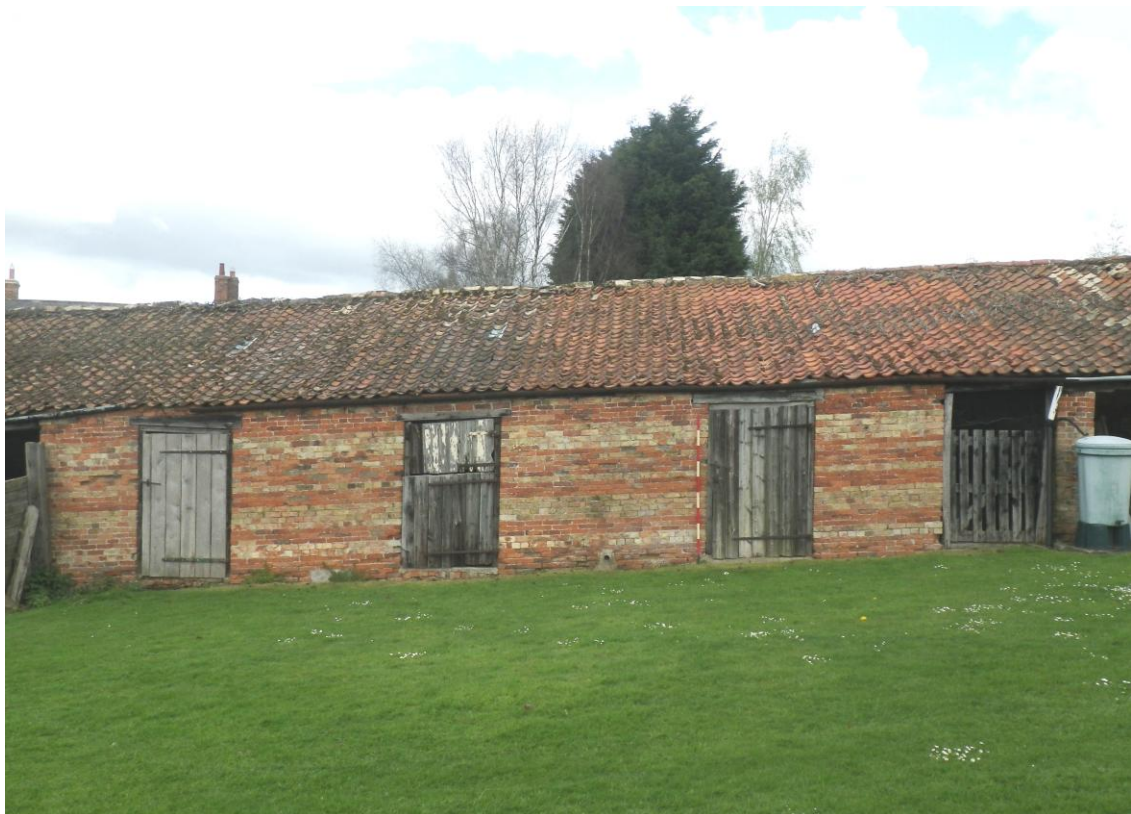
The central portion of the elevation comprised a brick wall containing four doorways (Plate 4). With the exception of small areas of brickwork above and below the doorways the brick courses had been laid with the slope rather than being stepped. They had also been laid in

Plate 4 The central, fully enclosed part of the building viewed from the south-east (2m scale)

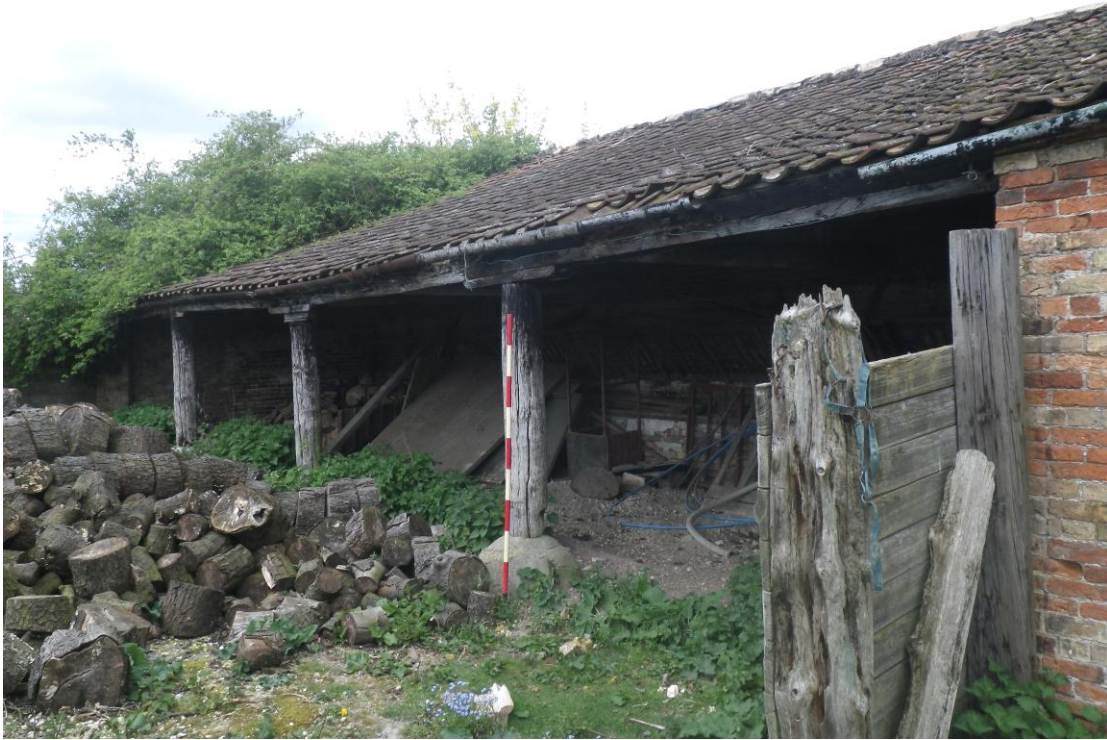
Plate 5 The western cart shed viewed from the east (2m scale)

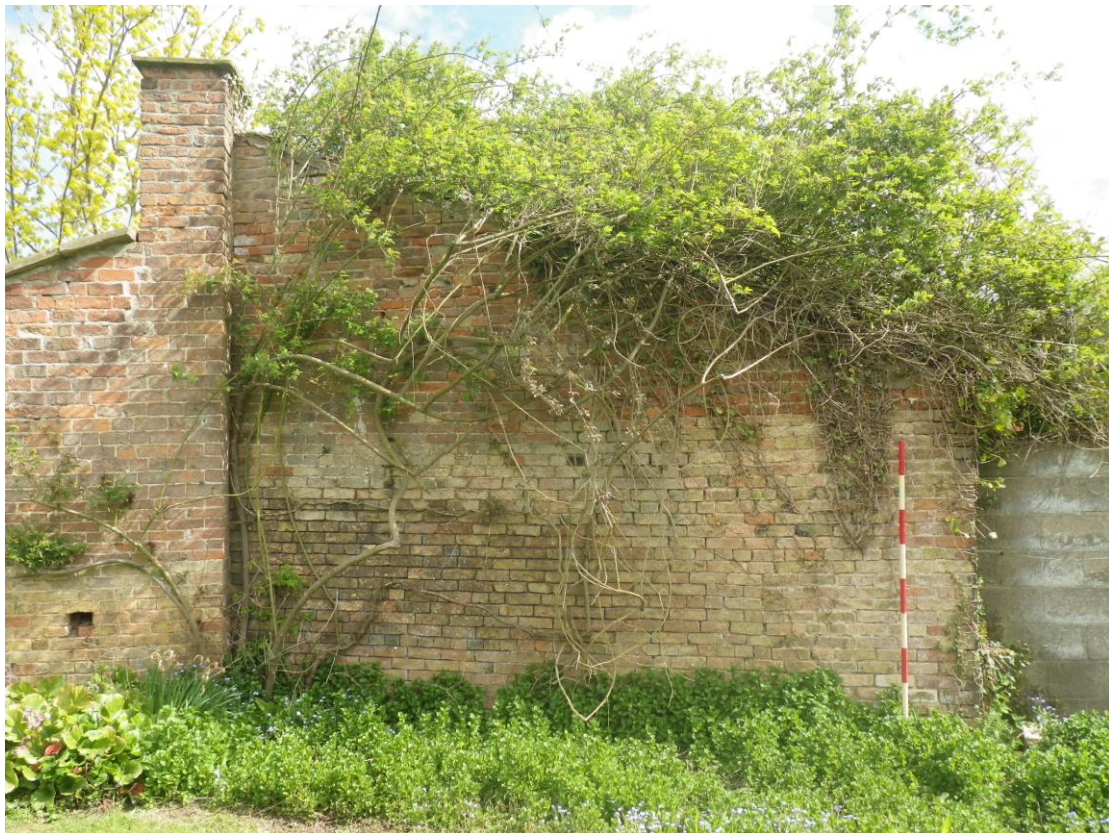
This elevation was devoid of openings and consisted in its lower part of the buff brick that was described earlier and in its upper part, of the orange-red brick (Plate 6). The bonding used within the wall could not truly be described as English garden wall bond (three courses of stretchers to each of headers) since quite a number of the ‘header’ courses contained many stretchers.

Internal examination of the junction between the east wall and the north wall clearly showed that the former had not been bonded into the latter, though externally there was no sign of a straight joint (Figure 3, Plate 6)

Plate 6 The west elevation (2m scale)

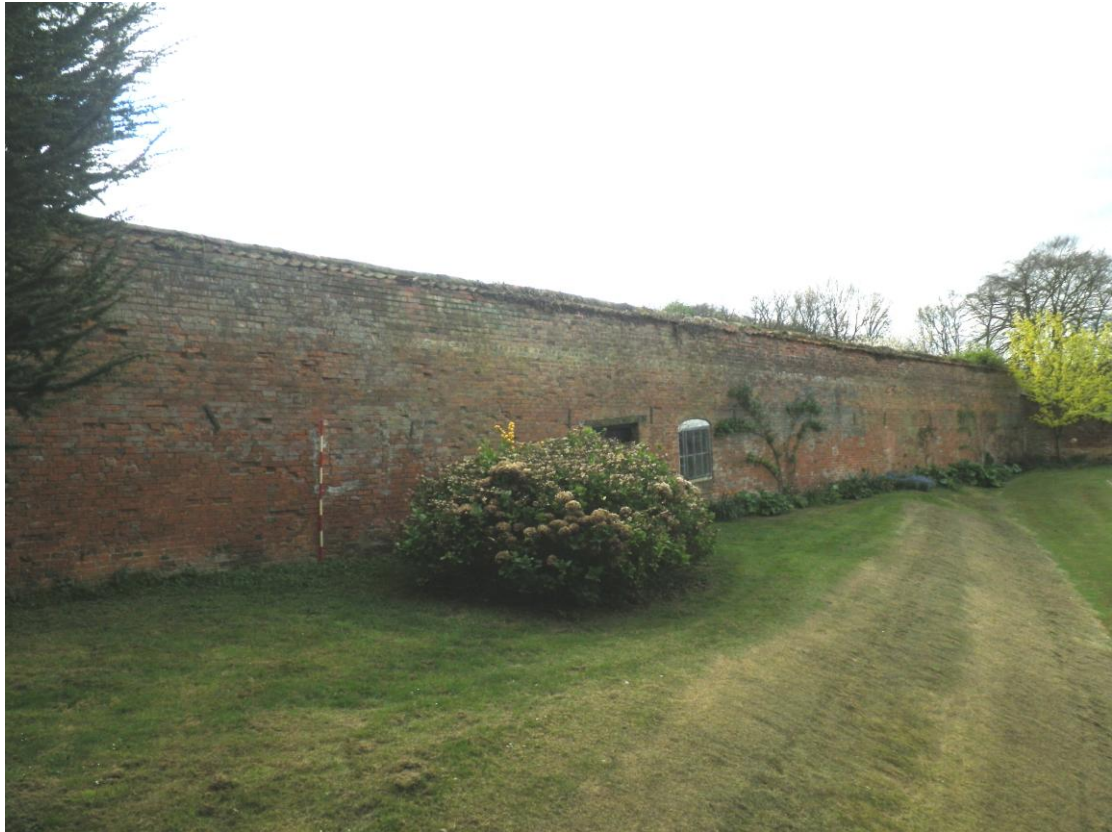
This elevation had few features and consisted predominantly of orange-red brick laid largely in stretcher bond with occasional use of headers (Plates 7-10). The bricks were of size 9" x 4" x 2<sup>1</sup>/<sub>4</sub>" (228mm x 102mm x 57mm). This brickwork extended up to a height of around 3m. Above this there were eleven courses of what appeared to be a pink brick, though somewhat weather stained (Plates 7 and 8). Like the brickwork of the central part of the south elevation, this had been laid in Scottish bond, the lowest course consisting of headers.

Finally with regard to this elevation, there were a number of small rectangular, wrought iron tie-plates positioned at intervals along its length (Plates 7, 9 and 10).

Plate 7 The north elevation viewed from the north-east

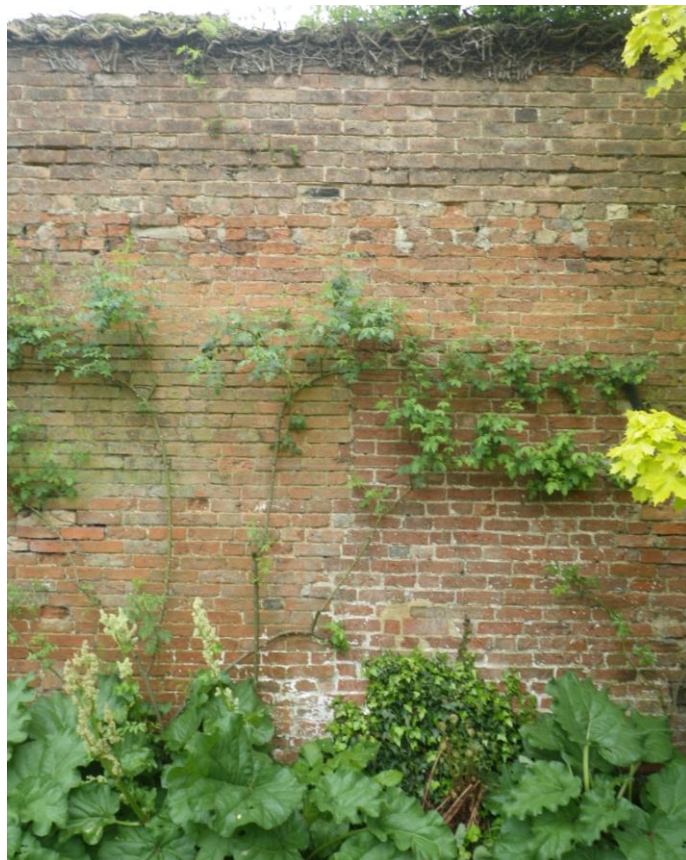
At the western end of the elevation and extending for a length of around 5m and to a height some nine courses below the buff brick, there was an area of dark red or russet brick that appeared, like the orange-red brick, to be predominantly of stretcher bond with occasional

use of headers (Figure 3, Plate 8). These bricks were also of size 9" x 4" x 2¼" (228mm x 102mm x 57mm).

Plate 8 A portion of the southern part of the north elevation showing the change of brickwork in the lower portion and the raising of the wall height in the upper part

It was not possible to ascertain why there was a substantial area of darker red or russet coloured brick at the west end of the north face of the north elevation, though a slight offset to the north wall is shown in this area on the 1907 map.

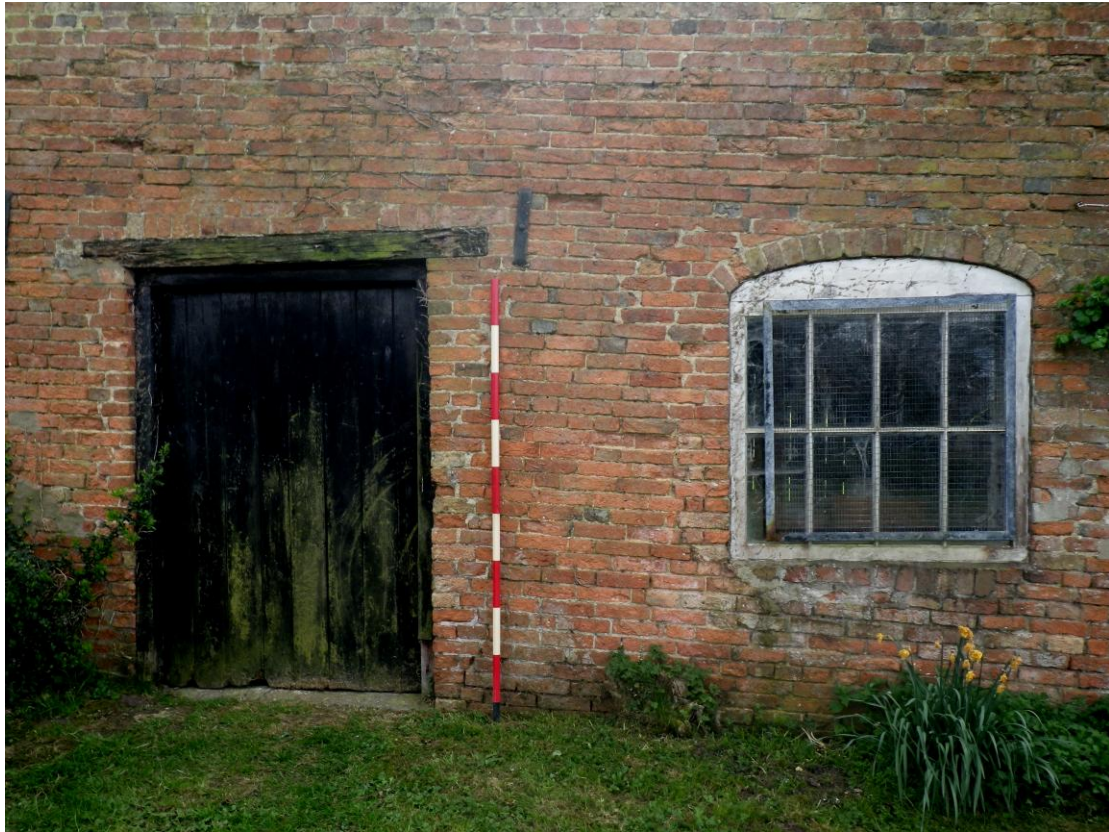
Near the centre of the elevation there was a plank and batten door (Plates 9 and 20) that was the northern entrance to the passageway through the building (Figures 2 and 3). There was a little evidence to either side of the door that the brickwork may have been altered, though this might merely have been re-pointing. Above the door there was a substantial wooden lintel and above that, two awkwardly tapering courses of brickwork made necessary by the fact that as with the south elevation, the brickwork here ran with the fall of the ground. Next to the door there was the window of room 1 (*ibid*, Plate 9). Here there appeared to have been substantial alterations to the brickwork surrounding the window indicating that it was a later insertion. The window itself was of eight panes and was surmounted by a quite flattened arch comprising a single course of brick on edge.

Plate 9 North door to passageway and window of room 1 in the north elevation (2m scale)

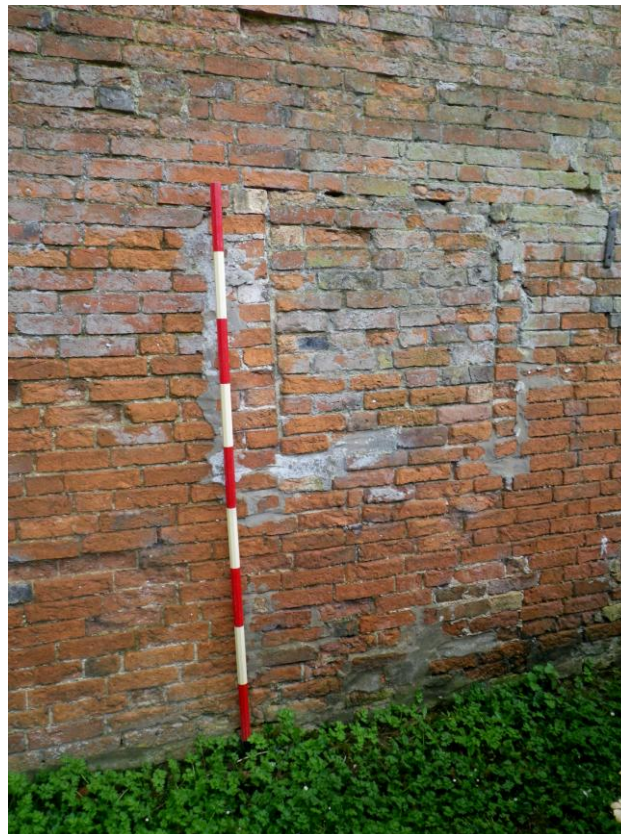
Further to the east there was what appeared to have been a brick blocking, possibly of a former window (Figures 2 and 3, Plate 10). This was better seen from the south (Plate 16).

Plate 10 Blocked window (?) in the northern part of the north elevation (2m scale)

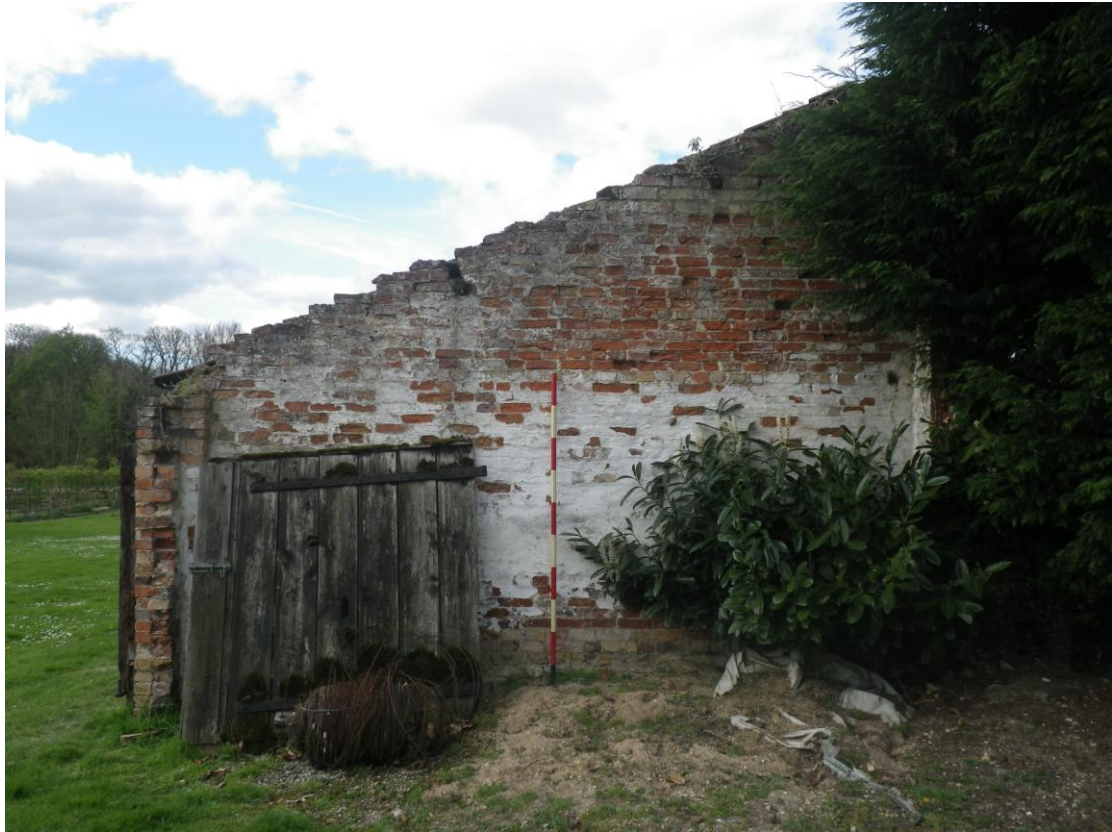
Plate 11 The east elevation (2m scale)

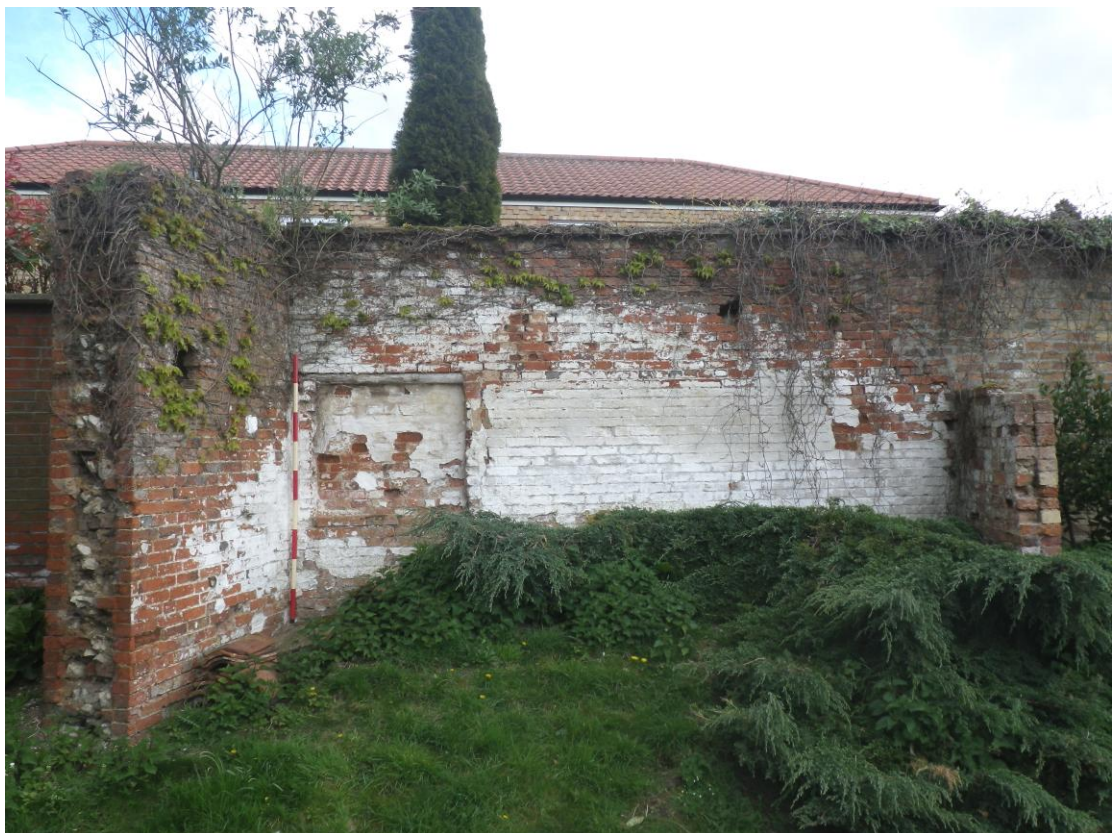
Apparently the building had been cut through to make an access way in the latter part of the 20th century (S. Merrick pers comm) and this sectioned both the north and south elevations. The north wall was especially interesting in that it was a substantial structure, as has been seen, faced in brick to the north (and also as will be seen to the south), but with a chalk rubble core (Plate 12). The wall was around 0.50m thick.

Plate 12 The former eastern end of the building, now detached from the rest of the building, as viewed from the south-west (2m scale)

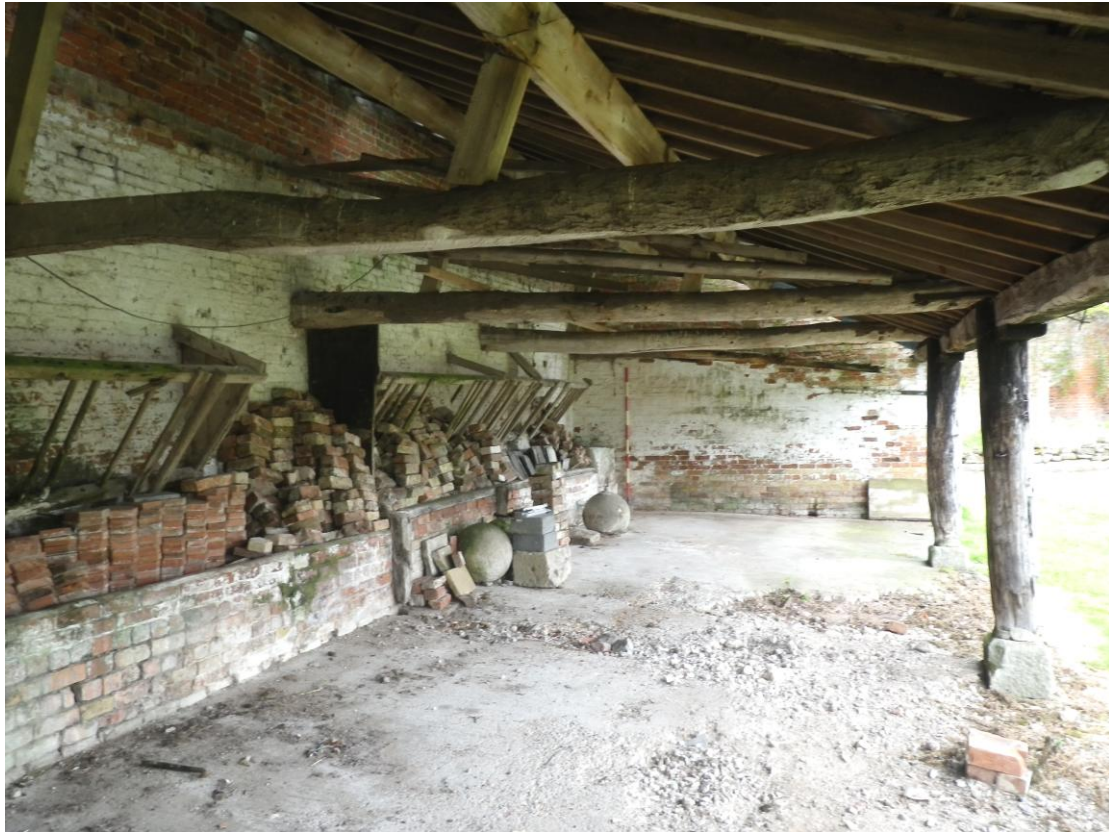
Viewed from the inside it could be seen that all of the roof structure, with the exception of the beams, had been replaced in modern times (Plates 13 and 14). Each beam carried a pair of raking struts that in turn supported a pair of purlins that ran the length of the shed. The beams were without doubt, along with the posts already described and the longitudinal members

A feeding trough ran along the whole length of the north wall (Figures 2 and 3, Plates 13 and 14). The trough was 0.65m high and consisted in its external face of bricks of size 9" x 4" x 2<sup>3</sup>/<sub>4</sub>" (228mm x 102mm x 70mm). The brick was topped by a wooden member. Two timber posts were present flush with the trough and of the same height (Figure 3). These posts were identical to examples to be seen in the western shed (Plate 27). At the easternmost end of the feeding trough there was a stone trough that would have contained water (Figures 2 and 3, Plate 15). The stone trough stood a little higher than the feeding trough and was of overall size 1.10m x 0.65m x 0.45m.

Plate 13 The interior of the eastern cart shed viewed from the south-west (2m scale)

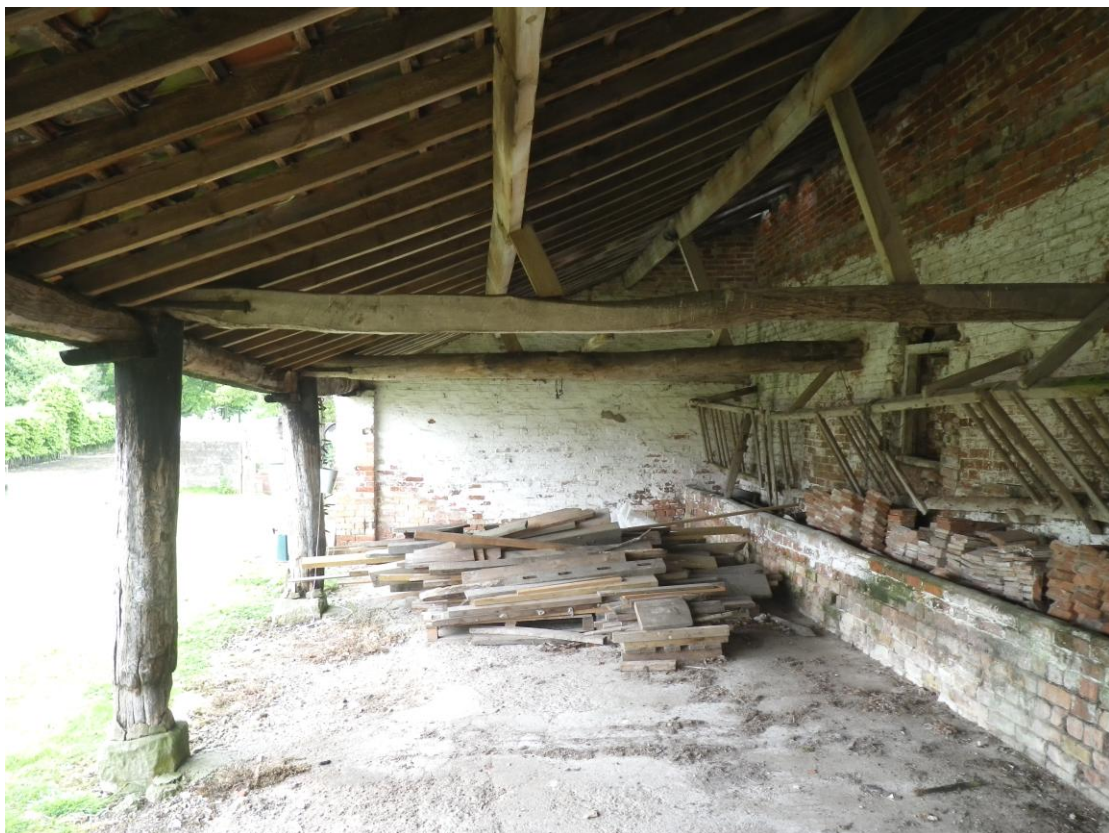
they supported, part of the original structure. Of the four truss beams, three (beams 1, 2 and 4) were predominantly of round wood that had been largely unconverted and thus retained a good deal of bark. These were all around 0.18m in diameter. The other beam (beam 3) had been largely, though rather crudely, squared-off (Plates 14 and 17).

Plate 14 The interior of the eastern cart shed viewed from the north-east. Note the largely squared-off beam 3 in the foreground

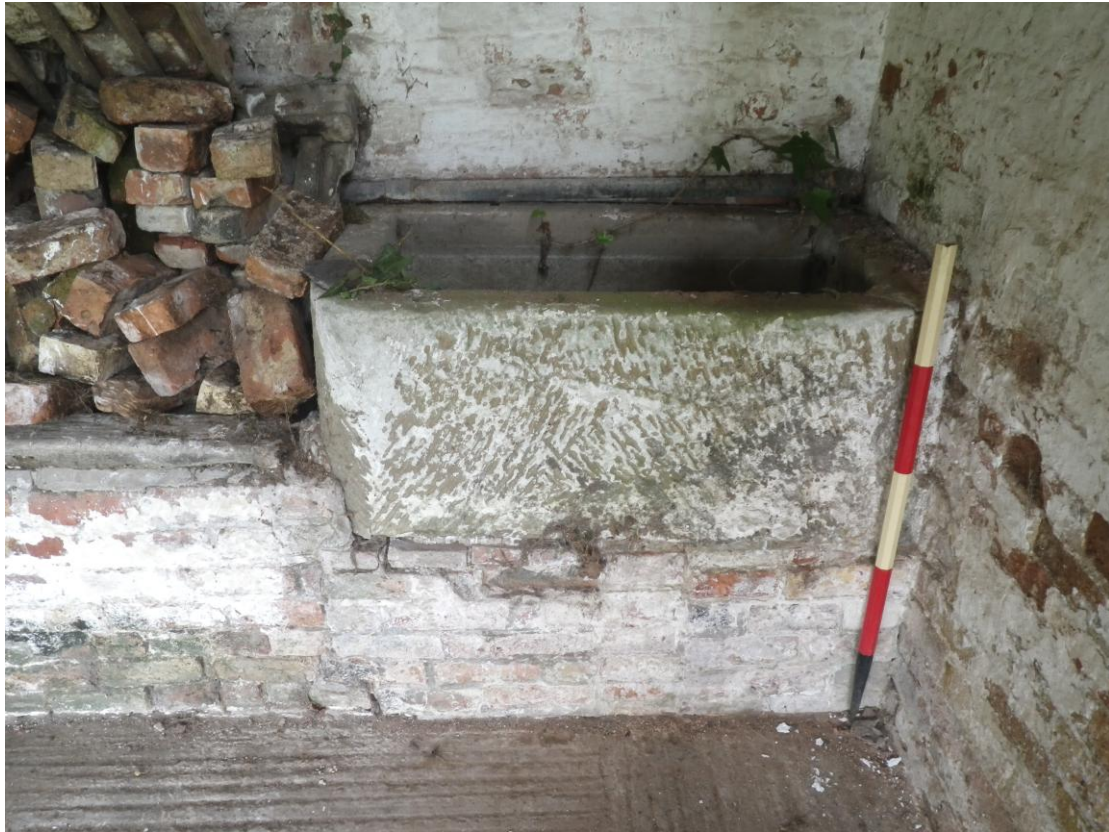
Plate 15 Stone trough at the east end of the feeding trough (1m scale)

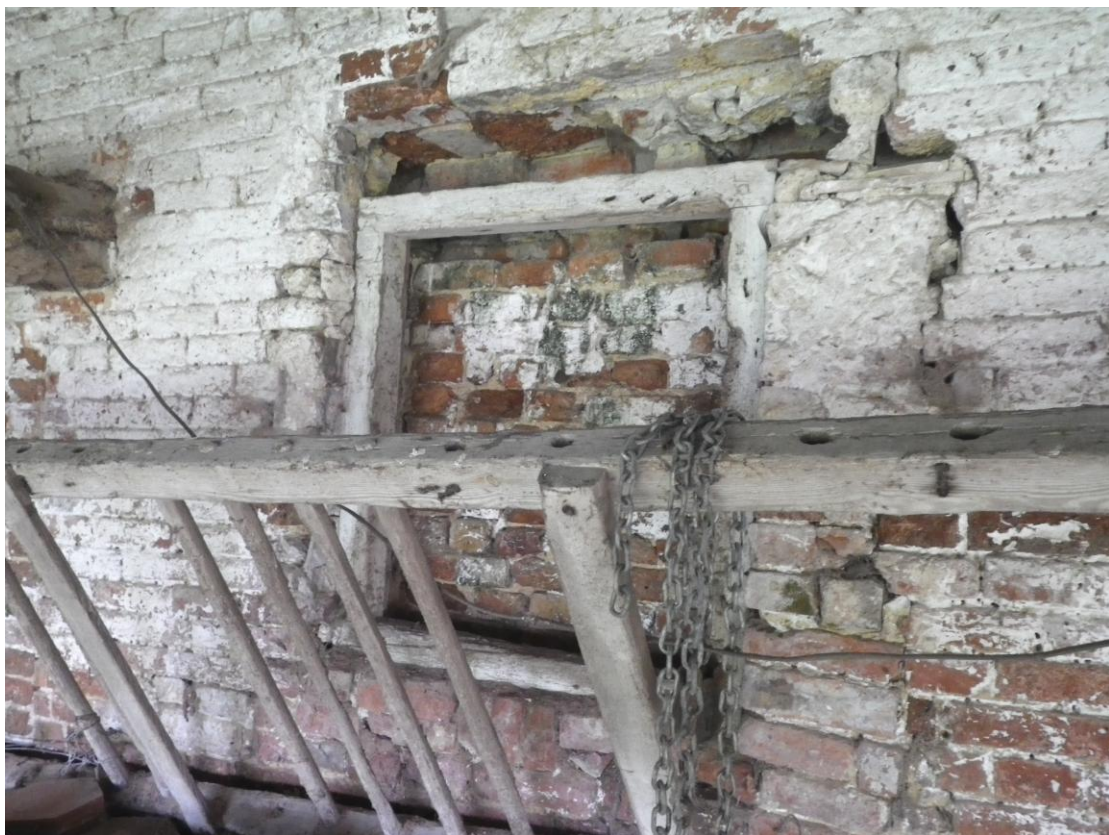
With regard to the possible blocked window described above, unlike in the external elevation where the brick blocking was flush with the face of the wall, internally there was no blocking, with a timber (window?) frame having been left in place ((Figures 2 and 3, Plate 16). A little to the west of the blocking described above, two straight joints were visible on the internal face of the wall (Figure 3, Plate 18). These were not visible externally and what they were indicative of remains unclear.

Plate 16 Partially blocked window (?) in the north wall with part of the manger in the foreground

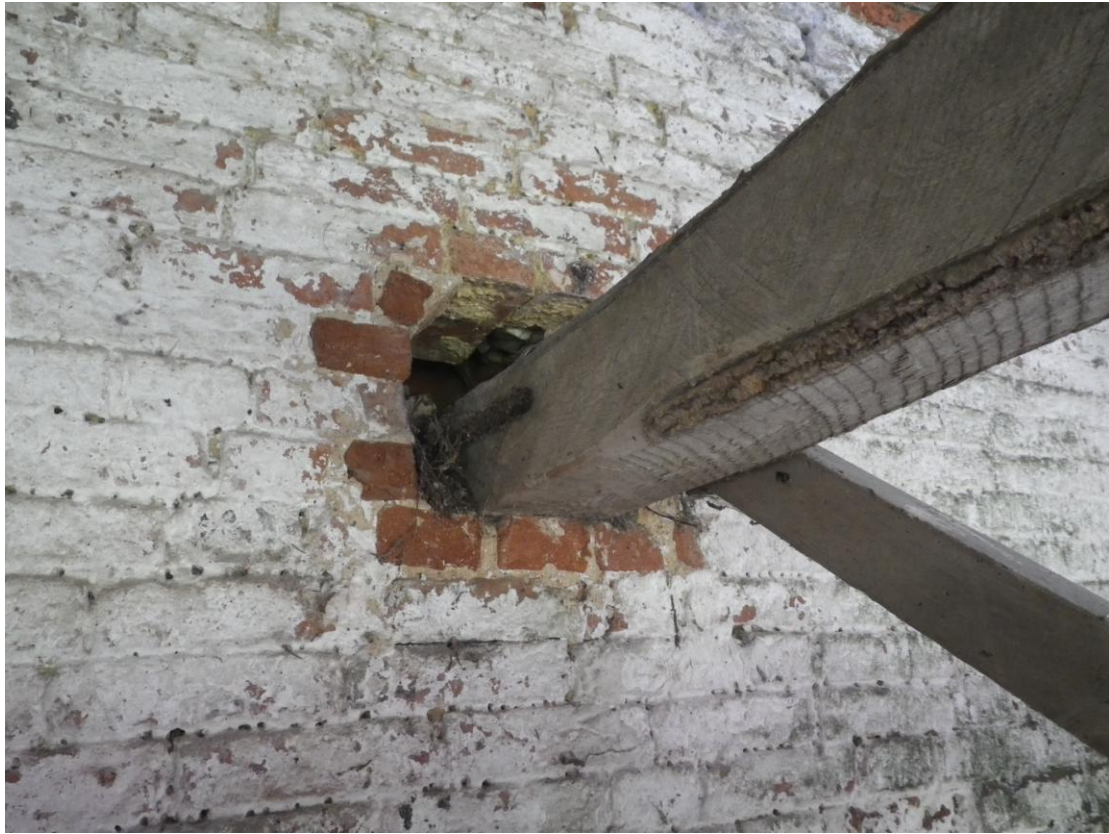
Plate 17 Setting in the north wall for beam 3 viewed from the south

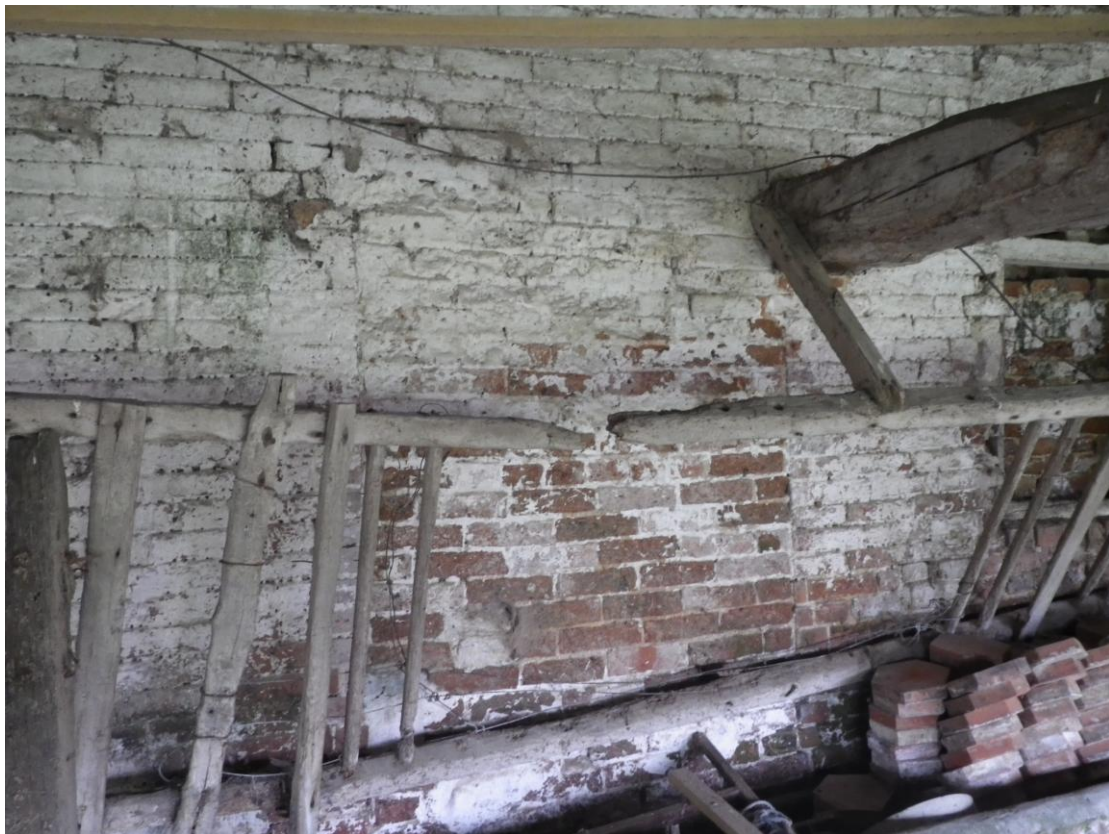
Plate 18 Straight joints in the north wall to the west of beam 4

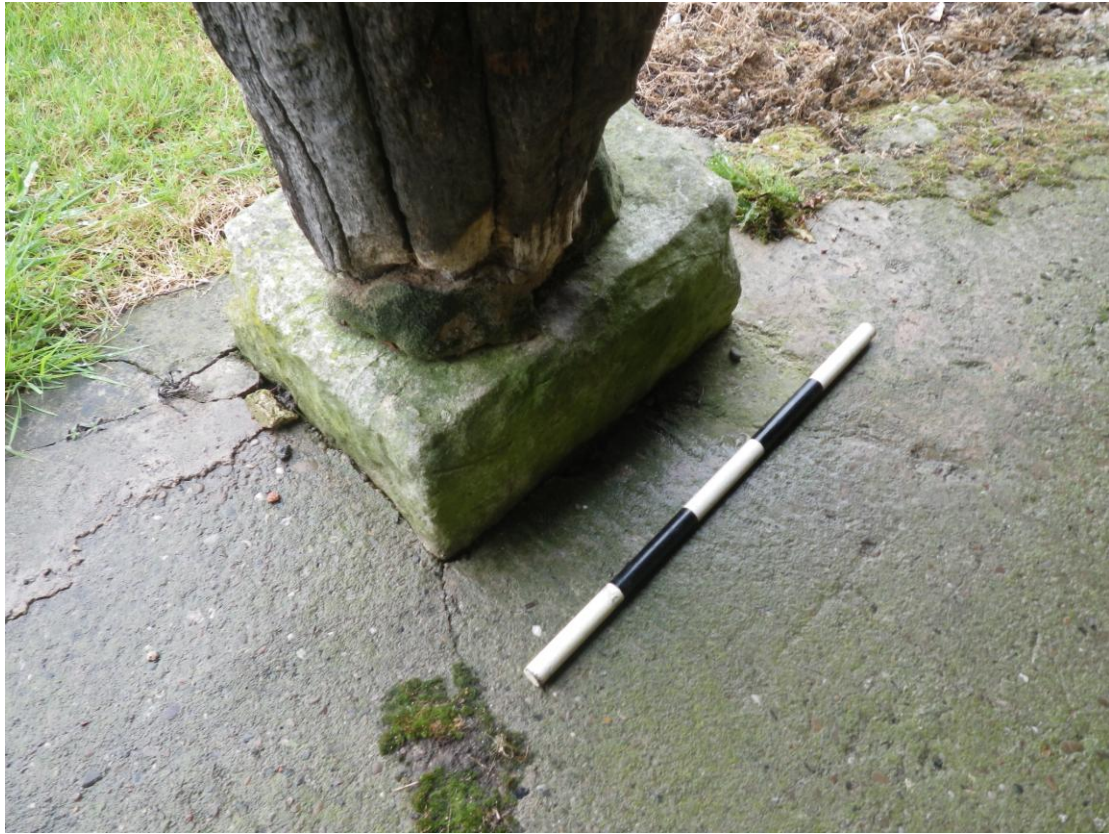
As has been stated above, this comprised three sections. The eastern cart shed was open-fronted along this elevation, the roof being supported by four circular-section wooden posts, all of a diameter of around 0.26m (Plates 1-3, 13 and 14). They had weathered to a mostly silver-grey colour though a tar coating had been retained in their upper portions. The posts were supported by rectangular-section pad stones of average size 0.38m x 0.30m x 0.15m. The easternmost stone retained clear chamfering on its uppermost surface though the other stones had remnants of such working (Plate 19).

Plate 19 The stone base for the beam 1 post (0.5m scale)

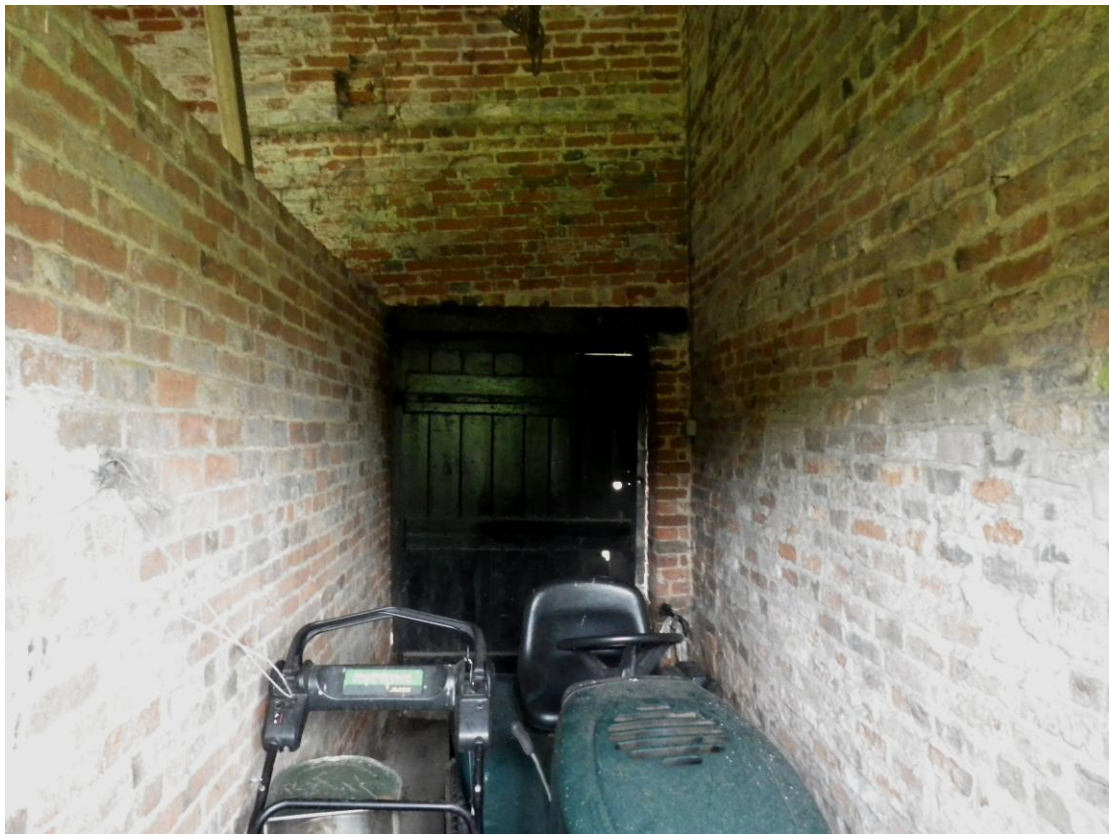
The only thing to note here was that whereas the wall to the east ran up to roof height, the wall to the west ran only to the height of a roof truss (Plate 20). Neither wall was bonded in to the north wall.

Plate 20 The passageway viewed from the south-east

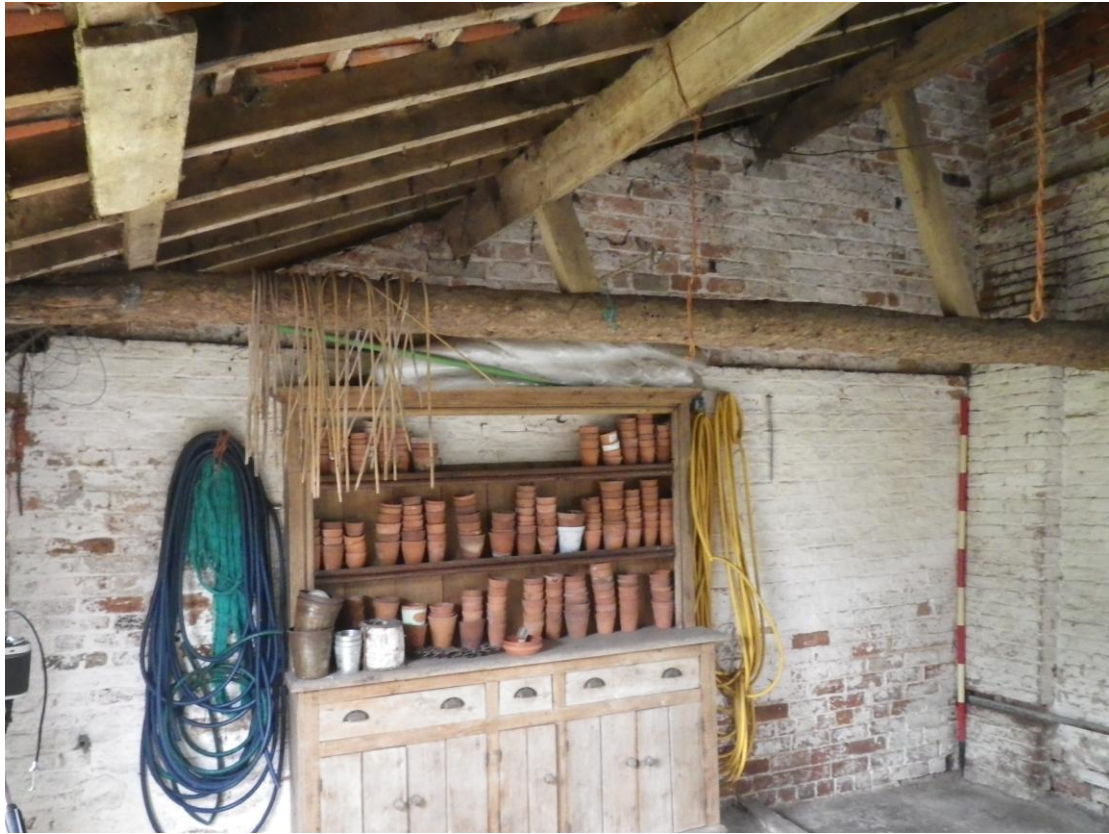
Both the roof trusses were of the type seen in the eastern cart shed, with round wood beams that here retained almost all their bark (Plate 21). Another buttress for the north wall could be seen in the north-west corner of the room (*ibid*). In the same corner of the room there was a depression in the cement floor accompanied by a single row of bricks along its south side (Figure 3, Plate 22). Its former function was unclear.

There was a slight set back to the east wall above 2.10m and unlike the rest of the wall surfacing throughout the room, which had been largely painted over, the brickwork running up to roof level had remained largely unpainted (Plate 21).

Plate 21 Room 1 viewed from the east (2m scale)

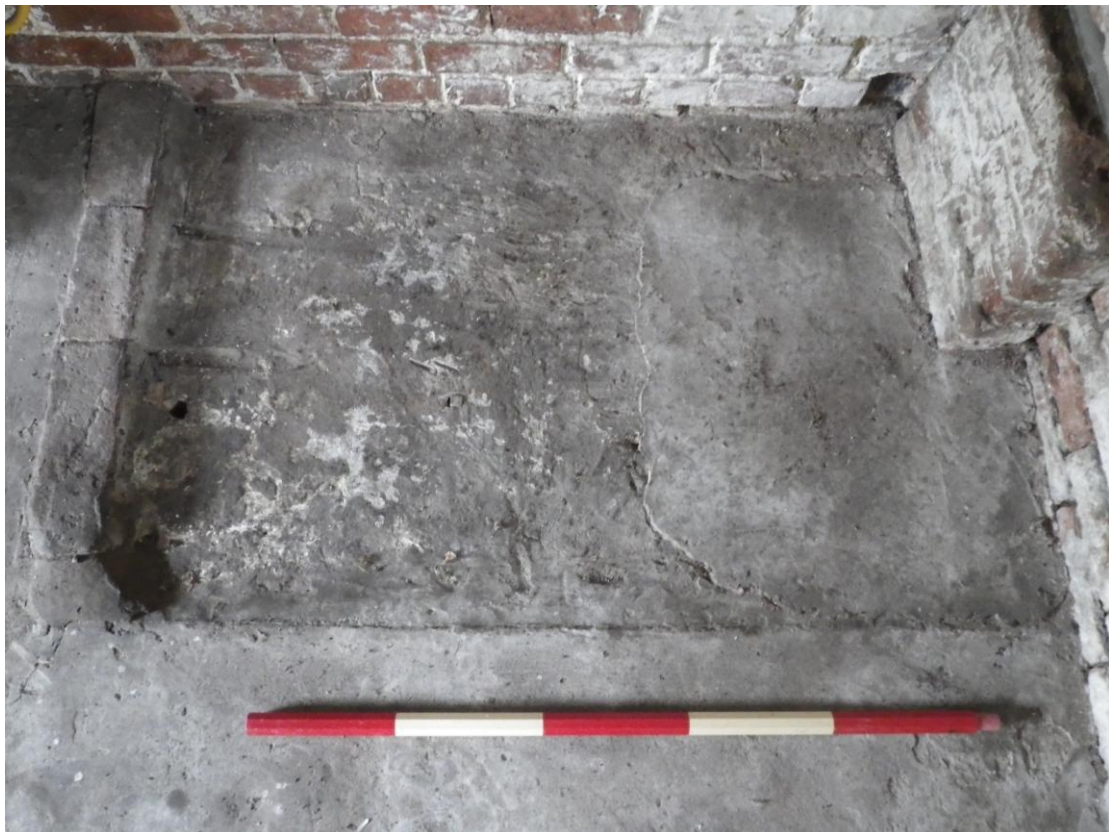
Plate 22 The recess in the west corner of the floor of room 1 (1m scale)
