## **HISTORIC BUILDING RECORDING**

**HOME FARM  
MAIN STREET  
SOMERBY  
LINCOLNSHIRE**

**Humber Field Archaeology Report no. 2014**

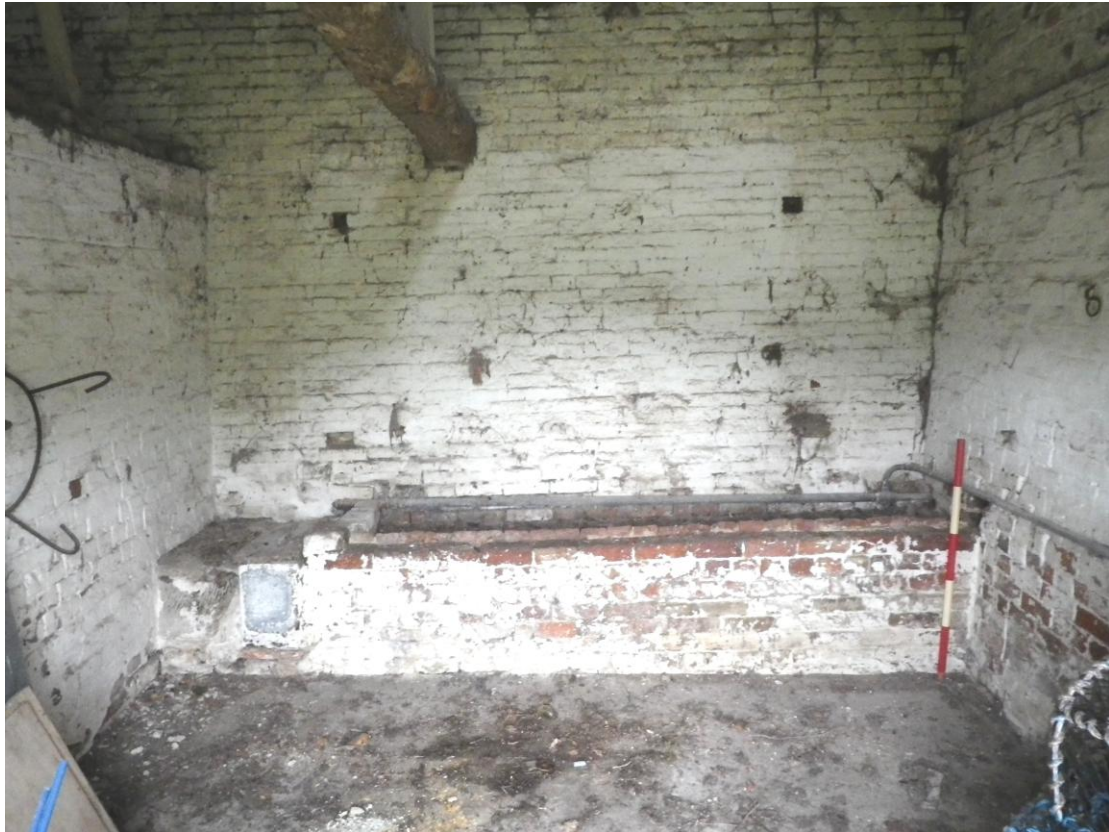
Again, neither the east nor the west wall had been bonded into the north wall, the west wall only rising to the height of the roof truss. All the walls had been heavily painted over (Plate 23). The single roof truss spanning the room was of the configuration and character described above. A feeding trough ran along most of the length of the north wall (Figure 3, Plate 23). It was very similar to that described earlier though it was missing the wooden 'rail' that would have run along the top of the brickwork. At the west end of the trough there was a lead cistern measuring 0.54m x 0.26m and containing a ball cock (*ibid*, Plates 23 and 24). To the west of the cistern there was the end of a stone trough, that was similar to the one in the eastern cart shed, but here backfilled with cement (*ibid*).

Plate 23 Room 2 viewed from the south-east (1m scale)

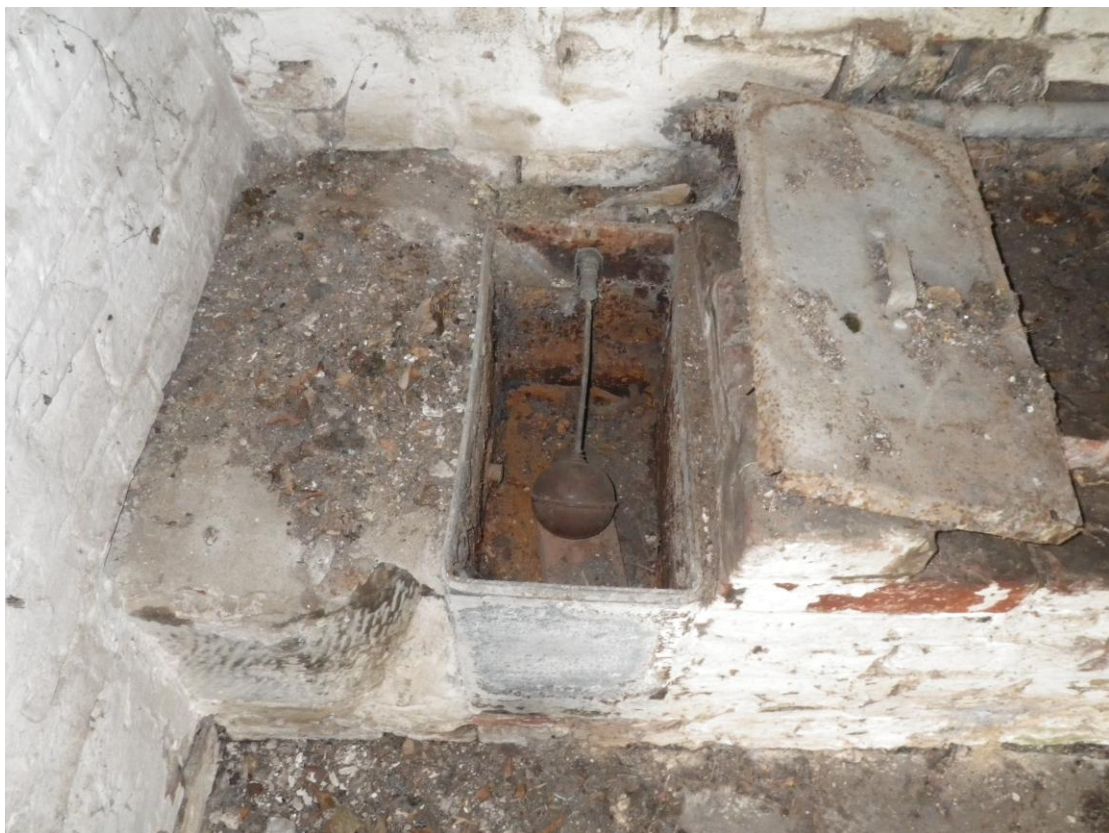
Plate 24 Backfilled stone trough and lead cistern with ball cock at the west end of the feeding trough

Room 1 may have functioned as a tack room or workshop given the presence of a window and the absence of a feeding trough. Room 2 may have been a loose box. Next to the feeding trough there was a lead cistern with ball cock that was clearly involved in managing the flow of water to various troughs to the west of the passageway. Room 3 had a low level trough and this presumably at one time linked to the trough in room 2, though there had been much alteration in the relevant corners of each room that would have made the arrangement more comprehensible. The low level of the trough and the presence of the small gate in the opposite wall suggest that room 3 might have been used as accommodation for young animals, though the author has never seen a feature such as the latter before.

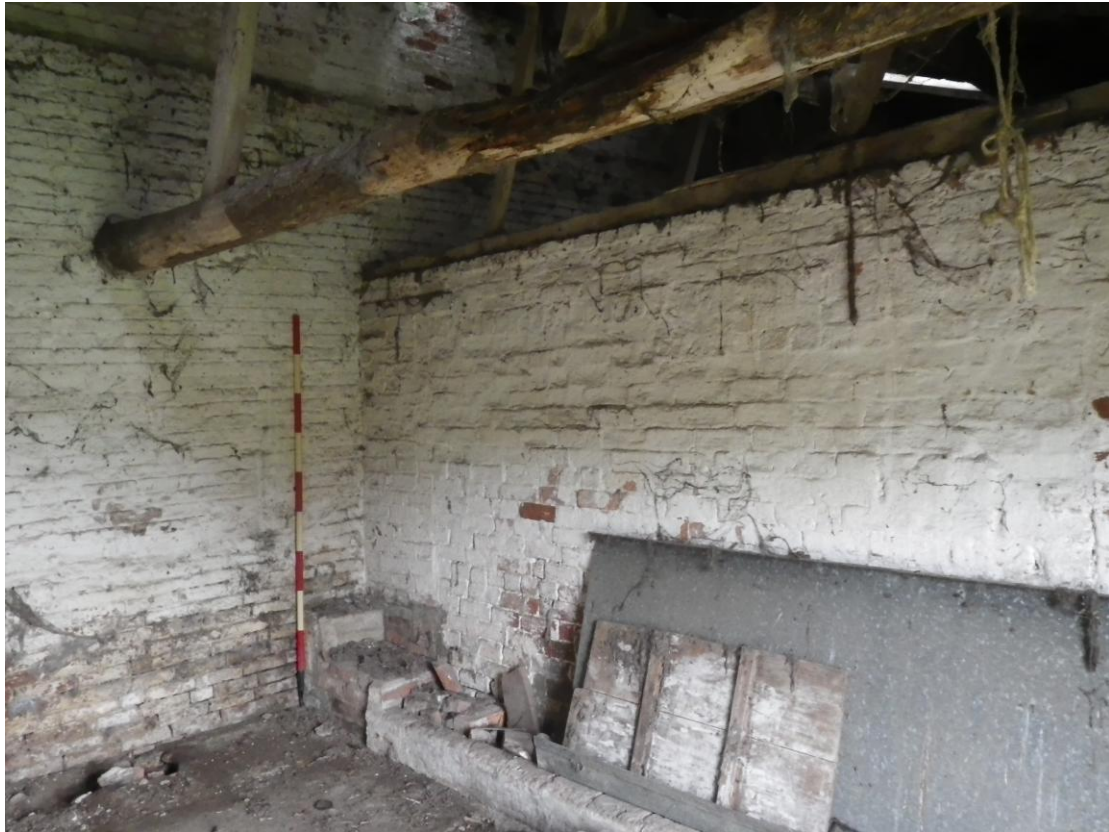
Both the east and west walls rose only to roof truss height, the west wall not being bonded in to the north wall. As in the other rooms much of the wall surfacing had been painted. The single roof truss spanning the room was of the configuration and character described above. A feeding trough around 0.30m high ran along much of the length of the east wall (Figures 2 and 3, Plate 25).

Plate 25 Room 3 viewed from the south (2m scale)

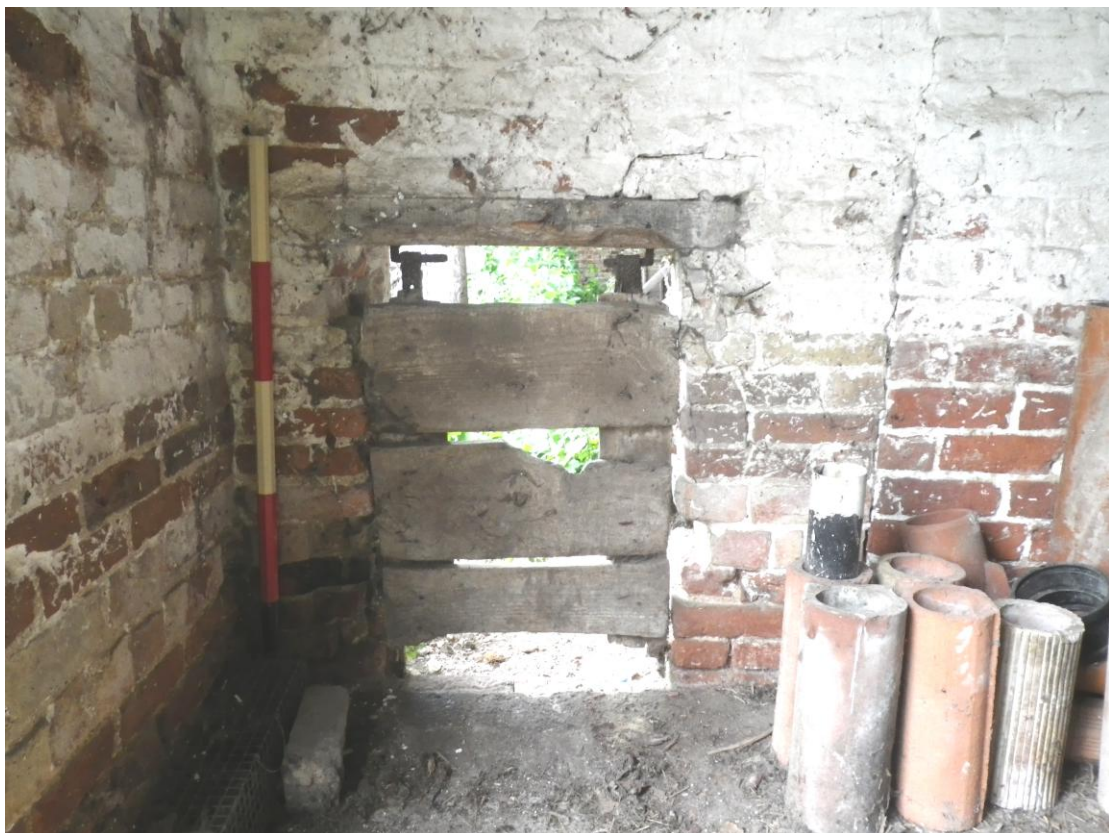
At the south end of the west wall there was a small opening at the base of the wall containing a slatted wooden flap that was attached by means of hinges to the wooden lintel above (Figures 2 and 3, Plates 26, 27 and 29). It appeared that a wooden bar (attached to the other side of the wall) could stop the flap from being used (Plates 27 and 29). A straight joint in the brickwork to the north of the flap suggested that there may once have been a doorway in this part of the wall that was then partly brick-blocked and the flap inserted. The possible function of the flap will be discussed later.

Plate 26 Wooden hatch suspended from lintel in the south corner of the room (1m scale)

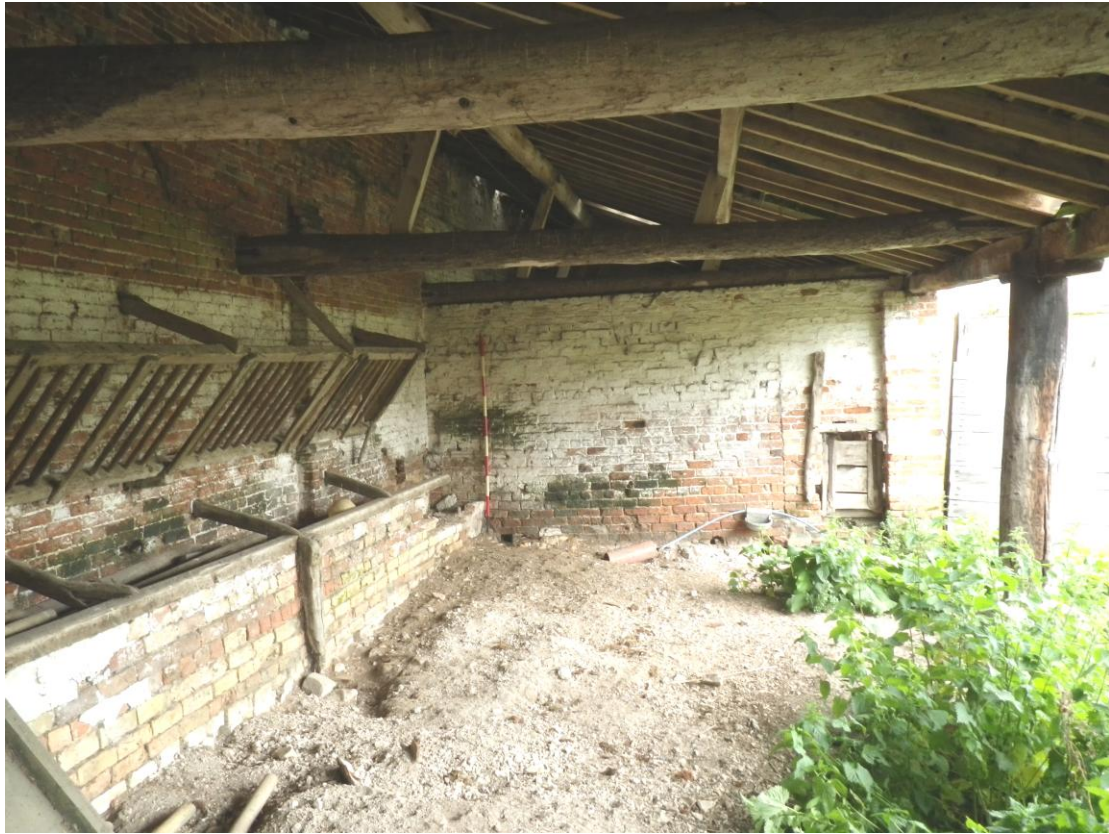
This cart shed was very similar internally to that to the east. The three roof trusses were again of the design described earlier with round wood beams (Plate 27). A feeding trough ran the length of the north wall (Figures 2 and 3) and this was of the same height and design as that in eastern cart shed, except that here a significant number of buff bricks had been used in the construction. There were three wooden posts positioned against the feeding trough (Figure 3, Plate 27). The floor surface of the shed was of loose material and rabbit burrowing had exposed drains leading from the feeding trough in at least two places (Figure 3, Plate 30).

Plate 27 The interior of the western cart shed viewed from the south-west (2m scale)

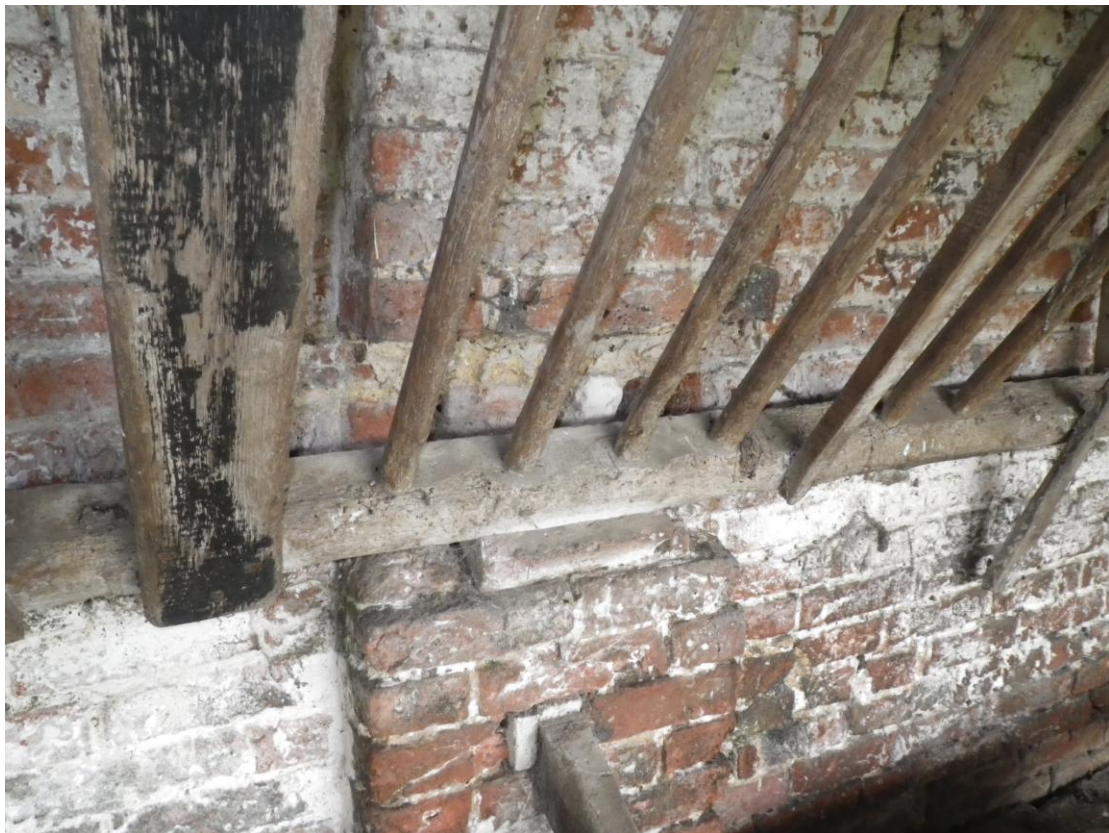
As in the eastern cart shed, a manger ran along the north wall above the feeding trough (*ibid*) and notches had been cut into the two buttresses of the wall to accommodate it (Plate 28). The significance of this will be discussed later. Notable also, was the fact that that the mortar of the north wall had been pockmarked, presumably by the roots of climbing plants (Plate 31).

Plate 28 Detail of manger woodworking cutting into one of the buttresses of the north wall

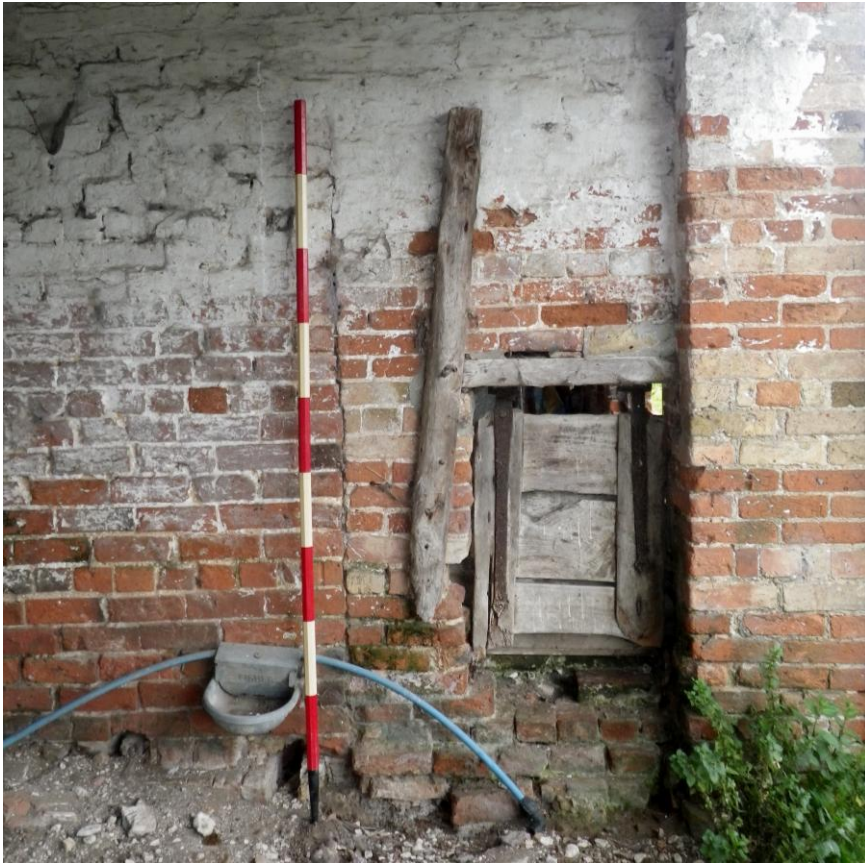
Plate 29 The wooden hatch viewed in room 3, here seen from the south-west (2m scale)

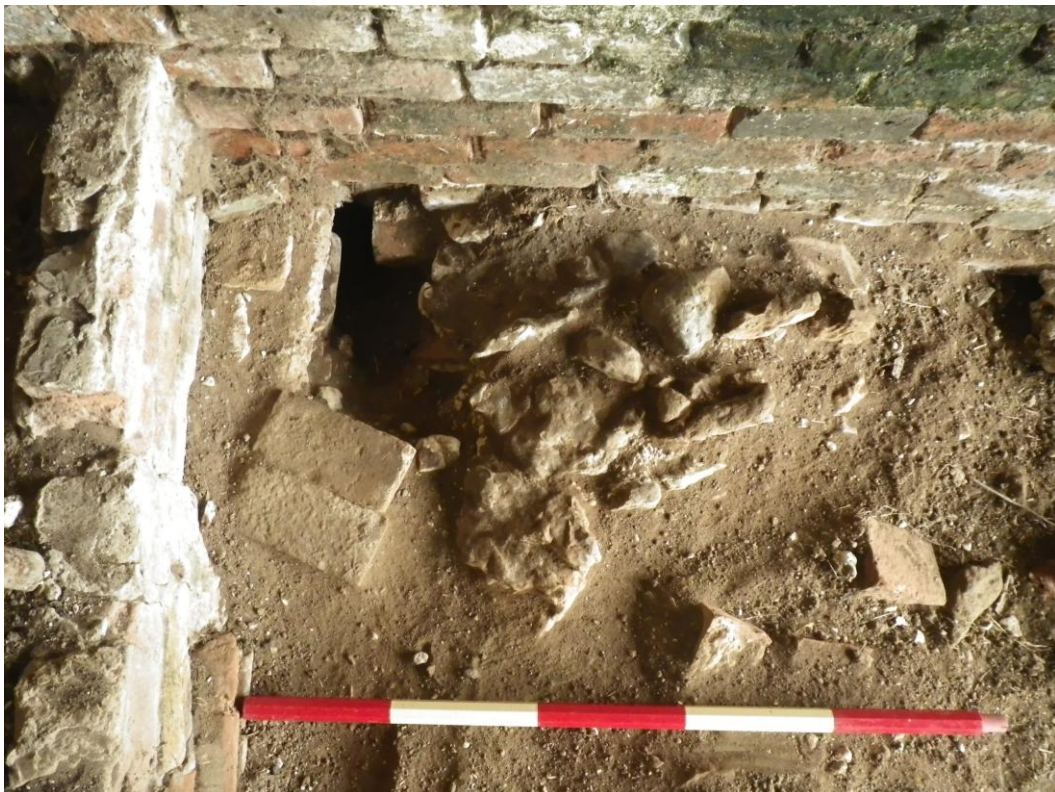
Plate 30 Exposed drain adjacent to the east end of the feeding trough (1m scale)

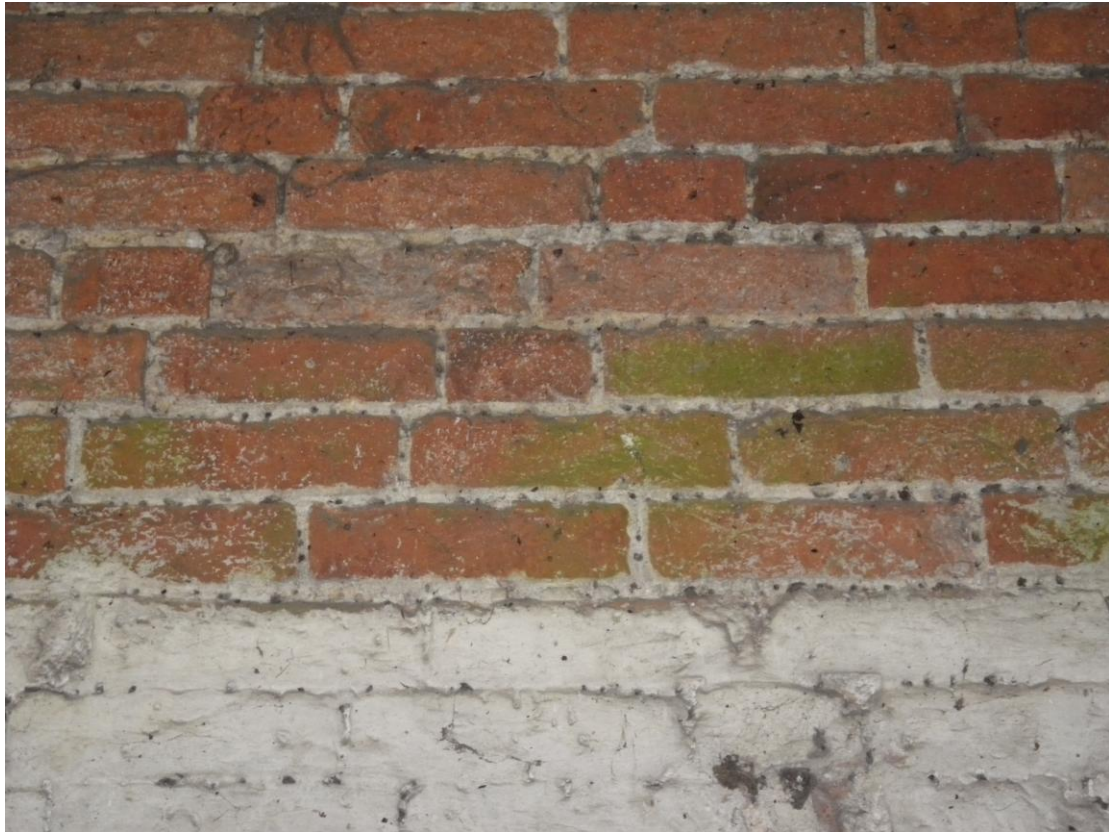
Plate 31 Damage to mortar caused by climbing plants in the north wall of the western cart shed

A number of pieces of evidence point to the north wall of the building pre-dating the rest of the structure. The first is that the wall was substantially thicker than any of the other walls in the building and was different in construction, having a rubble stone core. Secondly, where the junctions of walls could be viewed, it was clear that most, if not all the walls running south of the north wall, were not bonded into it. The wall also had buttresses on its south side, indicating that this was once an external face, and in places the buttresses had been cut into to allow the positioning of the manger in both the east and west cart sheds. Finally, the wall showed quite clearly along the western portion of its south face that climbing plants had once grown up against it, as evinced by the large amount of root damage to the lime-based mortar.

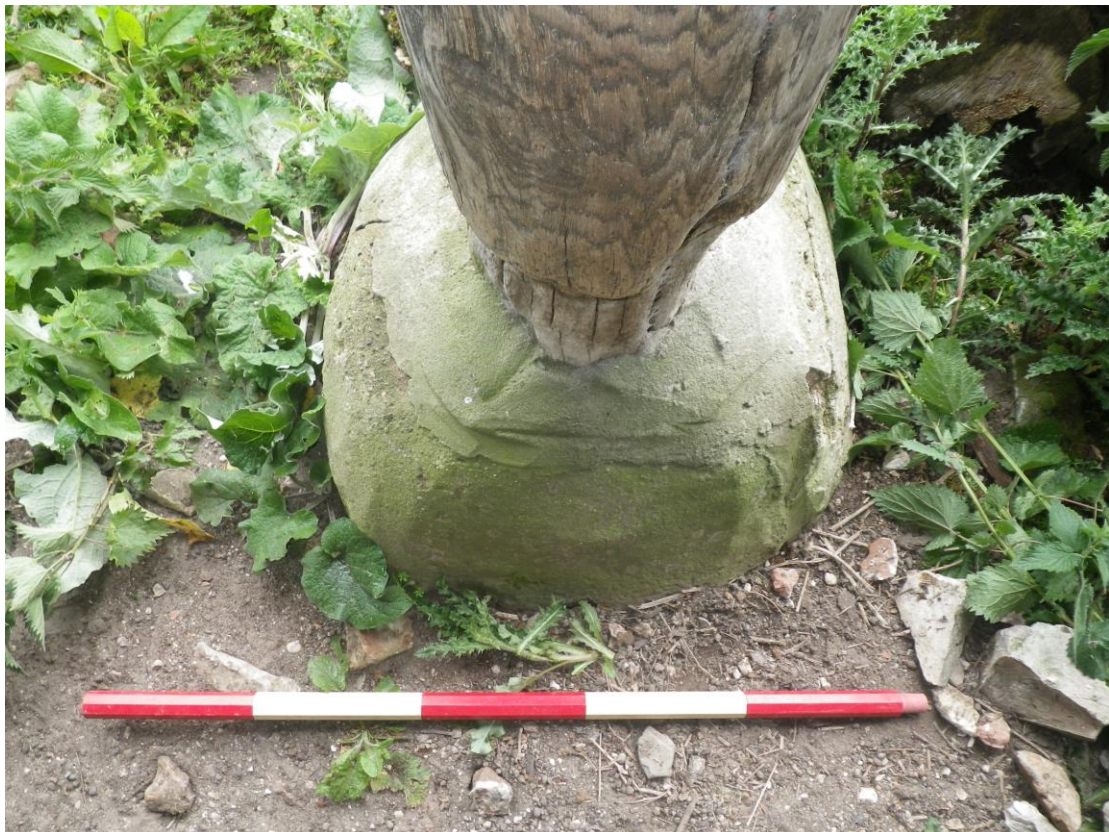
Plate 32 Concrete and cement base to the most easterly wooden post of the western cart shed (1m scale)
