## **ARCHAEOLOGICAL OBSERVATION, INVESTIGATION AND RECORDING**

**SOUTH FERRIBY – HORKSTOW – BONBY – WORLABY  
11KV OVERHEAD LINE REBUILD NORTH LINCOLNSHIRE**

**APRIL 2016 – MAY 2017**

**Humber Field Archaeology Report no. 2033**

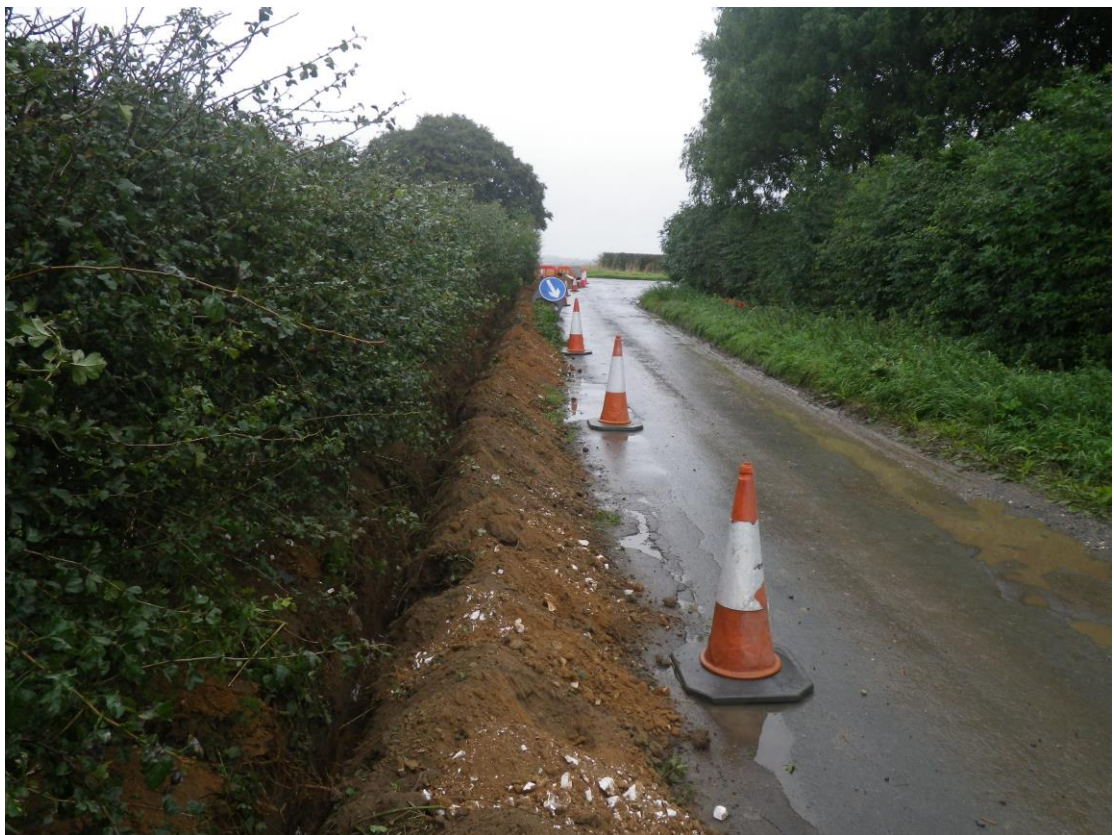
Plate 18 The cable trench alongside Wold Road looking north-east

The trench (Plate 18) was a little over 200m long excepting the portion that crossed Wold Road to its south side which was not observed (Figure 4). The trench was generally around 0.40m wide and up to 0.90m deep. No archaeological features were observed. Throughout the base of the trench there was a layer at least 0.20m thick of orange-brown sandy clay silt containing very occasional chalk fragments (1002) (Plate 19), Above this there was a layer up to 0.70m thick of dark grey-brown topsoil that again contained very occasional chalk fragments (1001).

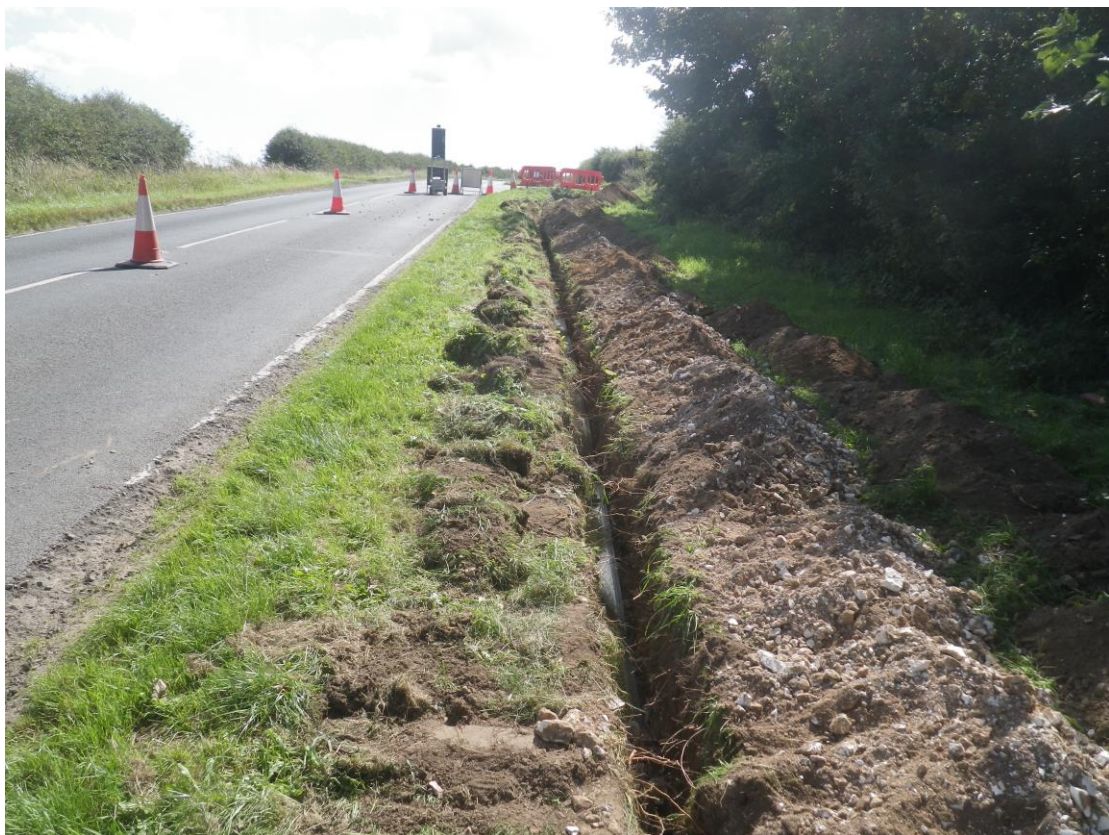
Plate 20 The southern end of the B1206 trench looking south

The trench was over 1.9km long and ran for its entire length along the west side of B1206 (Plates 20 and 21), save where it crossed a short redundant stretch of former roadway near the B1206/A15 junction (Figure 4). The trench was generally around 0.40m wide and up to 0.90m deep. No archaeological features were observed. Generally throughout the base of the trench there was a layer at least 0.30m thick of chalk brush, above which there was a 0.30m thick layer of (1002) and a maximum of 0.30m thick layer of (1001) (Plate 22).

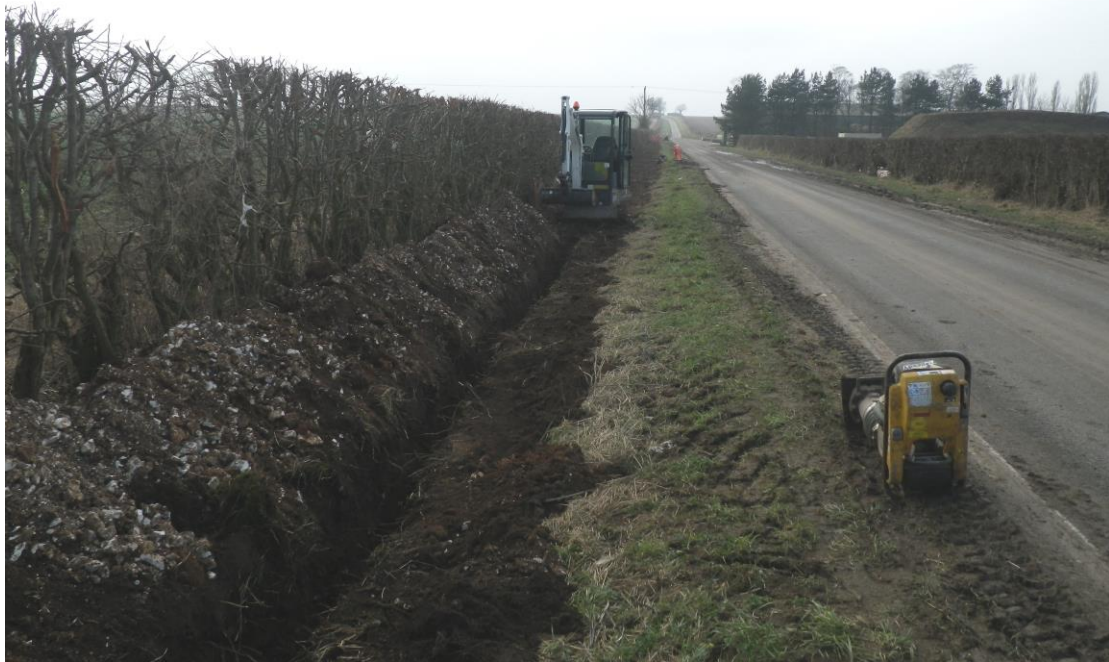
Plate 23 The south-west end of the Bonby Lane trench looking south-west

The trench was around 1.2km long and ran for its entire length along the south side of the lane (Figure 4, Plates 23-25). The trench was generally around 0.40m wide and up to 0.90m deep. As with the B1206, throughout the base of the trench there was a layer at least 0.30m thick of chalk brush, above which there was a 0.30m thick layer of (1002) and a maximum of 0.30m thick layer of (1001) (Plate 26).
