A PROGRAMME OF HISTORIC BUILDING RECORDING

**LAND WEST OF BRIGG ROAD
CAISTOR
WEST LINDSEY
LINCOLNSHIRE**

MARCH 2018

Humber Field Archaeology Report no. 2060

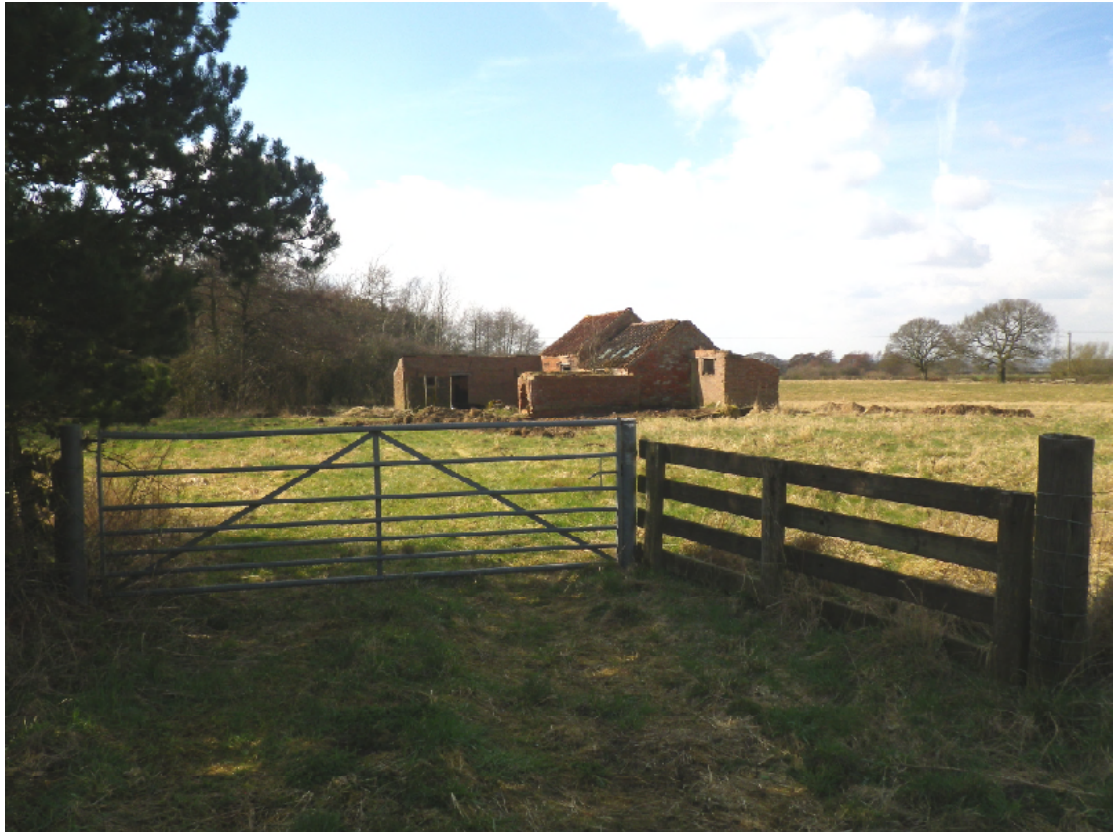
The building was a roughly ‘U’-shaped single-storey structure of an orange-red brick except where stated otherwise below. It had gabled pantile-covered roofs to its central portion (Rooms 1 and 2), a corrugated asbestos mono-pitched roof to its west ‘wing’ (Rooms 5 and 6), with the east ‘wing’ (Room 3) and the tiny extension to the east of room 2 (Room 4) being roofless at the time of survey (Figure 2, Plates 1 and 2).

Plate 1 General view of the building from the south-east

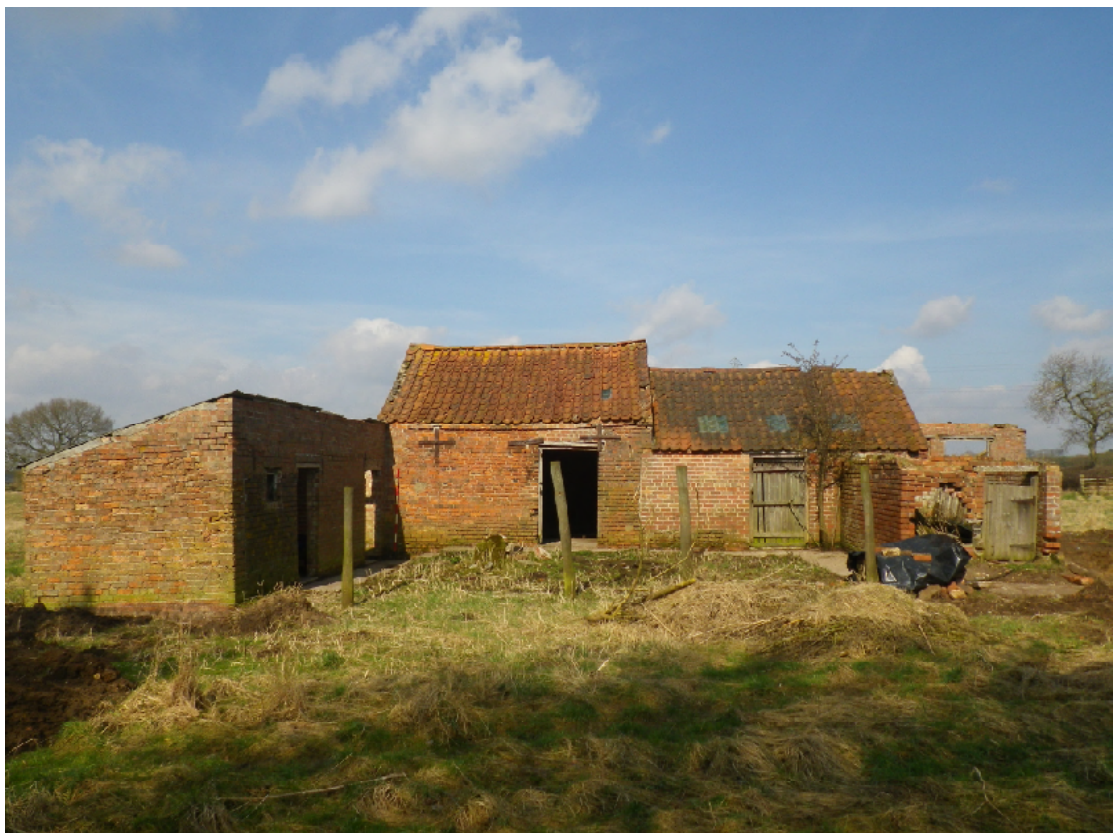
Plate 2 General view of the building from the south

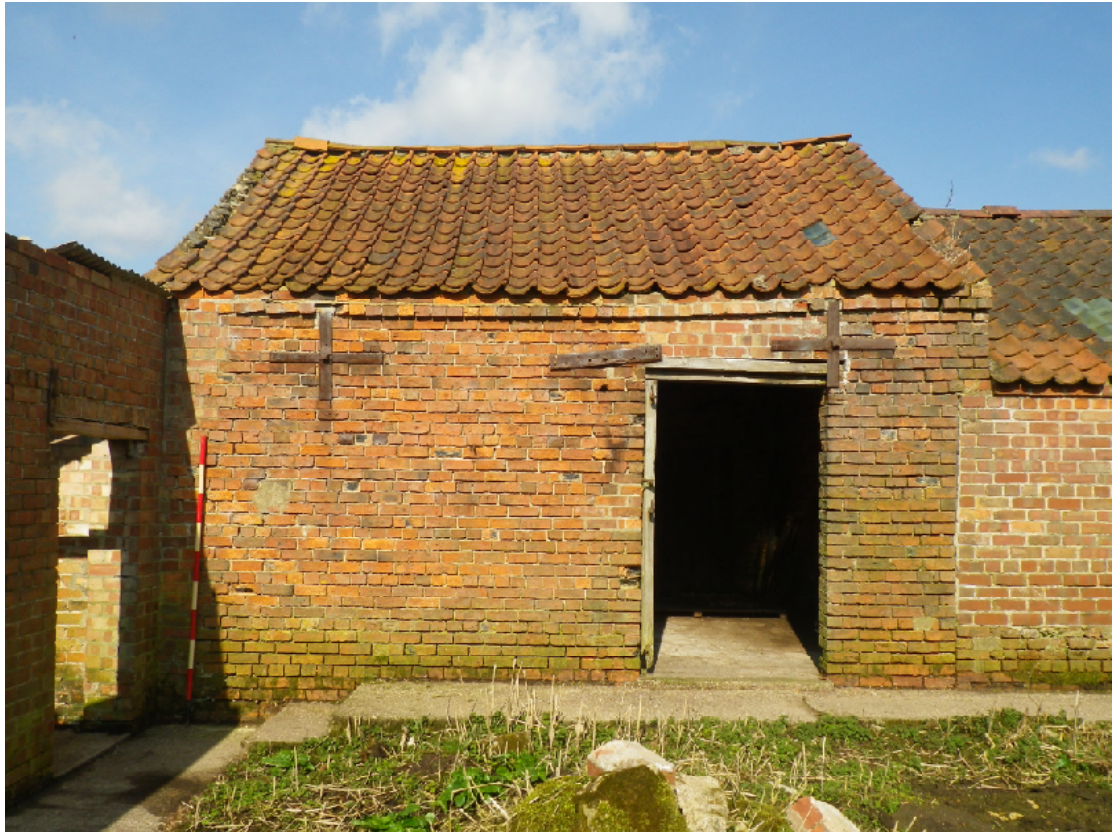
The brickwork had been laid in an English garden wall bond (three courses of stretchers to each of headers), the bulk of the bricks being 210mm x 105mm x 65mm in size. The most prominent feature in the elevation was a doorway towards its east end (Figure 2, Plate 3). Immediately above the doorway there was a later repair in reddish pink bricks of size 225mm

x 105mm x 75mm. Another such repair had been made in the upper part of the elevation at the west end. Throughout the elevation the two uppermost courses had been offset slightly from those below. The upper part of the elevation was also notable for having a pair of cruciform wrought iron tie straps and a single wrought iron tie strap.

This elevation abutted that of Room 1, there being a straight joint between the two (Plates 3 and 4). The brickwork was predominantly of the reddish pink type noted earlier and had been laid in Scottish bond (five courses of stretchers to each of headers) and also at six courses of stretchers to each of headers (Plate 4). However, in the base of the western part of the elevation there were six courses of the brick noted above as the predominant type encountered in the elevations for Room 1. The principal feature of the elevation was a slatted plank and batten door. On the west side of the door frame there were also four redundant cast iron lugs that may have once carried heck or split doors. At eaves level there was a single course of offset brick. The south side of the pantile roof contained two areas of glazed tiles.

Plate 3 South facing elevation of Room 1 (2m scale)

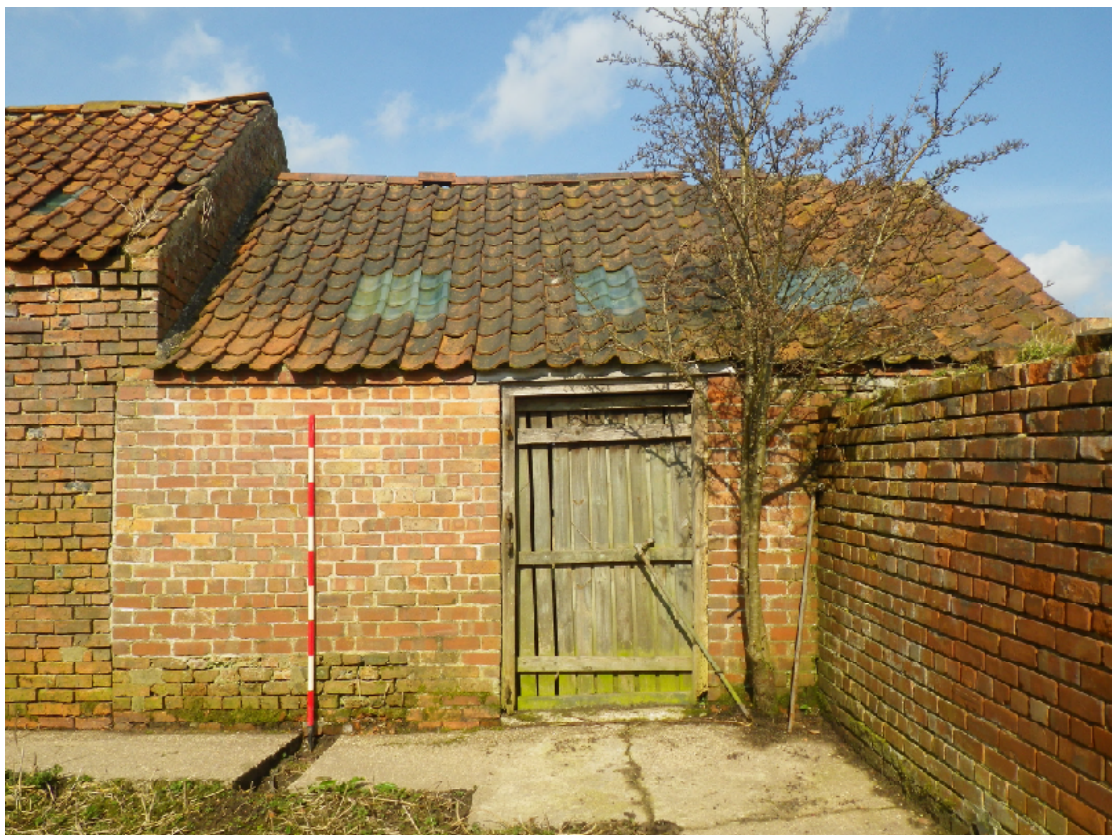
A small portion of gable elevation was visible since the roof of the adjacent Room 2 was a little lower than that of Room 1 (Plates 4 and 8). The bricks appeared to be of the same size and colour as those used in the bulk of the south elevation.

Plate 4 South facing elevation of Room 2 (2m scale)

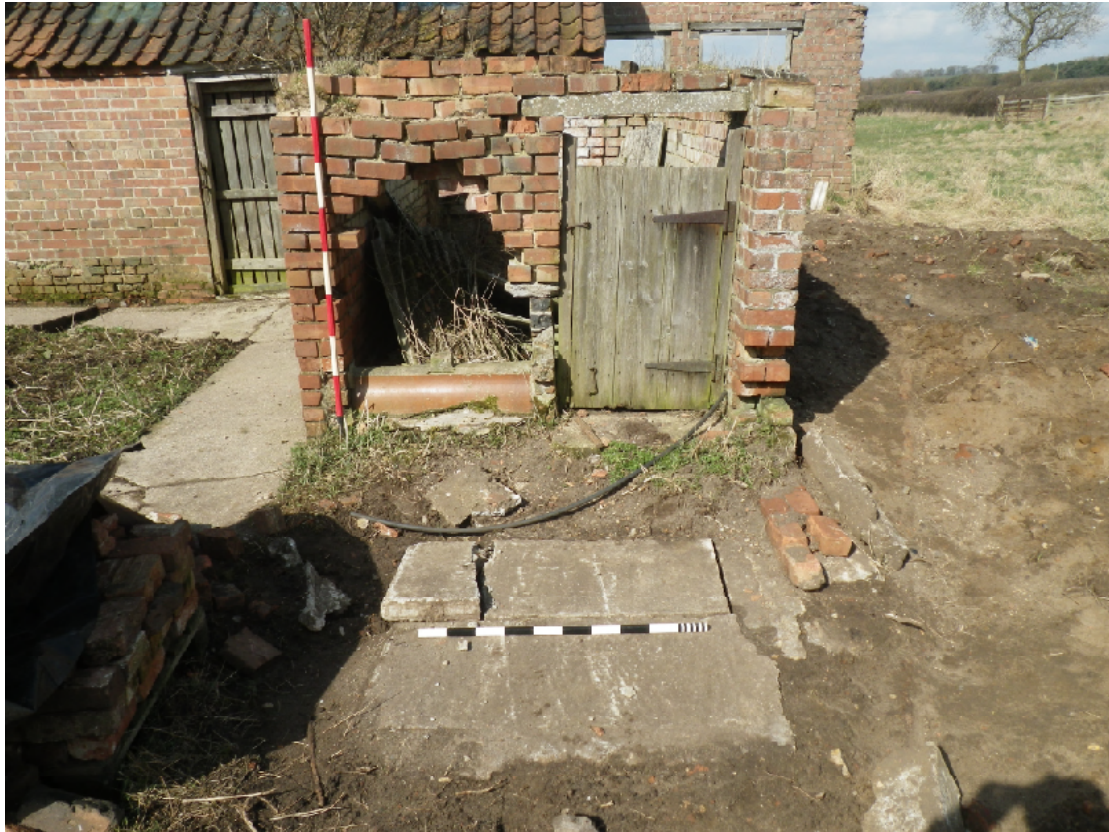
This roofless ‘wing’ running south from the south-east corner of Room 2 (Figure 2), was a little lower than Room 2 and comprised plain walls to the east and west, both of which were of the reddish pink brick laid in English garden wall bond (Plates 4-6). The bricks were of size 230mm x 110mm x 70mm. The short south elevation had been damaged and contained a low plank and batten door with iron strap hinges, above which was a precast concrete lintel. Adjacent to the door, the east elevation appeared to have at one time continued to the south (Figure 2, Plate 5). At the base of the damaged part of the elevation there was a semi-circular section portion of salt glazed drainage pipe that may have been used as a feeding trough.

To the south of the room there were a pair of precast concrete slabs that covered a brick lined well (Figure 2).

Plate 5 South facing elevation of Room 3 with concrete slabs over the well in the foreground (1m and 2m scales)

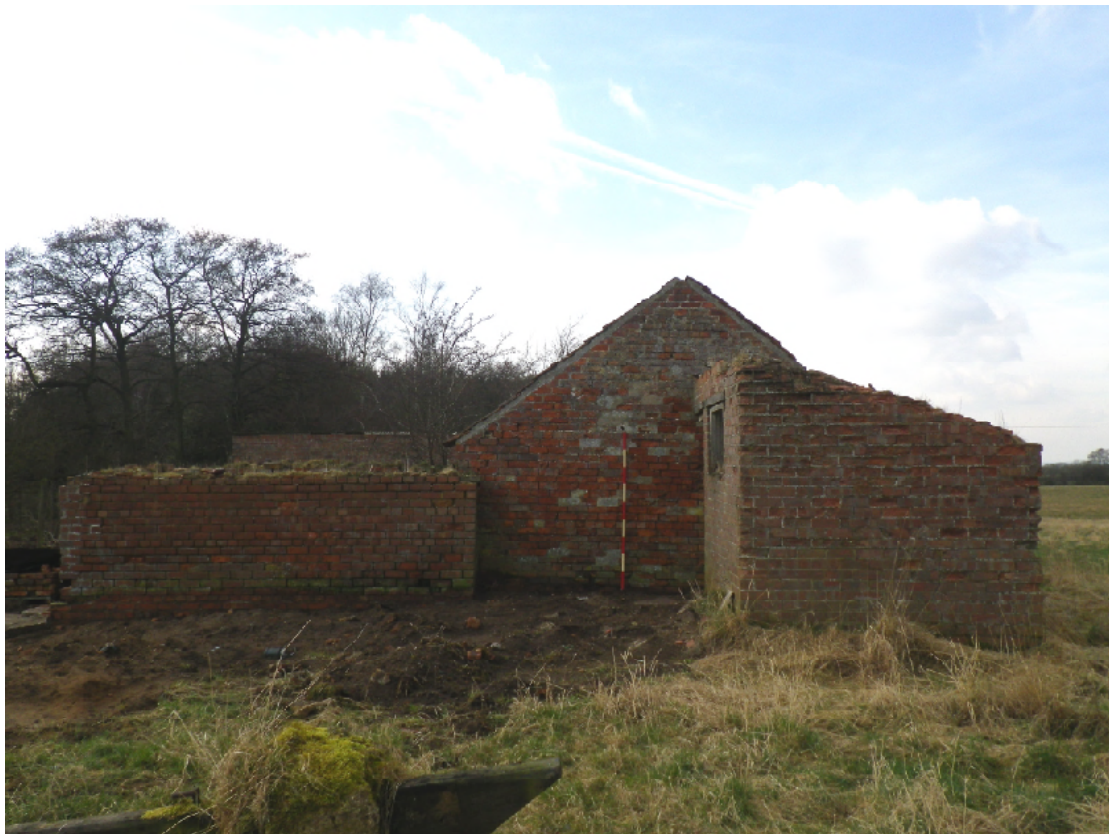
The plain brick gable end had been built in a red or russet coloured brick that had been laid in Scottish bond (Plate 6). The bricks were of size 220mm x 110mm x 70mm. The southern end of the elevation was slightly abutted by Room 3 and the northern end by Room 4 (Figure 2).

This small additional space had been added to the east elevation of Room 2 (Figure 2). It would originally have had a mono-pitched roof that ran up from north to south (Plate 6). This addition had been built in a dull pink brick laid almost entirely in stretcher bond with bricks of size 220mm x 105mm x 70mm (Plates 6 and 7). The south elevation contained a doorway and a window that was unglazed at the time of survey, whilst the east and north elevations were featureless save for a single terracotta ventilation block in the north elevation (Plate 7). A basic attempt had been made to ‘stitch’ the brickwork of this elevation to that of Room 2.

Plate 6 East facing elevations of Rooms 2, 3 and 4 (2m scale)

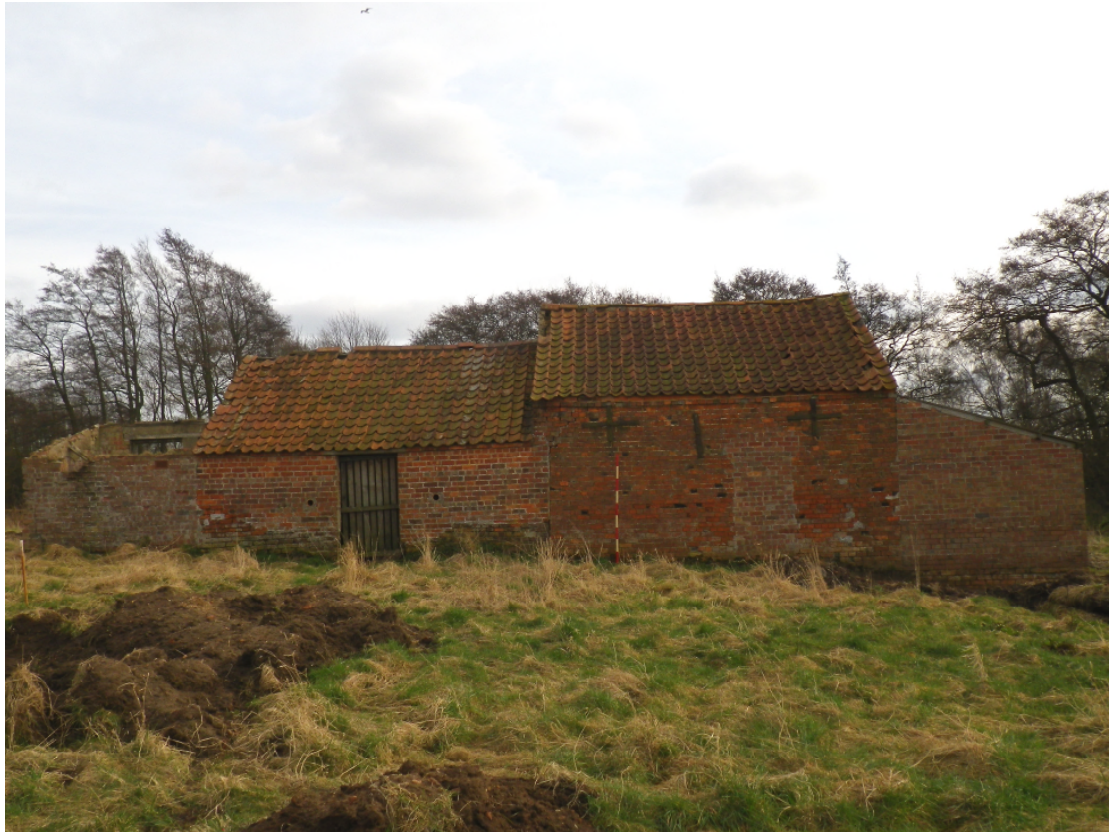
The brickwork here had also been laid in English garden wall bond, the bricks being very similar in size to those used throughout the bulk of the south elevation (Plates 7 and 9). The principal feature of the elevation was a brick-blocked former doorway, the blocking bricks being of the pinkish red type and size noted earlier. The elevation also had the offset courses and tie straps noted in the description of the south elevation.

The brickwork was predominantly of the reddish pink type noted earlier and had been laid in Scottish bond (Plates 7 and 8). Like the south elevation, this one also had earlier brickwork at the base of the elevation – though here it was rather more extensive, rising to a height of up to 12 courses. There was a single course of offset brick at eaves level. Again, the principal

Plate 7 General view of the building from the north (2m scale)

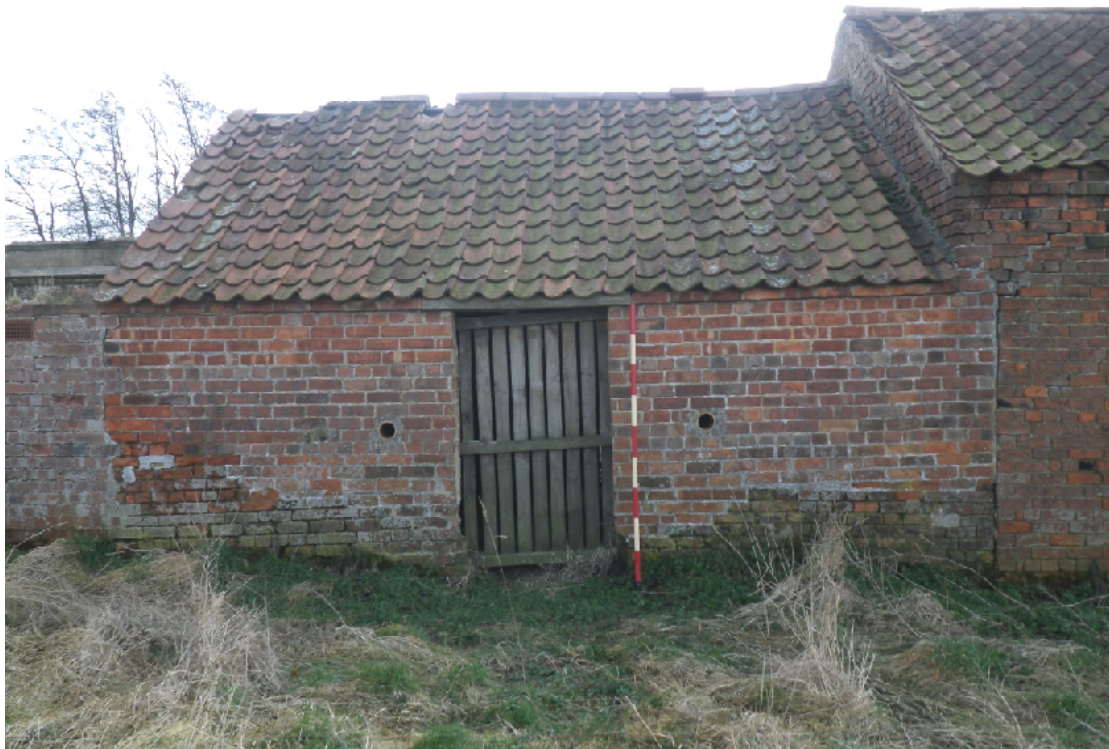
feature of the elevation was a slatted plank and batten door. The elevation also contained a pair of ventilation hole, apparently comprising portions of ceramic land drain.

Plate 8 North facing elevation of Room 2 (2m scale)

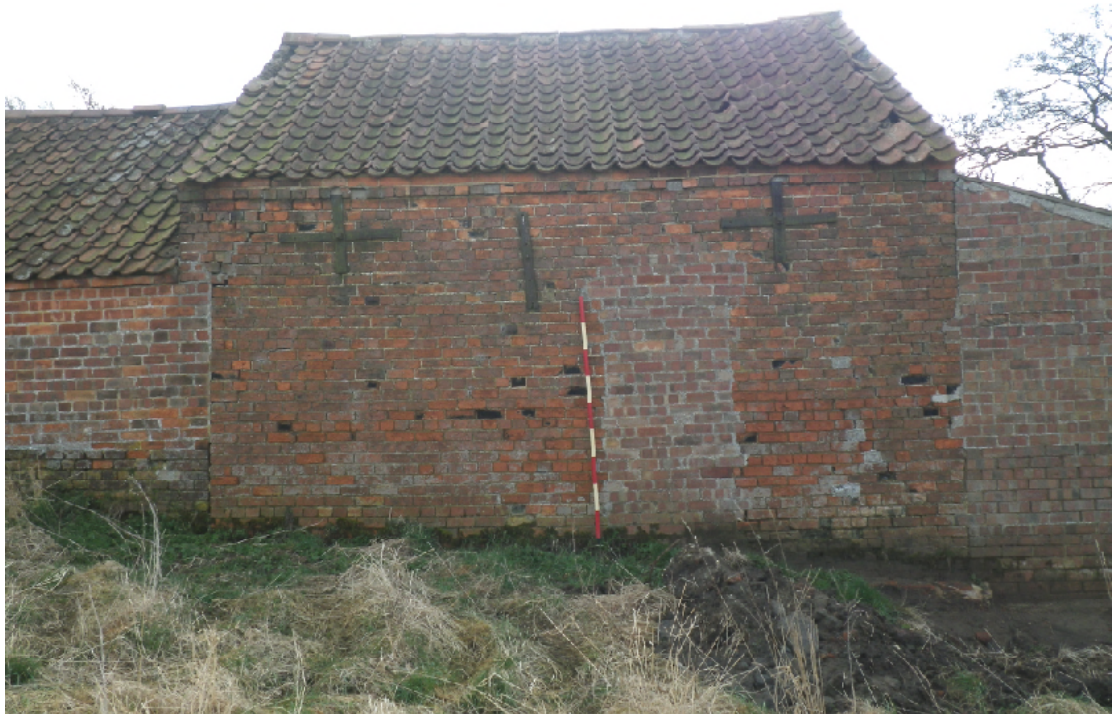
Plate 9 North facing elevation of Room 1 (2m scale)

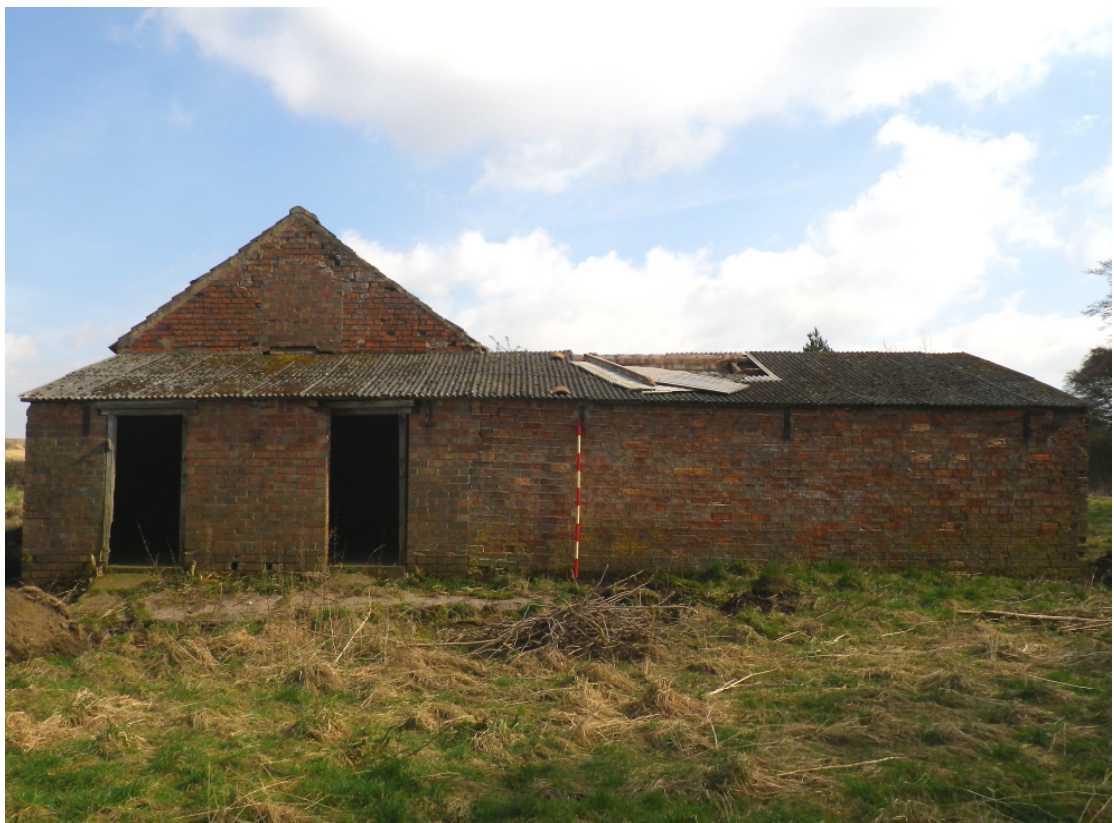
Although abutted by Room 5 to the west (Figure 2), this gable end was rather more prominent than that to the east (Plates 10 and 11). The brickwork again appeared to be of the usual type for Room 1, having been laid predominantly in English garden wall bond. There was also a brick-blocked former window (or loading door?), the blocking again utilising the pinkish red brick mentioned earlier.

Plate 10 General view of the building from the west (2m scale)

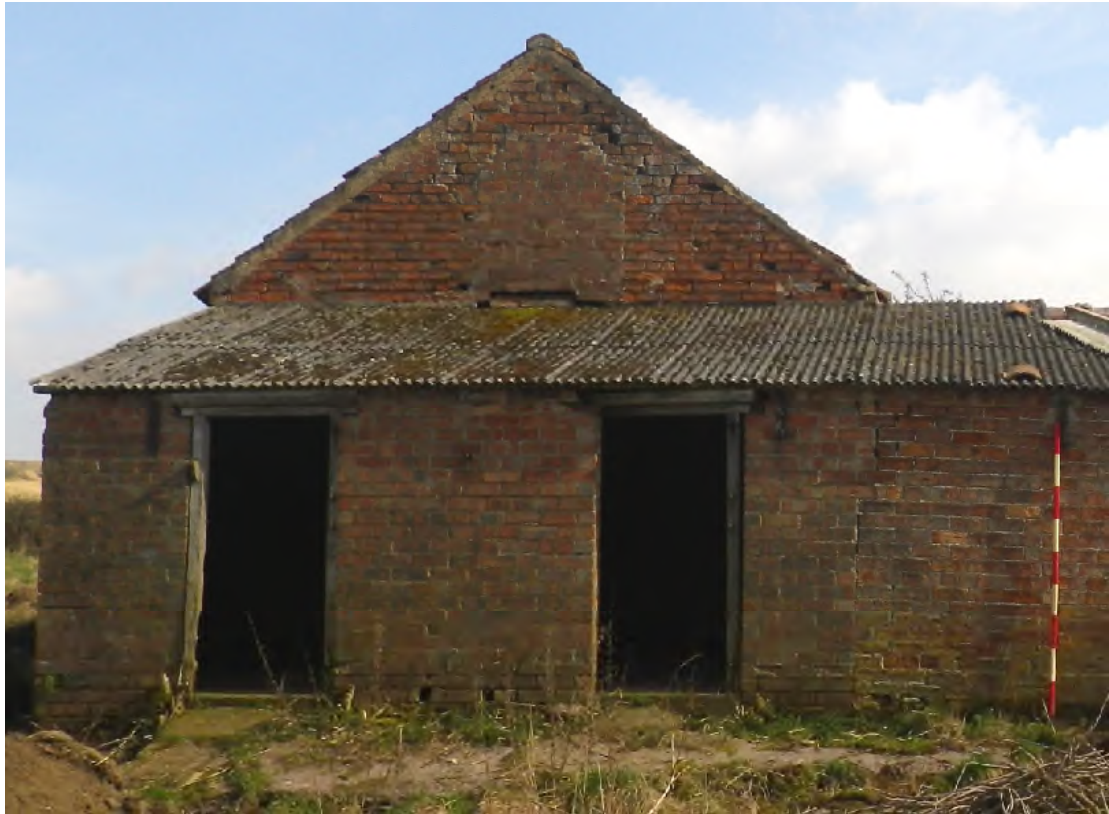
This comprised the northern part of the west ‘wing’ (Figure 2). Both the north and west elevations were of the reddish pink brick laid in stretcher bond, with the bricks being of size 220mm x 105mm x 70mm (Plates 7, 10 and 11). The north elevation was featureless and the west elevation contained two doorways. In the upper part of the joint between the west elevation of this room and Room 6, an effort had been made to ‘stitch’ the brickwork together (Plates 11 and 12).

Plate 11 West facing elevation of Room 5 and the gable of Room 1 (2m scale)

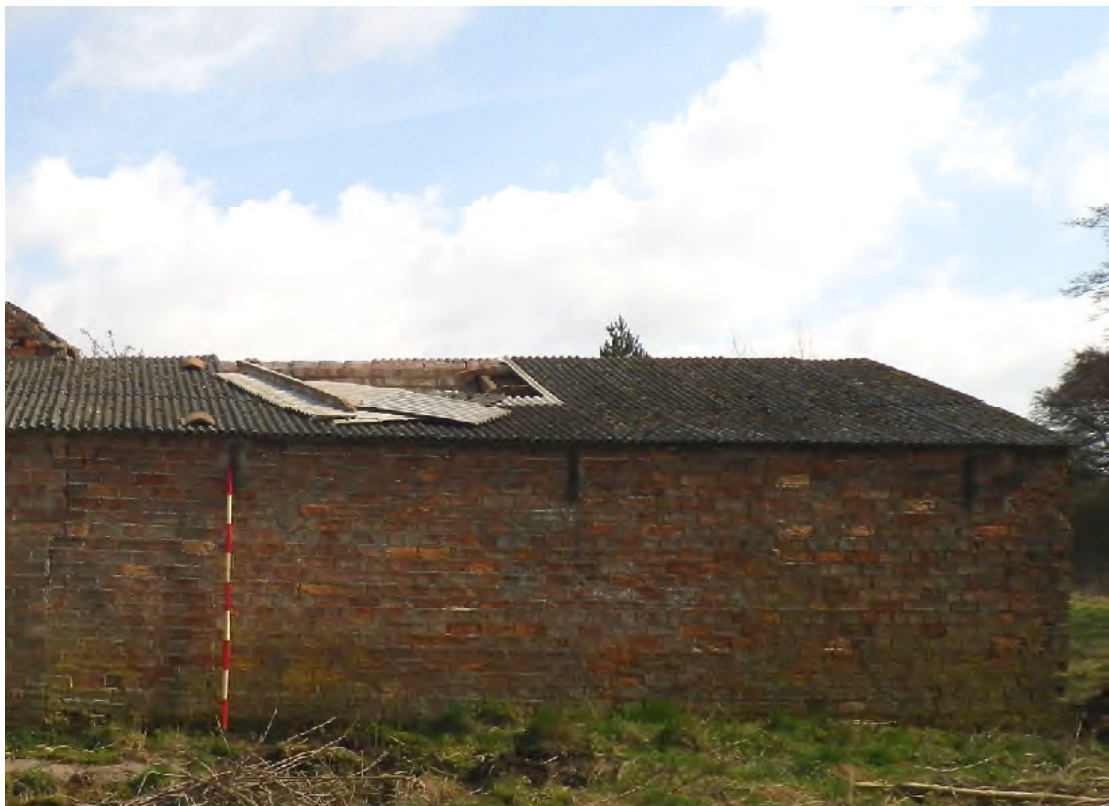
The orange-red brickwork had been largely laid in Scottish bond, the bricks being of size 220mm x 110mm x 75mm (Plate 12). The elevation was featureless save for the presence of three wrought iron strap ties.

Plate 12 West facing elevation of Room 6 (2m scale)

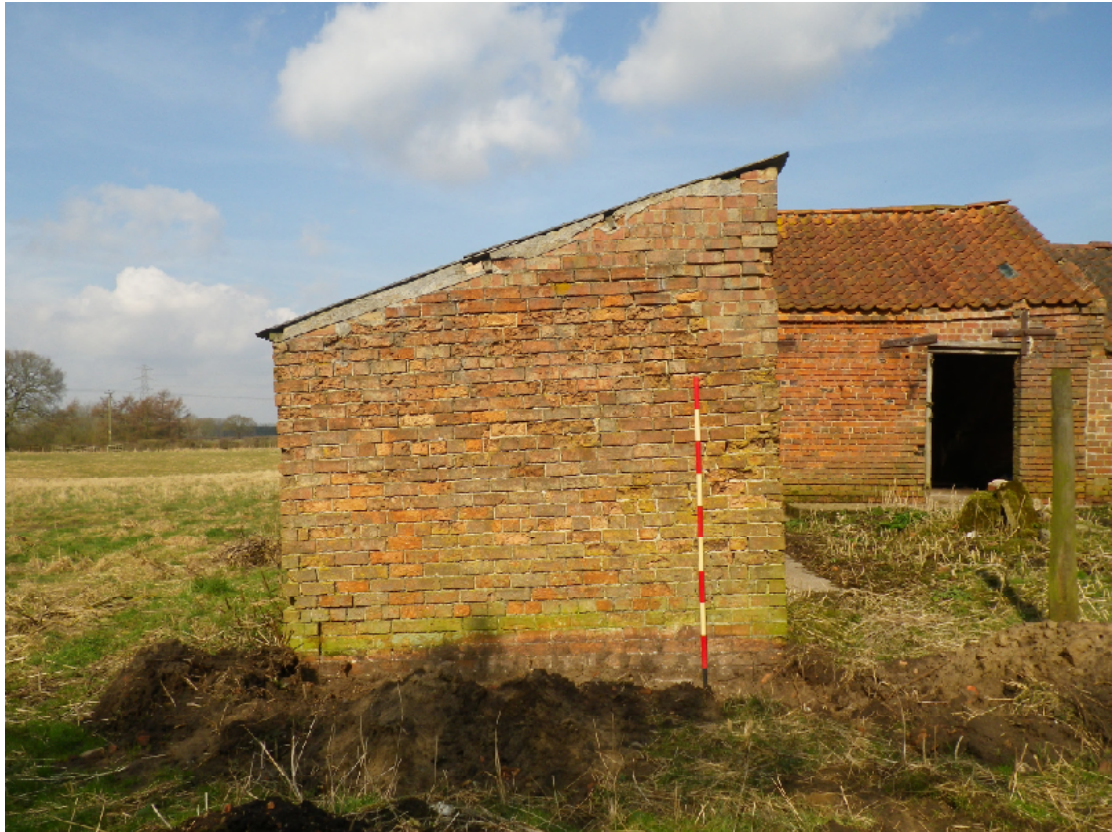
The colour, bonding and size of the brick was the same as that in the west elevation save that the reddish pink brick had been used in the uppermost part of the elevation (Plate 13).

Plate 13 South facing elevation of Room 6 (2m scale)

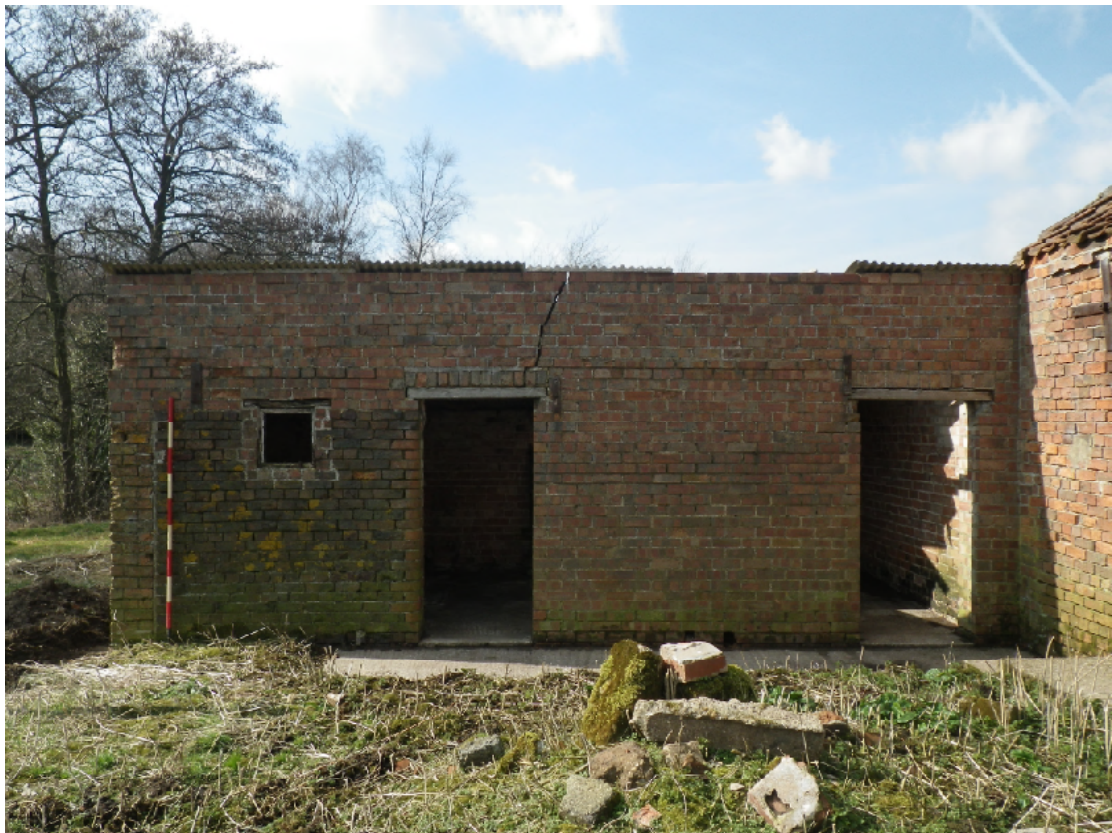
This elevation was very largely of the reddish pink, laid in stretcher bond and of size 220mm x 105mm x 70mm (Plate 14). However, in the lower part of the elevation at its southern end,

there was a closely delineated area of the orange-red brick laid in English garden wall bond. There was also a straight joint between this area of brickwork and that of the south elevation. Within the area of orange-red brick there was a small window that was unglazed at the time of survey. It looked as though it had been inserted. There were two doorways in the elevation, both of which had wooden lintels and a course of brick on edge above. The southernmost doorway had bullnose brick in its south surround. As in the west elevation there were three wrought iron tie straps.

Plate 14 East facing elevation of Room 6 (2m scale)

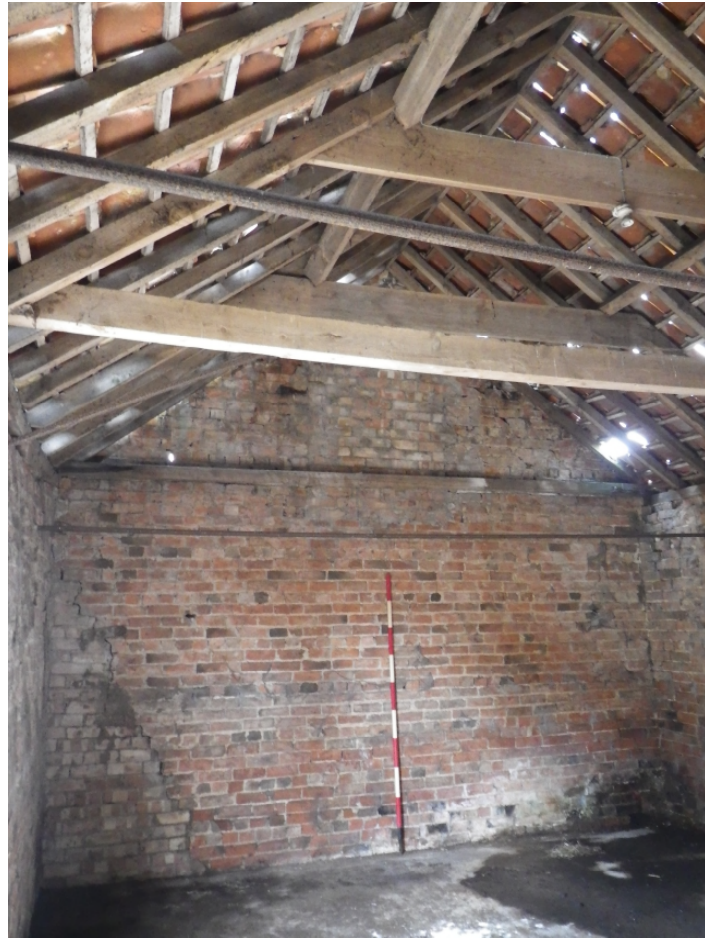
The west wall was predominantly of dark reddish pink brick laid in English garden wall bond. The lower south corner of the west wall showed extensive repair to the brickwork undertaken in the reddish pink brick described externally (Plate 15). There appeared also to have been some brick replacement higher up the elevation.

The central roof truss comprised a slender beam and a collar with clasped purlins (Figure 2, Plate 15). Slender beams also ran from north to south at either end of the room and were, like their centrally placed counterpart, attached at either end to the wall plate by means of wrought iron straps. A ridge piece was present at the apex of the roof.

Plate 15 West wall of Room 1 (2m scale)

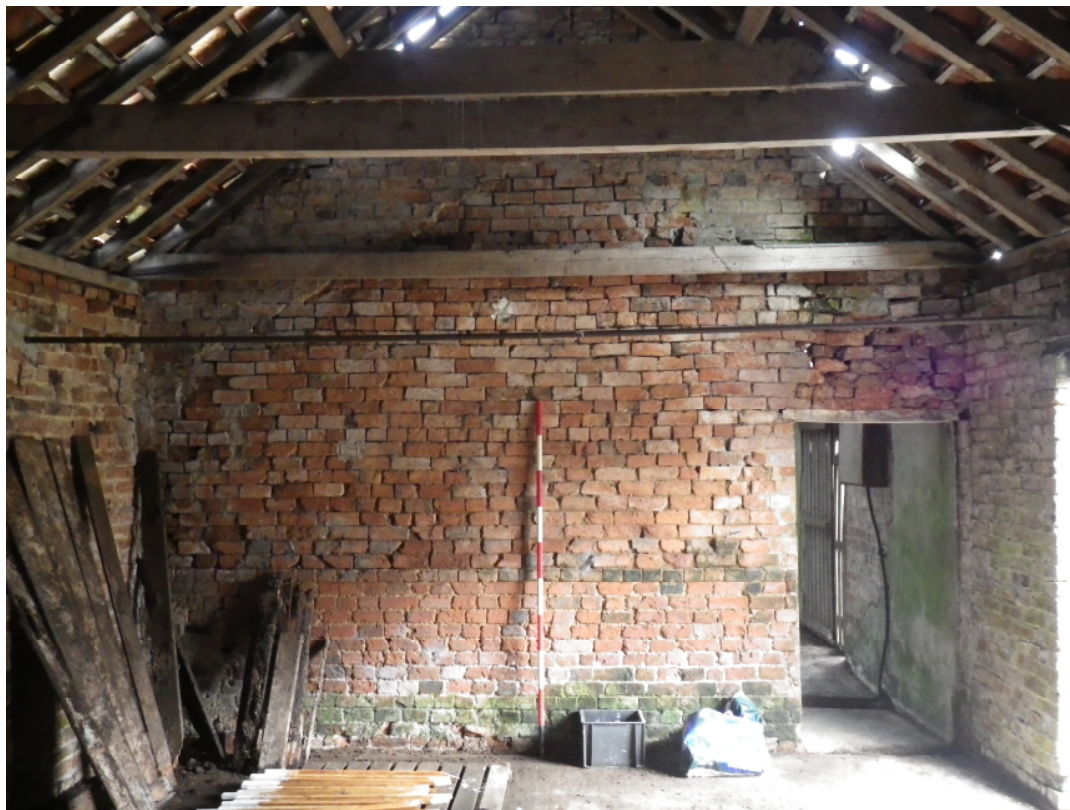
The east wall brick was very similar to that used in the west wall though here the lowermost 13 courses were laid almost entirely in headers whilst the rest of the wall showed no discernible type of bonding (Plate 16). The upper part of the wall appeared to have been distempered or whitewashed at some time.

Plate 16 East wall in Room 1 (2m scale)

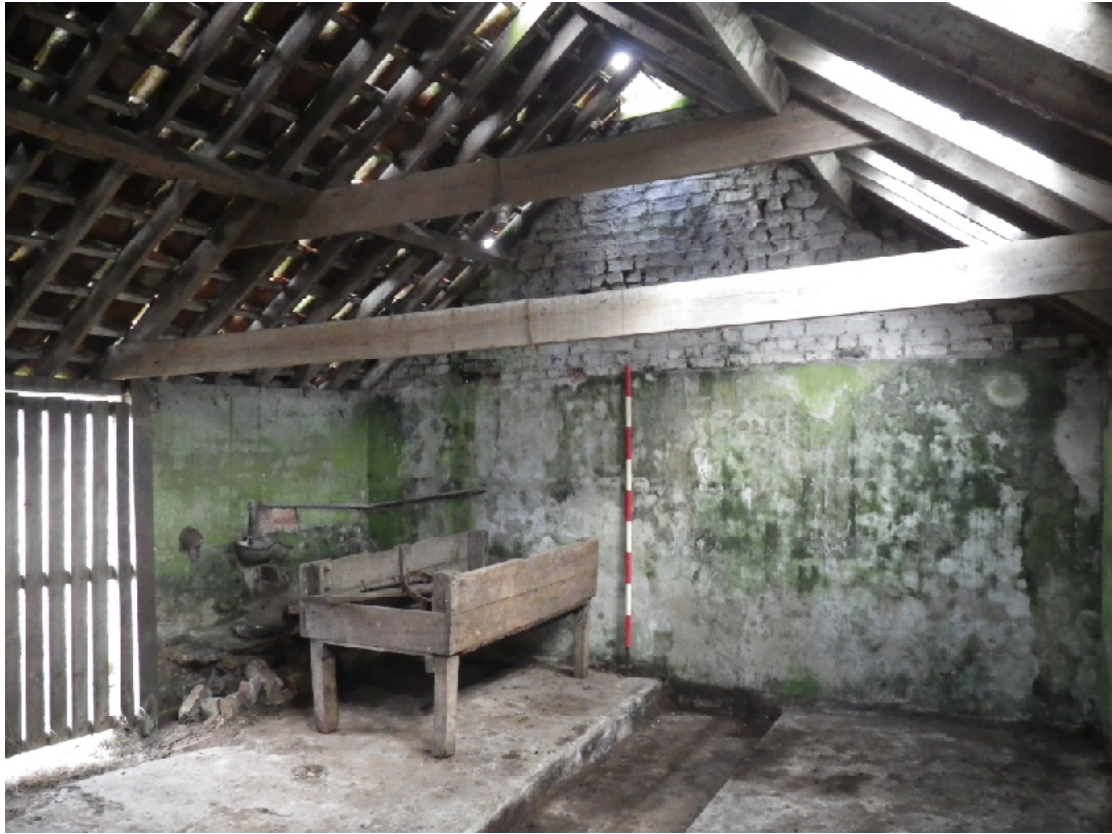
The walls of room were rendered up to eaves level (Plates 17 and 18). The roof structure was very similar to that of Room 1, though here there was only a single beam running across the room together with a collar and clasped purlin arrangement above. Within the concrete floor there was an east to west running gully that varied in depth between 10mm and 18mm. Connected it was another gully some 10mm deep that ran off to the south (Figure 2, Plates 17 and 18). Also within the floor was a series of four holes running from east to west. In the north-east corner of the room there was wooden cattle feeding trough that was not fixed in position (Figure 2, Plate 17).

Plate 17 Room 2 viewed from the south-west (2m scale)

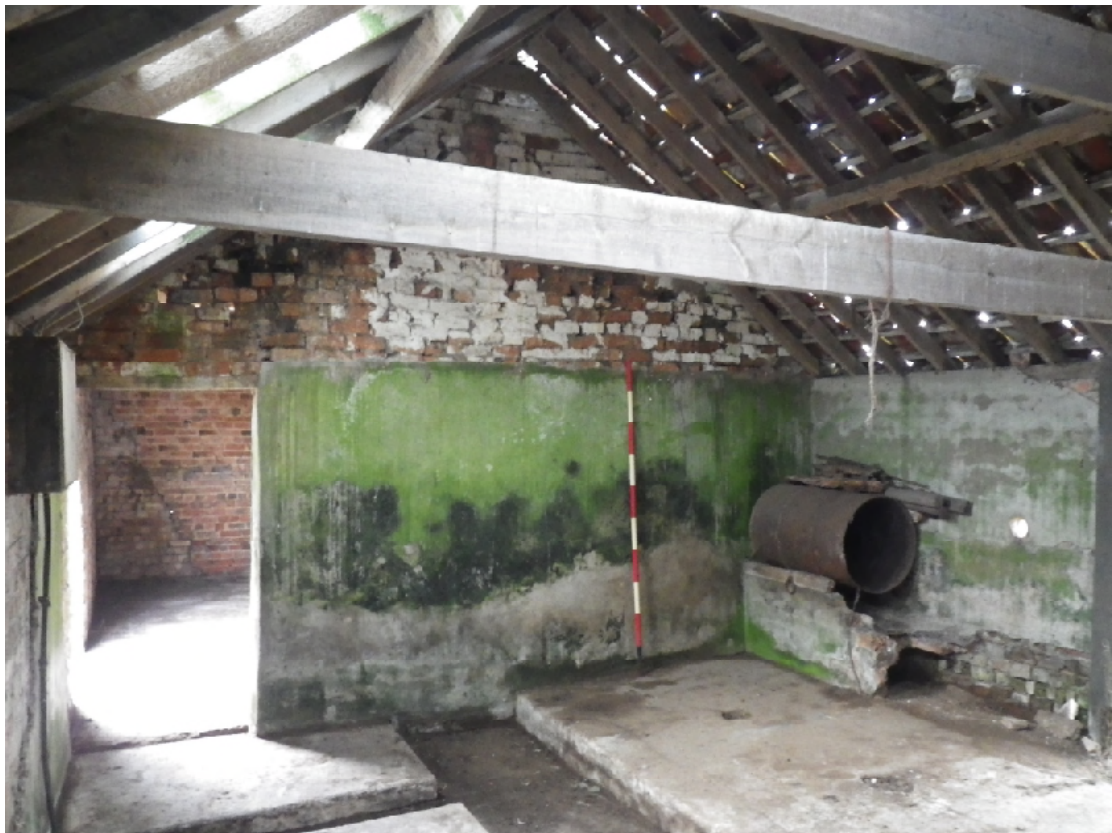
Plate 18 Room 2 viewed from the south-east

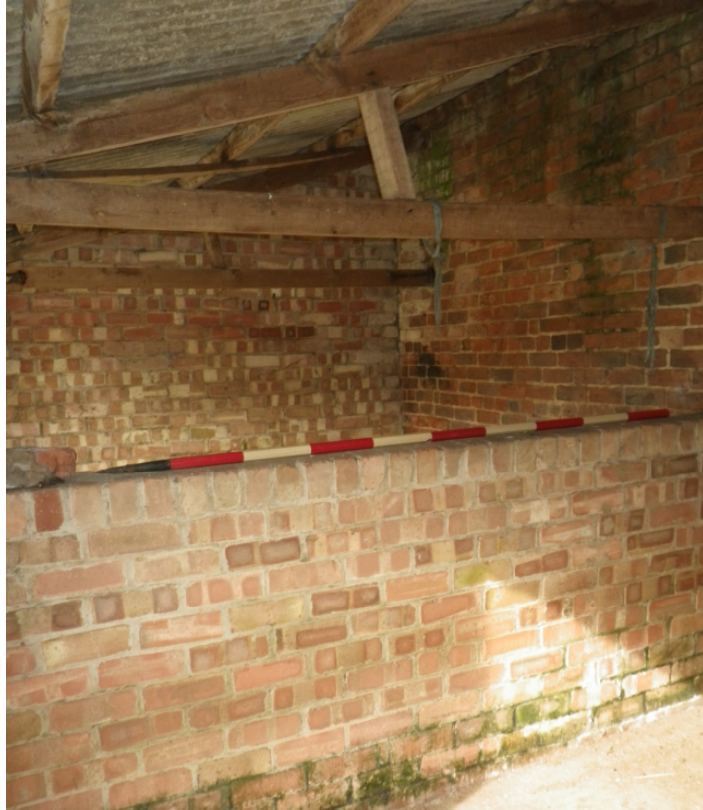
The room was divided in two by a 1.13m high wall that comprised the same brick that had been used in the external walls (Figure 2, Plate 19). Three half-trusses ran across the room, each consisting only of beam, rafter and a single raking strut (*ibid*).

Plate 19 Room 5 viewed from the south-west (2m scale)

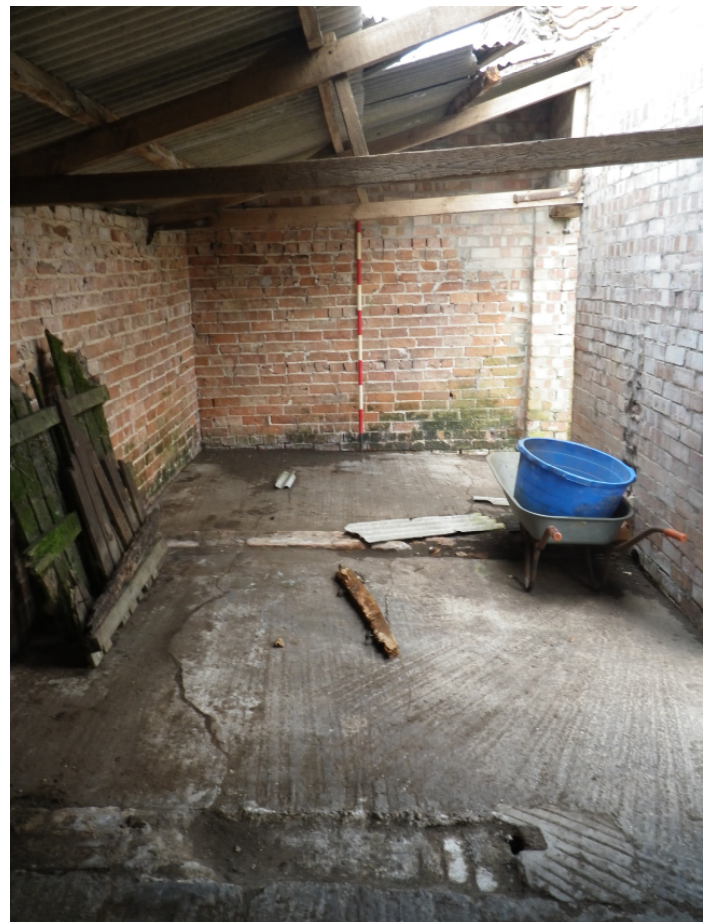
Scars in the concrete floor indicated that two walls once subdivided the room into three spaces (Figure 2, Plate 20). A gap in the southernmost scar indicated that there was once a door at this point (*ibid*). A scar in the wall at the eastern end of the northern floor scar indicated that this wall would have been around 1.20m high – similar to the dividing wall in Room 5. Some bullnose bricks were visible lower down in the northernmost door surround.

The three half-trusses were of the type previously described with regard to Room 5.

Plate 20 Room 6 viewed from the south (2m scale)
