ARCHAEOLOGICAL WATCHING BRIEF

**NORTON WATERMILL
NORTON MILL LANE
NORTON
DONCASTER
SOUTH YORKSHIRE**

Humber Field Archaeology Report no. 2098

**AN
ARCHAEOLOGICAL
WATCHING BRIEF
AT
NORTON WATERMILL
NORTON MILL LANE
NORTON
DONCASTER
SOUTH YORKSHIRE
2017/2018**

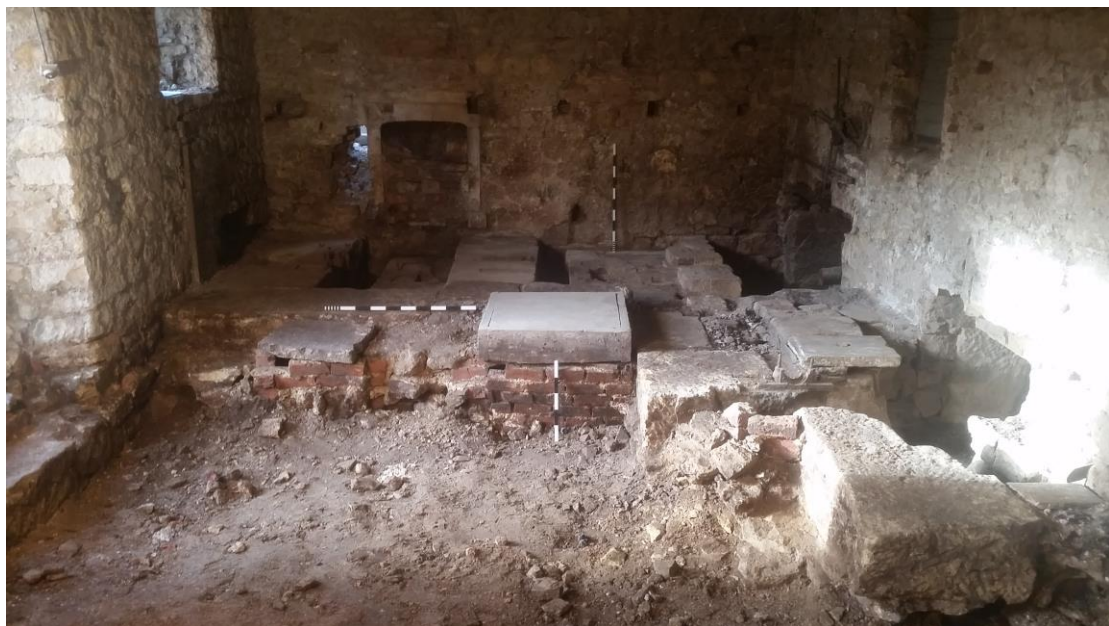
Plate 2 The western interior of the mill, following the removal of all the above floor mill apparatus and flooring and after some initial ground reduction. Wooden trapdoor in centre, leading to Slots 1, 2 and 3 behind and the two layshaft cavities to the right. Fireplace to left rear. Looking west, 1m & 0.5m scales

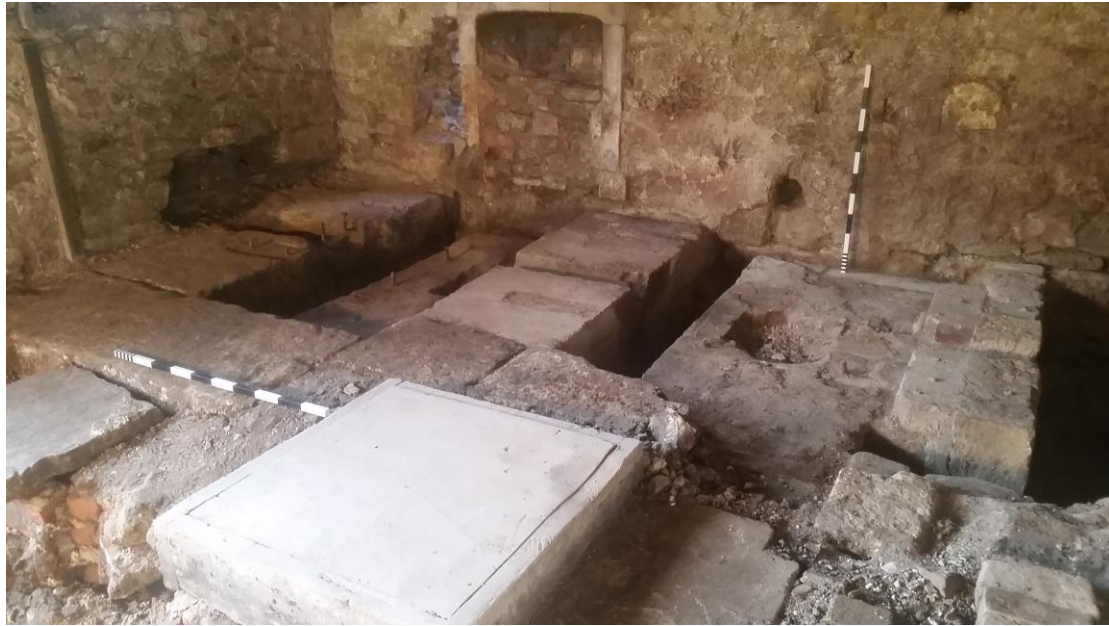
Plate 3 Oblique view of the western end of the mill interior, showing Slots 1, 2 and 3 in more detail.
Viewed from the north-east, 1m scales

The northern slot (Slot 1 on Figure 3) was 1.81m long, 0.72m wide and up to 0.85m deep and had a layer of dry, loose earth at the base, probably obscuring the true depth of the cavity. At the north wall, the description by Gregory suffices suggesting a rough cut out of the stone work for a former “cast iron wall box through which the layshaft enters the mill” (2012, Photograph 32). Once the bevel gear had been removed, it was clear that the work in this area was generally considerable, with the original stone work removed in a fairly haphazard fashion, and then reinforced with a stone slab at the base and another stone slab set upright on the west side of the newly-formed hole. Presumably 19th-century brickwork had also been added at the base of the slot, either for maintenance access, the necessity for stability or as the rebuilding of former damage. Further, there was evidence of a sloping stone slab at the north-west corner, mirroring the edge of the bevel gear. Whether this sloping slab was a later addition during the 19th-century mill refit or of earlier date could not be ascertained.

A southerly slot (Slot 3 on Figure 3) for the final bevel gear measured 2.61m long and 0.26m wide, and was greater than 0.80m deep. Similarly to Slot 2, the hole extended underneath a limestone slab to connect with the ‘access tunnel’ which led to the trap door. At only 0.26m wide, the gap was particularly thin for an access, however. The south side of the slot was built using limestone rough-worked foundation stone with a much large limestone squared slab measuring 1.96m x 0.80m x 2.85m which also had the remnants of iron bolts for fittings to receive the layshaft. The opposite side of the slot was similar to the north side of Slot 2, in that it was also constructed of 19th-century brick with Portland cement-based mortar up to the same ground height. The gap between Slot 2 and 3 was filled with similar material it seems, capped off with decayed wooden boards. There was also a wooden board at the south-west end between Slots 2 and 3, in the area of the disused fireplace (see above)

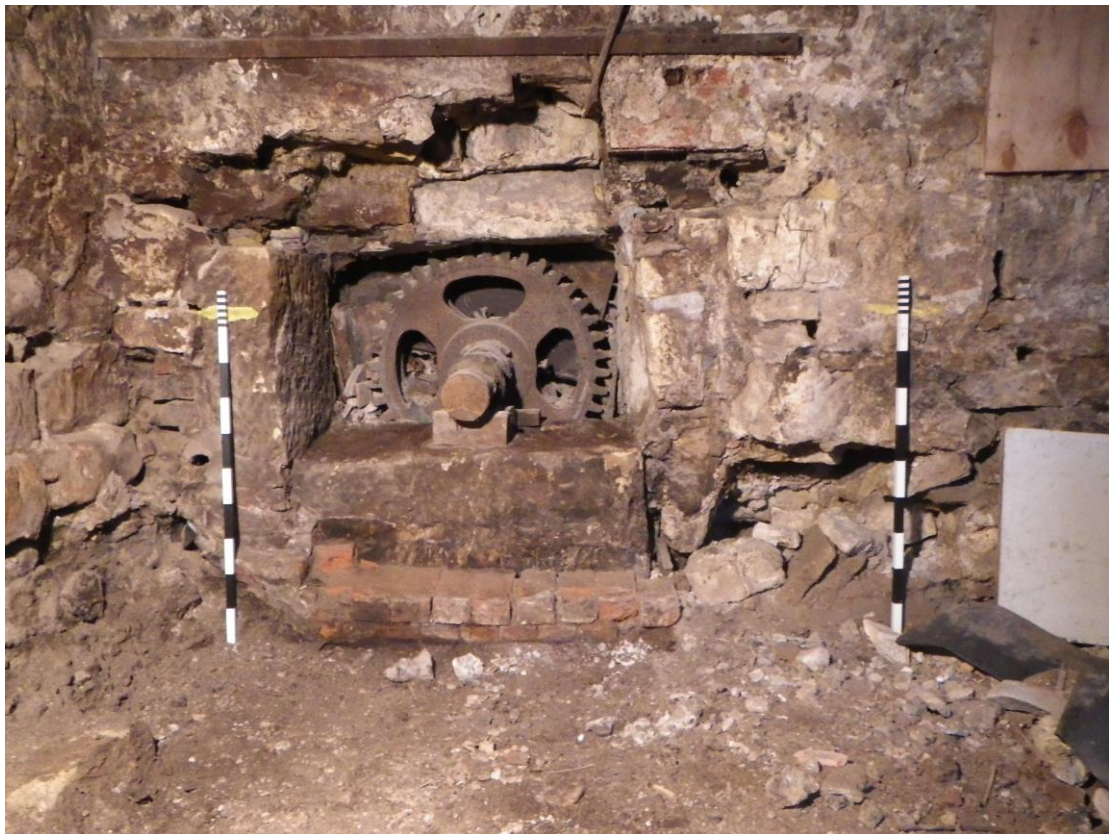
Plate 4 North-west layshaft, showing several alterations and insertions, following removal of Slot 1.
Looking north, 1m scales

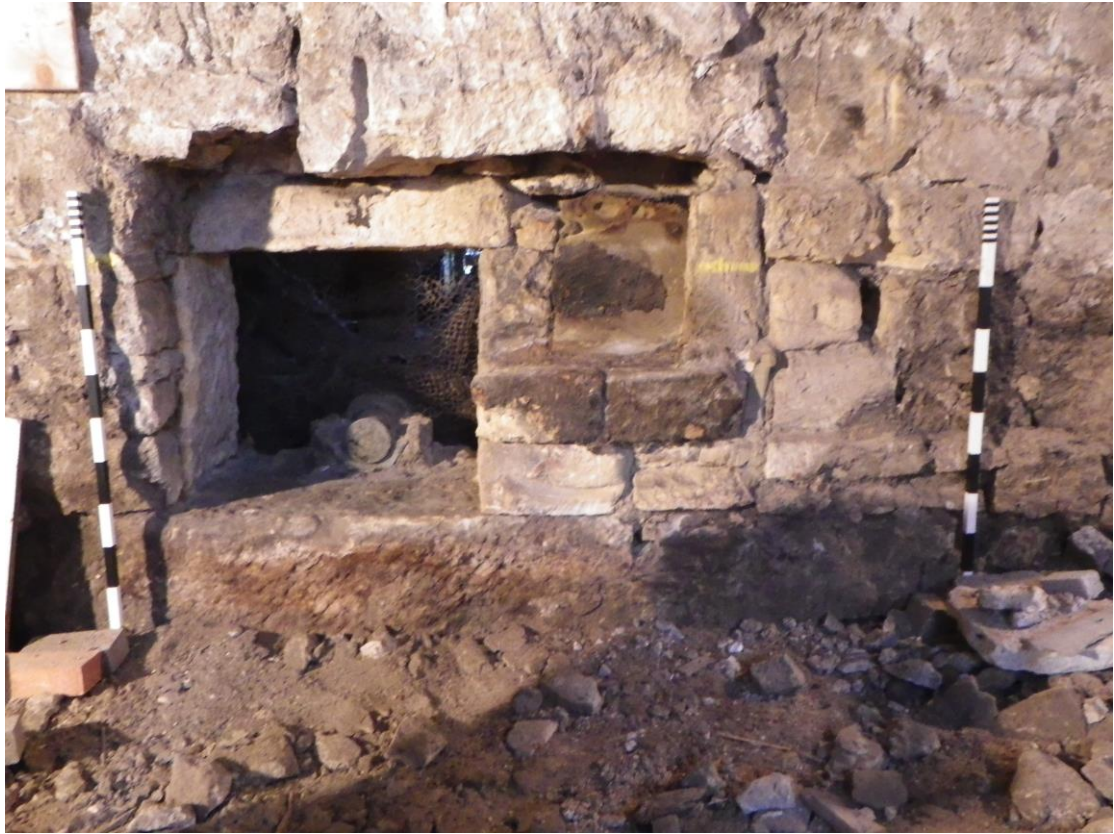
Plate 5 North wall interior, central layshaft and subsequent alterations, looking north, 1m scales

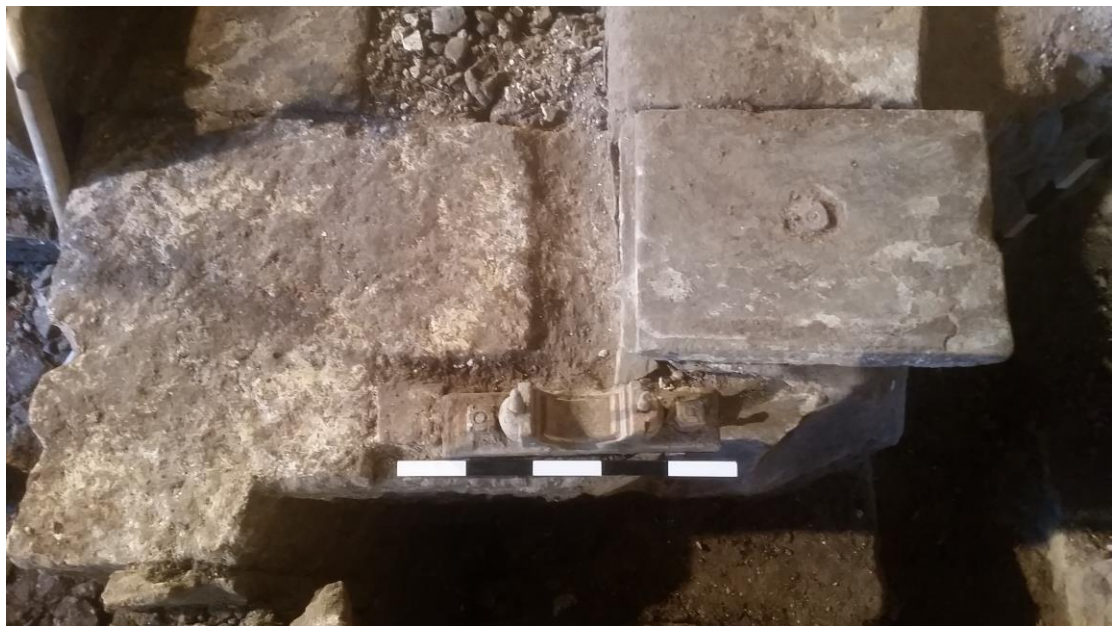
Plate 6 Detail of layshaft brackets and channels running parallel to the north wall along with evidence of re-used stonework. Vertical shot, 0.5m scale

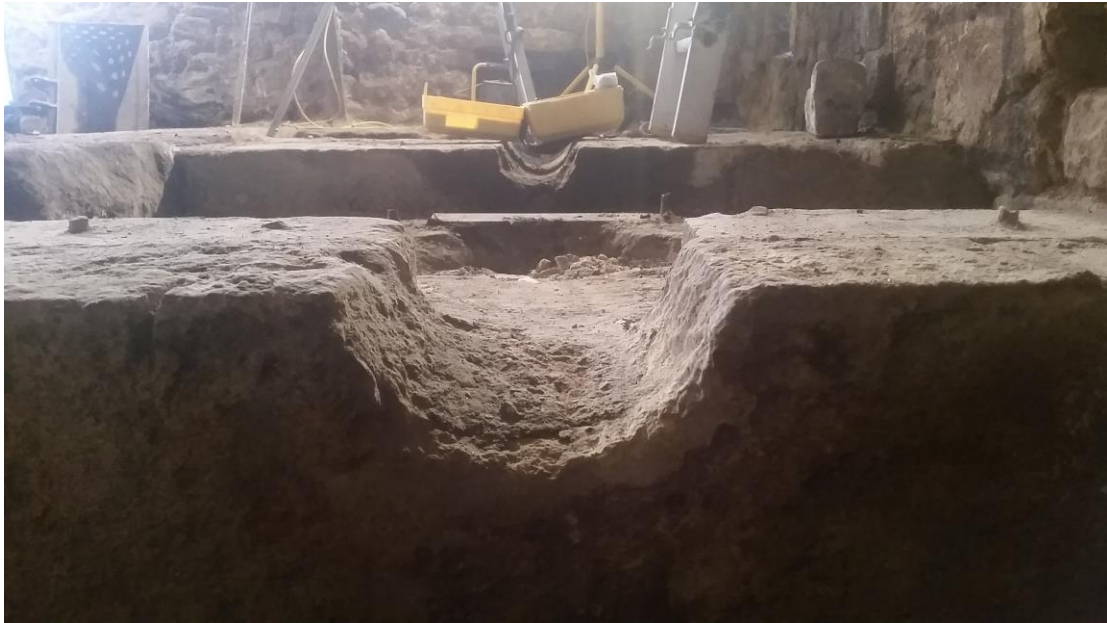
Plate 7 North-south aligned layshaft channel running parallel to the west wall, cutting through likely earlier stonework blocks. Looking south

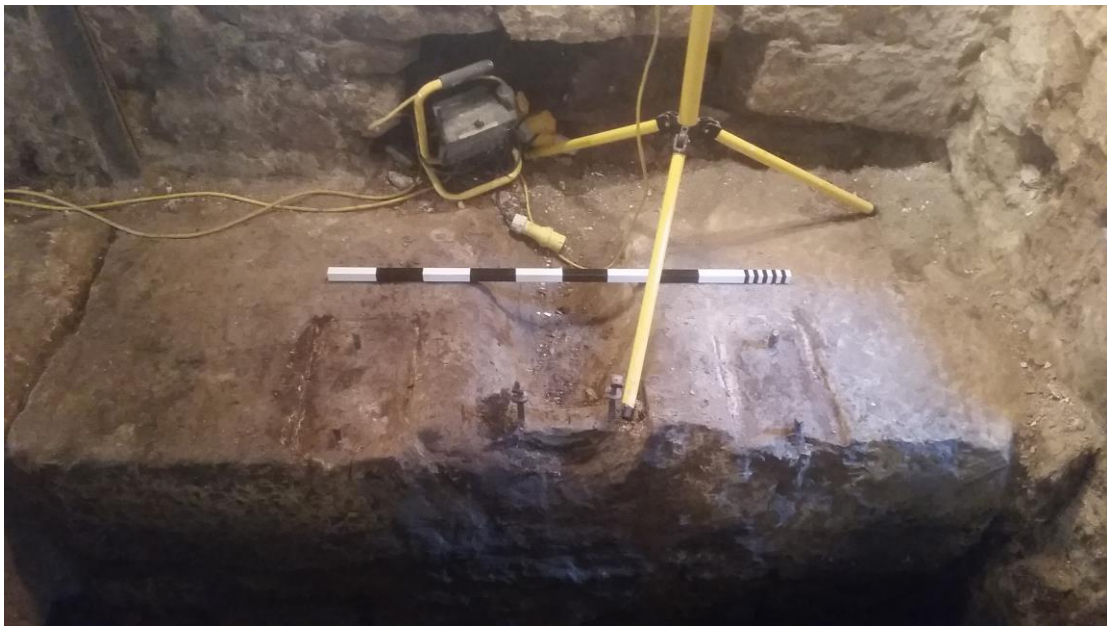
Plate 8 Detail of ironwork bolts for 19th century layshaft set into earlier stone ashlar-type blocks around Slot 3. Looking south, 1m scale

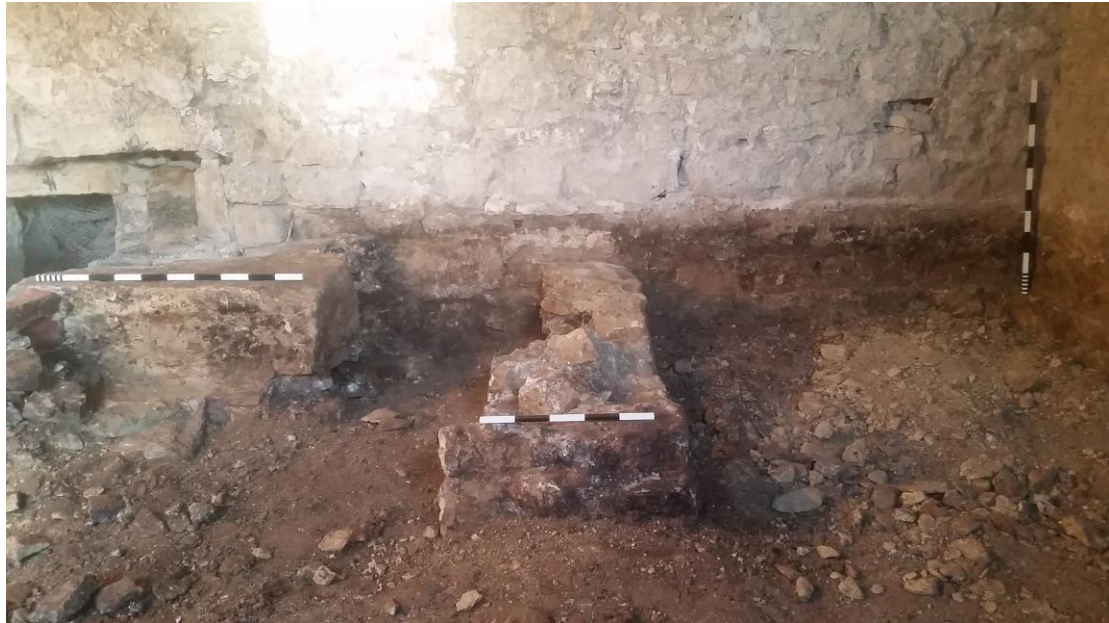
Plate 9 Interior dividing wall foundation remnant 111, oriented south-east – north-west, and overlying an earlier foundation. Looking north-west, 0.5m and 1m scales

Overlying the foundations of the mill on its north side were the remnants of a short, stub-wall foundation 111 (Figures 2, 3 and 6, S.4, Plates 9 and 10). The foundation consisted, in the main, of rough-worked or unworked limestone blocks of varying sizes with the remains of facing stones at the south where the stub wall ended. The dimensions of the wall were 1.96m north-south and up to 0.72m west-east along the south face, narrowing to around 0.50m where the stub wall met the mill interior wall foundations. The stonework was bonded with what appeared to be a creamy lime mortar. The stones used in the construction were of many varying sizes. This was clearly installed to create a subdivision within the interior of the mill, but one which had potentially not made it in to the renovations of the mill during the 18th and 19th centuries. There was no visible cut for the insertion of the foundation and the reduced ground level was too mixed to see any further definition of such.

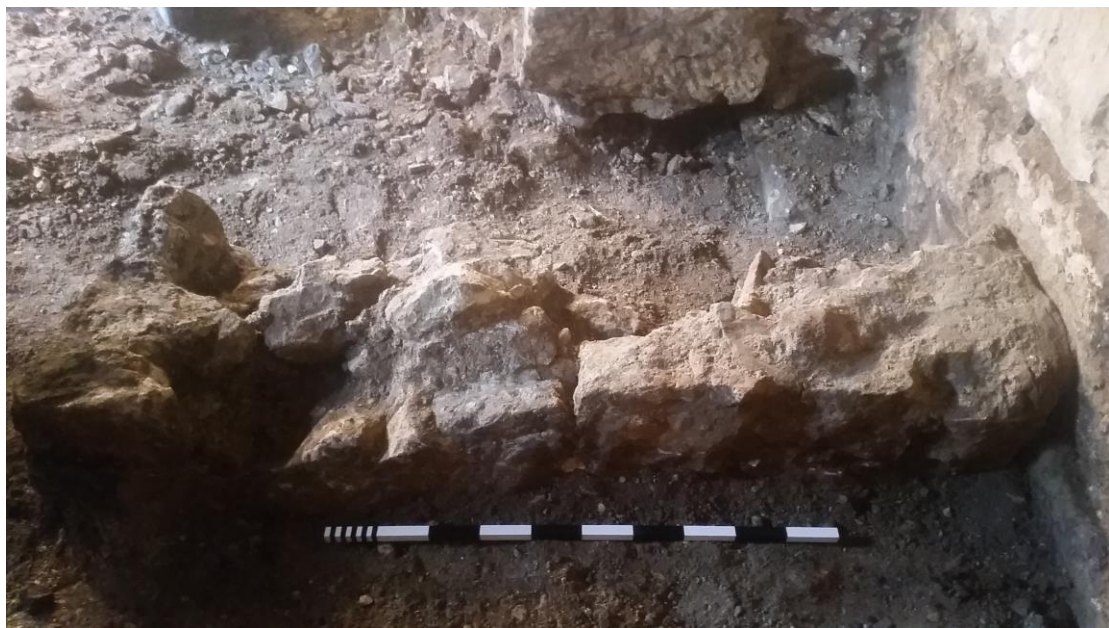
Plate 10 Foundation 111 viewed from the east (1m scale)

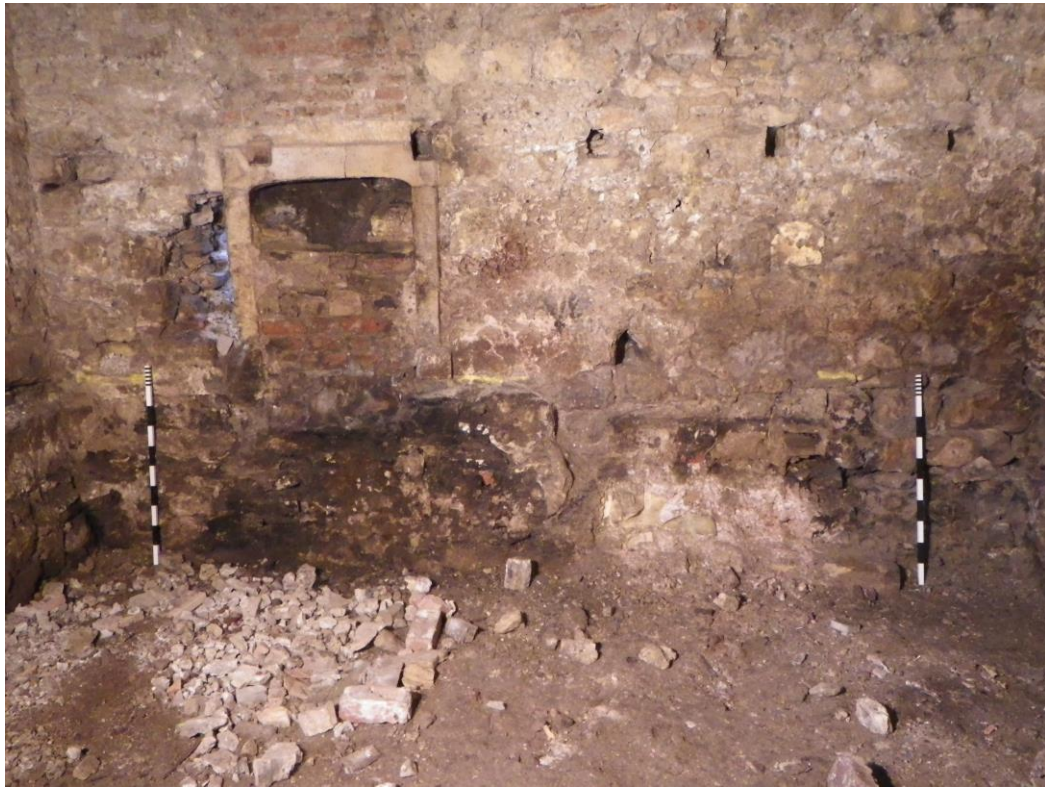
Plate 11 Full level ground reduction in the interior of the mill, showing fireplace 112 in the west wall and subsequent floor joist insertions. Looking west, 1m scales

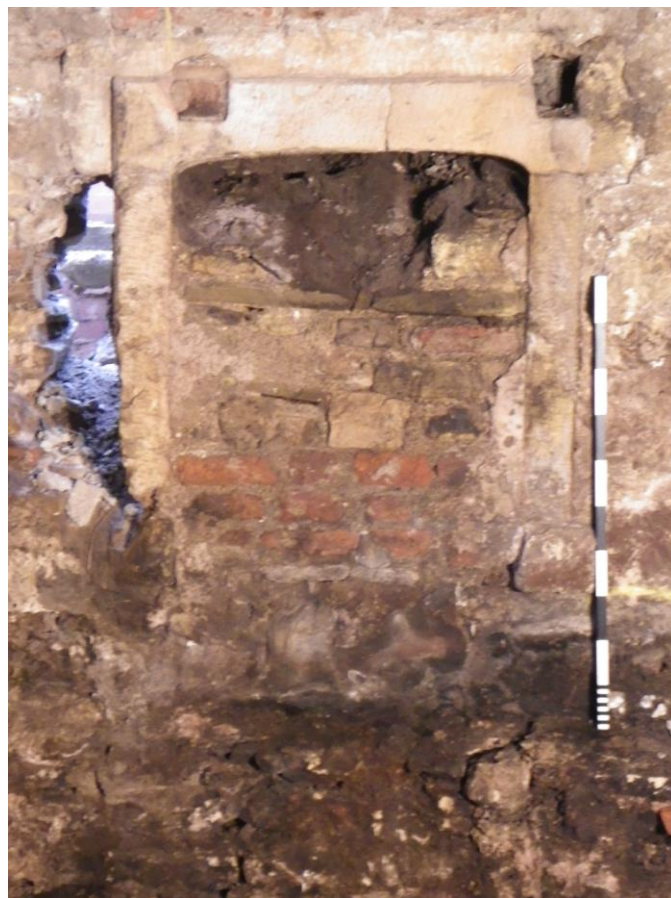
Plate 12 Detail of inserted fireplace 112 in the west wall. Looking west, 1m scale

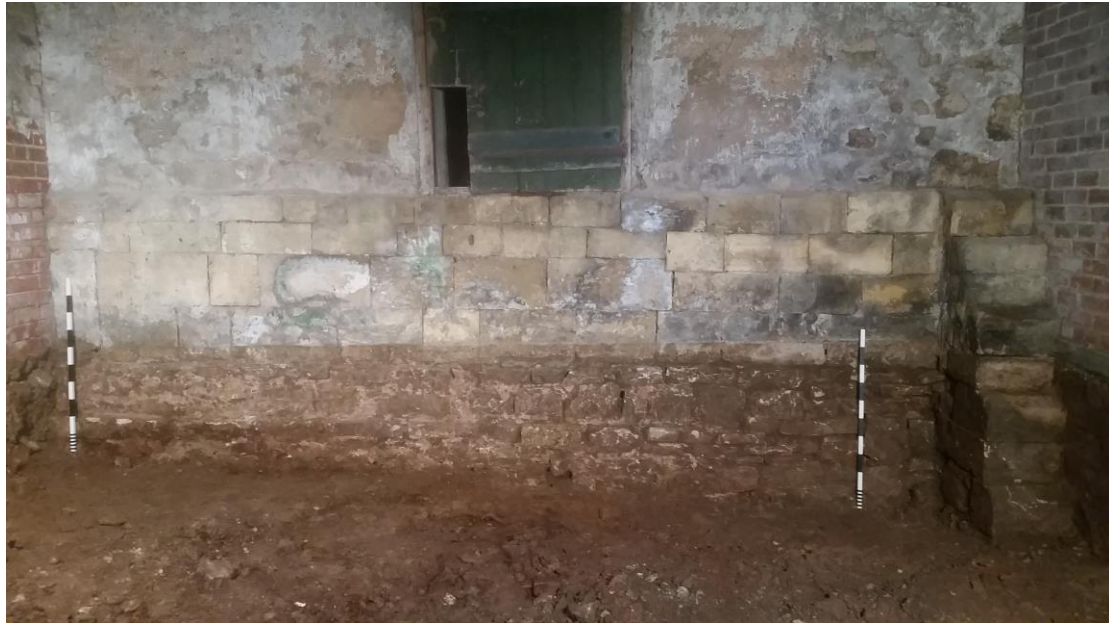
Plate 17 The worked stone foundations 105 for the east exterior wall of the mill, as seen during full depth ground reduction. Reused ashlar blocks 109 may be seen above. Looking west, 1m scales. Note rebuilt supporting buttress 108 to right (north)

Set within the cut was the foundation 105 for what was very likely to have been a medieval building. Although it was not entirely exposed to the basal course, enough was visible to ascertain the method of its construction: an initial foundation of rough worked limestone blocks of varying sizes (smallest 0.16m x 0.12m, largest 0.64m x 0.14m/0.41m x 0.20m) were laid, bonded with a creamy-pink mortar, to a height of at least 4 courses (0.61m) along a visible length of 3.52m from the exposed south-east corner. The courses were stepped out

As mentioned above, immediately above the stone foundation 105 there were four courses of reused probable medieval ashlar 109 (Figure 7, S.5, Plates 17-19). These consisted of squared and/or rectangular blocks of limestone. The blocks had dimensions ranging from 0.20m x 0.18m up to 0.84m x 0.29m. Some of the blocks still exhibited evidence of claw tool marks, running diagonally across the exposed surfaces. These blocks were bonded with a lighter lime-based mortar than that used below for 105. That these blocks of ashlar had been reused was indicated by the presence of four lewis holes in the face of the wall – such holes would originally have been concealed within a wall since they were made in the upper surfaces of stones for the purpose of lifting. It was assumed that the lewis holes were of a split-pin nature, each being a circular drilled hole. The exposed dimensions of this upper wall section were 5.20m from south-east-north-west and up to 1.05m in height.

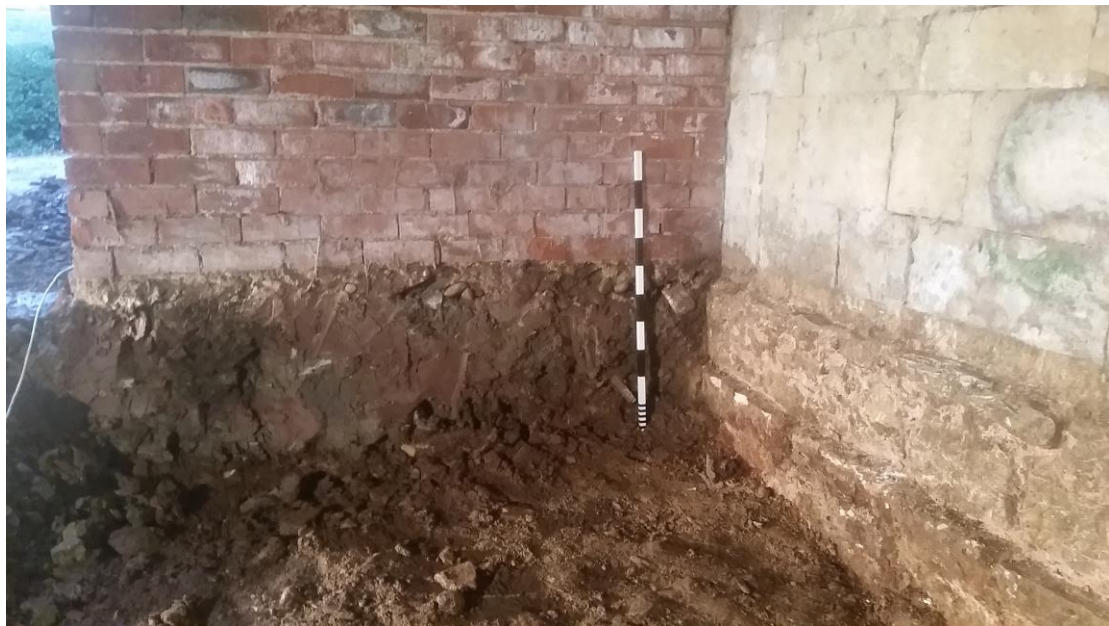
Plate 18 View of construction cut 103 for 105, looking south, 1m scale. Note the stepped nature of 105

At a point 1.09m from the south-west mill wall foundation, the construction cut 103 for a possible medieval wall foundation was recorded, aligned south-east-north-west for a distance of 4.46m in plan (Figure 4, Plate 18). The base of the cut was not established as it continued below the required level of excavation for the new structural works.

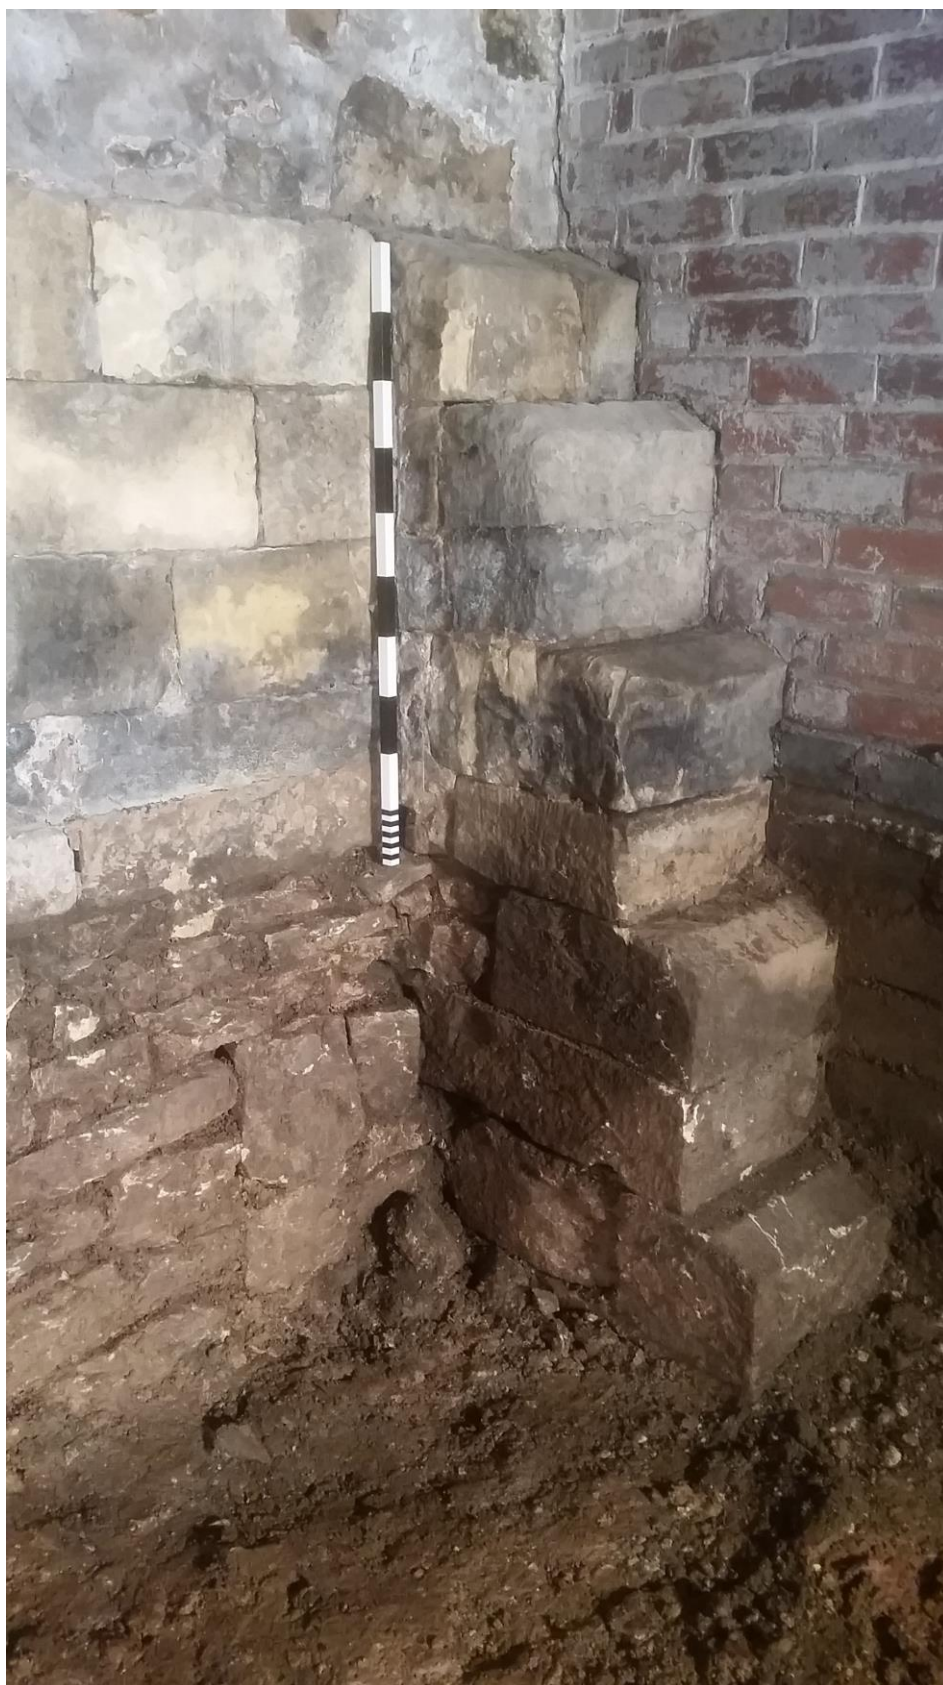
Plate 19 Detail view of the rebuilt footing 107 and rebuilt buttress 108 on the exterior north-east corner of the earlier mill wall foundations 105. Looking north-west, 1m scale

At the northern end of the stepped foundation 105, a portion appeared to have been rebuilt (Figure 7, S.5 Plate 19). This was in the area of the wall where it met the mill race. A sub-circular area approximately 1.30m in radius was cut 106 through the original construction cut. The depth of the cut was not ascertained, but clearly originated from the historical ground level. In an apparent attempt to underpin the structure, an area measuring greater than 1.72m south-west-north-east and up to 0.62m high was rebuilt 107, with much smaller blocks of limestone, some not even roughly worked, and some more like rubble fragments together with a couple of fragments of flat roof tile. The cut around this area was then backfilled with a mid to dark brown silt clay with stony inclusions 142, again up the historic ground level. This repair work was associated with a buttress 108 which was only partially keyed into the existing wall.

The buttress was at least 1.83m high, with the lowest, visible course being 0.83m long, narrowing to 0.17m at the top. It was constructed of limestone blocks for the most part, again with some having evidence of claw tooling. The buttress stepped back towards the main mill wall every 2 courses, and at the top of every second course the terminal block was chamfered. It is interesting to note that the angle of the chamfers differed slightly every time (with one being very worn, possibly through water erosion?). It is probable that this was a medieval (or substantially medieval) buttress that was reused in a later period.

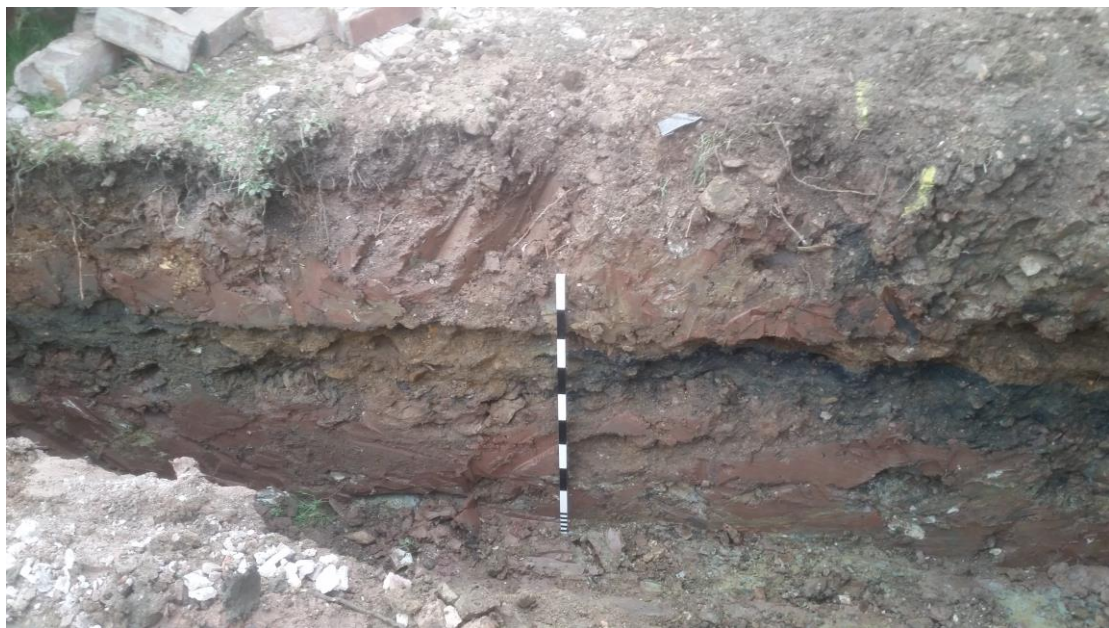
Plate 21 View of the levelling deposits to the south of the mill in the east foundations for the new build. Looking west, 1m scale

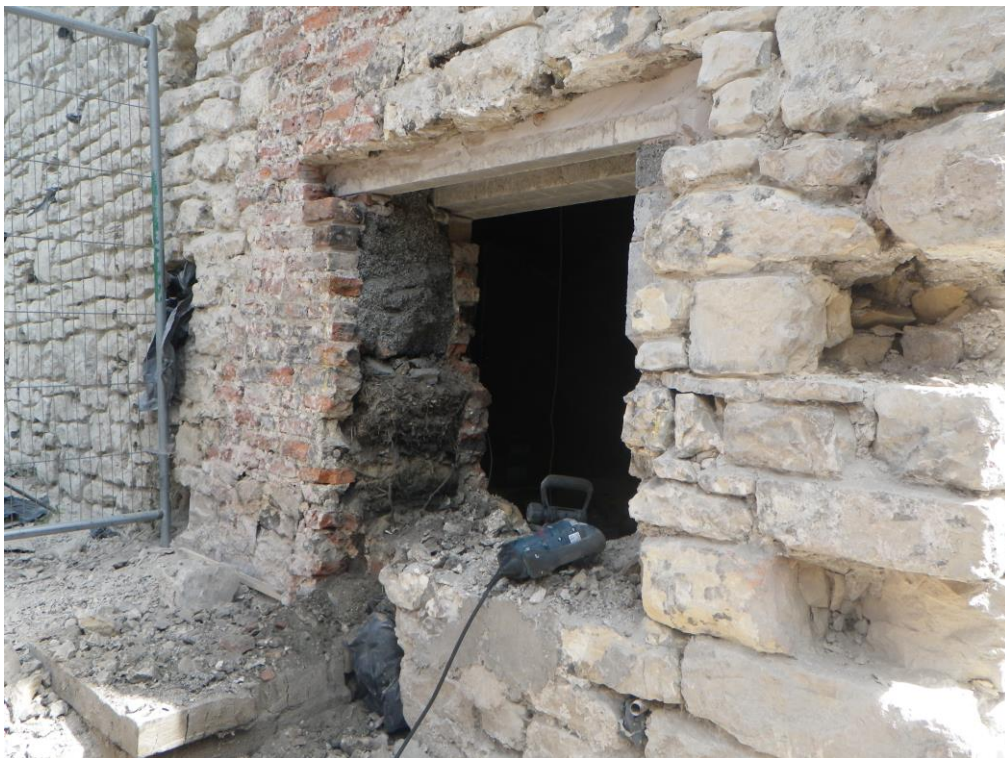
Plate 23 The cutting of the new doorway into the west side of the mill, bisecting the fireplace, looking north-east

A modern doorway inserted into the west wall at the south-west corner of the mill revealed evidence of how the 18th/early 19th-century mill building was constructed; namely by having inner and outer walls of roughly dressed stone forming a ‘cavity wall’ that was infilled with loose rubble. The doorway also affected the *in-situ* stone fireplace, necessitating its removal and relocation within the restoration.

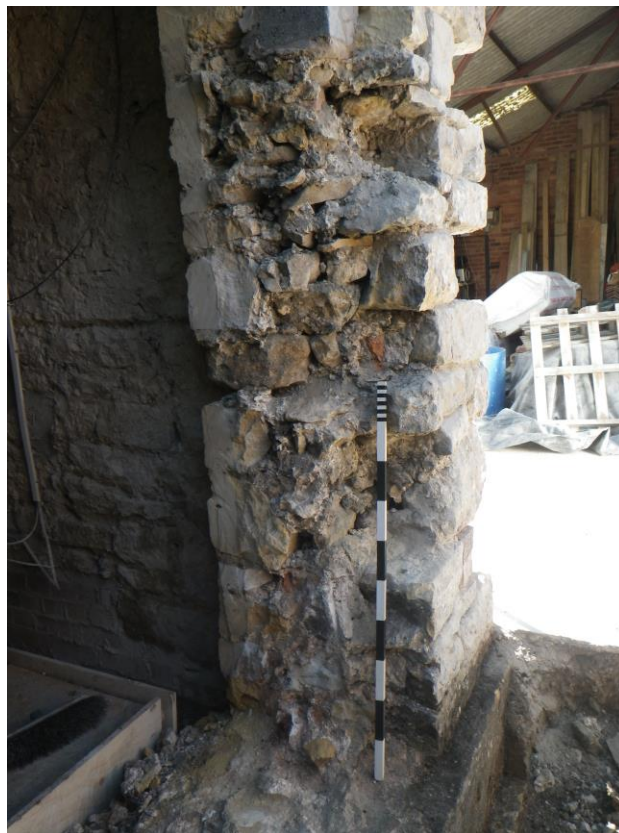
Plate 25 Cross section through the east side of the west mill wall (facing stones and rubble core), looking south, 1m scale

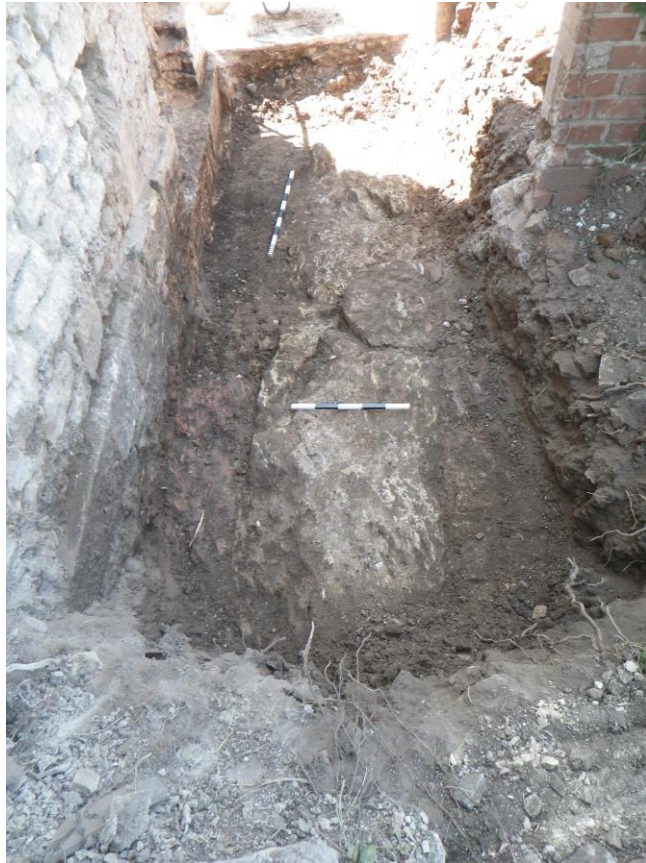
Plate 26 Initial view of wall 116, looking south, 1m scales

In total, the wall ran for 6.70m north-west-south-east before turning at a 90° angle to the north-east for a further 4.94m before coming to a robbed out 'stop'. The wall had an average width of 0.75m, and a combined height of around 0.75m (taken from the uppermost course seen at the north-west, to the lowermost course seen in a later foundation cut). In general, however, the wall had a surviving height of around 2 courses (0.20m), with only higher levels seen hidden underneath the mill bank itself. It was set within cut 124 which was seen to truncate the earlier fills associated with the earlier foundation 117. Due to site conditions, the cut for the wall was not seen in plan, however, in the composite section, a combined measurement of 1.11m width (W-E, butting the wall) was recorded, along with a total depth of 1.91m from the top of the mill bank to the basal course of the wall. It was backfilled to the west by redeposited clay 131 and friable dark silts 132.

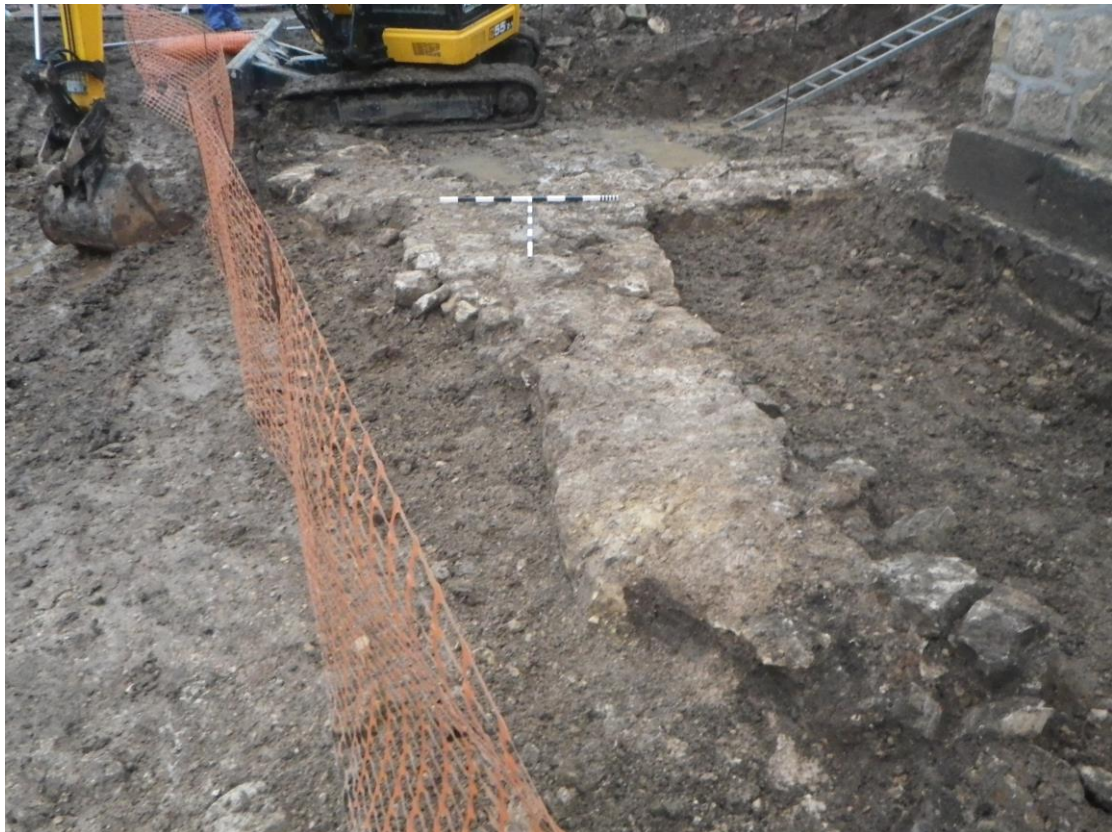
Plate 27 Wall 116 and adjoining 'lean to' wall 123, looking west, 1m scales

Associated with wall 116, at the south-west, was a further short section of foundation 123 (Figures 2 and 5, Plates 27-29 and 34). This appeared to have been 'tacked on' to the southern corner of 116 and was constructed of varying types of reused stonework together with some brick (dimensions 110mm x 75mm x 55mm) which appeared to have been handmade. The dimensions of the footing remains were 5.72m south-west-north-east and up to 0.99m wide and appeared to have been bonded with lime mortar. The south-west end of the wall had evidence of burning and burnt silt was settled between disturbed sections of the foundation. It may be that these were the foundations of a 'revetting' wall for the bank.

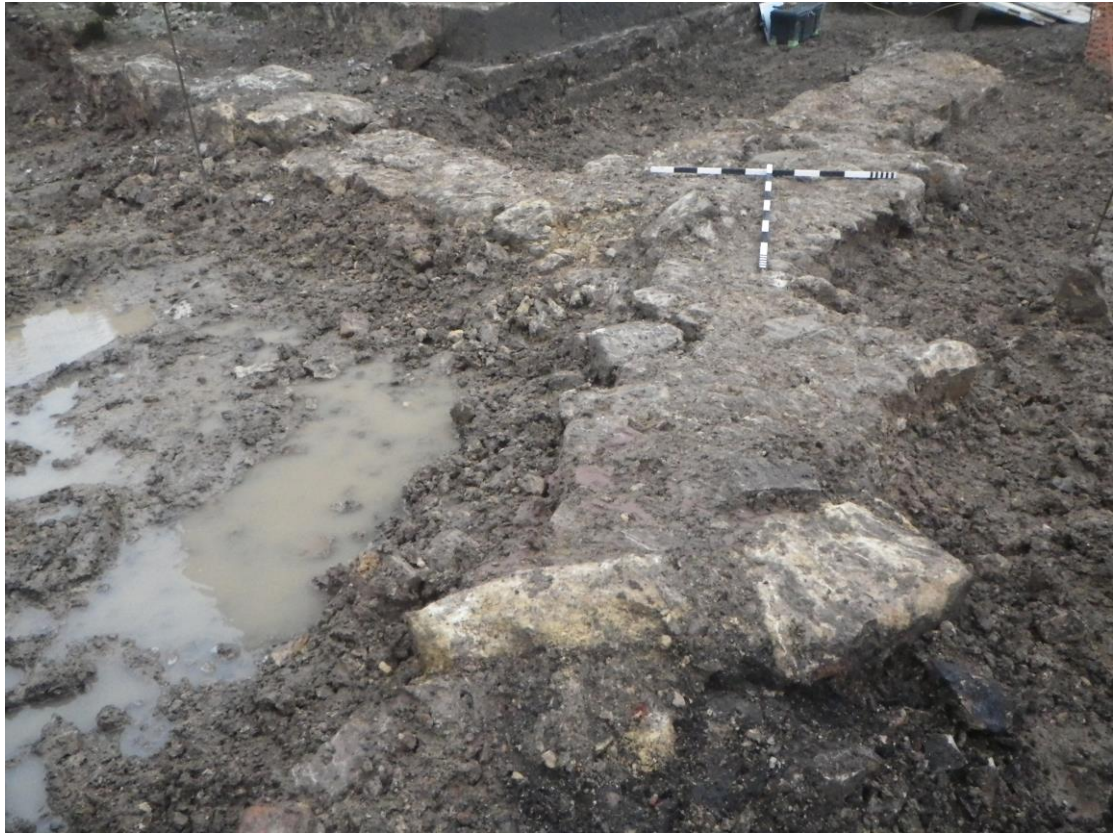
Plate 28 Alternate view of wall 116 and 'lean to' 123 (in foreground, note fire damage), looking north-east, 1m scales

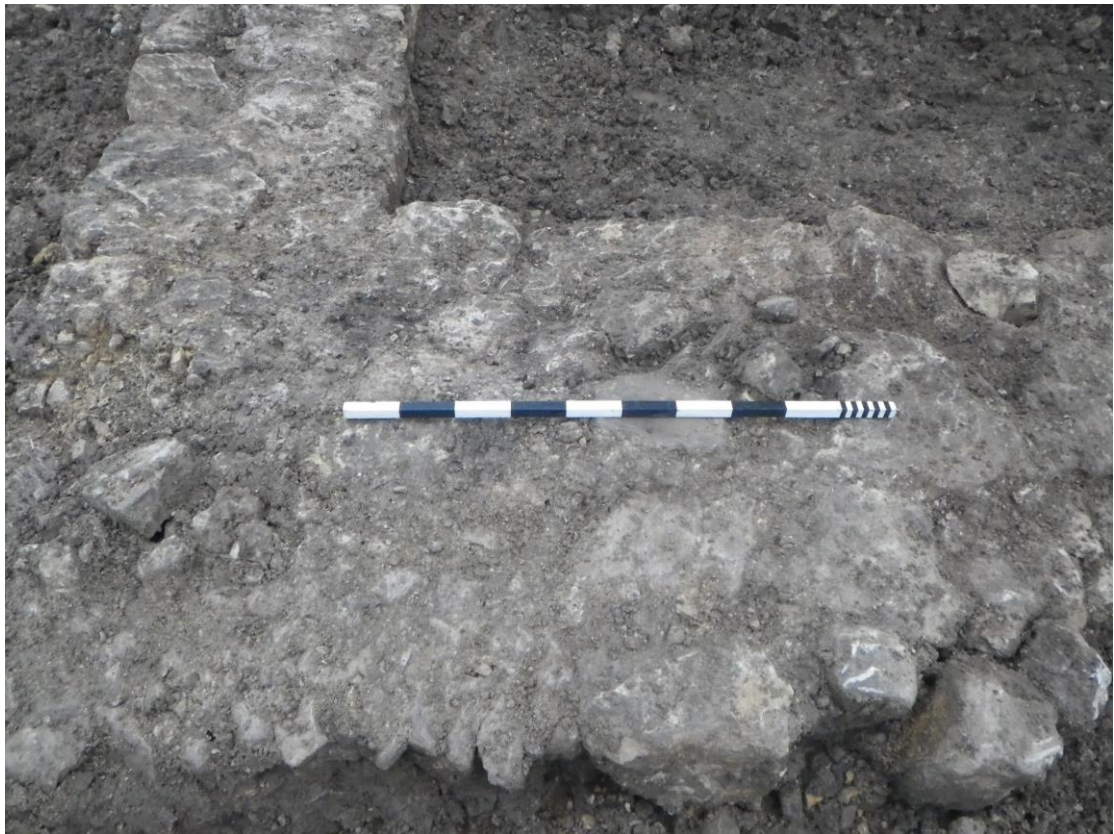
Plate 29 View of straight joint between wall 116 and 123, looking north, 1m scale

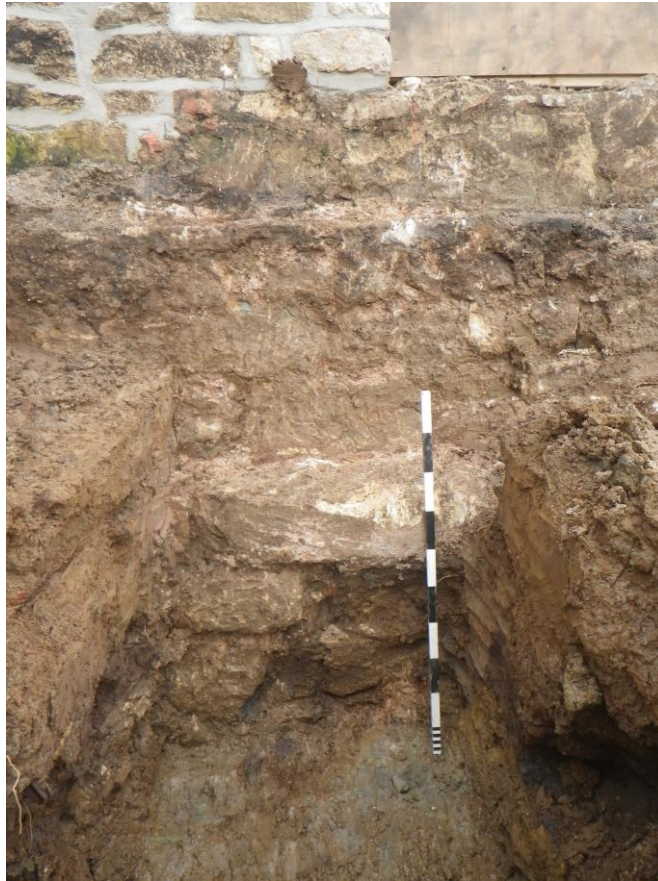
Plate 30 View of the worked stone foundation 117 on the west side of the mill, looking east, 1m scale

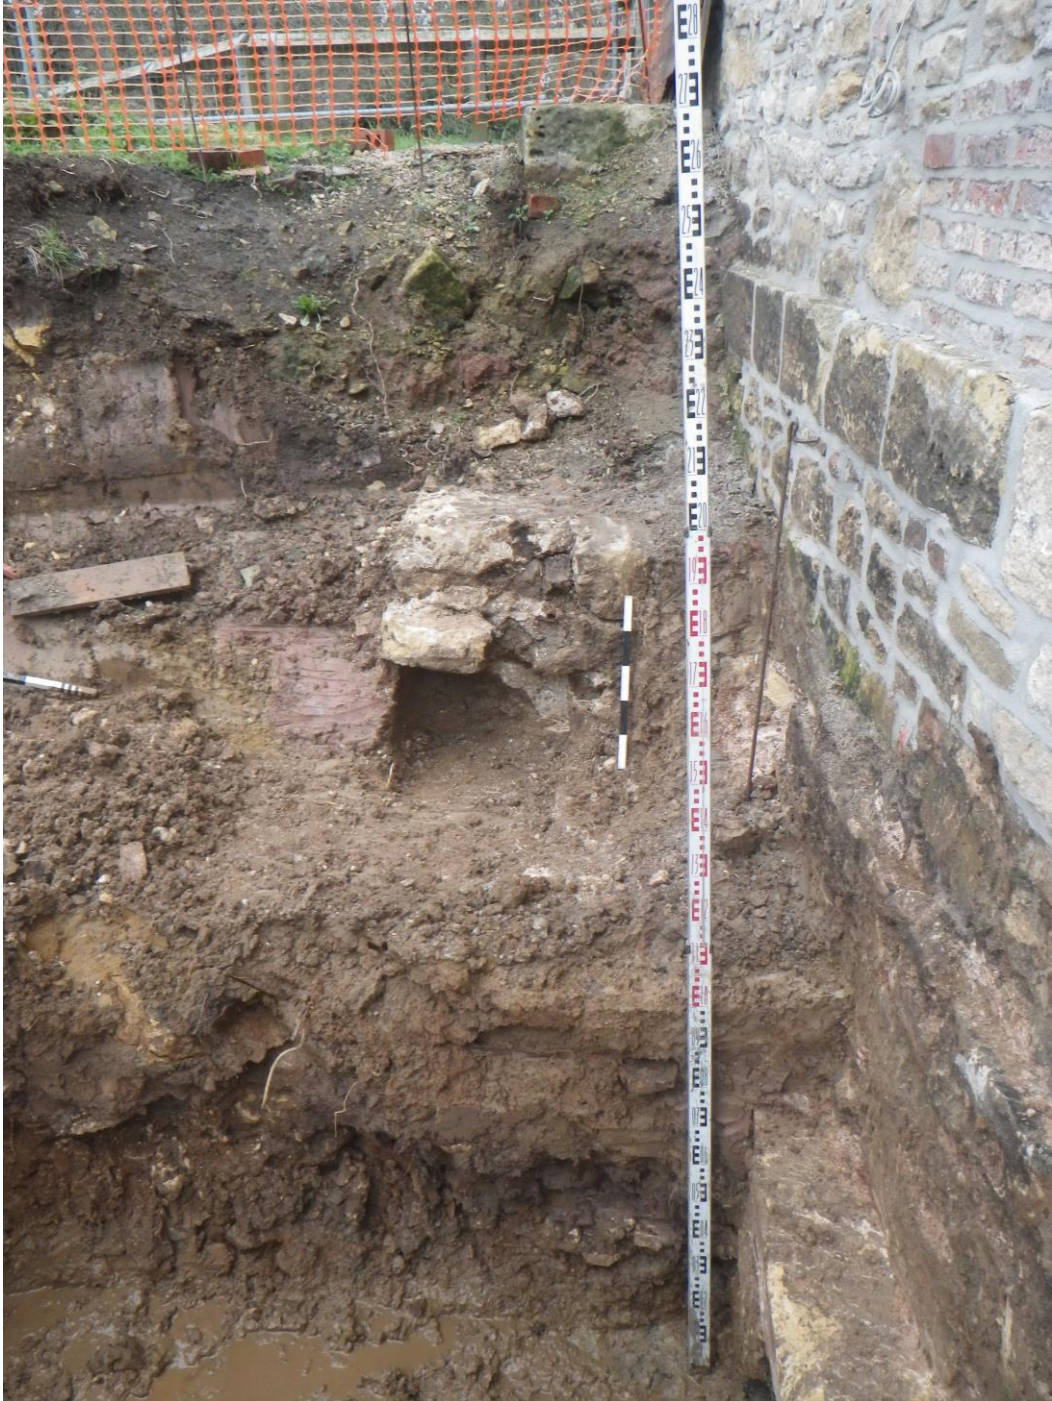
Plate 32 Multi-level shot of the foundations for the early wall 116 (centre) juxtaposed with the early footings 117 (right) of the current mill, with deposits associated with both construction horizons visible both below and to the left. Looking north. 1m scale and surveying staff to height of 2.8m

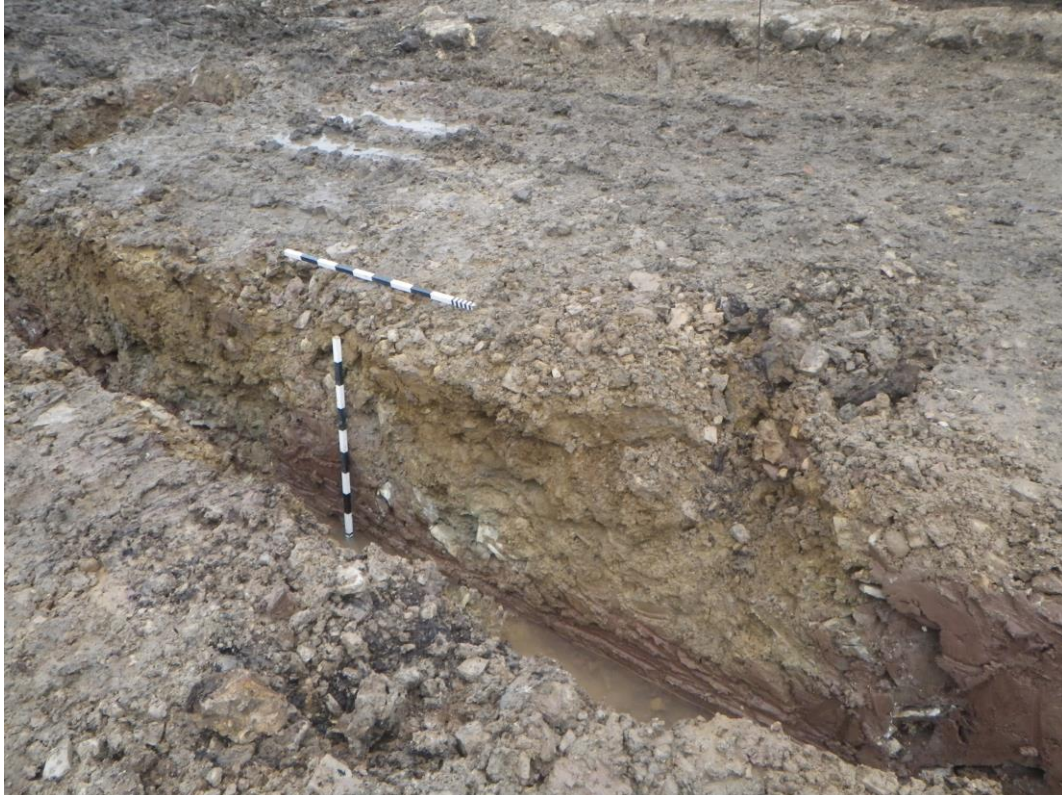
Plate 36 View of the typical stratigraphy in the strip foundation trenches to the south and west of the mill, looking north-west, 1m scales

Part of the works in this area also encompassed the excavation of foundation trenches for the new large extension which was attached to the southwest corner of the mill. The strip foundations covered an area measuring 14.75m north-west-south-east and up to 9.12m south-west-north-east and ranged between 1.00m and 1.45m deep (Figure 2, Plates 35 and 36). The main component seen within the trenches was natural clay 110. This formed the basal layer seen throughout. However, there was also evidence of some disturbance, in the form of what appeared to be a deliberate attempt at ground raising or levelling. Stony layer 136, appeared consistently throughout the foundation trenches, at varying levels. The variation in the levels appears to have occurred through possible infilling of glacial scarring, or as a result of clay being removed for other purposes and backfilled with 136. The thickness varied between 0.30m and 1.00m.
