ARCHAEOLOGICAL WATCHING BRIEF

**NORTON WATERMILL
NORTON MILL LANE
NORTON
DONCASTER
SOUTH YORKSHIRE**

Humber Field Archaeology Report no. 2098

**AN
ARCHAEOLOGICAL
WATCHING BRIEF
AT
NORTON WATERMILL
NORTON MILL LANE
NORTON
DONCASTER
SOUTH YORKSHIRE
2017/2018**

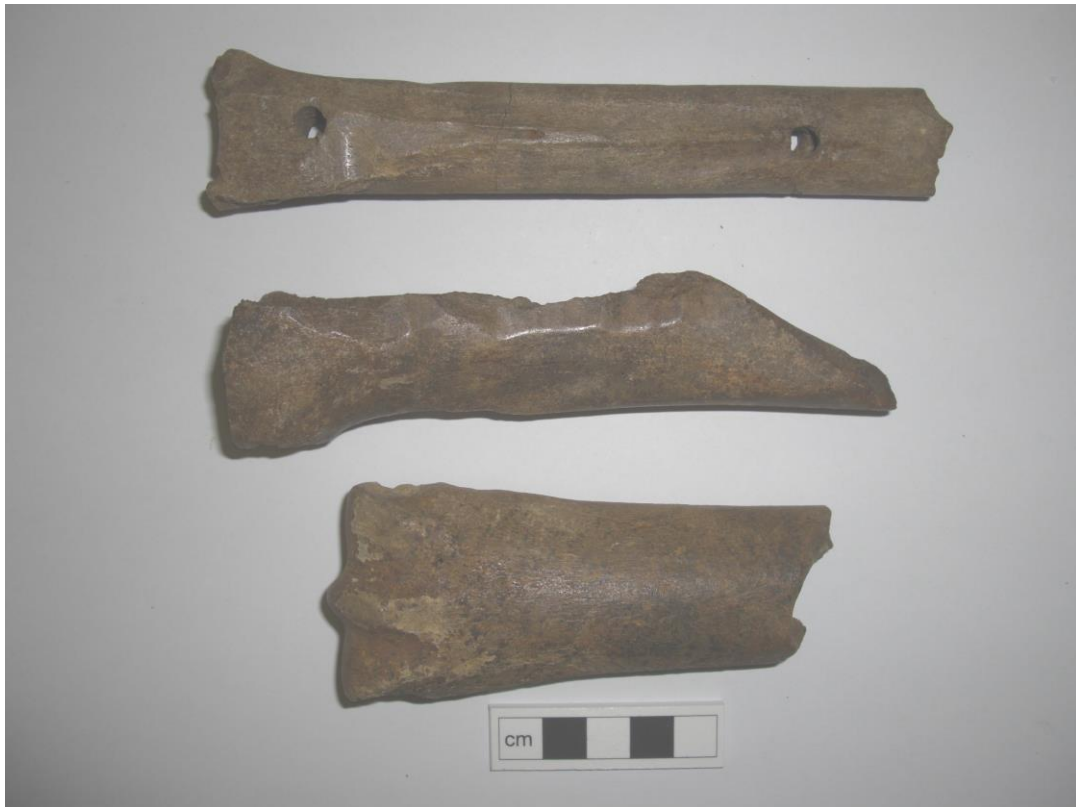
Plate 37 The three possible bone skates, showing polished wear on the undersides. From top: recorded finds 1, 2 and 3. 0.05m scale

The recorded finds consisted of three objects of worked animal bone. All three were found together, recovered from the backfill of the mill foundations (context 104). These three items all appear to have been manufactured using the limb bones of members of the equid family (horse). The first two skates could possibly have been made using the bones of a single animal; the third is from a larger animal.

Although they do not compare with the more carefully-made bones skates, they could all have conceivably functioned as ice skates made in a more perfunctory and ad hoc fashion. The wear which they have would be consistent with this use, though none appear to have seen lengthy use. Horse limb bones are relatively common materials chosen for the manufacture of ice skates, with their robusticity an obvious factor in the choice.

RF 1 Bone ?skate Made from the metatarsal of a small equid (horse family). Proximal end trimmed around the edges of the articular surface removing any protuberances, distal end cut on the diagonal. Two holes, 5-6mm diameter drilled through the shaft, 15mm from each end. Closer to the proximal end between these two holes a shallow scoop has been cut and smoothed either during manufacture or wear. One distal side has trimmed to form a flat surface, which shows some polish, through wear.

RF 2 Bone ?skate Fragmentary. Possibly made from the radius of a small equid (horse family). One articular surface cut through to form a flat surface. One longitudinal face knife-trimmed to form a flat surface, which has polish through wear. Other parts of the shaft show some modification by use of a file or rasp. Proximal end missing and shaft broken lengthways.

RF 3 Bone ?skate Fragmentary. Distal end of equid (horse family) metatarsal which has broken mid shaft. The break does appear to have some signs of wear, which may have been around the edge of a transverse drilled hole. One surface, which shows signs of polish (?through wear) has been slightly modified using a file or hasp.

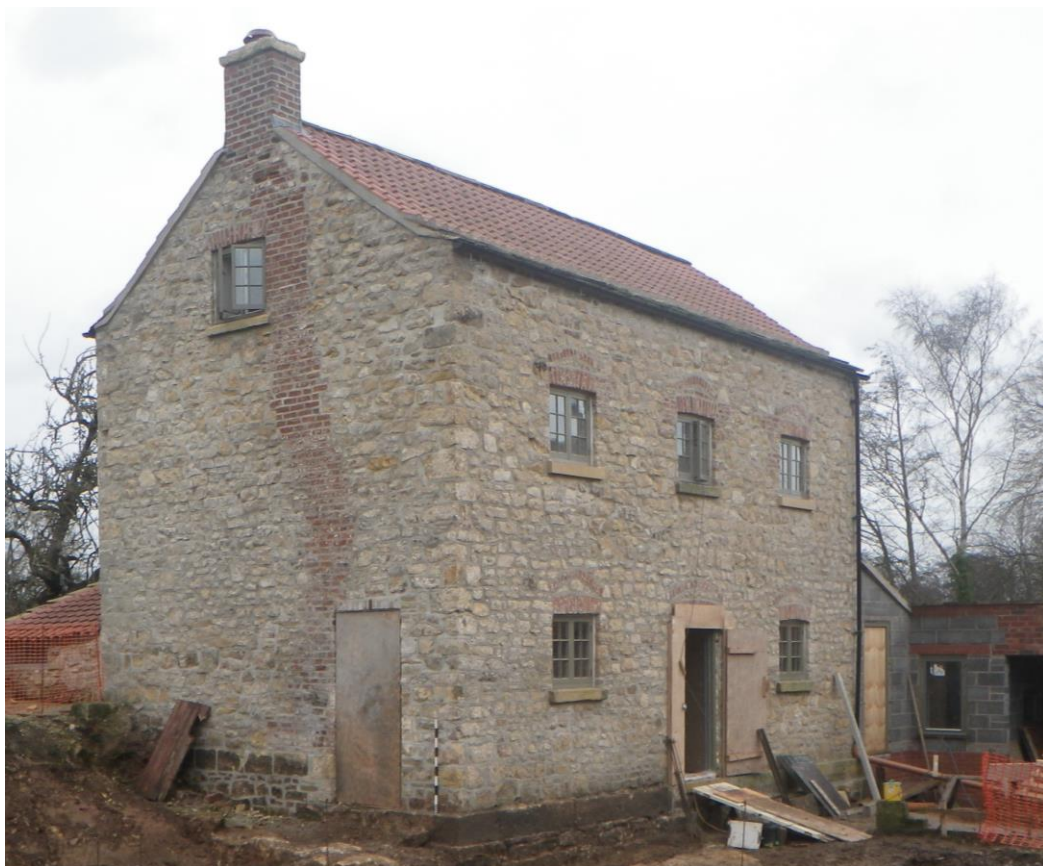
Plate 38 The south and west elevations of the mill after the removal of the render, looking north-east. 1m scale

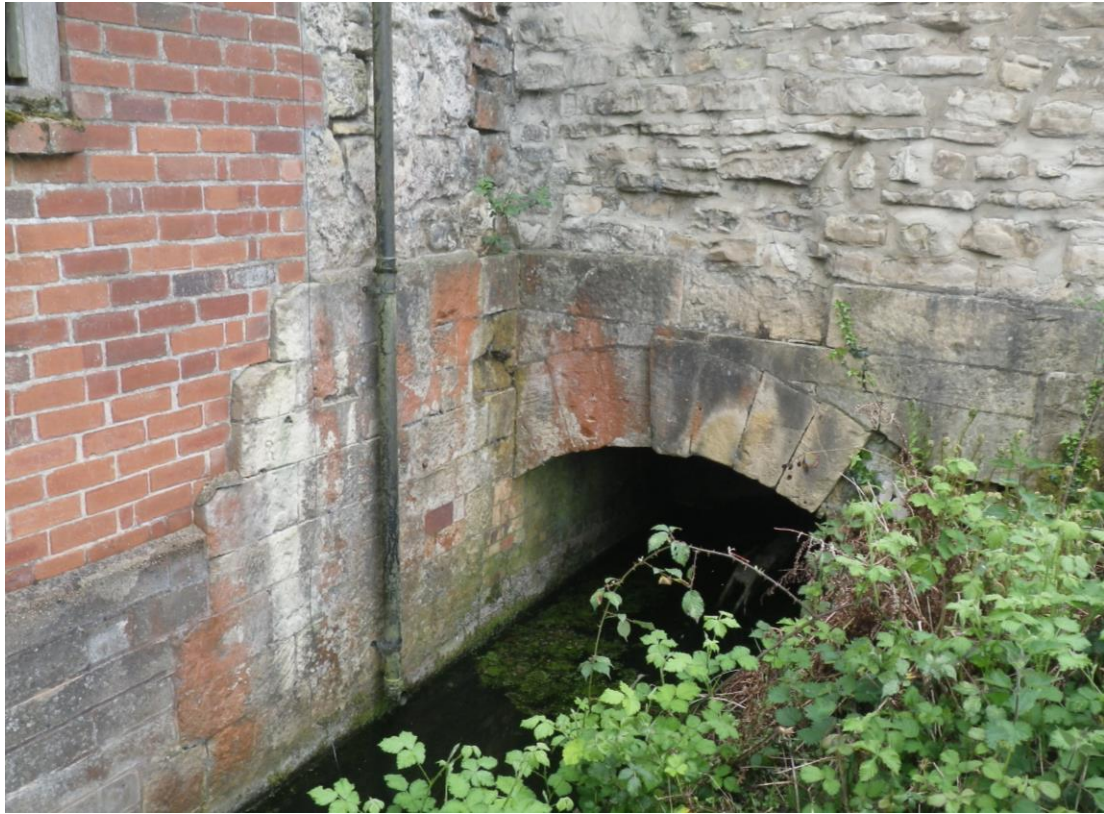
Plate 39 The arch at the east end of the wheelhouse, looking south-west
