**ARCHAEOLOGICAL MONITORING AND RECORDING  
AT  
PLOT 1  
COLLEGE ROAD  
EAST HALTON  
NORTH LINCOLNSHIRE**

**Humber Field Archaeology Report no. 2125**

*Work carried out for Mr A. Whitehead*

Planning Reference:	PA/2016/704	&
	PA/2018/101	
National Grid Reference:	TA 1383 1965	
HFA Site Code:	WB2019.021	
Museum Reference:	EHAV

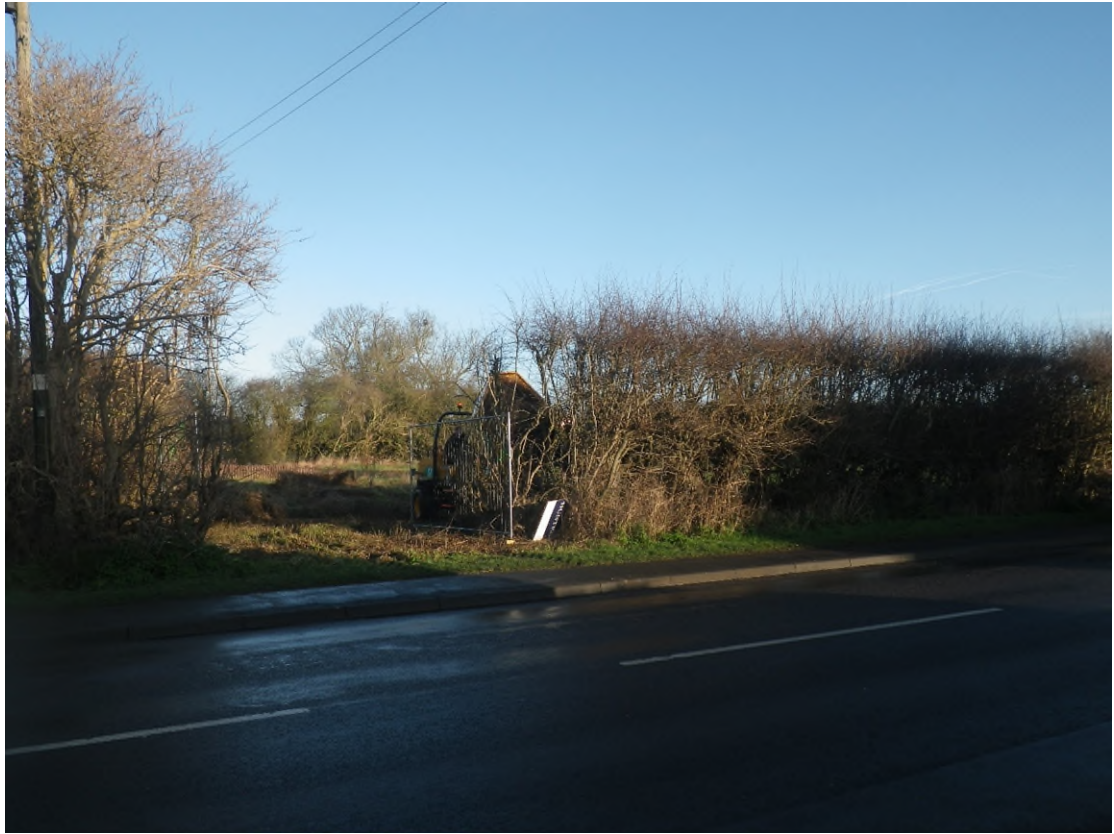
Plate 1 The site of the development, looking N

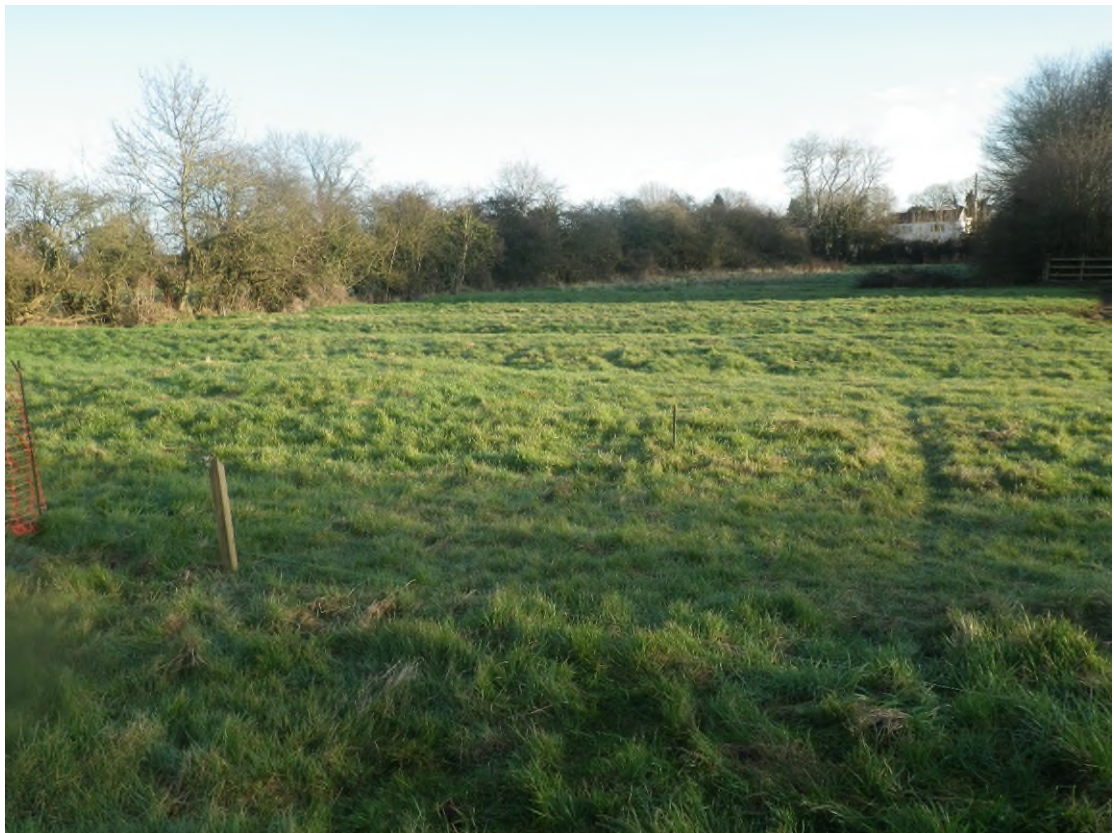
Plate 2 The extant ridge a furrow east of Plot 1 (view from centre of Plot 1), looking E

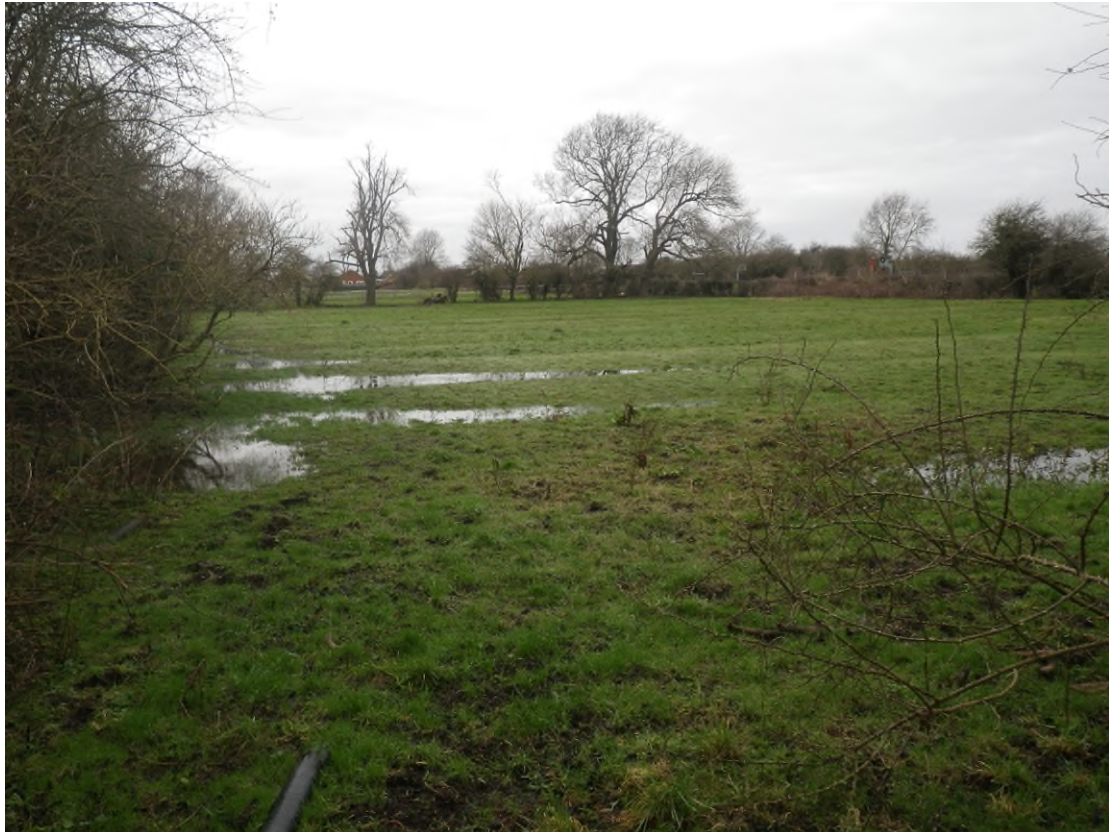
Plate 3 View of the field immediately to the N of Plot 1, showing extant medieval ridge and furrow, looking W

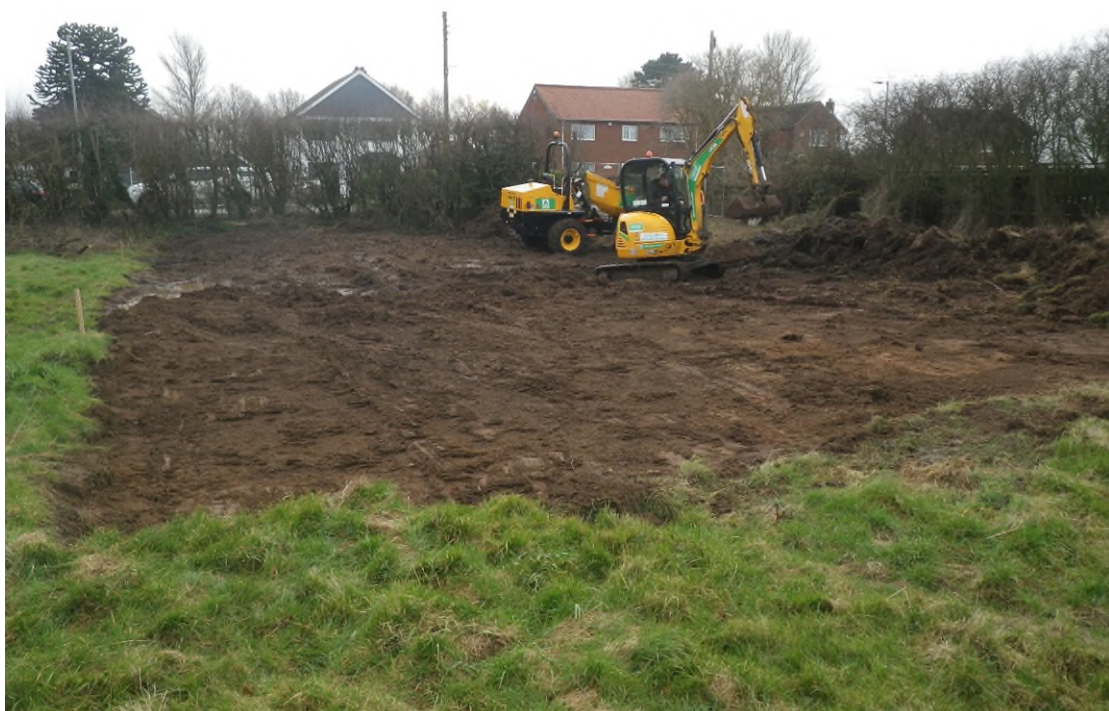
The site strip covered an area measuring 32.35m NNW-SSE, 20.60m WSW-ENE covering an area of 683.73m<sup>2</sup> with a perimeter of 107.02m. The depth of the strip averaged 0.05m – 0.10m, removing only, as much as possible, the overlying turf to expose the topsoil proper 101, leaving a level surface for the excavation to proceed.

Plate 4 The site undergoing the site strip, only partially removing topsoil 101, looking S

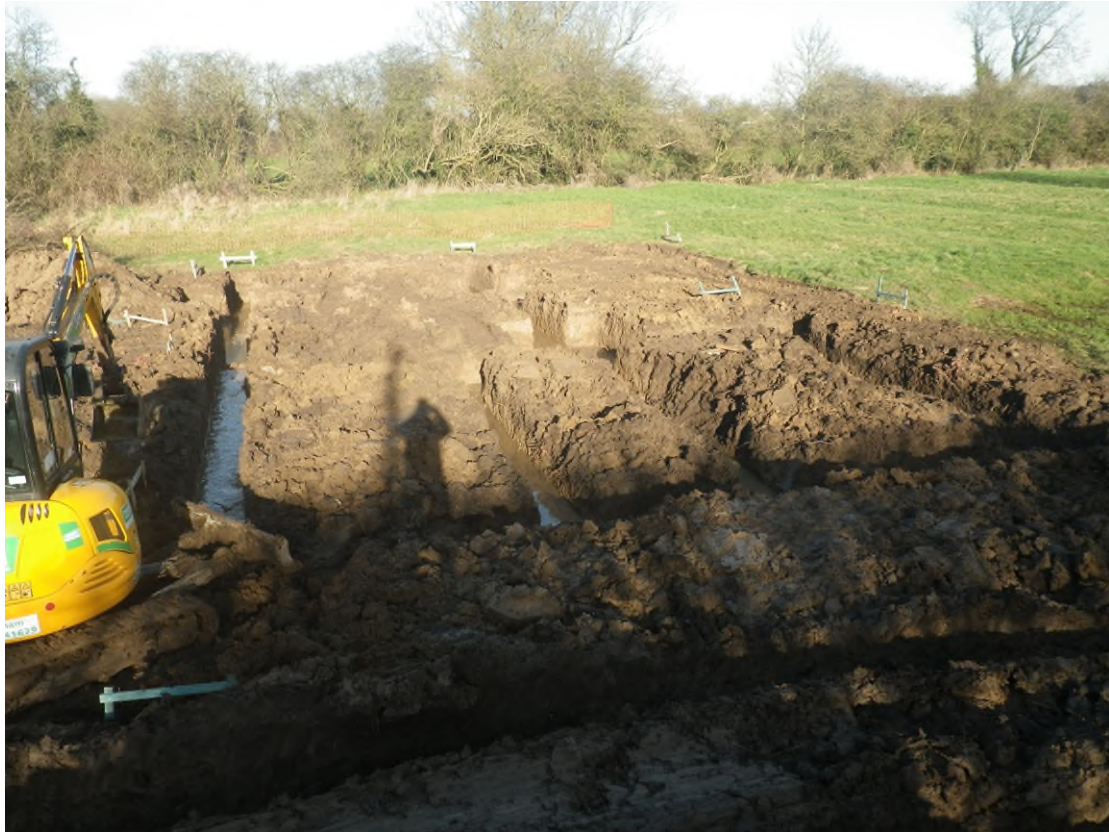
The plot was L-shaped, with its excavation limits being 17.35m NNW-SSE and 10.20m WSW-ENE. The average width of the trenches were 0.60m, and the depth up to 0.80m. During this work, ground water ingress was an issue, with parts of the trenches being up to 0.20 – 0.30m deep in water.

Plate 5 Plot 1 house foundations fully excavated, looking N

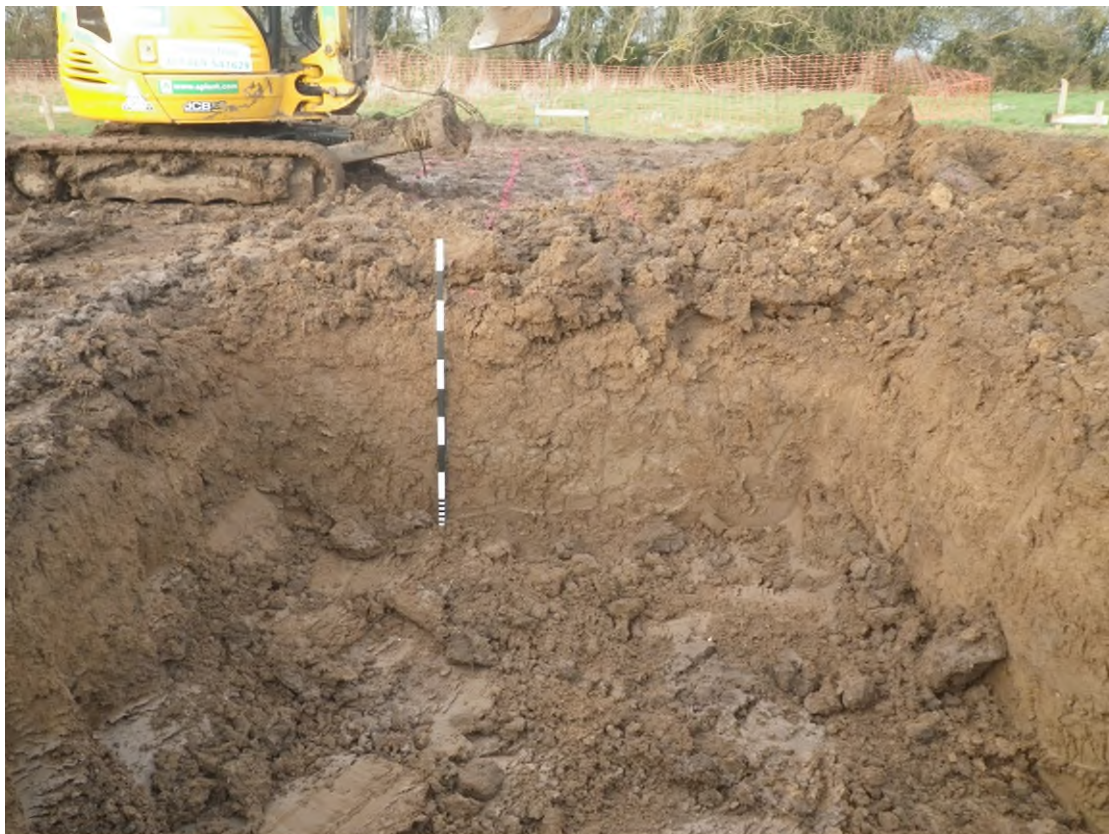
The basal deposit exposed was 102, dark orange brown clay, at least 0.30m thick and continuing below the level of excavation. This was sealed by the topsoil deposit 101, dark orange brown silt clay, which was generally 0.50m thick.

Plate 6 Sample profile view of deposits 101 and 102 in Plot 1 house foundation trenches, looking N

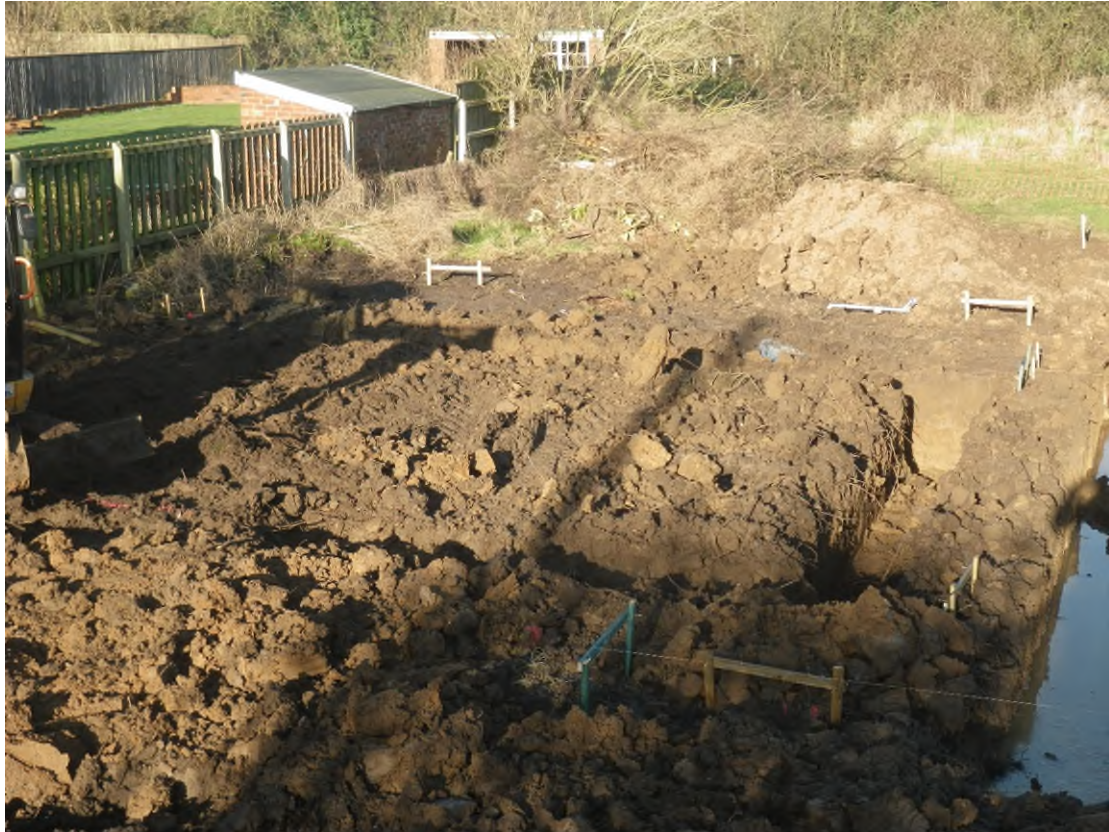
The garage was almost square in plan, its excavation limits being 6.00m NNW-SSE and 6.60m WSW-ENE. The average width of the trenches were 0.60m, and the depth up to 0.80m. As with the house foundations, ground water ingress was an issue, with parts of the trenches being up to 0.20 – 0.30m deep in water.

Plate 7 Plot 1 garage foundations fully excavated, looking NW

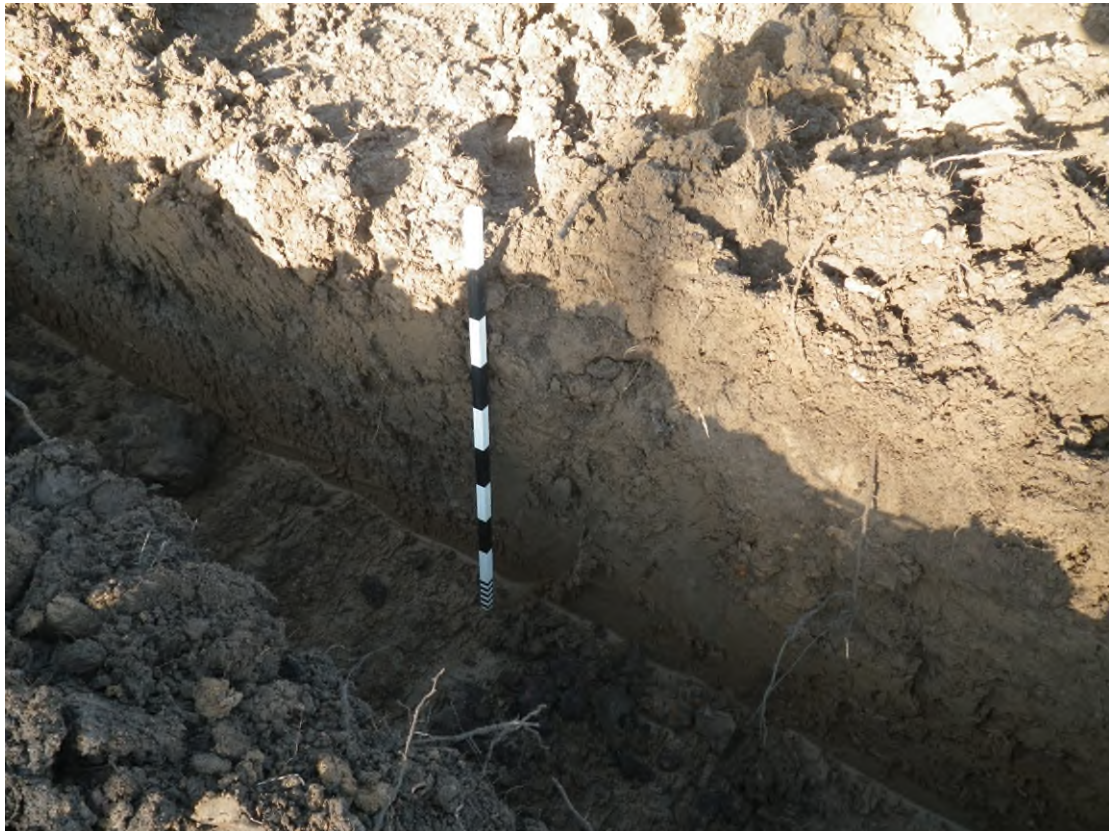
The basal deposit exposed was 102, dark orange brown clay, at least 0.30m thick which continued below the level of excavation. This was sealed by the topsoil deposit 101, dark orange brown silt clay, which was around 0.50m thick.

Plate 8 Sample profile view of deposits 101 and 102 in Plot 1 garage foundation trenches, looking SW
