## **ARCHAEOLOGICAL OBSERVATION, INVESTIGATION AND RECORDING**

**11 KV UNDERGROUNDING  
THIXENDALE  
NORTH YORKSHIRE**

**Humber Field Archaeology Report no. 2123**

*Work carried out for Northern Powergrid (Yorkshire) Plc*

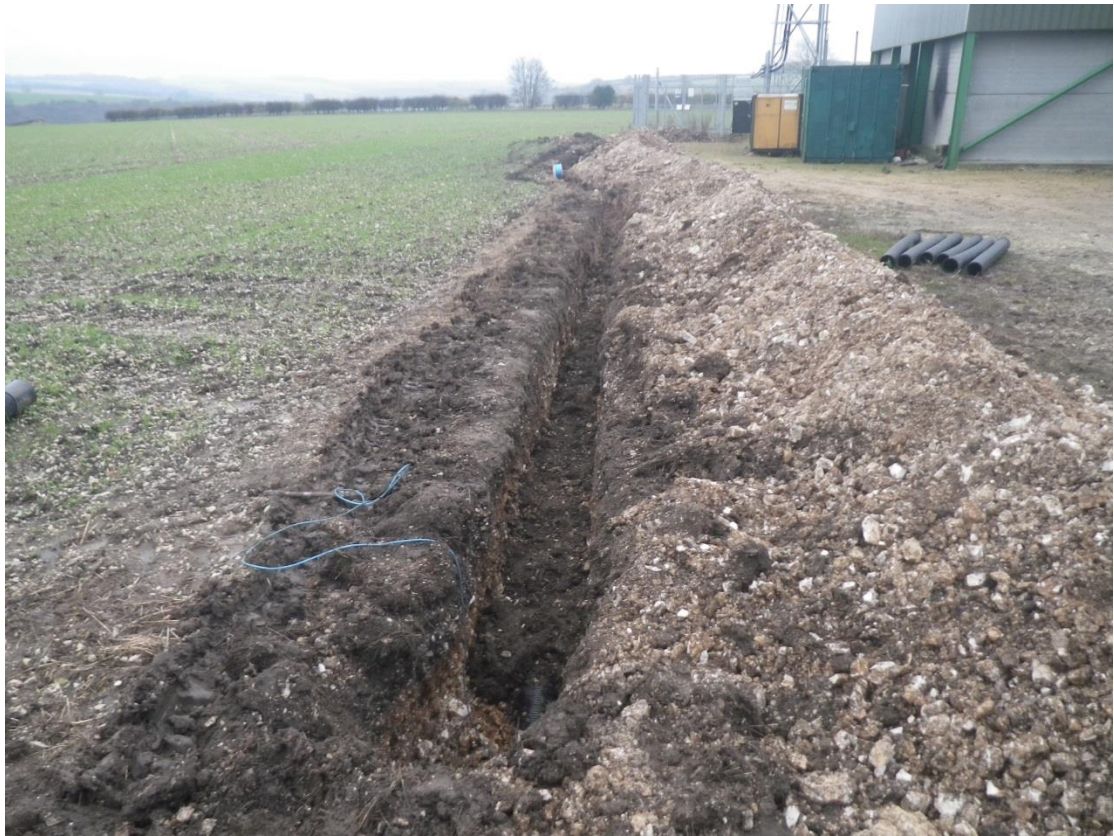
The trench in field A ran for around 300m from the transmitter tower, then along the northern edge of the field before crossing the road (*ibid*, Plates 1, 3 and 5). No archaeological features were observed within the trench. The part of the trench to the west of the transmitter tower was around 0.90m deep, there being in the base of the trench a layer at least 0.40m thick of a chalk brash within a yellow-brown clayey silt matrix (1003) (Plate 2). Above this there was a 0.30m thick layer of dark red-brown sandy silt clay containing occasional chalk fragments (1002), and a 0.20m thick layer of very dark grey-brown topsoil (1001).

Plate 1 Cable trench to the west of the transmitter tower, looking east

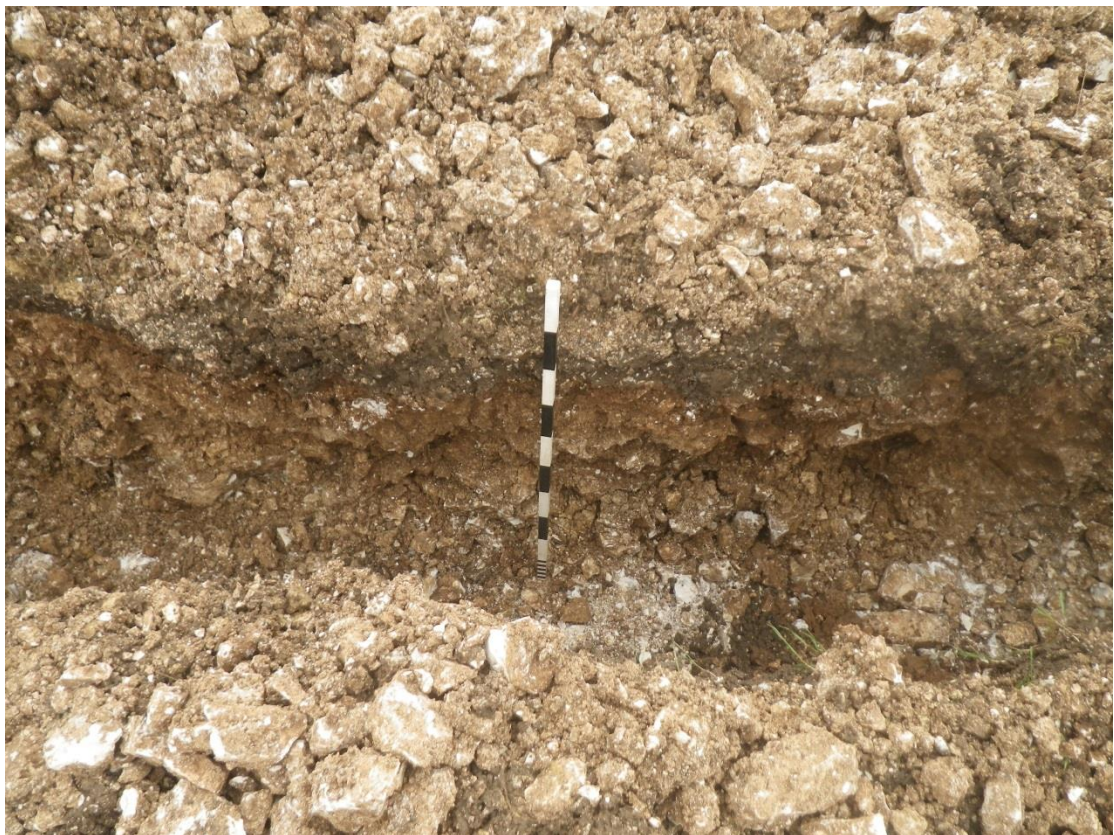
Plate 2 Contexts (1001)-(1003) in trench to west of transmitter tower (1m scale)

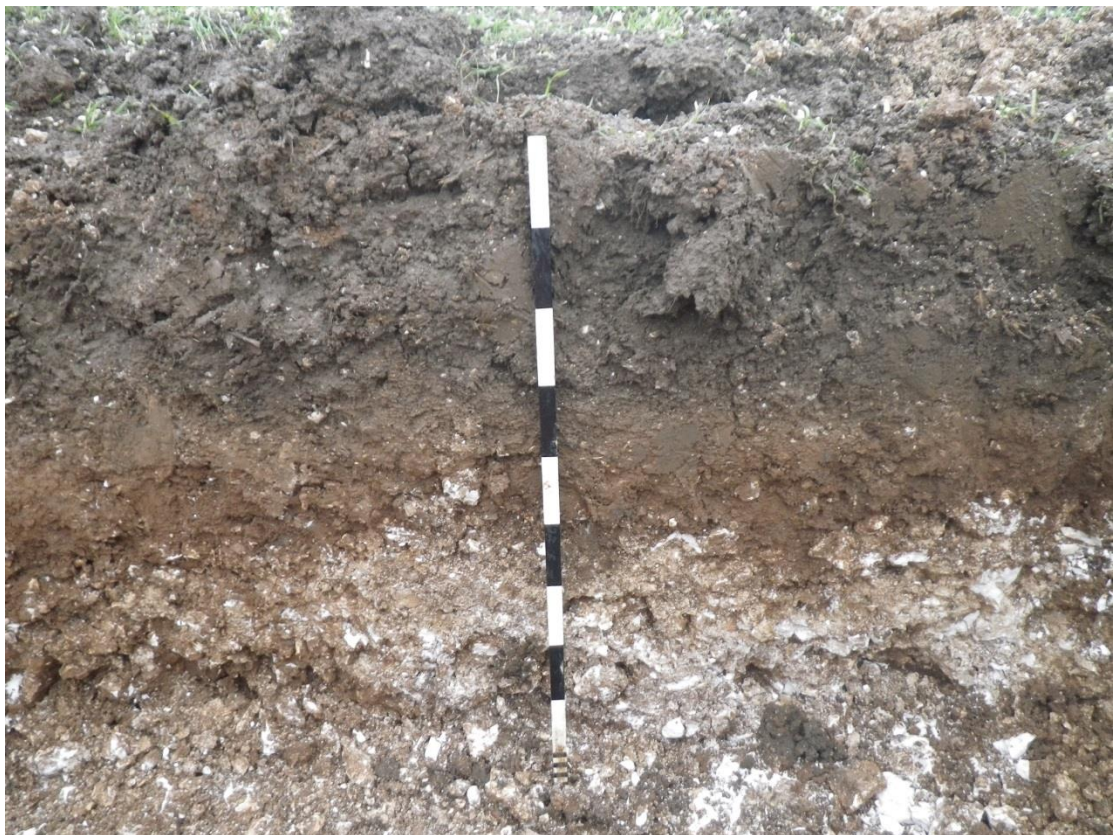
The part of the trench running along the northern edge of field A was around 1m deep, there being a layer at least 0.50m thick of (1003) in its base (Plate 4). Above this there was a 0.20m thick layer of (1002) and a 0.30m thick layer of (1001).

Plate 4 Contexts (1001)-(1003) in trench along northern edge of field A (1m scale)

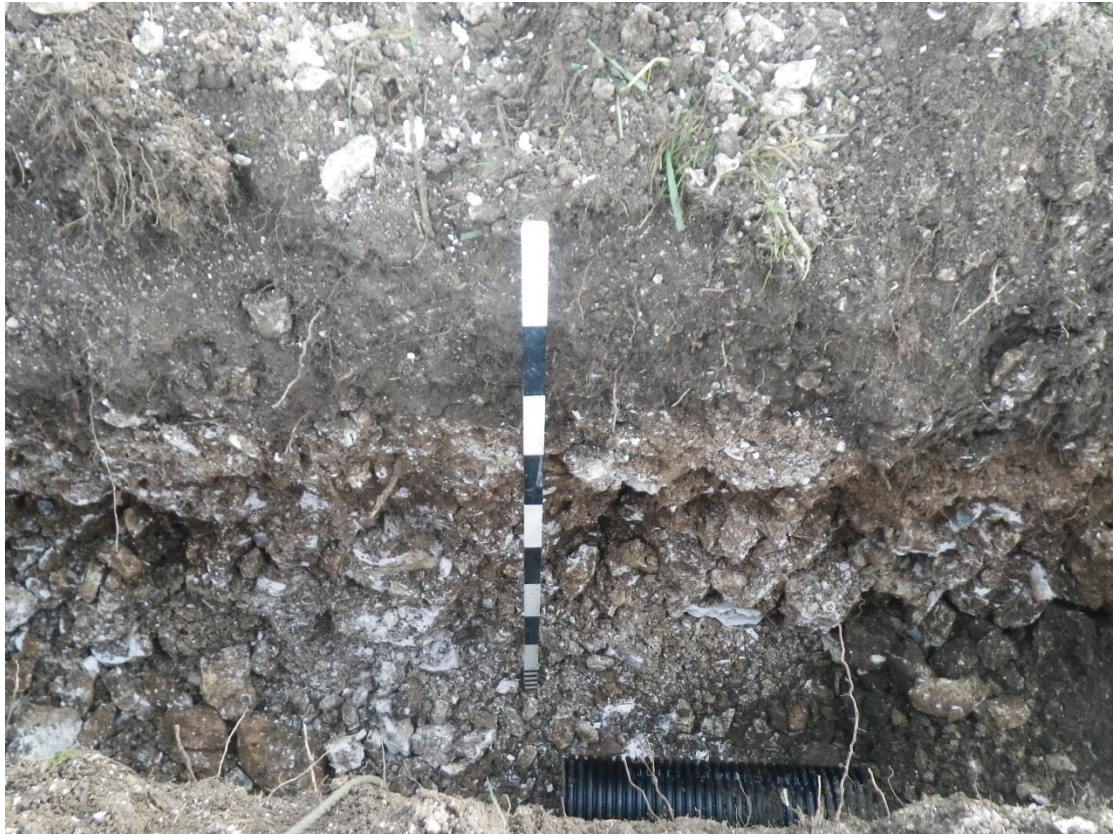
The trench in field B ran for a little over 200m (*ibid*, Plate 6). No archaeological features were observed within the trench. The trench was generally 1m deep, there being a layer of (1003) at least 0.70m thick in the base of the trench (Plate 7). The layer (1002) clearly observed in field A was virtually absent here, though the upper part of the clayey silt matrix of the 1002 was nearer to red-brown in colour. The 1003 was topped by a 0.30m thick layer of (1001).

Plate 7 Contexts (1001)-(1003) in trench running along southern edge of field B (1m scale)

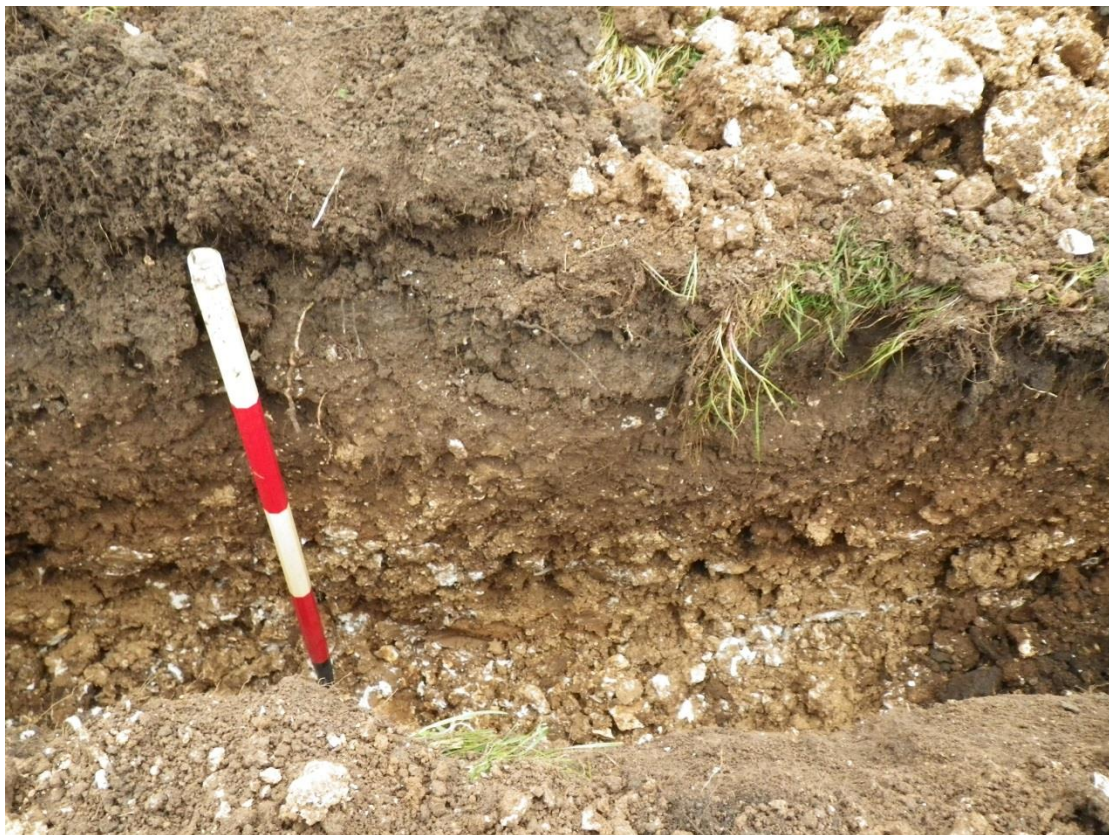
The trench in field C ran for around 150m (Figure 3, Plates 9, 11, 12 and 14). The trench was generally 1m deep, there being a layer of (1003) at least 0.60m thick in the base of the trench (Plate 10). Above this there was a 0.20m thick layer of (1002) and a 0.20m thick layer of (1001).

Plate 10 Contexts (1001)-(1003) in the eastern end of the trench in field C (1m scale)

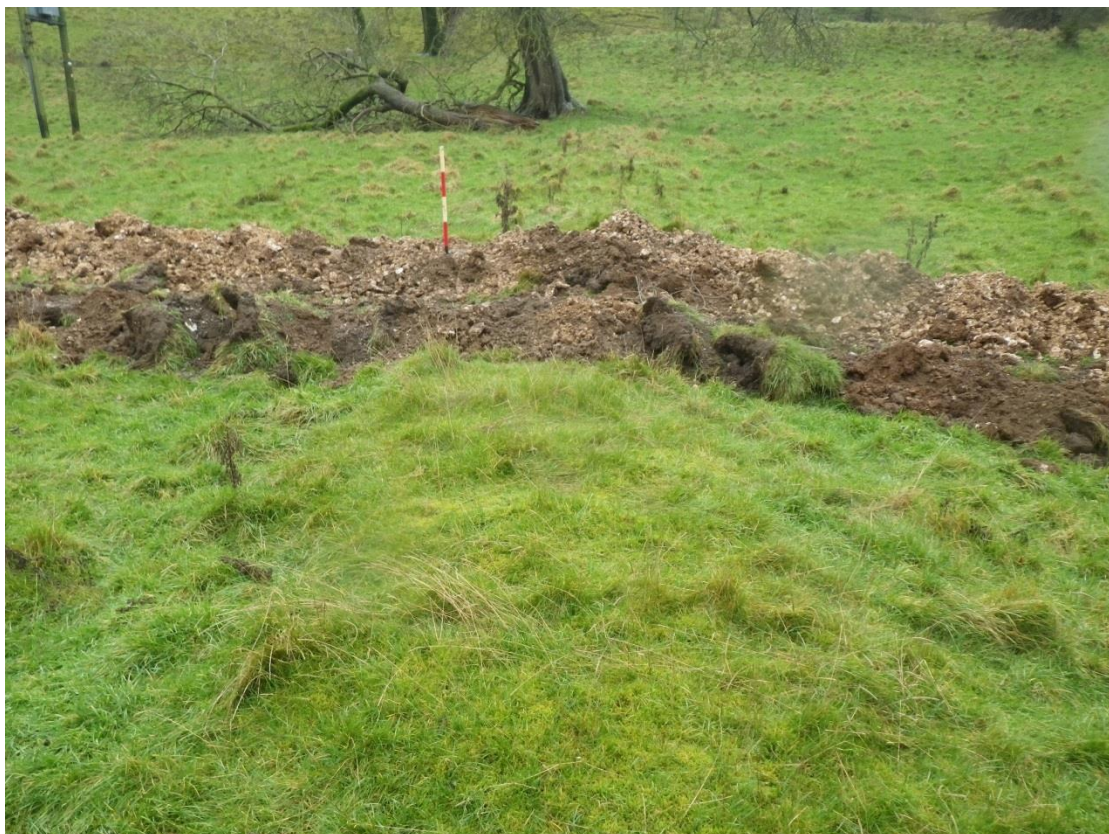
The central part of the trench cut through a low earth bank around 2m wide and up to 0.50m high that ran on a roughly north-east to south-west orientation from the north-east boundary

of the field (Figure 3, Plate 12). Immediately to the east of where the trench cut the bank a ditch cut could be seen in the 1003. The cut [1004] was up to 0.60m wide, 0.55m high and of unknown length, with concave sides merging imperceptibly into a concave base (Plate 13). The fill of 1004 consisted of a very dark grey-brown clayey silt containing occasional chalk fragments (1005).

Plate 12 The trench crossing the earth bank, looking south-west. The 1m scale marks the position of the associated ditch [1004]

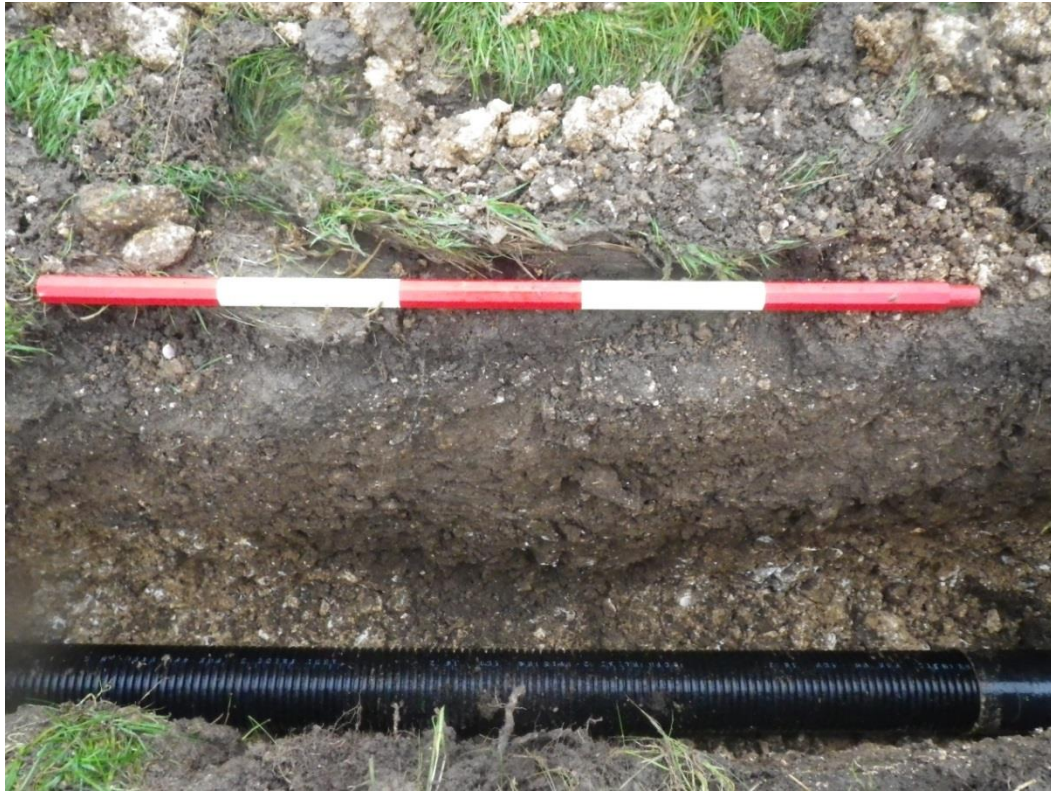
The ditch 1004 was very likely of medieval date, forming part of the property division indicated by the presence of the earth bank immediately to its west.

Plate 13 The backfilled ditch [1004] (1m scale)

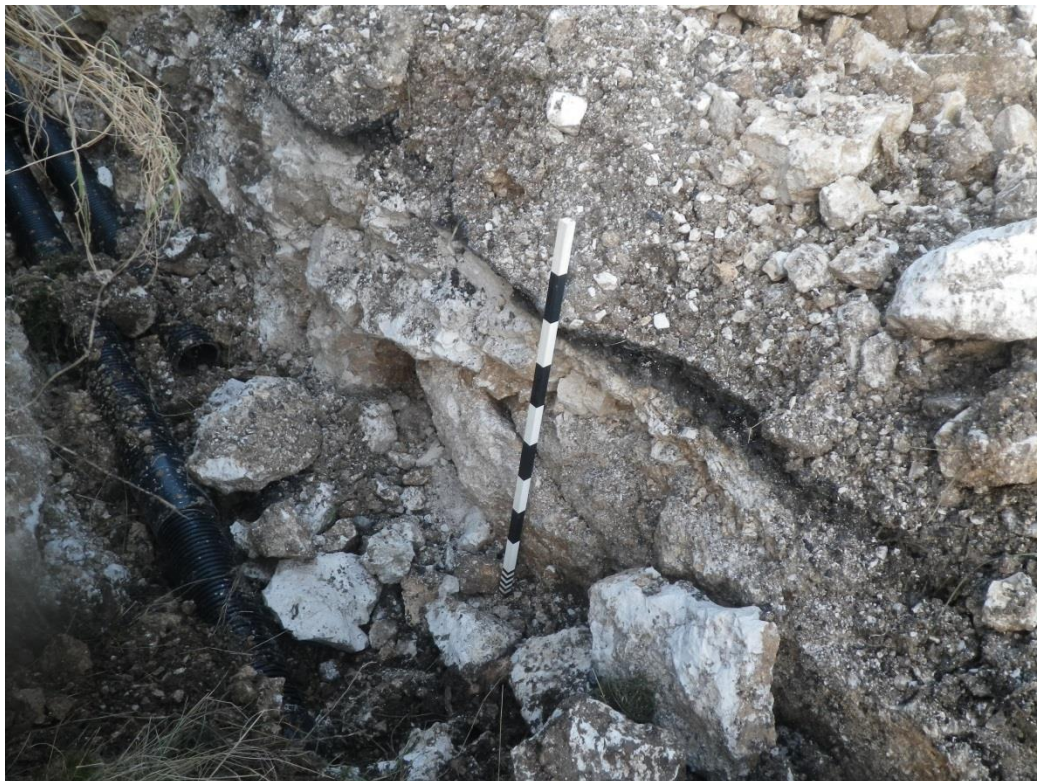
This was outside the remit of the recording programme though it is noted here that it was excavated in the northern edge of the road for around 150m, before crossing over and continuing in the southern edge for another 170m (*ibid*, Plates 8, and 15). It is worthy of note that chalk bedrock predominated in the final 20m or so of the road trench prior to its carrying on in field C (Plate 16).

Plate 16 Chalk beneath road in trench immediately to the west of the junction with the trench excavated in field C
